Memorandum

To: Scot Sokolowski, NAVFAC MIDLANT
From: David Brayack, Tetra Tech
Date: November 17, 2022
Re: Annual LUC Inspection and Operation Summary Report: Sites 1, 2, 3, and 4 –
NWIRP Bethpage
Contract/CTO Number: N6247016D9008/WE16

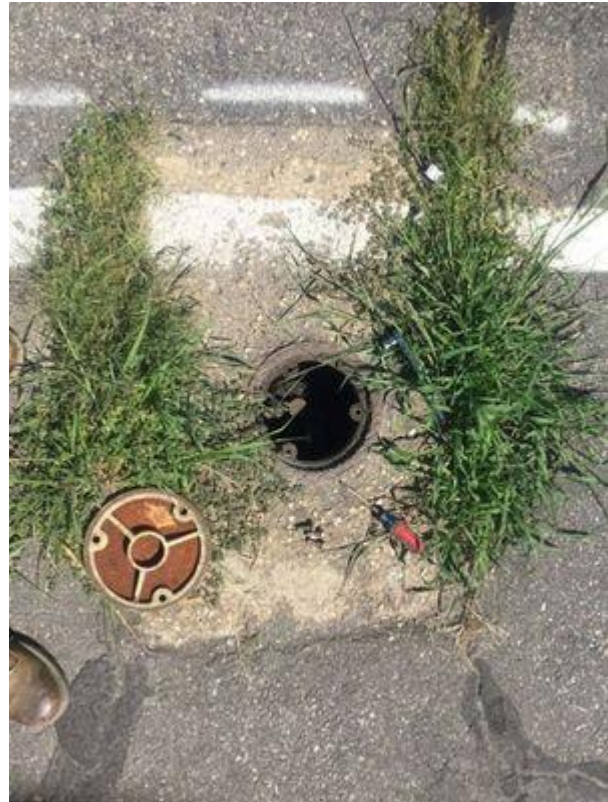
Client: Navy CLEAN	Facility: NWIRP Bethpage
Project Number: 112G08005-WE13	Location: Bethpage, New York
Date: September 2, 2022 11:59	Personnel: Jake Marlow
Well ID: BPGMMW17D	Well Location: 211382.161 1122827.429
Well Status: In Use (Confirmed)	Screen Interval: 278-298
WELL INVENTORY CONDITION	
Concrete pad in acceptable condition i.e. no cracks?	YES
Manhole cover present and in working condition?	YES
All bolts on manhole present and not stripped?	NO
Well plug present, locked and in good working condition?	YES
OVERALL CONDITION:	GOOD
Notes (Explain if answered No to any of the above) Missing bolt

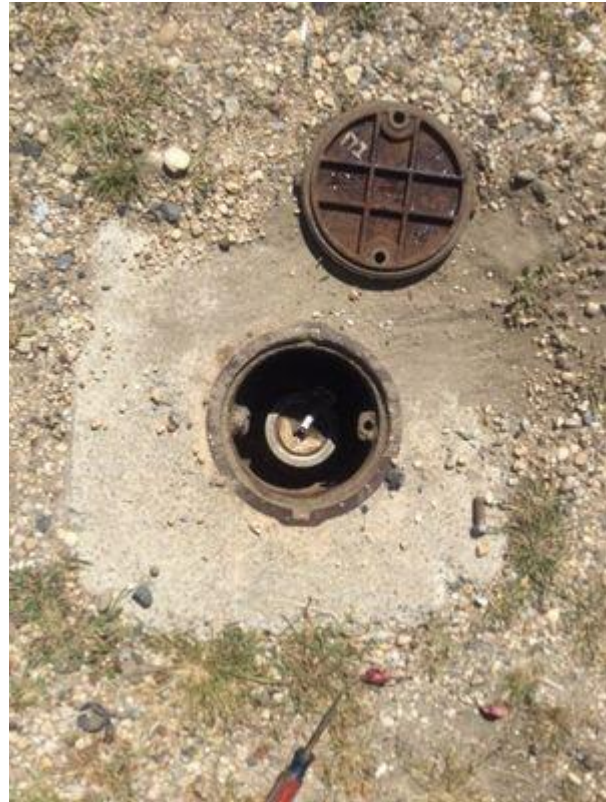
Client: Navy CLEAN	Facility: NWIRP Bethpage
Project Number: 112G08005-WE13	Location: Bethpage, New York
Date: September 2, 2022 11:56	Personnel: Jake Marlow
Well ID: BPGMMW17I	Well Location: 211391.428 1122830.969
Well Status: In Use (Confirmed)	Screen Interval: 100-120
WELL INVENTORY CONDITION	
Concrete pad in acceptable condition i.e. no cracks?	NO
Manhole cover present and in working condition?	YES
All bolts on manhole present and not stripped?	NO
Well plug present, locked and in good working condition?	YES
OVERALL CONDITION:	GOOD
Notes (Explain if answered No to any of the above) Cracked pad, missing bolt

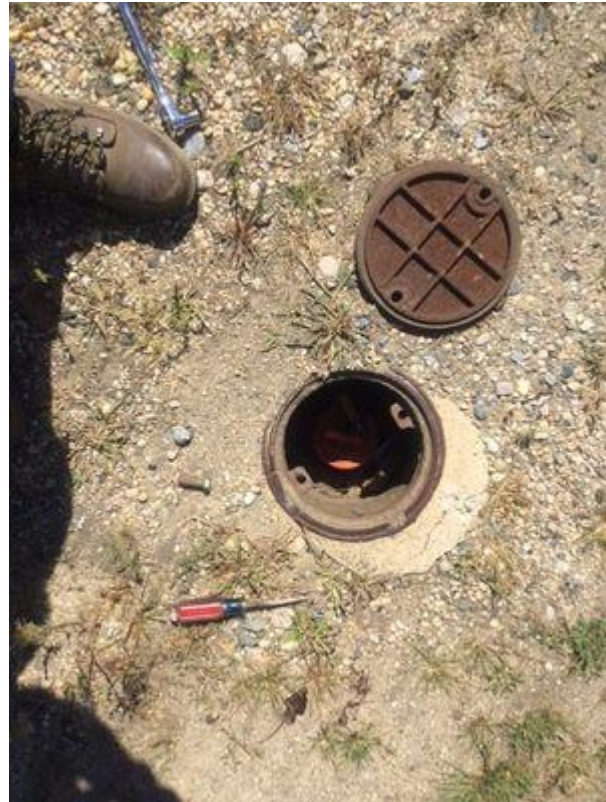
Client: Navy CLEAN	Facility: NWIRP Bethpage
Project Number: 112G08005-WE13	Location: Bethpage, New York
Date: September 2, 2022 11:46	Personnel: Jake Marlow
Well ID: BPGMMW18D	Well Location: 210403 1123701
Well Status: In Use (Confirmed)	Screen Interval: 290-300
WELL INVENTORY CONDITION	
Concrete pad in acceptable condition i.e. no cracks?	YES
Manhole cover present and in working condition?	YES
All bolts on manhole present and not stripped?	NO
Well plug present, locked and in good working condition?	YES
OVERALL CONDITION:	FAIR
Notes (Explain if answered No to any of the above) Two bolts sheared off in manhole

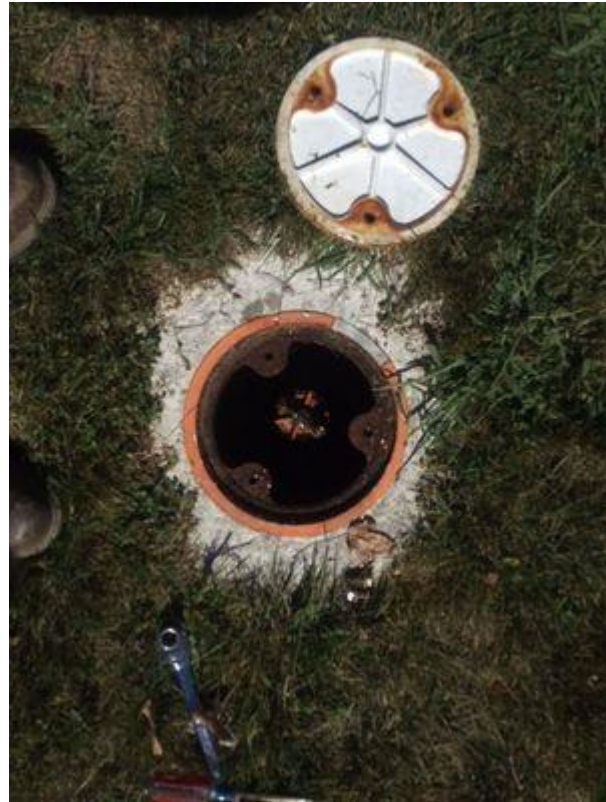
Client: Navy CLEAN	Facility: NWIRP Bethpage
Project Number: 112G08005-WE13	Location: Bethpage, New York
Date: September 2, 2022 11:31	Personnel: Jake Marlow
Well ID: BPGMMW39D	Well Location: 209882 1124170
Well Status: In Use (Confirmed)	Screen Interval: 262-282
WELL INVENTORY CONDITION	
Concrete pad in acceptable condition i.e. no cracks?	YES
Manhole cover present and in working condition?	NO
All bolts on manhole present and not stripped?	NO
Well plug present, locked and in good working condition?	YES
OVERALL CONDITION:	POOR
Notes (Explain if answered No to any of the above) Missing bolt, manhole cover cracked where bolt goes in

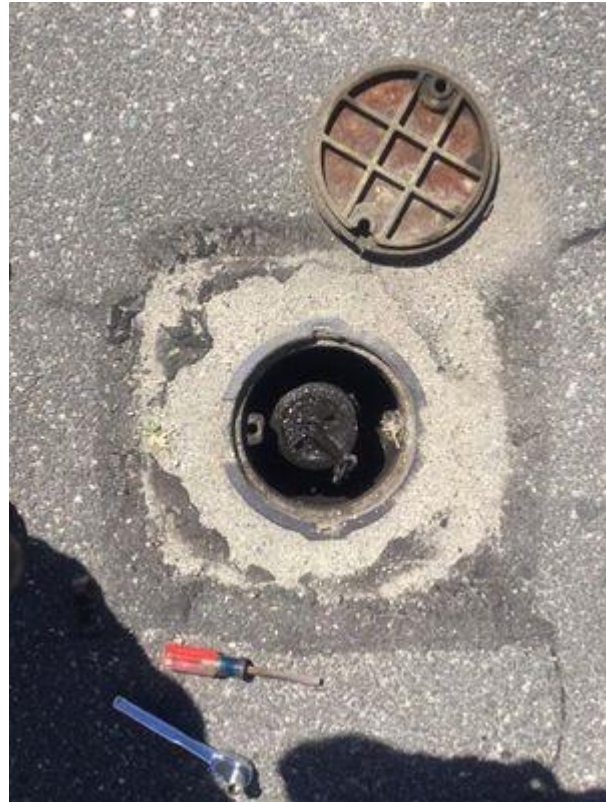
Client: Navy CLEAN	Facility: NWIRP Bethpage
Project Number: 112G08005-WE13	Location: Bethpage, New York
Date: September 2, 2022 11:28	Personnel: Jake Marlow
Well ID: BPGMMW39D2	Well Location: 209884 1124173
Well Status: In Use (Confirmed)	Screen Interval: 410-420
WELL INVENTORY CONDITION	
Concrete pad in acceptable condition i.e. no cracks?	YES
Manhole cover present and in working condition?	YES
All bolts on manhole present and not stripped?	NO
Well plug present, locked and in good working condition?	YES
OVERALL CONDITION:	FAIR
Notes (Explain if answered No to any of the above) Manhole cracked where bolts screw in

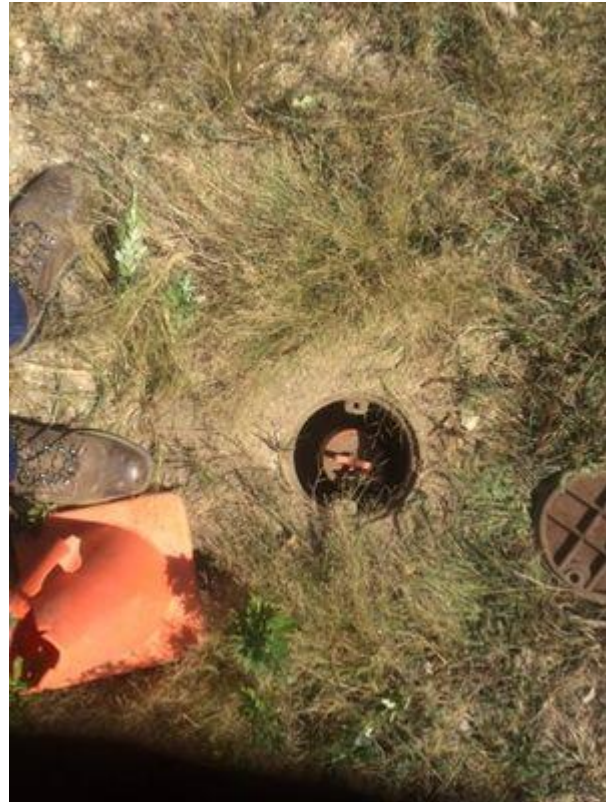
Client: Navy CLEAN	Facility: NWIRP Bethpage
Project Number: 112G08005-WE13	Location: Bethpage, New York
Date: September 2, 2022 13:32	Personnel: Jake Marlow
Well ID: BPGMMW73D2	Well Location: 209851.283 1124674.455
Well Status: In Use (Confirmed)	Screen Interval: 532-552
WELL INVENTORY CONDITION	
Concrete pad in acceptable condition i.e. no cracks?	NO
Manhole cover present and in working condition?	NO
All bolts on manhole present and not stripped?	YES
Well plug present, locked and in good working condition?	YES
OVERALL CONDITION:	FAIR
Notes (Explain if answered No to any of the above) Manhole cover does not attach to manhole, pad no longer there

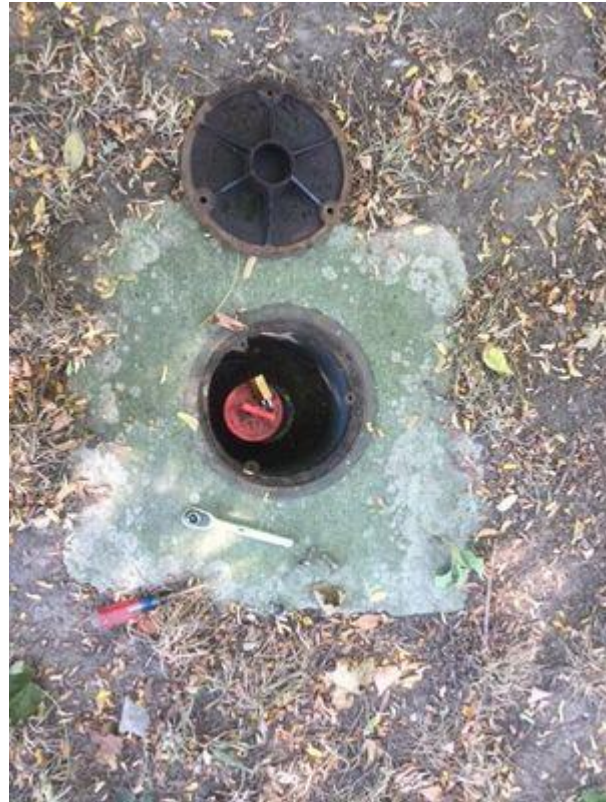
Client: Navy CLEAN	Facility: NWIRP Bethpage
Project Number: 112G08005-WE13	Location: Bethpage, New York
Date: September 1, 2022 15:28	Personnel: Jake Marlow
Well ID: BPHNMW24IR	Well Location: 214063.741045 1123251.03332
Well Status: In Use (Confirmed)	Screen Interval: 148-158
WELL INVENTORY CONDITION	
Concrete pad in acceptable condition i.e. no cracks?	YES
Manhole cover present and in working condition?	YES
All bolts on manhole present and not stripped?	NO
Well plug present, locked and in good working condition?	YES
OVERALL CONDITION:	FAIR
Notes (Explain if answered No to any of the above) Manhole stripped where bolts go in

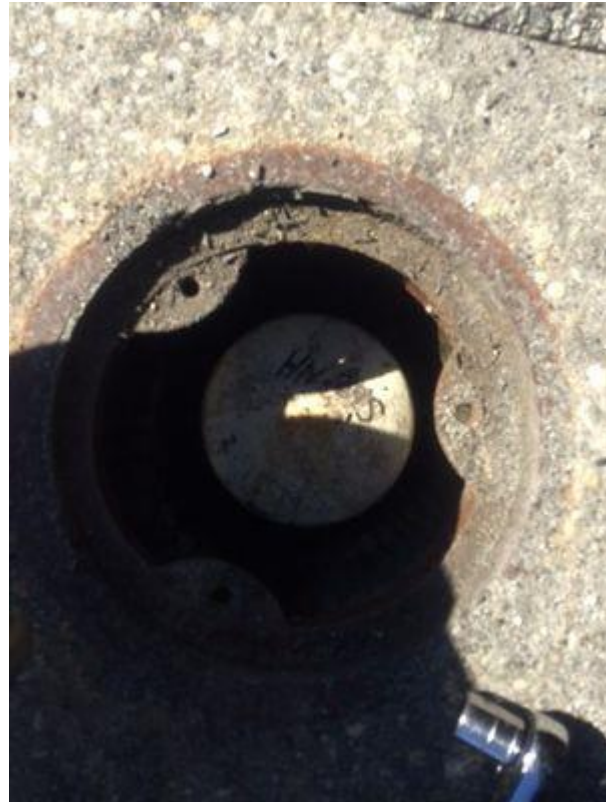
Client: Navy CLEAN	Facility: NWIRP Bethpage
Project Number: 112G08005-WE13	Location: Bethpage, New York
Date: September 1, 2022 17:11	Personnel: Jake Marlow
Well ID: BPHNMW29D	Well Location: 213933.694 1124704.902
Well Status: In Use (Confirmed)	Screen Interval: 210-220
WELL INVENTORY CONDITION	
Concrete pad in acceptable condition i.e. no cracks?	NO
Manhole cover present and in working condition?	NO
All bolts on manhole present and not stripped?	NO
Well plug present, locked and in good working condition?	YES
OVERALL CONDITION:	FAIR
Notes (Explain if answered No to any of the above) Manhole wear bolts go in is stripped, cracks in pad

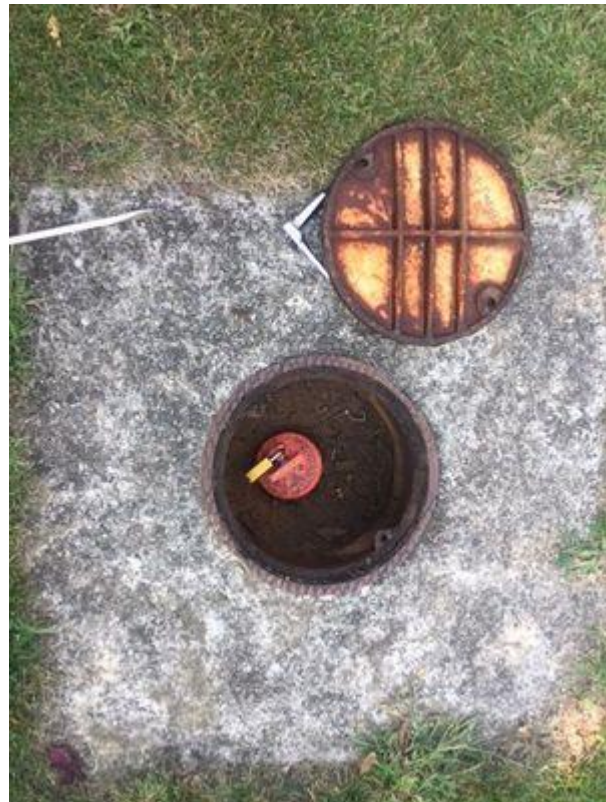
Client: Navy CLEAN	Facility: NWIRP Bethpage
Project Number: 112G08005-WE13	Location: Bethpage, New York
Date: September 16, 2022 11:46	Personnel: Jake Marlow
Well ID: BPOW 1-2	Well Location: 202009.697 1132173.169
Well Status: In Use (Confirmed)	Screen Interval: 310-335
WELL INVENTORY CONDITION	
Concrete pad in acceptable condition i.e. no cracks?	YES
Manhole cover present and in working condition?	YES
All bolts on manhole present and not stripped?	NO
Well plug present, locked and in good working condition?	YES
OVERALL CONDITION:	FAIR
Notes (Explain if answered No to any of the above) Bolts stripped on manhole

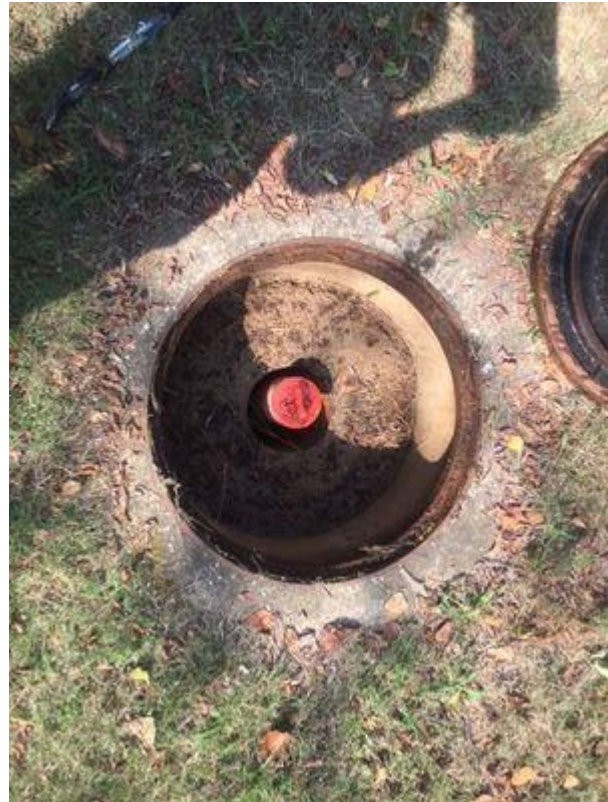
Client: Navy CLEAN	Facility: NWIRP Bethpage
Project Number: 112G08005-WE13	Location: Bethpage, New York
Date: September 16, 2022 13:20	Personnel: Jake Marlow
Well ID: BPOW 1-5	Well Location: 203315.538 1132141.261
Well Status: In Use (Confirmed)	Screen Interval: 600-650
WELL INVENTORY CONDITION	
Concrete pad in acceptable condition i.e. no cracks?	YES
Manhole cover present and in working condition?	YES
All bolts on manhole present and not stripped?	NO
Well plug present, locked and in good working condition?	YES
OVERALL CONDITION:	GOOD
Notes (Explain if answered No to any of the above) No bolts for manhole cover

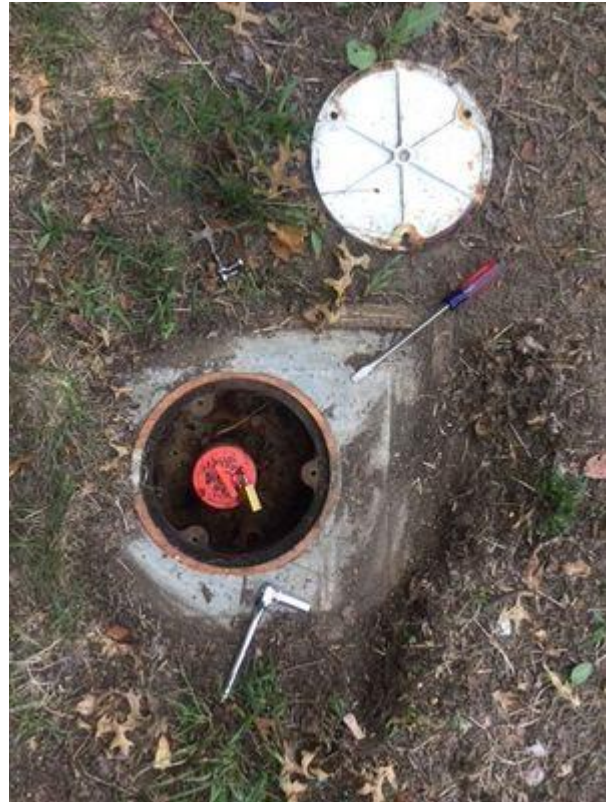
Client: Navy CLEAN	Facility: NWIRP Bethpage
Project Number: 112G08005-WE13	Location: Bethpage, New York
Date: August 17, 2022 08:52	Personnel: Beau Benfield
Well ID: BPOW 2-1	Well Location: 199726.122 1127424.086
Well Status: In Use (Confirmed)	Screen Interval: 356-396
WELL INVENTORY CONDITION	
Concrete pad in acceptable condition i.e. no cracks?	YES
Manhole cover present and in working condition?	YES
All bolts on manhole present and not stripped?	NO
Well plug present, locked and in good working condition?	YES
OVERALL CONDITION:	GOOD
Notes (Explain if answered No to any of the above) One bolt broken off inside well collar

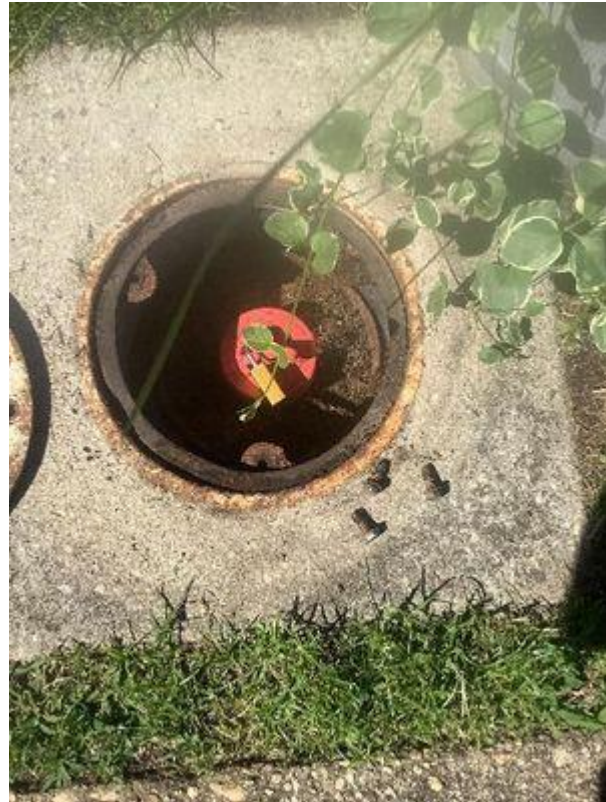
Client: Navy CLEAN	Facility: NWIRP Bethpage
Project Number: 112G08005-WE13	Location: Bethpage, New York
Date: September 2, 2022 15:33	Personnel: Beau Benfield
Well ID: BPOW 5-7	Well Location: 197274.15 1128702.39
Well Status: In Use (Confirmed)	Screen Interval: 525-550
WELL INVENTORY CONDITION	
Concrete pad in acceptable condition i.e. no cracks?	YES
Manhole cover present and in working condition?	YES
All bolts on manhole present and not stripped?	YES
Well plug present, locked and in good working condition?	YES
OVERALL CONDITION:	GOOD
Notes (Explain if answered No to any of the above) Needs backfill around riser

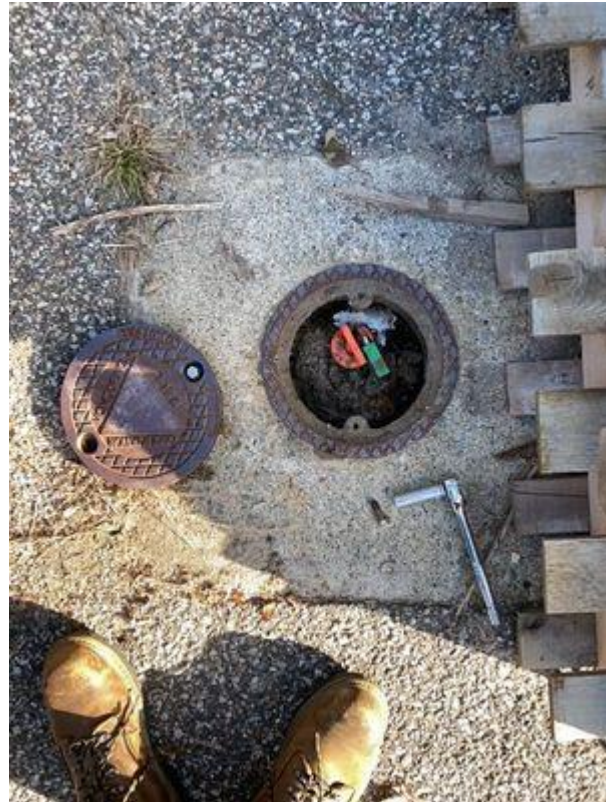
Client: Navy CLEAN	Facility: NWIRP Bethpage
Project Number: 112G08005-WE13	Location: Bethpage, New York
Date: September 16, 2022 14:41	Personnel: Jake Marlow
Well ID: BPS1-TT-MW30211	Well Location: 213812.87 1124251.046
Well Status: In Use (Confirmed)	Screen Interval: 110-120
WELL INVENTORY CONDITION	
Concrete pad in acceptable condition i.e. no cracks?	YES
Manhole cover present and in working condition?	NO
All bolts on manhole present and not stripped?	NO
Well plug present, locked and in good working condition?	YES
OVERALL CONDITION:	FAIR
Notes (Explain if answered No to any of the above) Manhole cover cracked and missing bolt
