**2008 FIVE-YEAR
REVIEW FOR SITES 1, 2, AND 3**

NWIRP BETHPAGE
Bethpage, New York

**Naval Facilities Engineering Command
Mid-Atlantic**

DECEMBER 2008

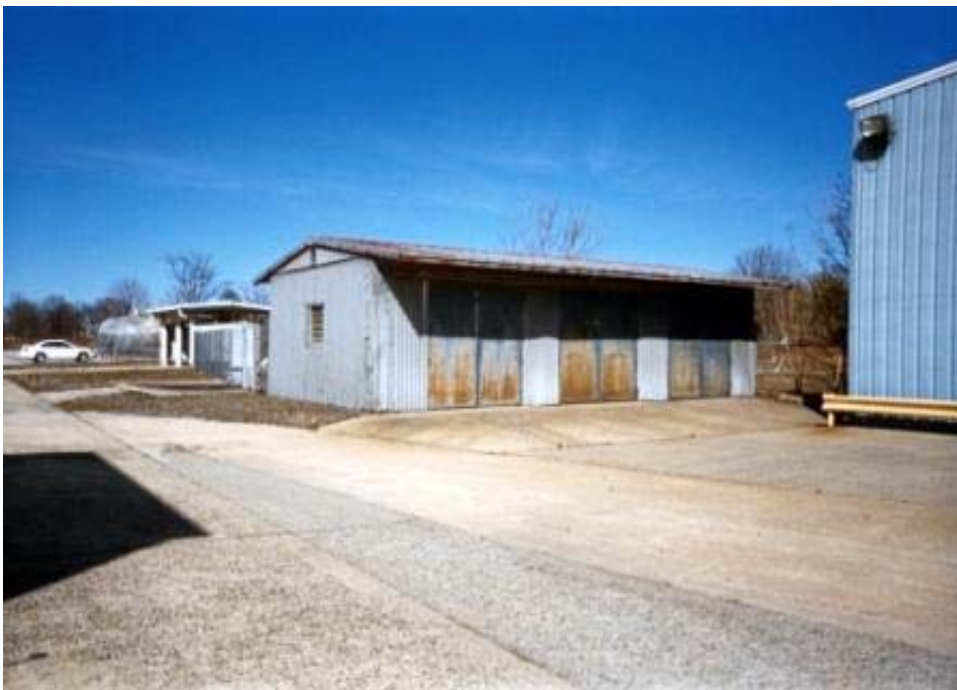
Photo 1 – Site 1, metal buildings, southwest concrete pad situated in the southwestern portion of the Site, looking northeast.

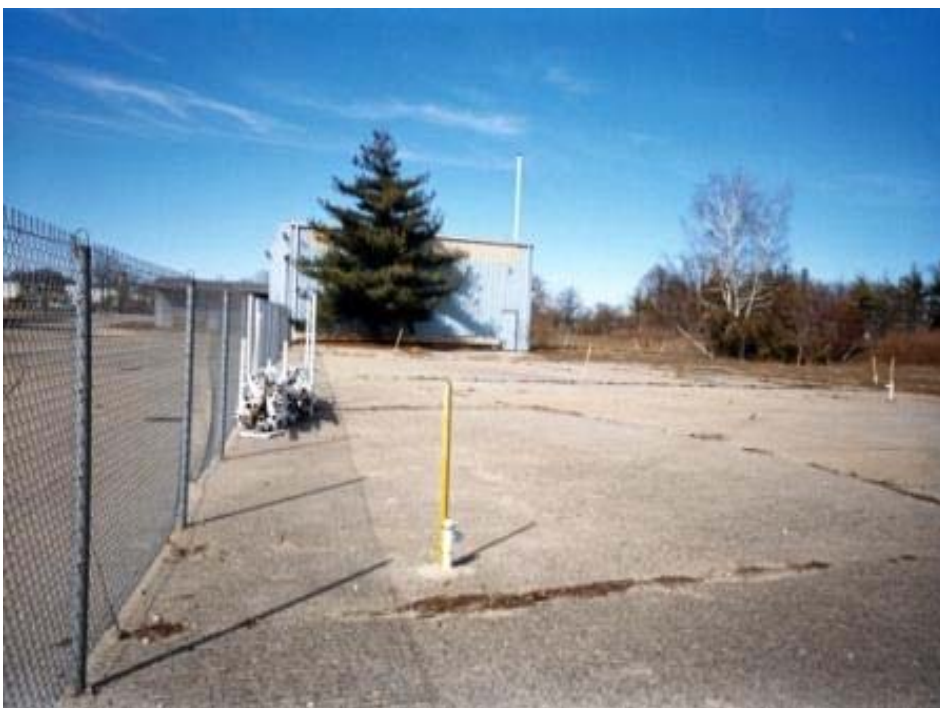
Photo 2 – Site 1, southwest concrete pad situated in the southwestern portion of the site, looking north

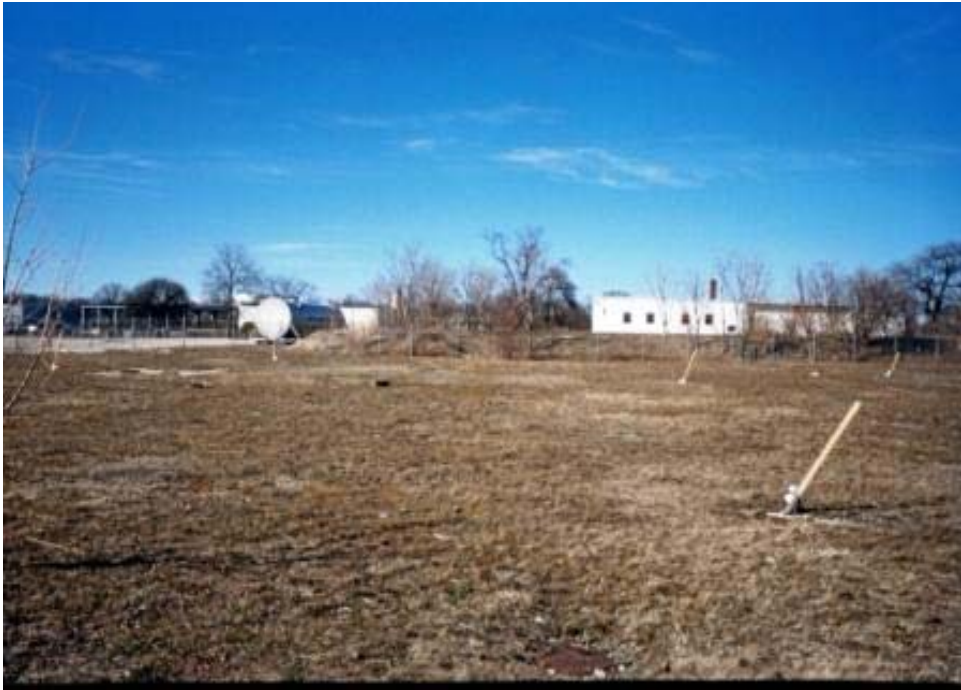
Photo 3 – Site 1, northern portion of the Site, looking north.

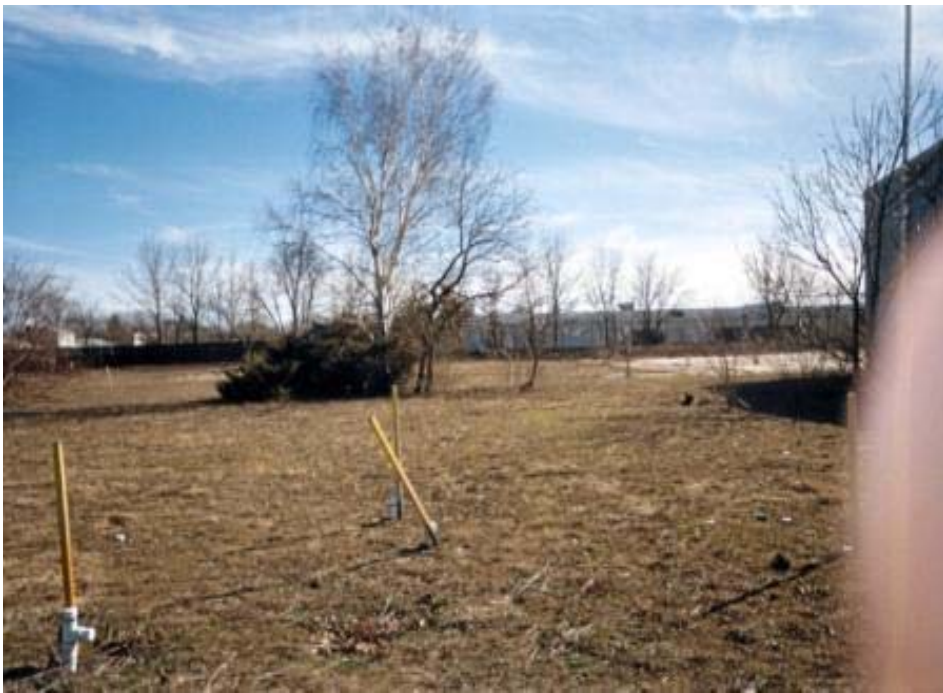
Photo 4 – Site 1, central portion of the Site, looking south.

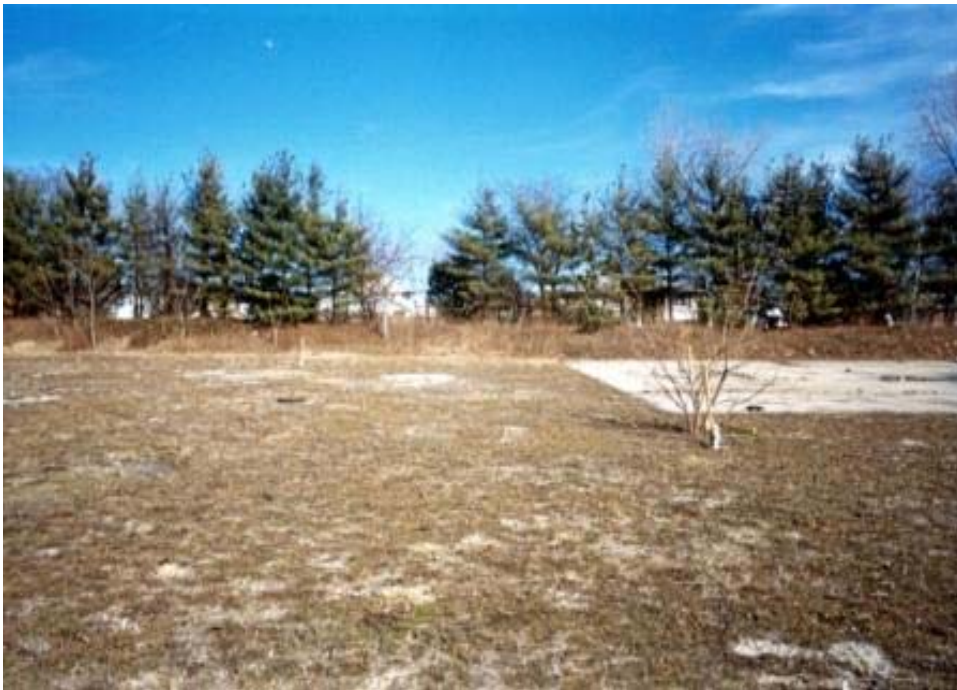
Photo 5 – Site 1, central portion of the Site, looking east.

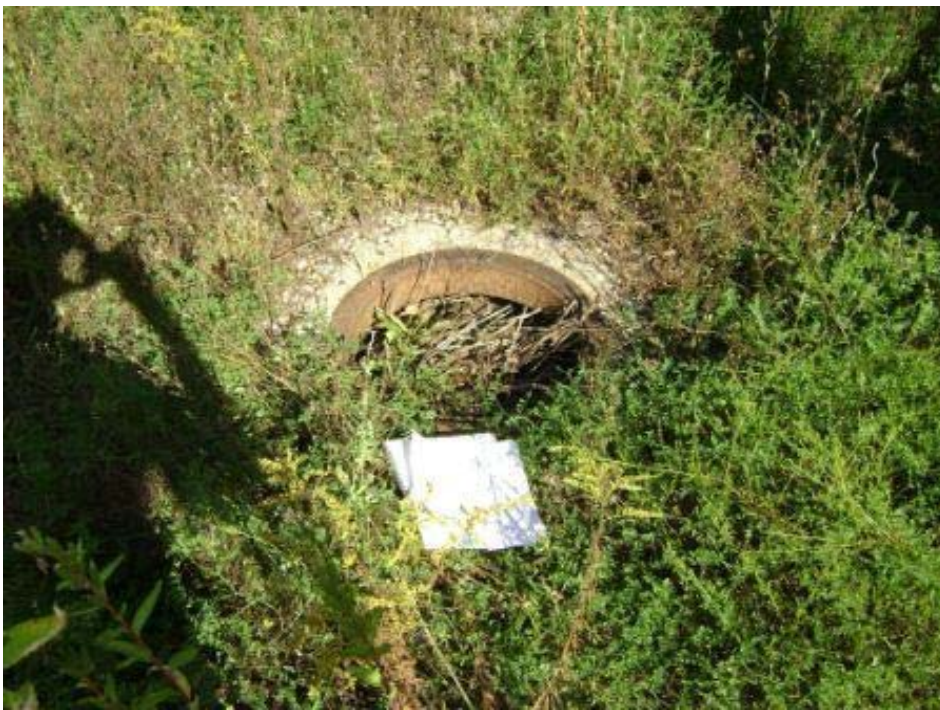
Photo 6 –Site 1, former cesspool.

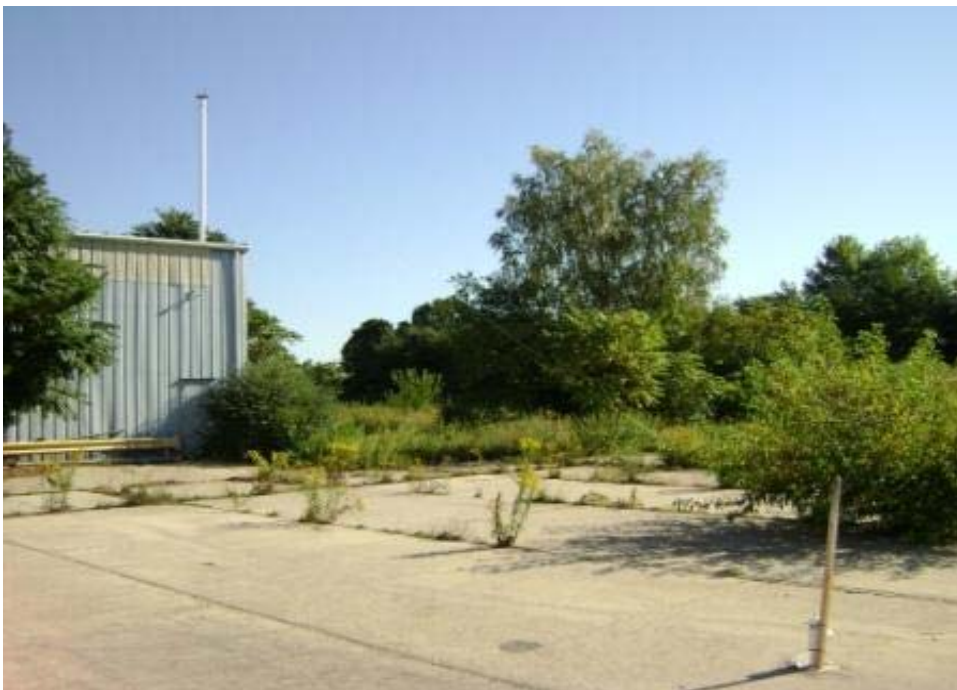
Photo 7 – Site 1, southwestern portion of the Site, looking northeast.

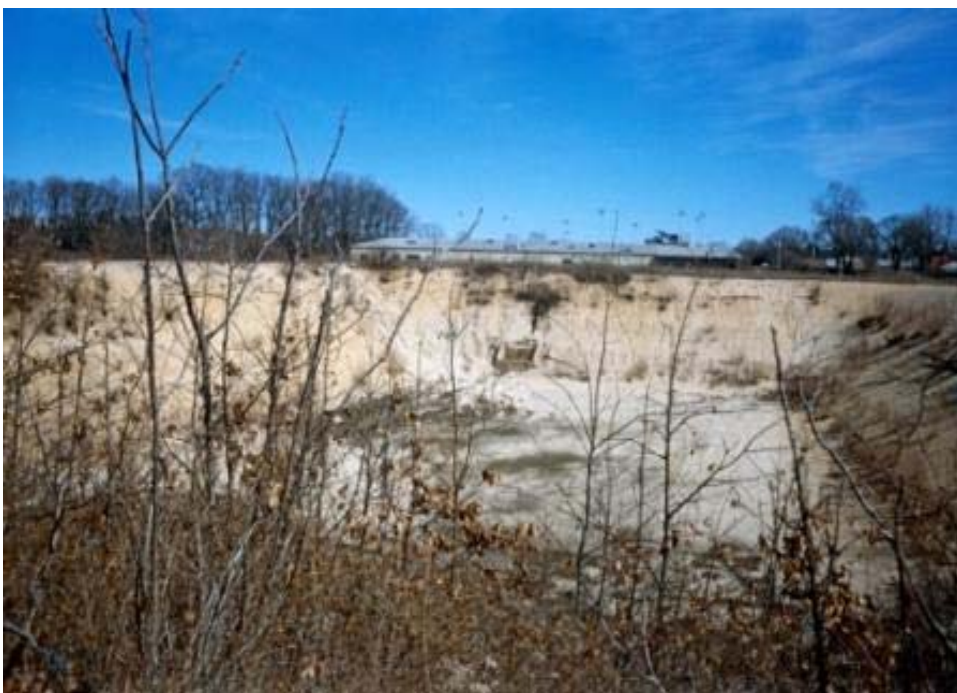
Photo 8 –Site 2, Southeast Recharge Basin, western portion of the basin looking east

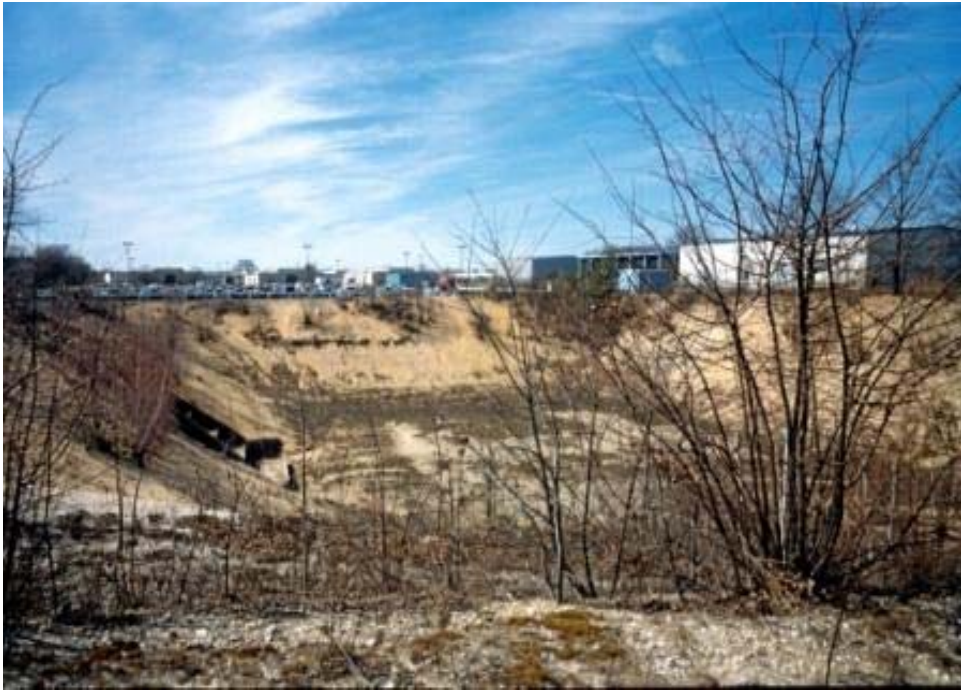
Some erosion was noted within the recharge basins. At this time, the erosion has not extended to soil cover at the top of the basins. Continued monitoring, and if required repair, of the erosion needs to be conducted to ensure that contaminated soils do not become exposed.

Photo 9 – Site 2, Southwest Recharge Basin, eastern portion of the basin looking west.

2.	Cracks <u>N/A</u> Lengths _____ Remarks _____	Widths _____ Depths _____ Location shown on site map _____	Cracking not evident
3.	Erosion Areal extent <u>20x40 Pct.</u> Remarks <u>Erosion noted on certain wall of Southwestern basin. Erosion being monitored.</u>	Location shown on site map _____ Depth <u>2 Pct.</u>	Erosion not evident

1. Continue to monitor the recharge basins for erosion. If the erosion reaches a point that a wall collapse is a concern or erosion of the soil cover occurs, repairs would be needed.

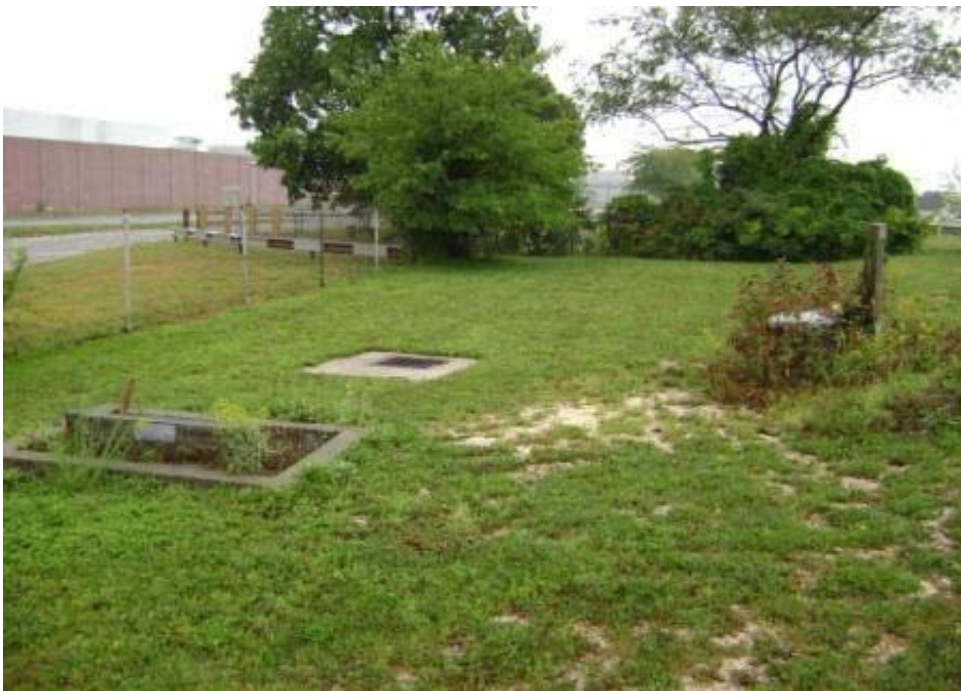
Photo 10 –Site 2, storm water diverter situated in the southeast portion of the Site.

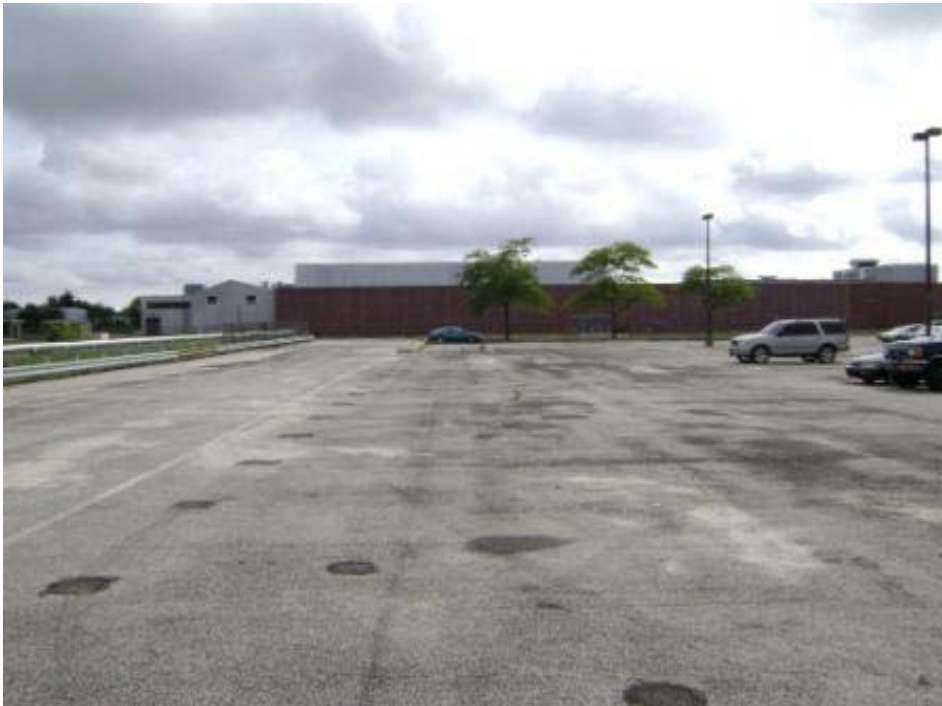
Photo 11 – Site 3, western portion of Impound Lot 1, looking south.

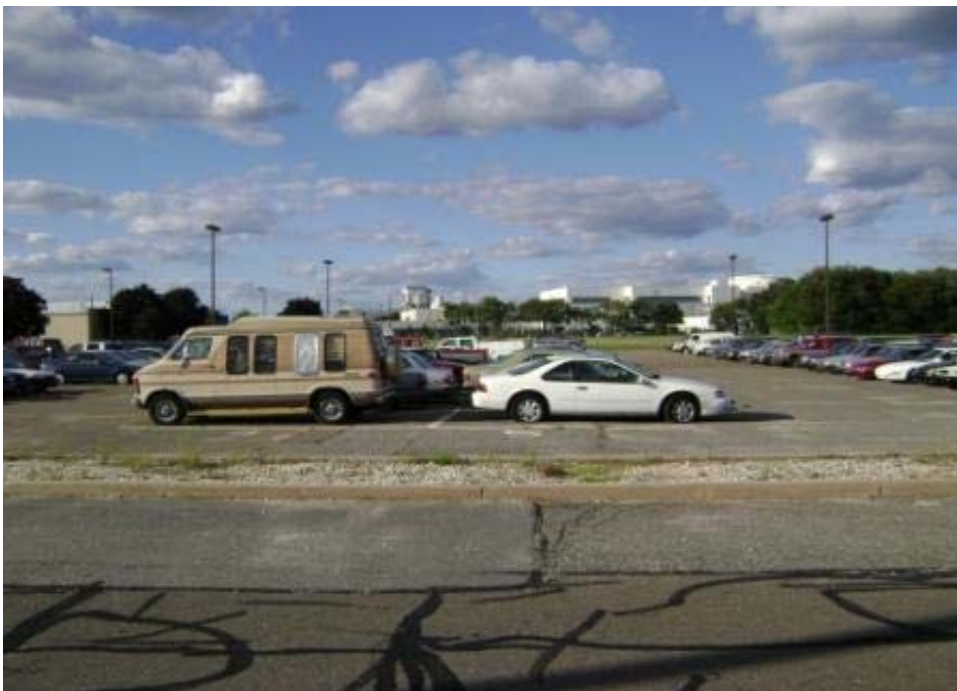
Photo 12 –Site 3, central portion of Impound Lot 1, looking north.

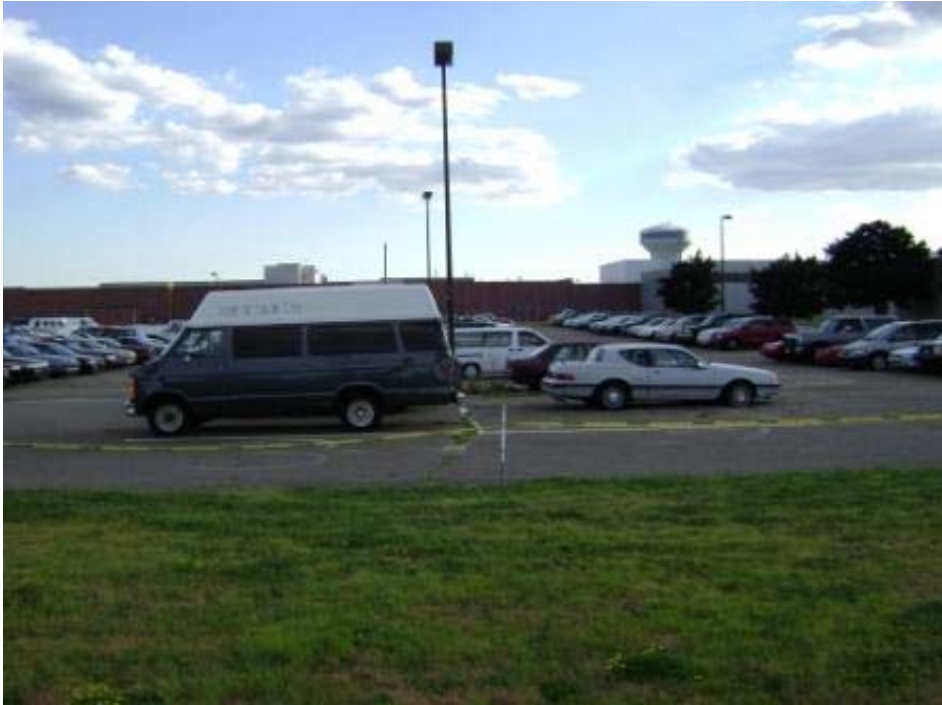
Photo 13 – Site 3, eastern portion of Impound Lot 1, looking south.
