Naval Facilities Engineering Command Northwest **Safety Lessons Learned Accident Abstract**

Accident Type: Electrical
Injury: Electrical Shock
Damage: N/A
Type of Work: Maintenance on burned out street light

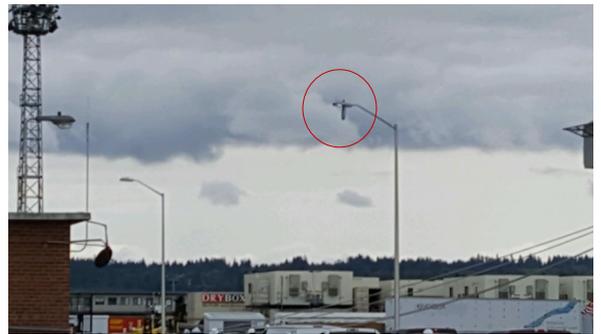
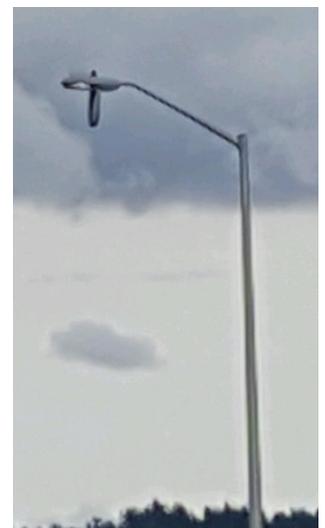
▪ On 07 July 2016 @ 1330, a BOSC general laborer used a Genie S65 Boom Lift to conduct maintenance on a burned out streetlight lightbulb (~ 20' up). The injured employee discovered the lightbulb was broken - bulb filament was exposed; the employee started removing glass from the cover (left hand), looked to the BOSC Low Voltage Electrician (LVE) on the ground for direction; and was motioned to close the cover. The BOSC LVE observed the employee shaking and then slumped in the lift basket; realizing the victim was being shocked, the LVE lowered the basket to the ground, communicated to people in the vicinity to call 911. CPR initiated on scene; eventually airlifted to a major trauma center.

- Hand contact with energized light filament

- Supervision inadequate – employee was not trained
- AHA not accepted by GDA; had been returned to the Contractor
- Energized work permit required was not issued.

- Failure to follow established company and contract safety procedures.
- No lockout/tagout (LOTO) utilized.
- Lack of electrical PPE when working on energized equipment
- General labor employee was not trained to conduct electrical work.

- Ensure electrical circuit is de-energized and validate zero energy state prior to work.
- Follow LOTO Hazardous Energy Control Plan (HECP) procedures (1910.147/EM 385 Section 12).
- Ensure personnel conducting maintenance are trained to do the required work.
- Follow energized work permit procedures (EM 385 Section 11).
- Utilize proper electrical PPE
