Contractor Fatality Heavy Equipment Rollover

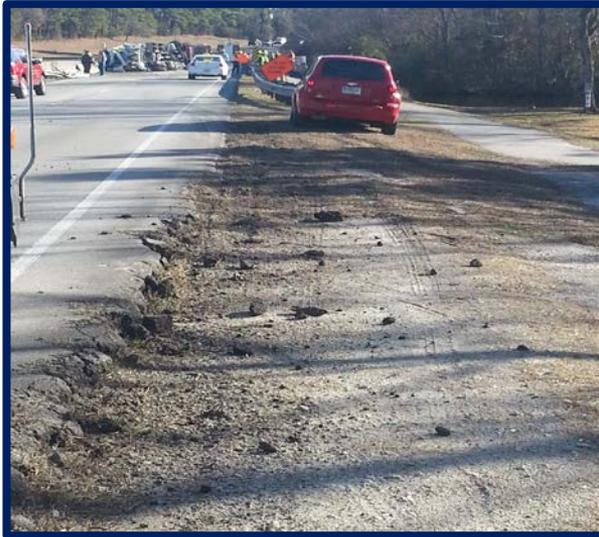
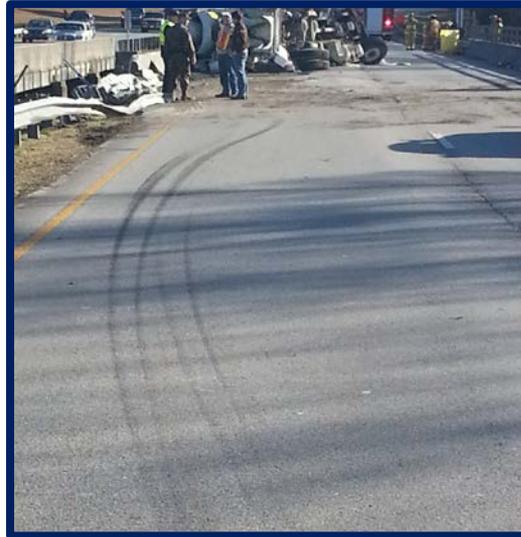
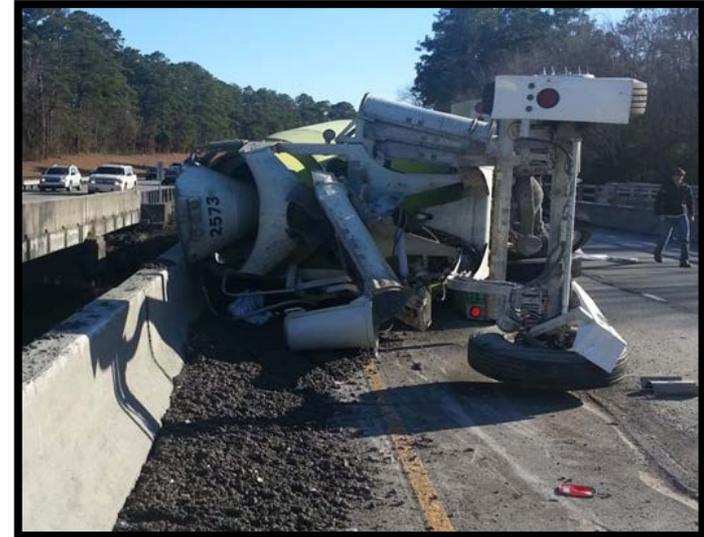
Activity: A concrete truck travelling approximately 50mph in an 55mph zone was delivering product when it left the roadway for reasons unknown. After travelling approximately 200' along a depressed shoulder, the truck returned to the asphalted surface, and but appeared to clip a guardrail before overturning and fatally injuring the driver. Cell phone use, drugs/alcohol, and mechanical failure were ruled out during investigations.

- Excessive speed for load being transported
- Risk assessment of highway travel not performed; associated risk mitigation actions not implemented

- Accident Prevention Plans should include travel activity within an installation – even if outside project limits
- An AHA for hauling on public roads and highways and that identifies manufacturer's recommended limits on load and speed should be prepared and discussed with all heavy equipment operators
