Contractor Fatality

Struck by Dropped Suspended Load

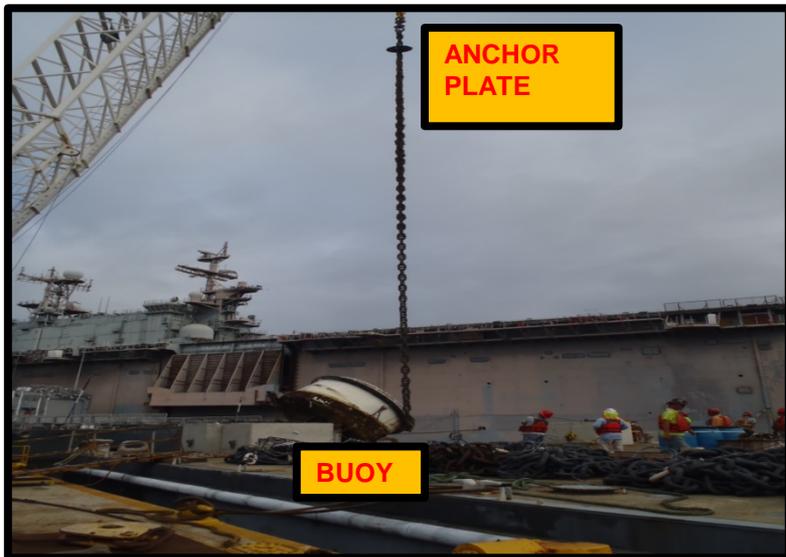
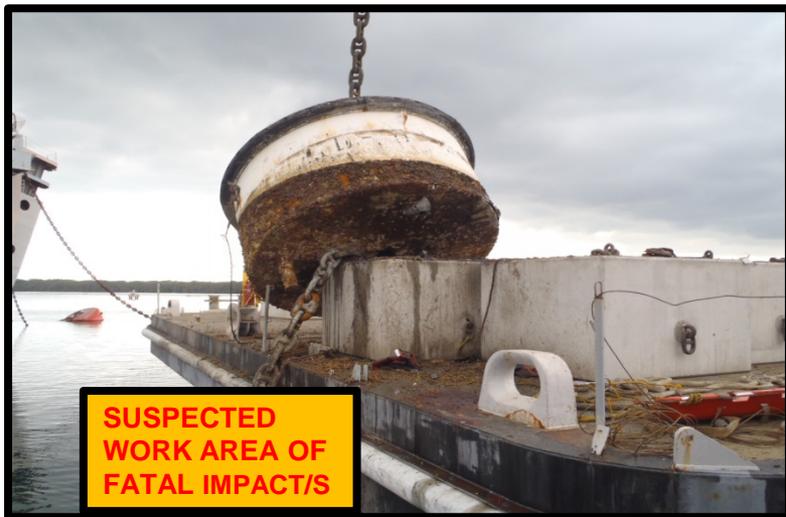
Activity: A barge crane operated was conducting maintenance on a mooring buoy, and included up to six workers working on the deck of a floating work barge under a 12,000lb mooring buoy, which was suspended overhead by a floating lattice boom barge crane. The buoy was being lifted by an anchor plate that was bolted to a flange located on the topside of the buoy. Initial inspection of both the anchor plate and the mounting flange showed signs of severe corrosion. A secondary restraint system consisting of a wire rope sling in a basket configuration was in use at the time of the lift, but due to the shock load caused by the perceived failure of the primary rigging system, the wire rope also failed and allowed the buoy to fall, striking two employees, who later died, and injuring two employees. The two other employees working on the barge did not sustain injuries.

- Employees may not have been fully aware of their surroundings and seemed to have been working under the load or in areas that are considered danger zones within the crane operating envelope.

- Employees shall avoid – to the greatest extent possible – from working under a suspended load.
- All individuals associated with weight handling operations shall be aware of the operating envelope of the equipment and safe positioning locations
