# Contractor Near Miss Report

## Loose Lugs on Aerial Work Platform

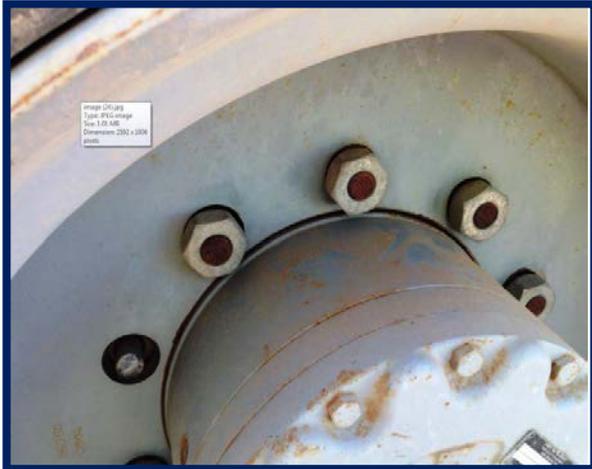
**Activity:** During a critical lift evolution, a crew member noted a broken lug/bolt on the ground that was traced back to an aerial work platform (AWP) tire. The crew member also noted that the adjacent nuts were loose and could be turned by hand. This AWP was to be used during the evolution to help place hangar rafters. Once informed, the project manager directed the AWP to be removed from site until repaired. Additionally the project manager discovered there was no pre-use inspection performed on the other AWP's. AWP work was suspended until pre-operational use inspections were completed per the operators manual.

- Failure to perform pre-operation inspection of AWP
- Failure to perform preventative maintenance on AWP

- Pre-operation inspections of AWP's must be performed before use
- AWP's shall be maintained in accordance with manufacturer's instructions
- Operator's training and licensing must be equipment specific
- Worksites in which the AWP shall be used shall be surveyed for potential hazards – overhead wires, uneven surfaces, etc. - prior to AWP operation
