Fatal Fact Lesson Learned

Accident Type: Electrocution
Injury: Fatality
Type of Work: Electrical
Equipment: Inoperable Light Motion Sensor

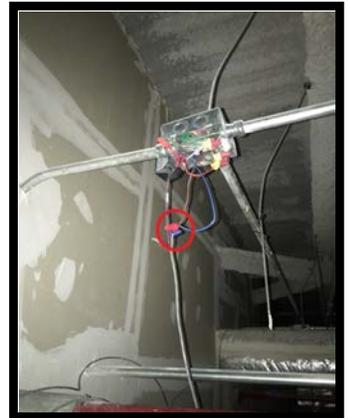
Base service contractor electrician was responding to a routine trouble call to repair an inoperable light motion sensor, located 4 ft. above the ceiling grid which was 9 ft. above the finished floor. While standing on an 8 ft. ladder the employee made contact with an energized 277 volt electrical wire causing electrocution and subsequent fall.

- ◆ Contact with 277 volt energized electrical lighting circuit.

- ◆ Culture! Lack of electrical sensitivity for LOTO requirement of all energy sources.
- ◆ Ensure all circuits are de-energized and validated using a meter prior to work beginning.
- ◆ Follow LOTO Hazardous Energy Control Plan (HECP) procedures 1910.147 / EM 385 Ch. 12.
- ◆ Ensure training is up to date with most current AHA's/SOP's and company policies.
- ◆ Energized work permit procedures must be followed EM 385 Ch. 11.
- ◆ Utilize proper electrical PPE.

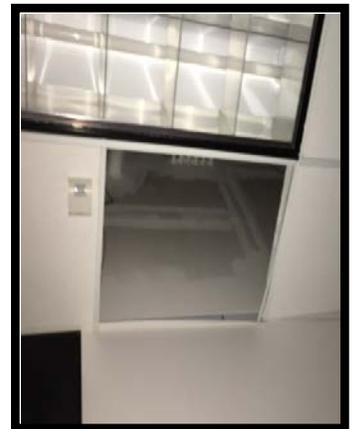
- ◆ Failure to follow established company and contract safety procedures.
- ◆ No lockout/tagout (LOTO) utilized.
- ◆ Lack of electrical PPE when working on energized equipment.

- ◆ Supervision inadequate - spot checks performed routinely with no documentation or Good Catches.
- ◆ Training not documented on newly instituted electrical safe work processes and Activity Hazard Analyses (AHA).
- ◆ Electrical safe work practices and accident prevention plan did not define the difference between trouble shooting energized equipment w/ required PPE or performing electrical work de-energized.
- ◆ Contractor policy requires two employees when working on or near energized circuits.
- ◆ Energized work permit required was not issued.
