Atlantic Division, Naval Facilities Engineering Command

ACCIDENT ABSTRACT

ACCIDENT TYPE: Crane over turned
INJURY: No Injuries
TYPE OF WORK: Demolition of underground tank
EQUIPMENT INVOLVED: Crawler, Fix boom
SAFETY EQUIPMENT: Long pants, shirt, safety glasses, and hardhat

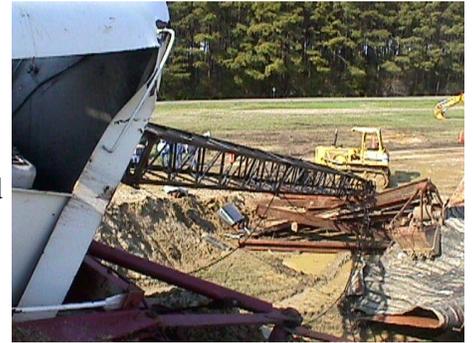
A contractor crane was removing and relocating scrap metal materials off of an underground tank during demolition.

The crane was overloaded for the configuration at the time of the accident.

- ◆ The crane was on unstable ground. The soil was disturbed.
- ◆ The crane had no load indicating device. .
- ◆ The operator did not know he was over loaded.
- ◆ Improper clamshell for removing scrap metal material.
- ◆ The operator did not have a current operator certification on site.
- ◆ The demolition plan was used to remove all tanks under the contract. It was not written as site specific. The plan calls for the use of a headache ball / crane rigging on a crawler. The contractor was using a clamshell. This was not specified in the demolition plan.
- ◆ The Activity Hazard Analysis was not amended or reviewed when the equipment used changed.
- ◆ The Preparatory Inspection was not amended, or reviewed with the crane operator.

All lattice boom cranes shall be equipped with a load indicating device or a load moment indicator, EM 385-17.D.01.
