Overall accident view for fall which occurred during a repositioning operation to steel joists of lower roof section 3 Feb 99.

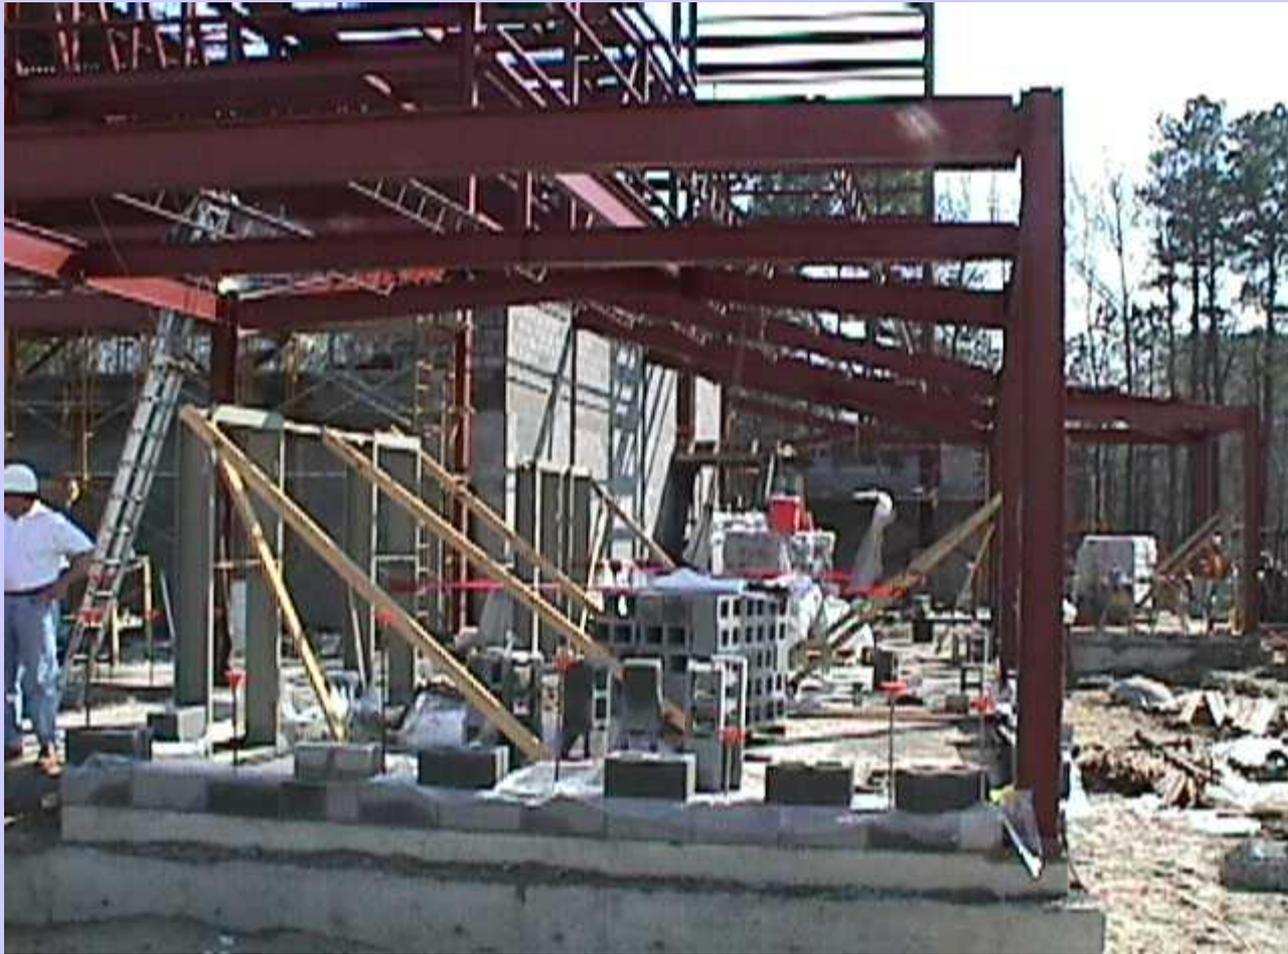
Steel erection worker/welder was reattaching joists for rework in this area when he fell approximately 12 feet

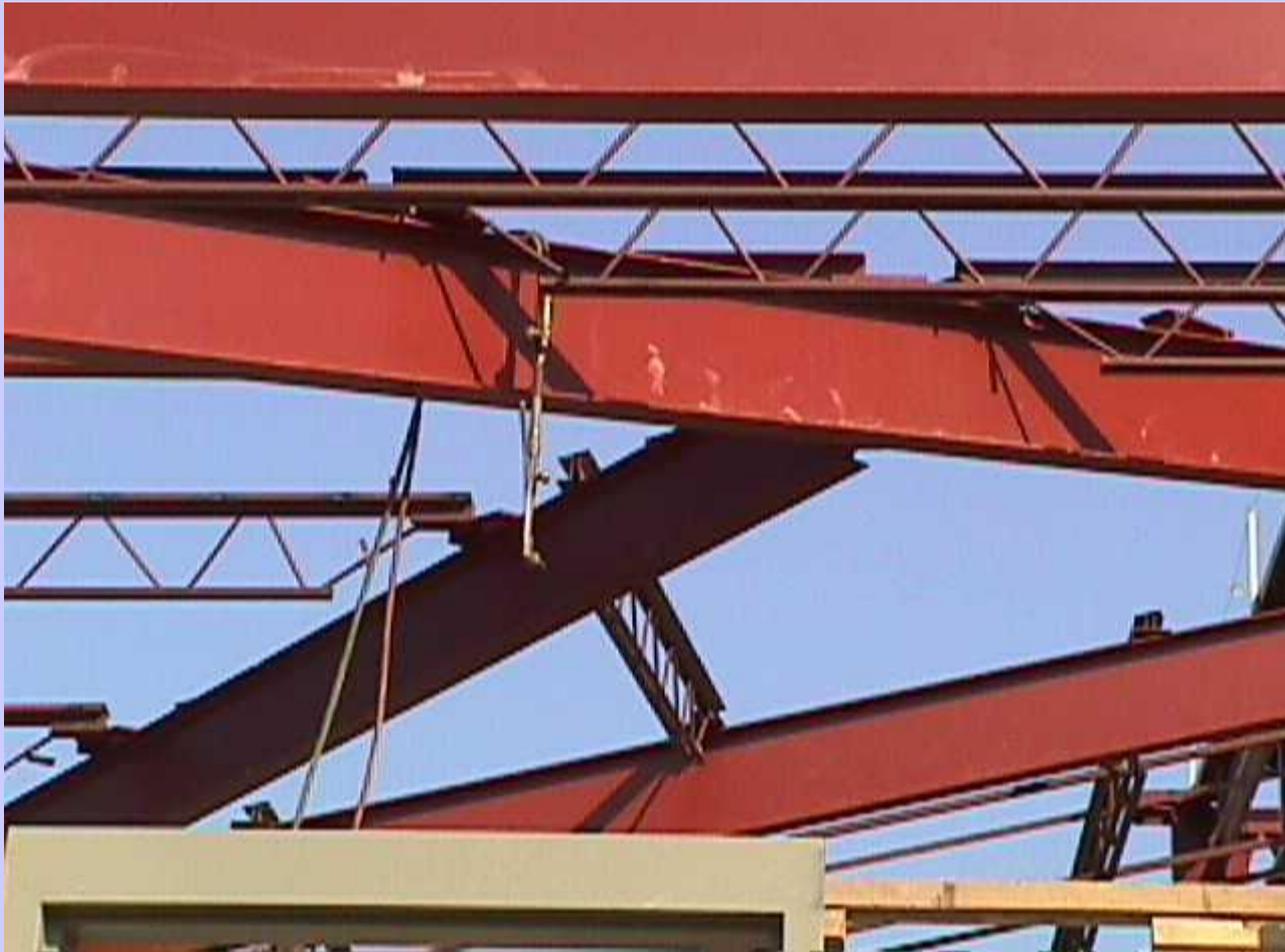
Witness summary indicates worker was welding at this location

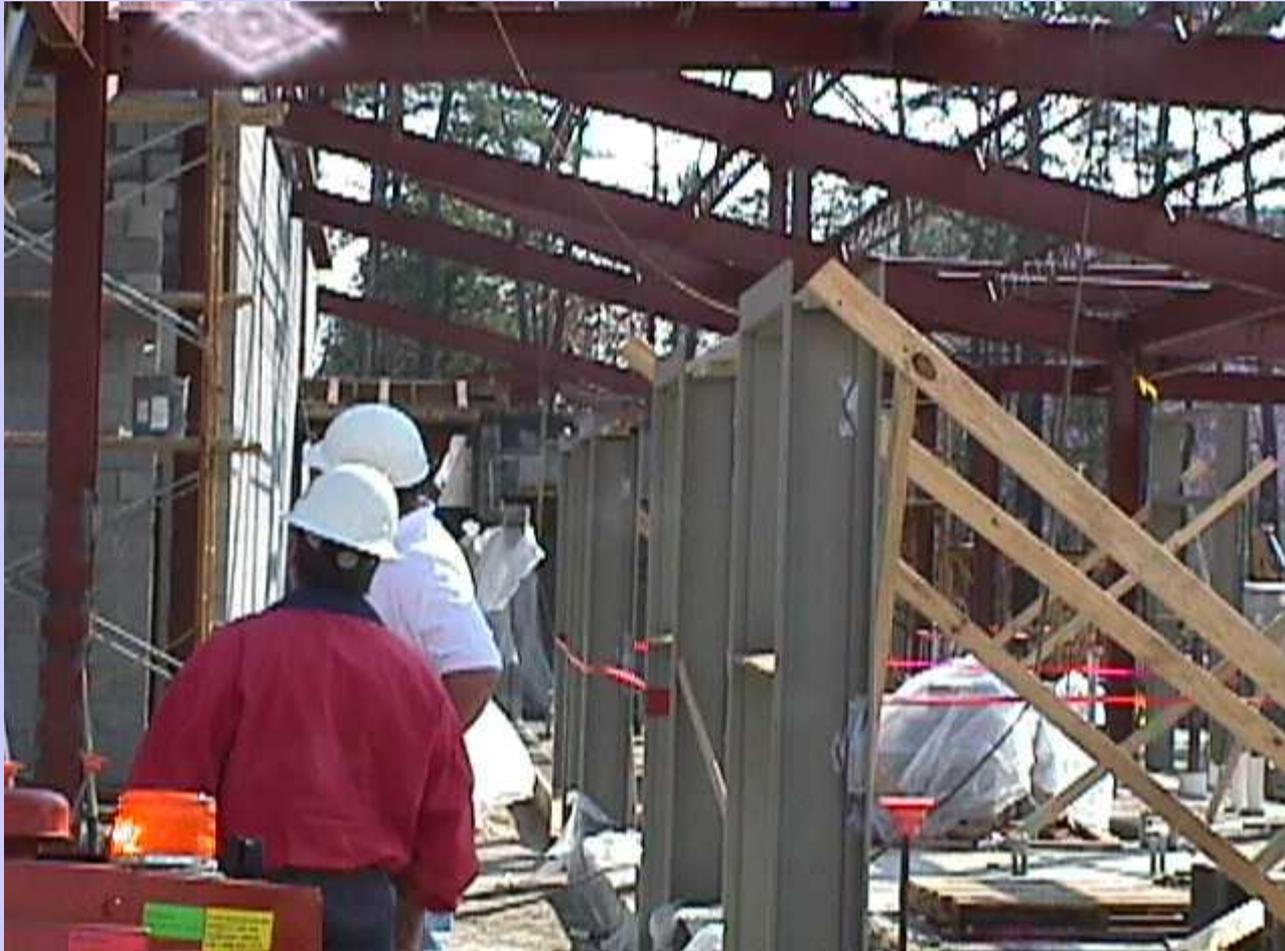
- **During fall the worker struck the top of this door frame with his lower torso**

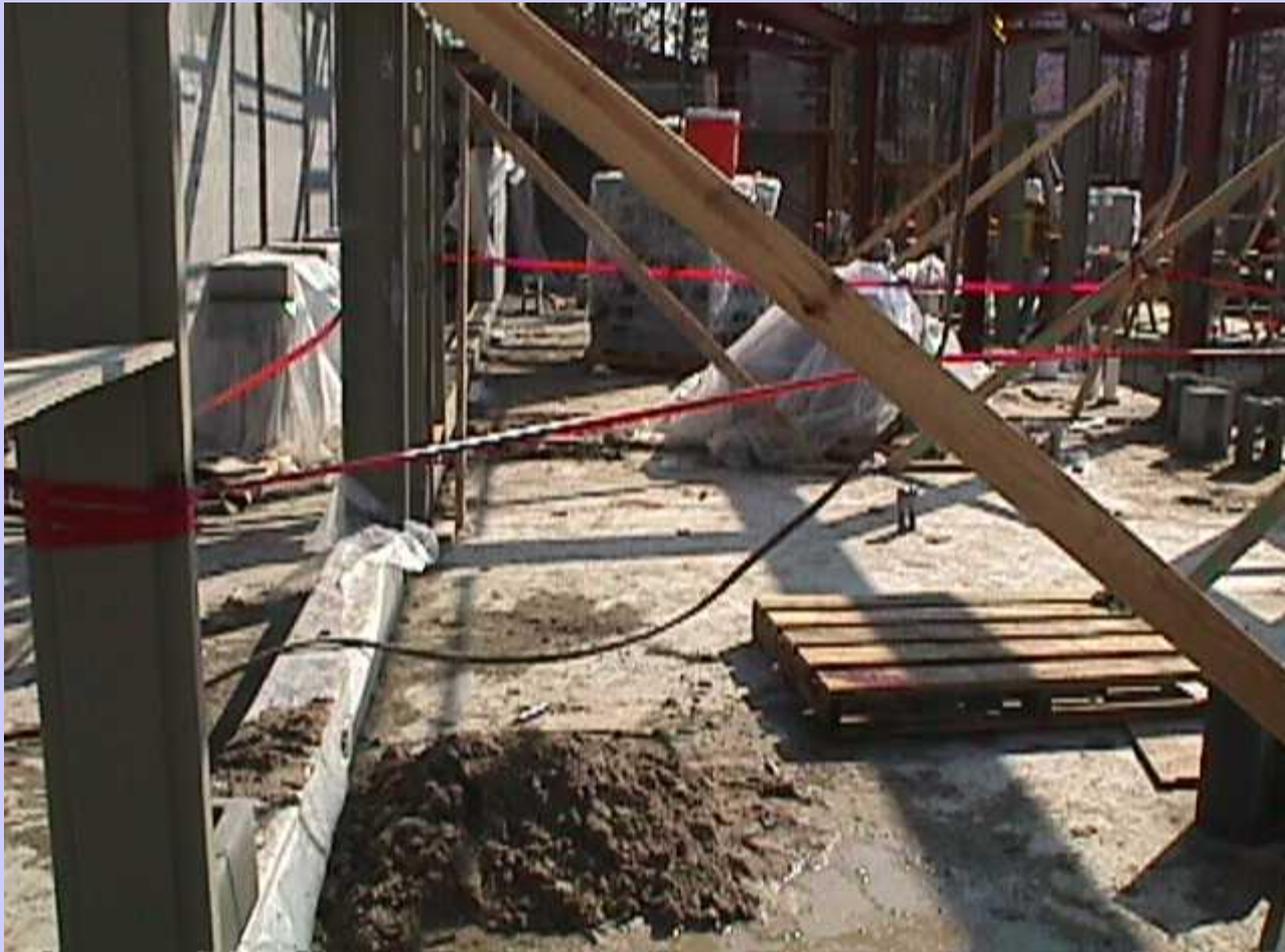
- **The worker then fell on this pallet causing a gash to the front head area**
