# Fall Mishap Information

**Date of Mishap:** 23 April 2001, 0715 AM.

**Contract:** Replace Roof and Siding

# ROOFING FALL MISHAP

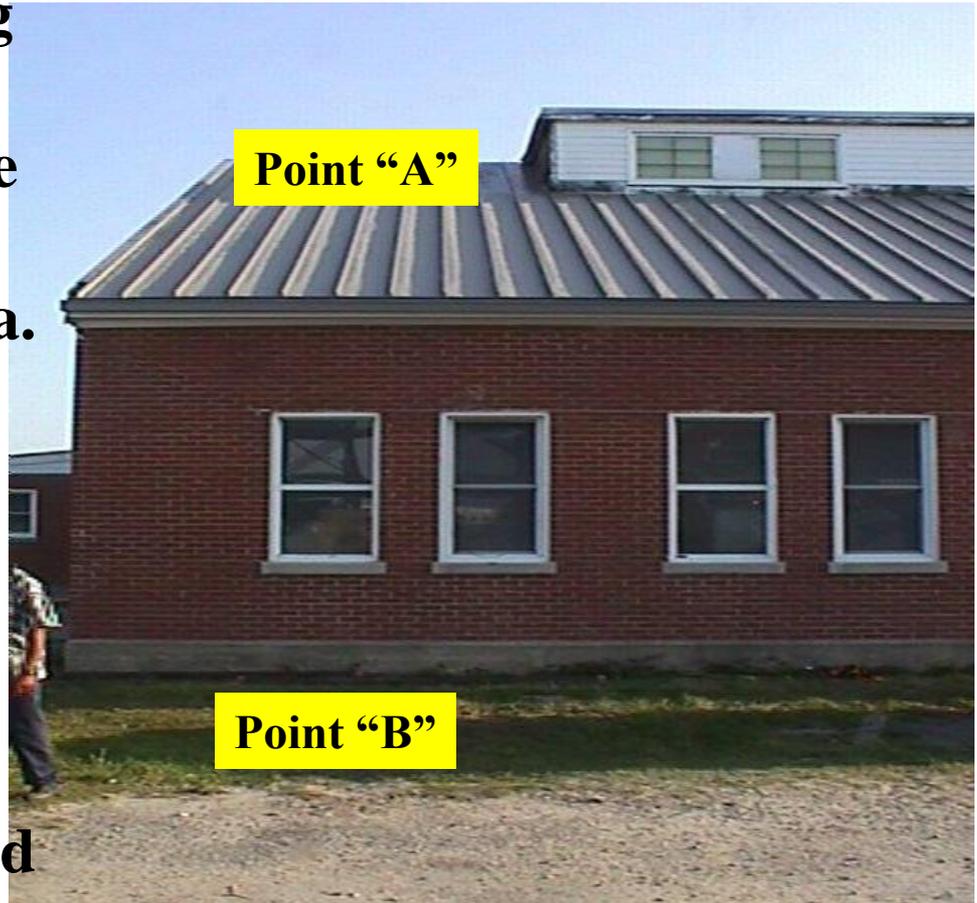
**Roofer in process of starting Work. Stepped on new Standing seam roof with one Foot. Other foot on to the Flat roof above window area. Metal sheet wet with dew. Worker not tied off but was Going to work area where His tie off point is located. Worker slid down metal Sheets, turning around and Fell to grassy area on ground Approximately 23 feet.**

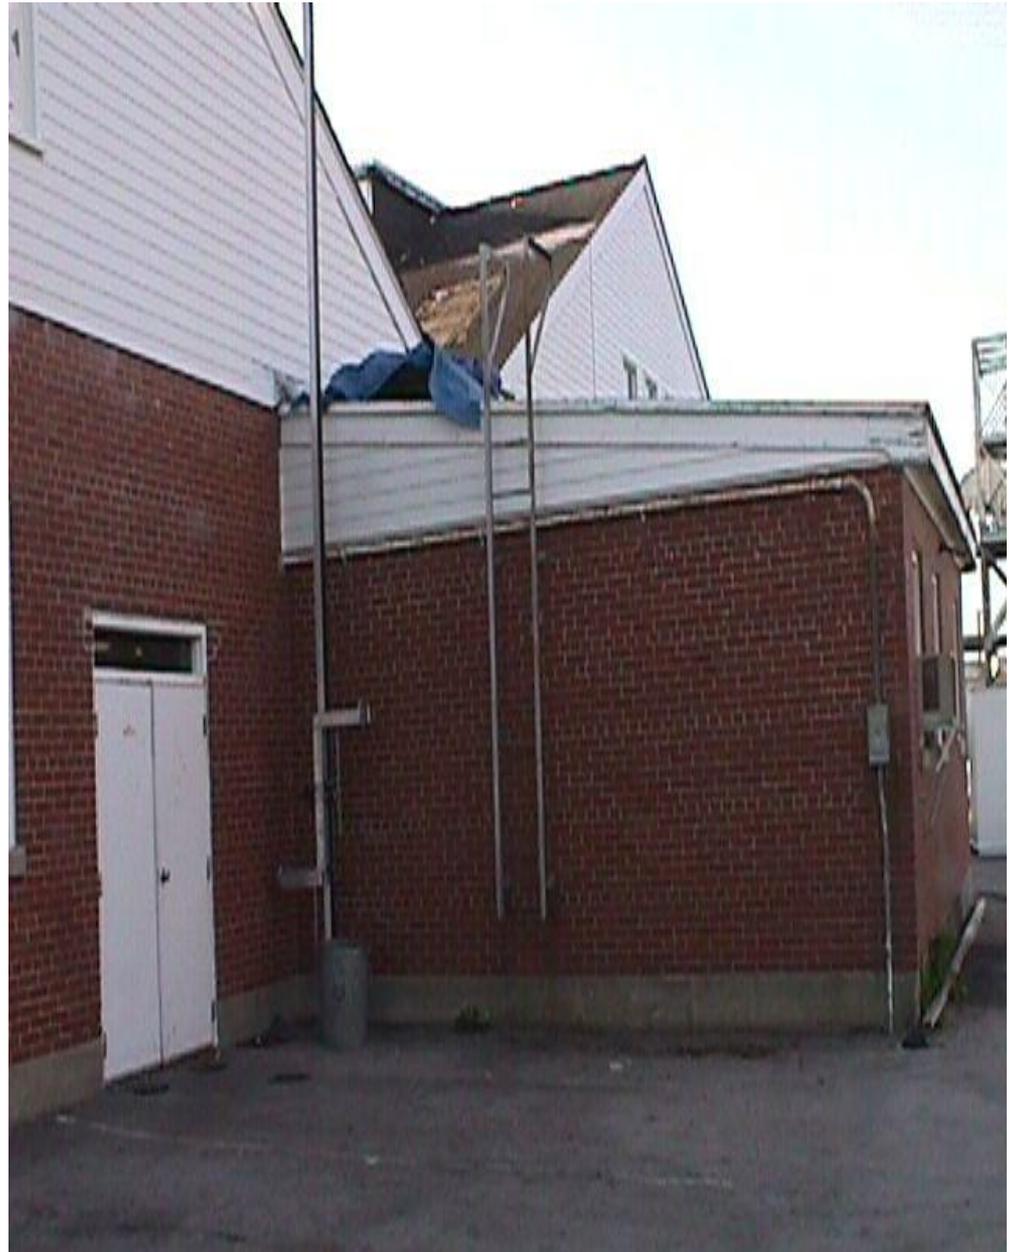
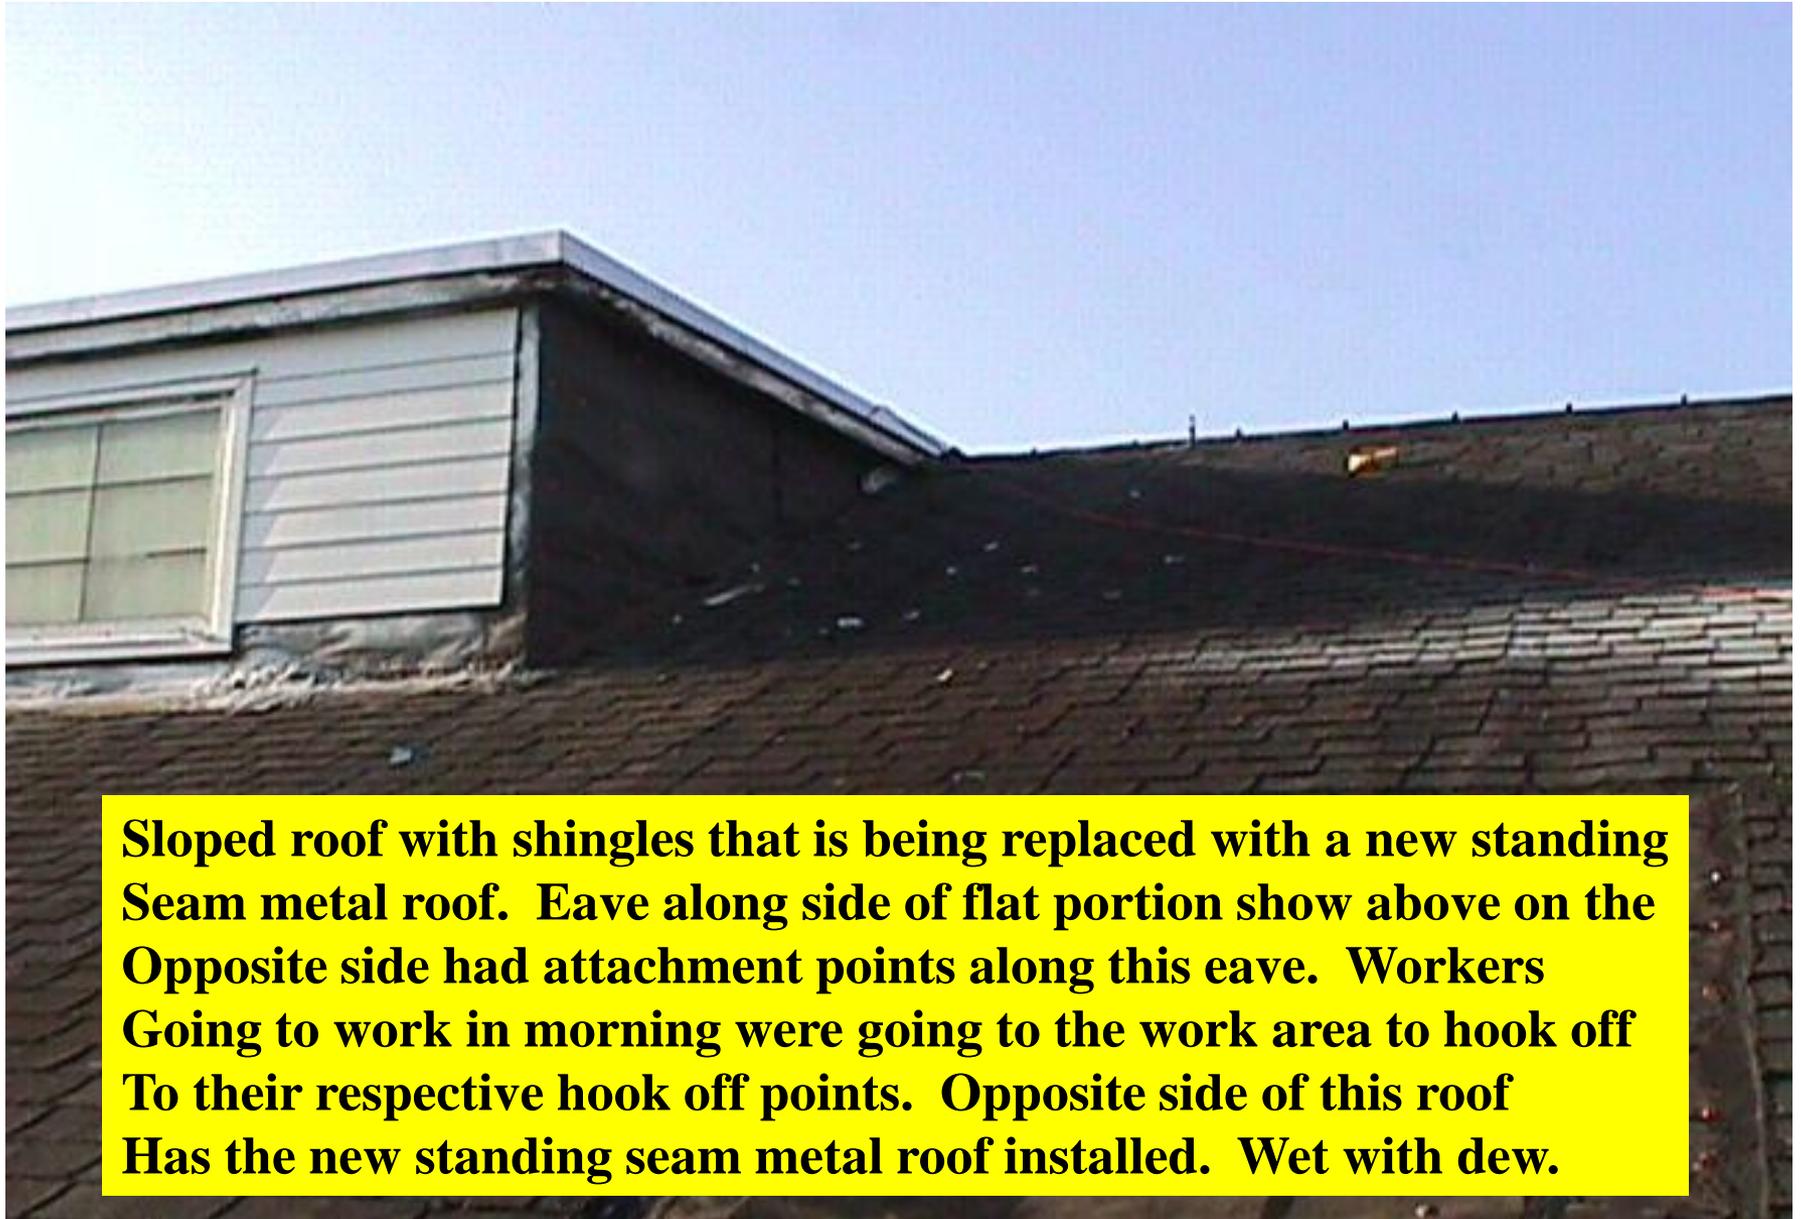
**Normal route to work area. Up the Permanent vertical ladder shown, Across flat roof to the shingled Portion of the sloped roof. Up sloped roof to the peak. Step up on the flat portion of the Roof to the hook off point located Along the eave of this flat portion Of the upper roof.**

**Opposite side of the sloped roof has Been completed with a new Standing seam metal roof.**

**The top of this sloped roof is Where the worker stepped on the Metal roof and slid down the roof And fell from the eave, which is Approximately 23 Feet.**

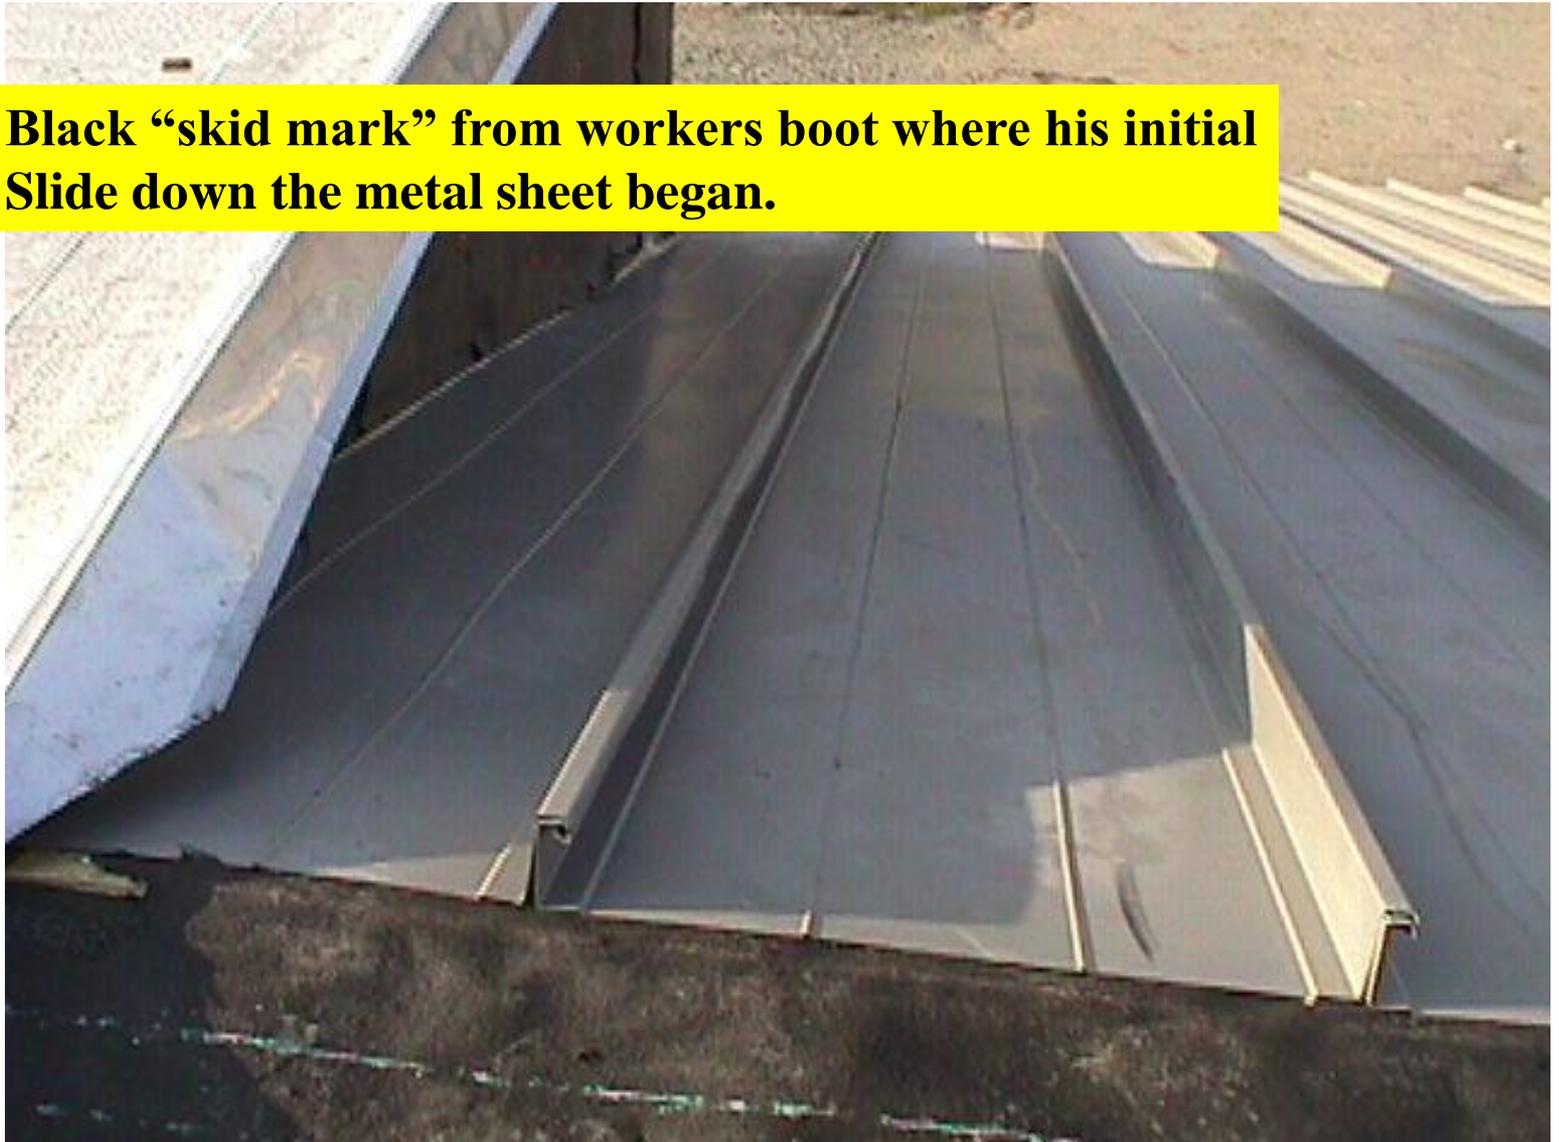
**Point of fall. One foot on flat roof on left, right foot on metal roof. Metal roof was wet with dew.**

**Black “skid mark” from workers boot where his initial  
Slide down the metal sheet began.**
