**Naval Facilities Engineering Command Southwest  
Safety Lessons Learned Mishap Abstract**

**Mishap Type: FALL FROM HEIGHT**  
**Injury: CRUSHING/INTERNAL INJURIES**  
**Damage: None**  
**Type of Work: RENOVATION**  
**Equipment: N/A**

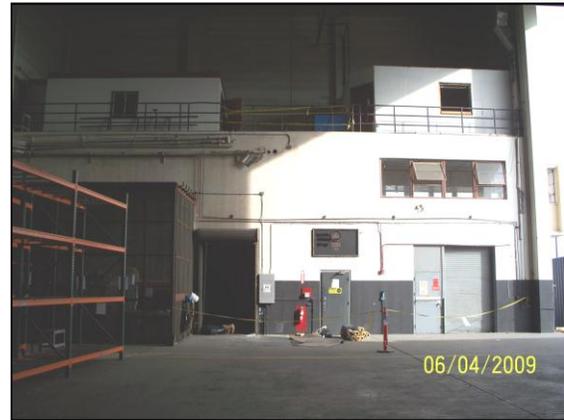
**DESCRIPTION OF THE MISHAP:** WG-10 construction mechanic sustained significant head and internal injuries when he fell 23 ft off of a mezzanine. Guardrail had been removed to facilitate the removal of equipment and material by a mobile crane team, and caution tape was placed to cover opening. Employee fell backwards through tape for unknown reason.

- Unauthorized change/alteration
- Inadequate training
- Failed to follow requirements
- Perceptual error, slip in attention or distraction

**ROOT CAUSE:** Personnel did not use approved procedure to adequately safeguard a fall hazard once existing safeguard was removed. Personnel recognized the fall hazard, but they did not use accepted controls, such as guard rails or a personal fall arrest system.

- Ensure all elements of Fall Protection Program are in place and operating effectively
- Need to apply Operational Risk management when workplace conditions change
- Importance of challenging co-workers and supervisors when unsafe conditions exist
