FINAL RESOURCE CONSERVATION AND RECOVERY ACT PARTIAL CLOSURE REPORT  
FOR BUILDING 5 HANGAR 5 WITH TRANSMITTAL LETTER NAS BRUNSWICK ME  
5/14/2010  
NAS BRUNSWICK

Subj: Final RCRA Partial Closure Report for Building 5 (Hangar 5)

**RCRA PARTIAL CLOSURE REPORT**  
for  
**HANGAR 5 – AIRCRAFT MAINTENANCE HANGAR PARCEL**  
**NAVAL AIR STATION BRUNSWICK, MAINE**  
**USEPA IDENTIFICATION NUMBER ME8170022018**  
**APRIL 2010**

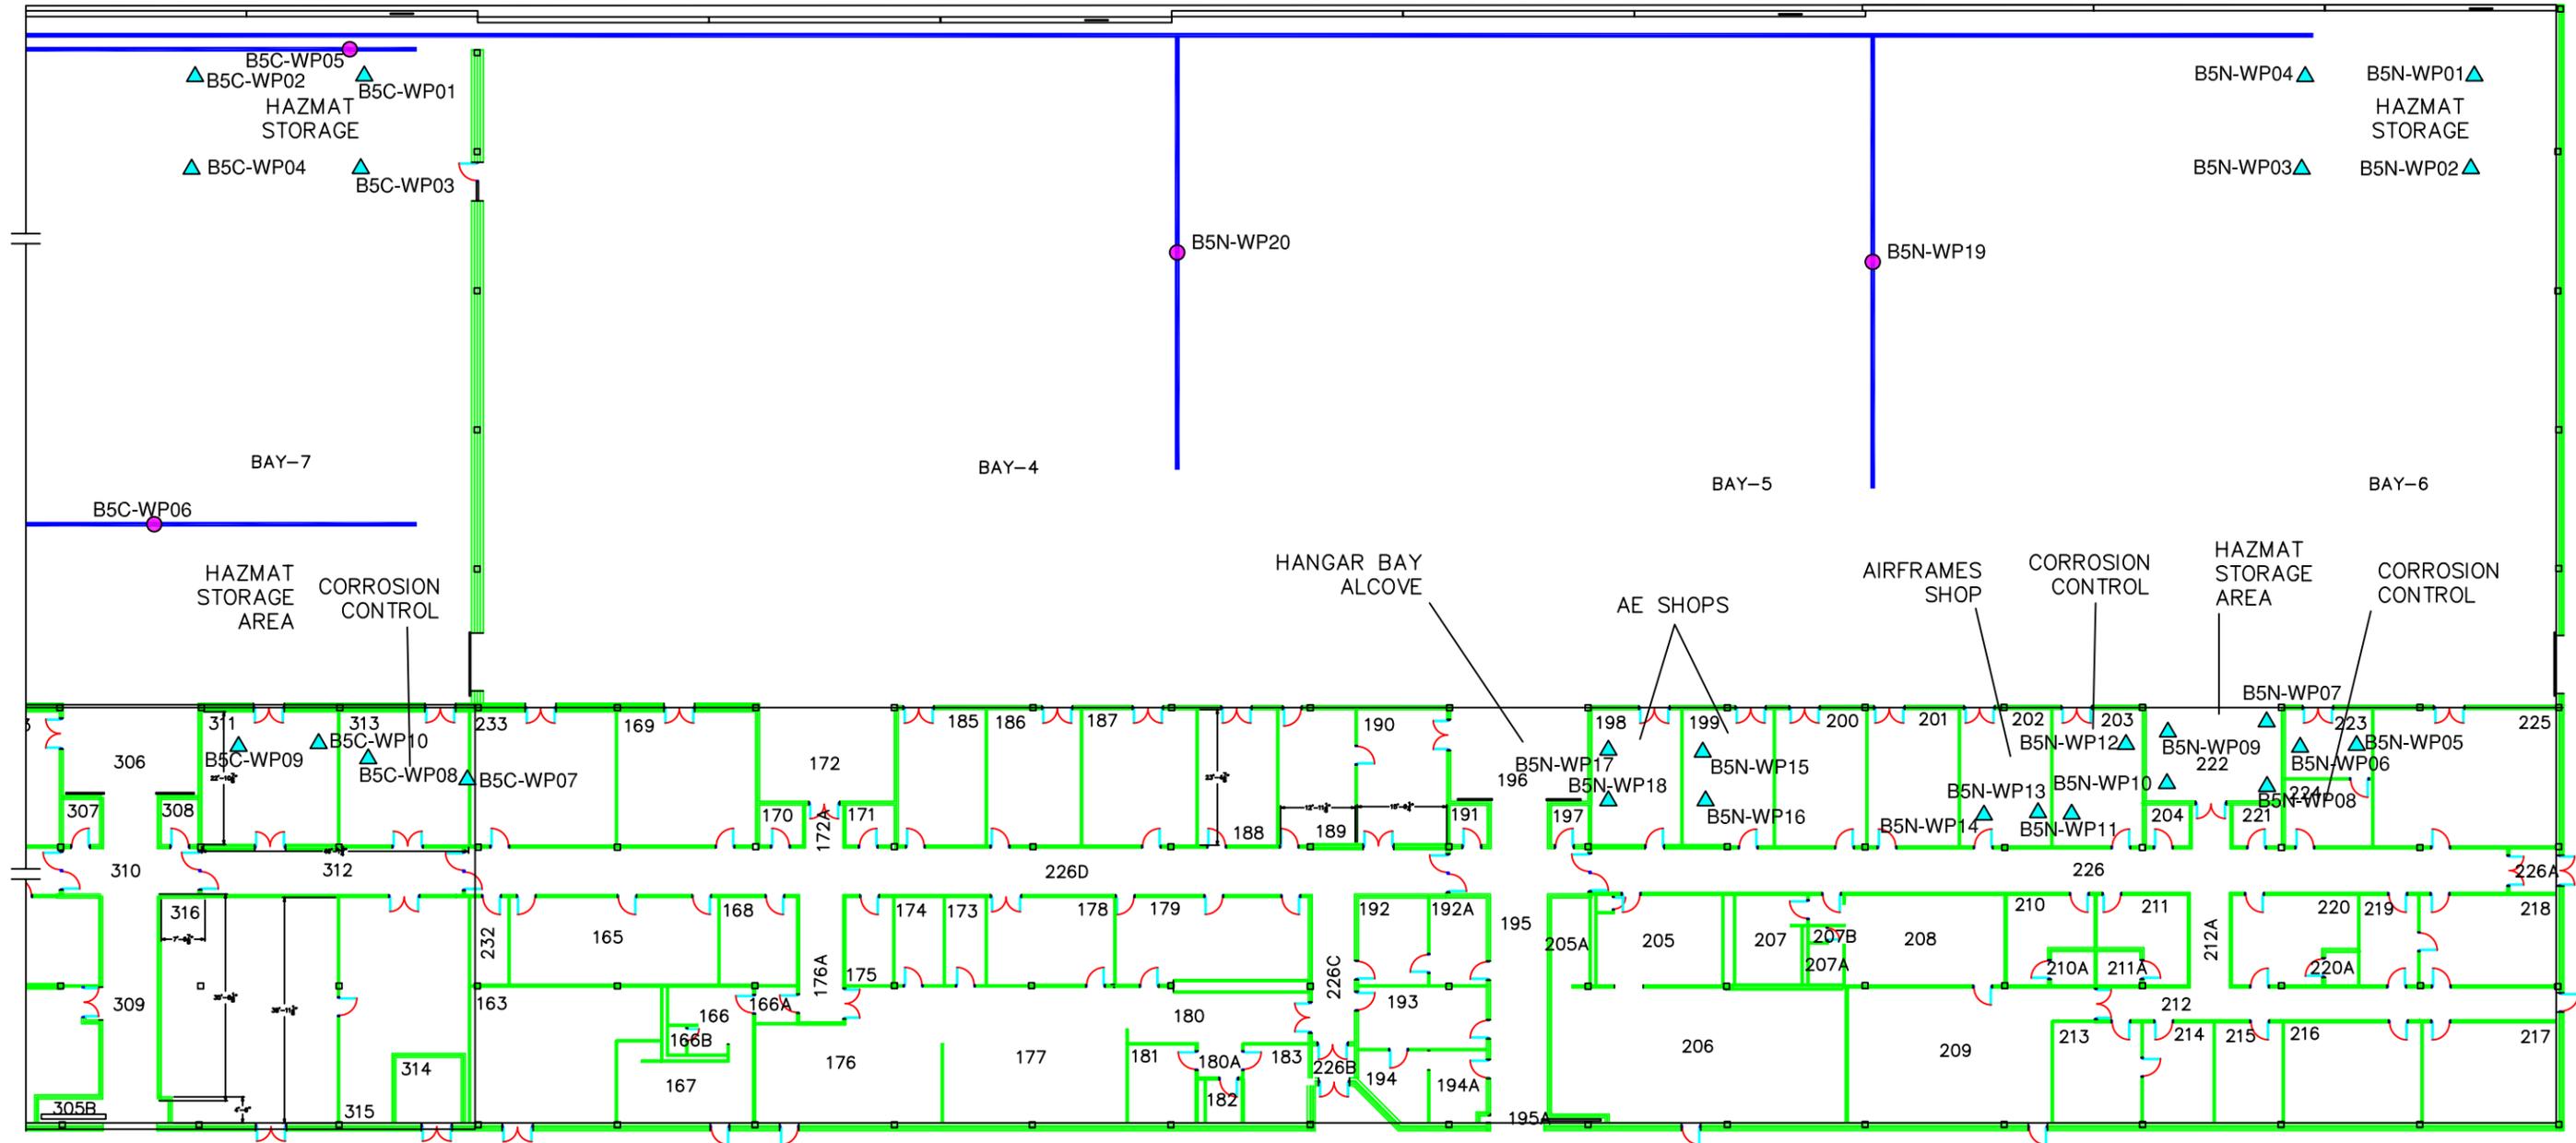
FILE \\.\NASB_H5_PRE_SAMP_N.DWG	SCALE AS NOTED
FIGURE NUMBER FIGURE NO. 3B	REV DATE 0 05/14/10

Hangar Bay 6 hazardous material storage area, northwest corner (floor)      The lead level in one of four samples exceeded the criterion ( $42 \mu\text{g}/\text{ft}^2$  in sample B5N-WP04). Lead levels of 34, 33, and  $30 \mu\text{g}/\text{ft}^2$  were detected in the other three samples (B5N-WP01 through -WP03).

Room 222 – Hazardous Materials Storage Area (floor)      The lead level in one of four samples exceeded the criterion ( $69 \mu\text{g}/\text{ft}^2$  in sample B5N-WP10). Lead levels of 33, 27, and  $28 \mu\text{g}/\text{ft}^2$  were detected in the other three samples (B5N-WP07 through -WP09).

Room 203 - Corrosion Control (floor)      The lead level in one of two samples ( $41 \mu\text{g}/\text{ft}^2$  in sample B5N-WP12) exceeded the criterion. A lead level of  $24 \mu\text{g}/\text{ft}^2$  was detected in the second sample (B5N-WP11).

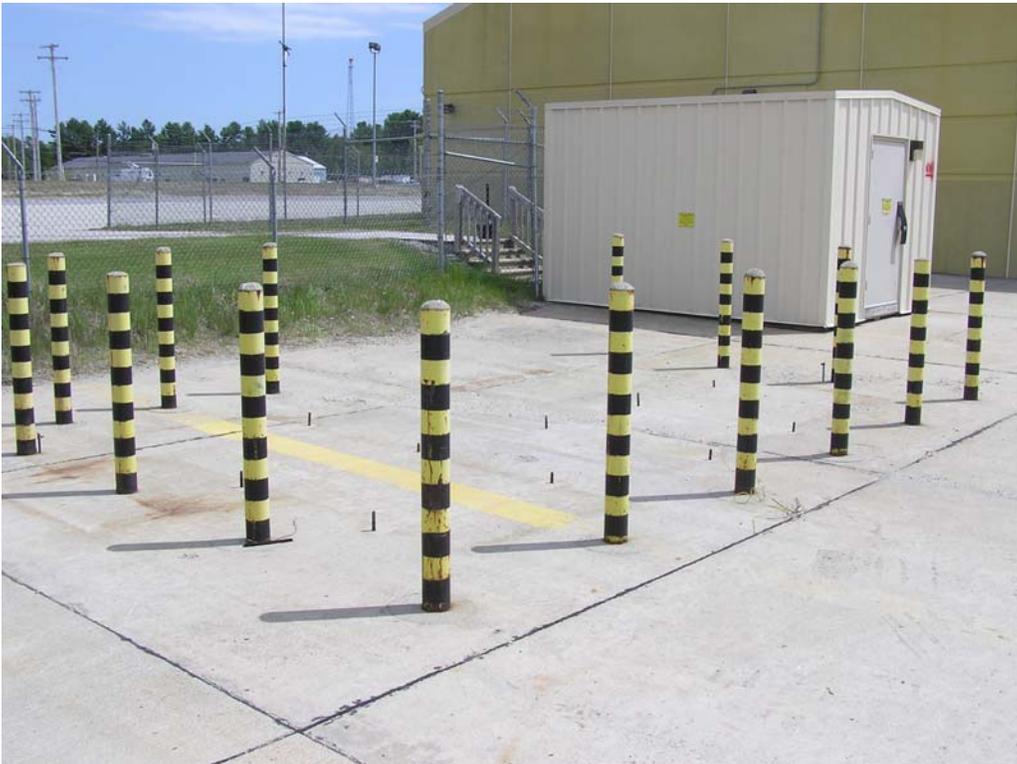
- The SAA hazardous waste shed and waste oil tanks for Hangar 5 South had been removed prior to the site visit. The SAA hazardous waste shed for Hangar 5 North had also been removed, and the associated waste oil tanks had been cleaned and were still in place. No visual staining, cracking, spalling, or discoloration of the concrete was noted. The expansion joints appeared in good condition. The vegetation adjacent to the south end of the Hangar 5 South SAA was not distressed. Vegetated areas are not present near the Hangar 5 North SAA.

No. 3 Hangar 5 – NAS Brunswick  
Hangar 5 – South satellite accumulation area

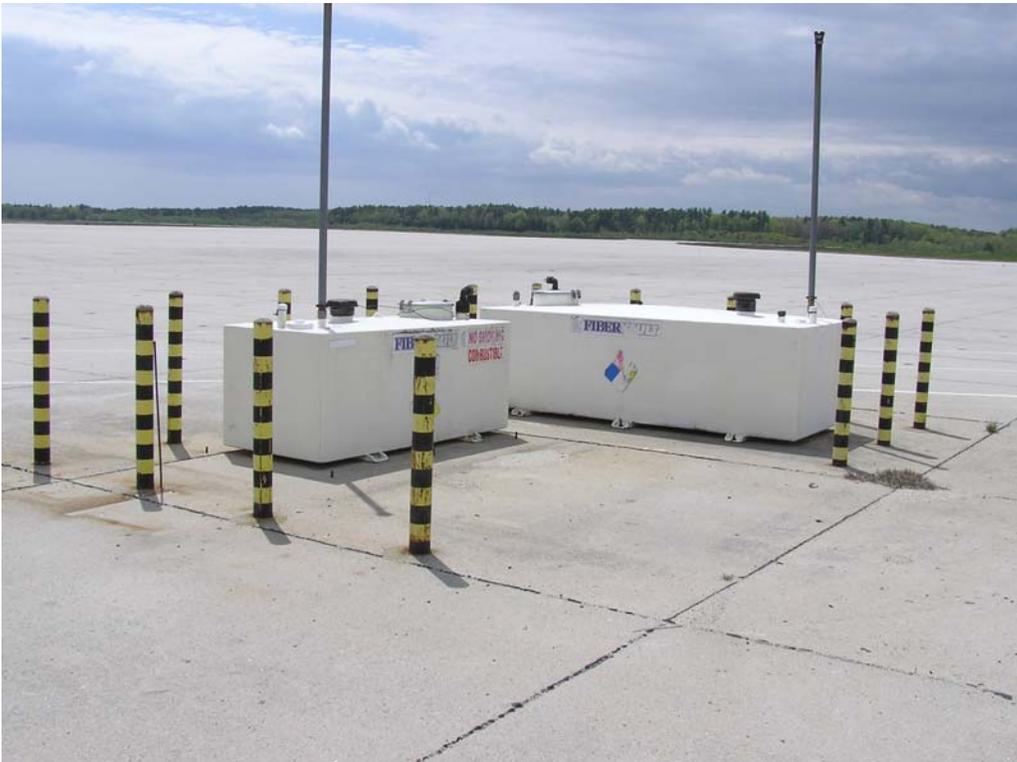
No. 4 Hangar 5 – NAS Brunswick  
Hangar 5 – North satellite accumulation area

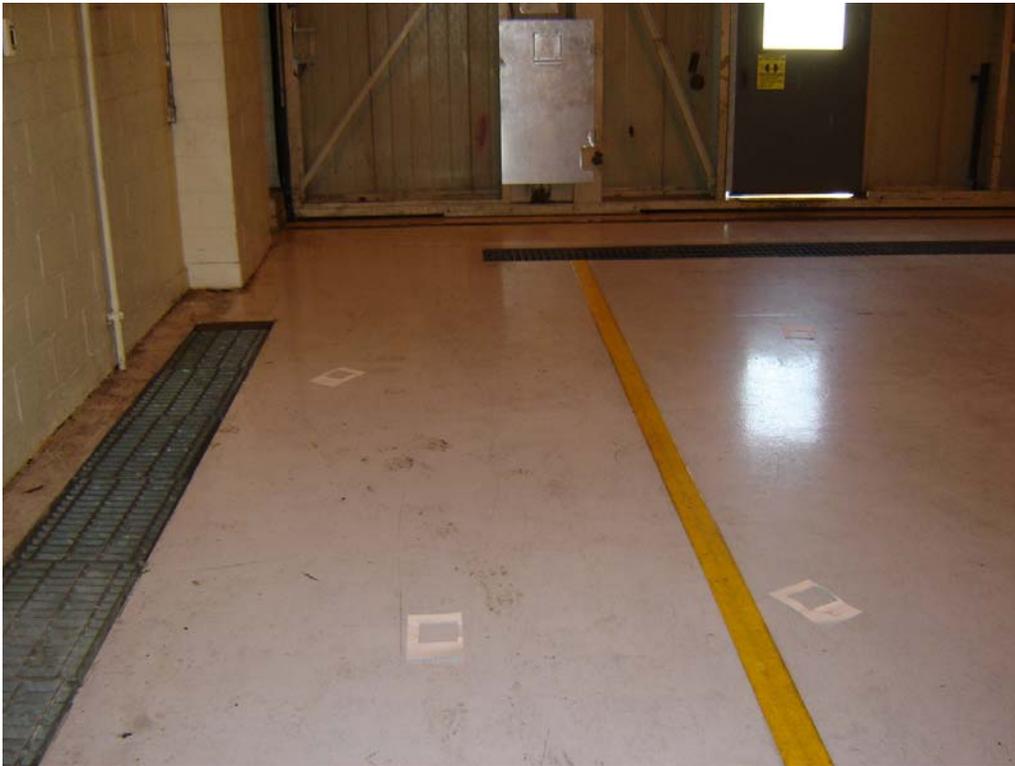
No. 5 Hangar 5 – NAS Brunswick December 1, 2009  
Hangar 5 – Wipe sample locations in Hangar 5 South hazardous materials storage area

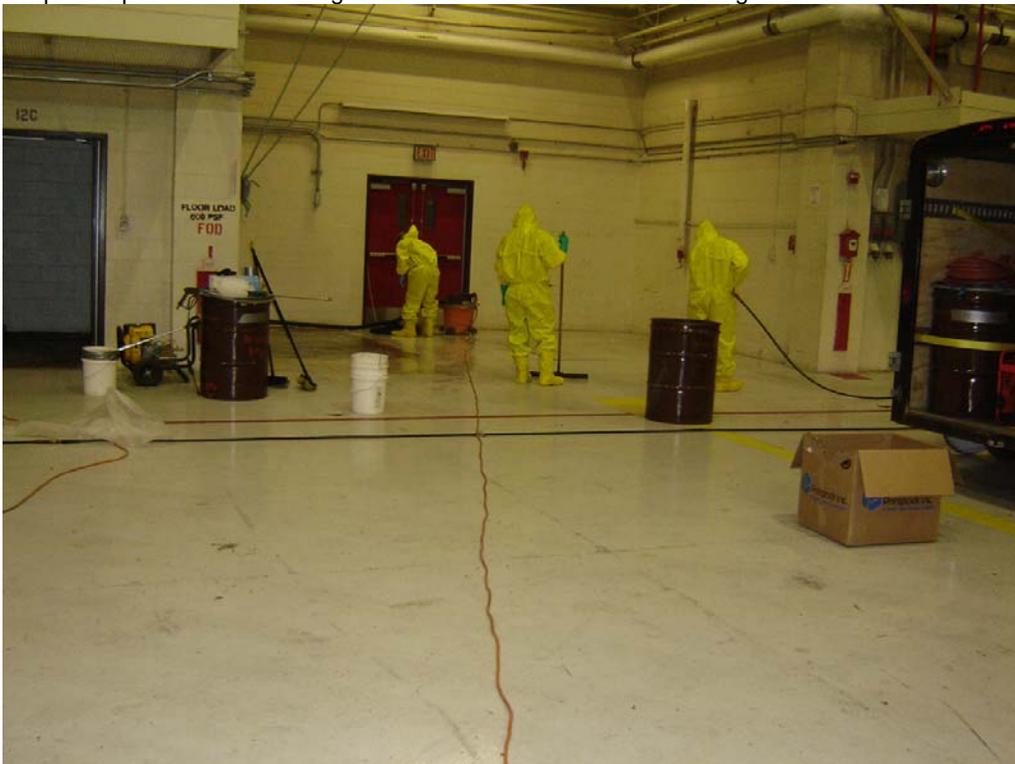
No. 6 Hangar 5 – NAS Brunswick March 24, 2010  
Hangar 5 – Cleaning lead-contaminated dust in the Hangar 5 North hazardous materials alcove

Tetra Tech's cleaning subcontractor (Global Remediation Services [Global]) performed floor-cleaning activities at Hangar 5 on March 22 and 23, 2010. Global initiated cleaning activities in the Hangar Bay 6 hazardous material storage area on March 22 and followed with cleaning of the hazardous materials storage area (Room 222), and the two Corrosion Control rooms (Rooms 203 and 313) on March 23. Prior to cleaning, floor openings were covered and sealed with polyethylene sheeting. The floor was then manually swept and then vacuumed with a HEPA vacuum. After sweeping and vacuuming, floors were sprayed with a 2-percent, lead-specific detergent solution, scrubbed, and pressure-washed using a 5,000-pounds-per-square-inch (psi) steam-cleaner. All cleaning wastewater was containerized using a wet-vacuum, placed in 55-gallon drums (3 drums generated) and transferred to the NAS Brunswick hazardous waste department for disposal. Upon completion, the Tetra Tech field representative performed a visual inspection of the cleaned area.
