FINAL RESOURCE CONSERVATION AND RECOVERY ACT PARTIAL CLOSURE REPORT
FOR BUILDING 49 WITH TRANSMITTAL LETTER NAS BRUNSWICK ME
6/18/2010
NAS BRUNSWICK

Subj: Final RCRA Partial Closure Report for Building 49

RCRA PARTIAL CLOSURE REPORT
for
BUILDING 49 – REGULATOR SUBSTATION BUILDING
NAVAL AIR STATION BRUNSWICK, MAINE
USEPA IDENTIFICATION NUMBER ME8170022018
JUNE 2010

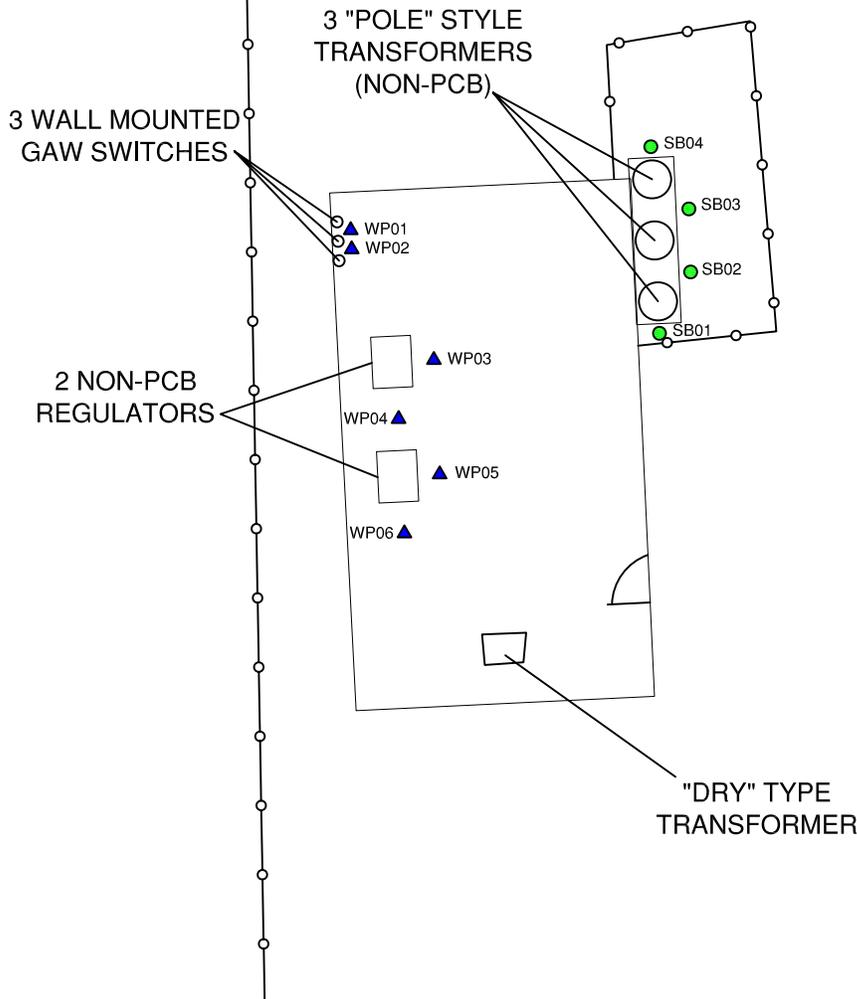
SCALE AS NOTED	
FILE \\.\NASB_BLDG_49_FP.DWG.DWG	
REV 0	DATE 06/11/10
FIGURE NUMBER FIGURE NO. 3

Due to the unknown manufacture date of the regulators and switches at Building 49, there could be potential areas of PCB surface contamination within Building 49, if there had been an historical leak. To evaluate the potential presence of PCB contamination, wipe samples were collected from six locations inside Building 49. On March 11, 2010, Tetra Tech collected two samples [NASB-B49-WP01 and NASB-B49-WP02] from the northwest floor, below the switches. Four samples [NASB-B49-WP03 through NASB-B49-WP06] were collected from the floor around the regulators. Sample locations are presented on Figure 3.

Because the three exterior transformers could potentially contain PCB-contaminated oil, as discussed above, PCB-contaminated soil could be present in the transformer area if there had been an historical transformer leak. To evaluate the soil in this area, surface soil samples were collected on May 6, 2010, from four locations surrounding the transformer pad. A hand auger was used to collect the samples: four were collected from 0 to 6 inches below ground surface (bgs) [NASB-B49-SB01-0006 through NASB-B49-SB04-0006] and four were collected from 6 to 24 inches bgs (NASB-B49-SB01-0624 through NASB-B49-SB04-0624). Sample locations are included on Figure 3.

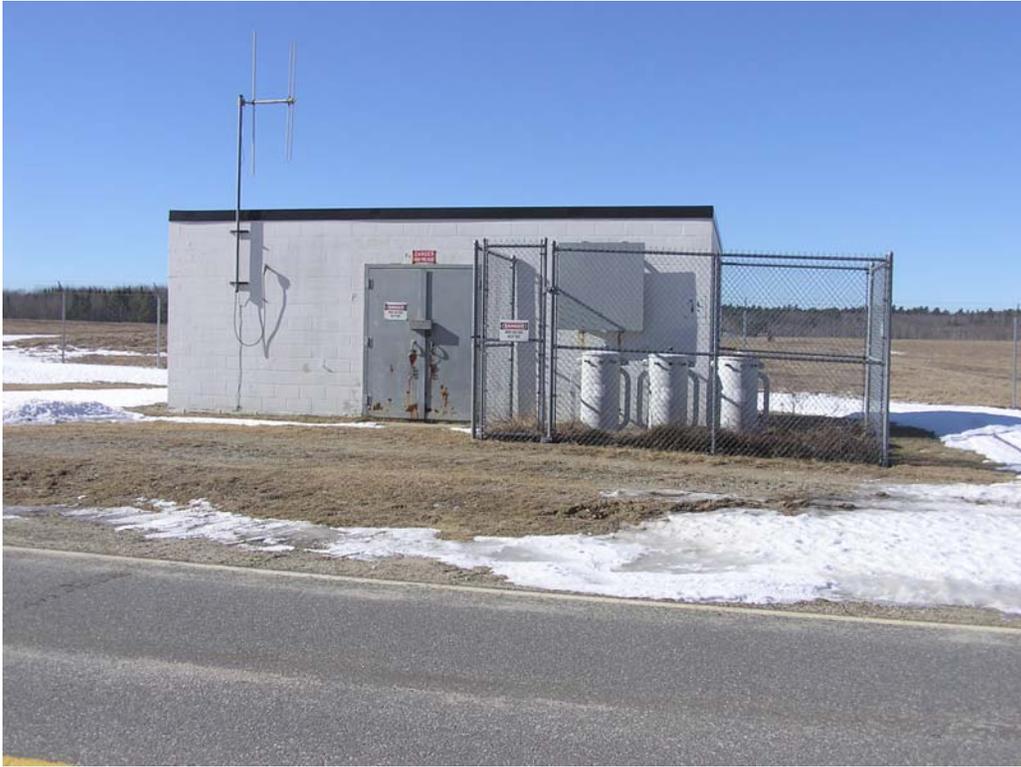
No. 1 Building 49 – NAS Brunswick
Regulator Substation Building east elevation

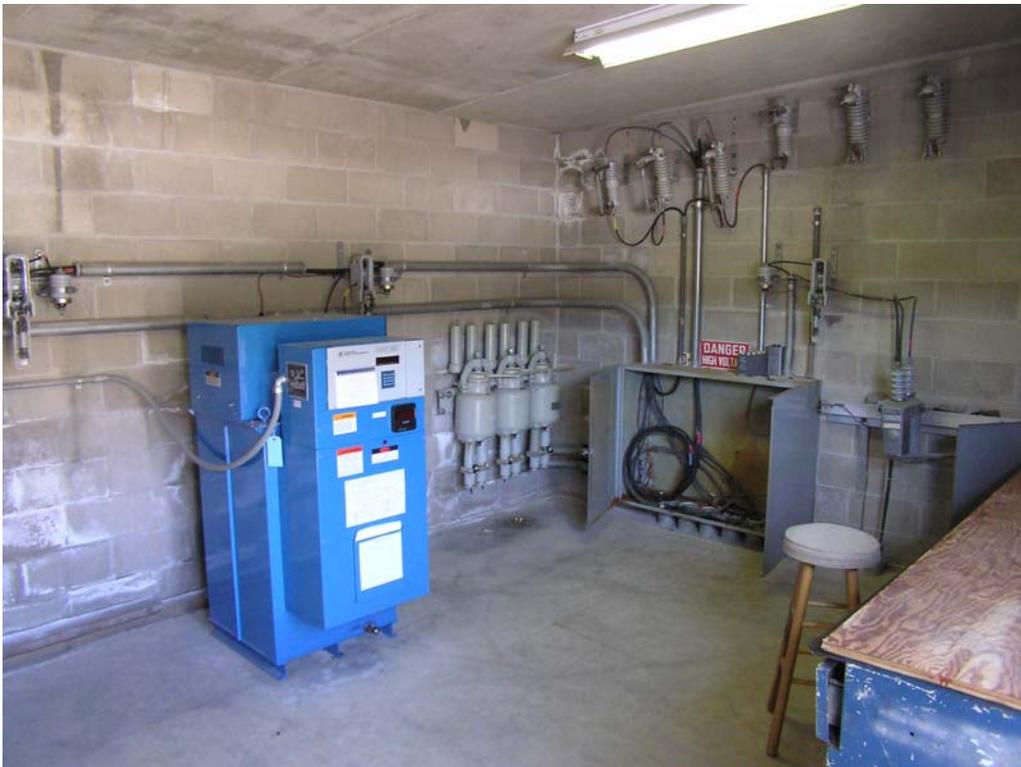
Staining was observed on the floor in the northwest corner of the building beneath the GAW switches. No additions, which may conceal signs of a past release, were observed.

No. 2 Building 49 – NAS Brunswick
Regulator Substation Building northwest interior, switches and regulator

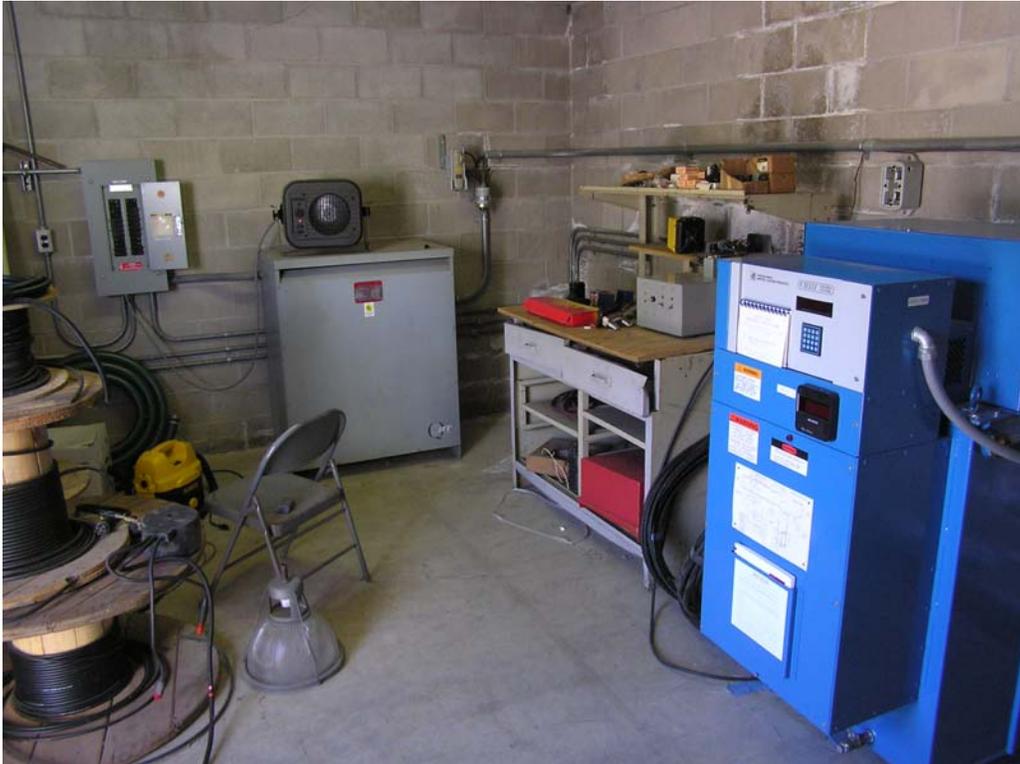
No. 3 Building 49 – NAS Brunswick
Regulator Substation Building southwest interior, regulator and dry transformer

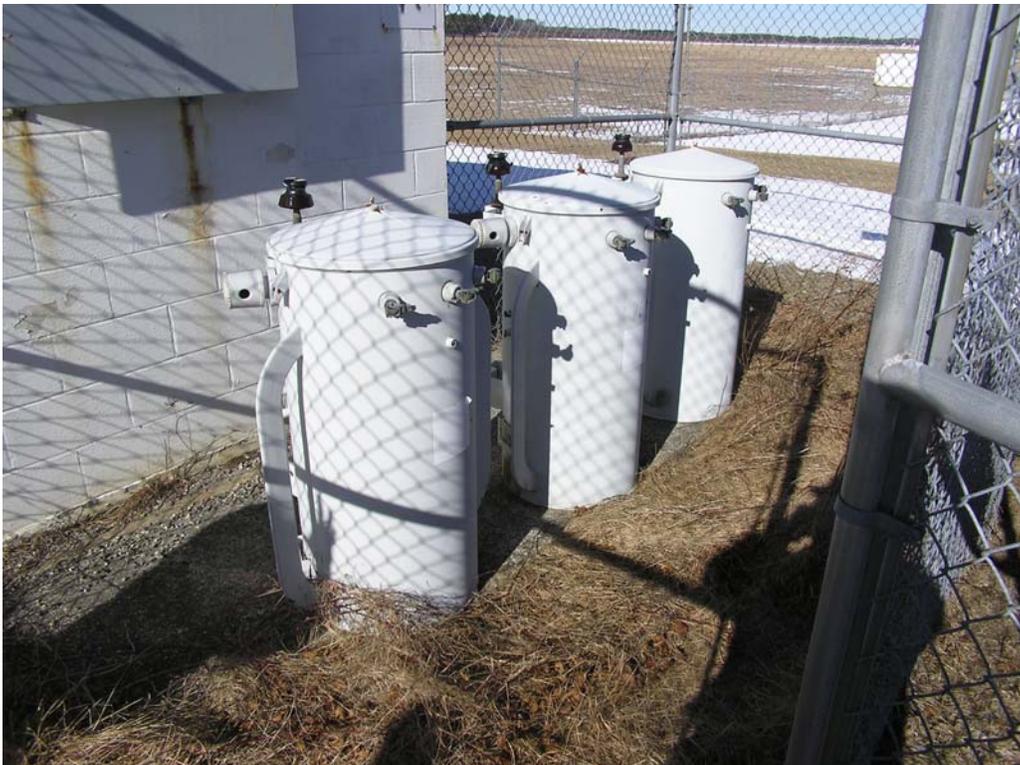
No. 4 Building 49 – NAS Brunswick
Regulator Substation Building northeast exterior, three pad-mounted transformers
