FINAL RESOURCE CONSERVATION AND RECOVERY ACT PARTIAL CLOSURE REPORT
FOR BUILDING 209 WITH TRANSMITTAL LETTER NAS BRUNSWICK ME
7/16/2010
NAS BRUNSWICK

RCRA PARTIAL CLOSURE REPORT
for
BUILDING 209 – ELECTRIC DISTRIBUTION BUILDING
NAVAL AIR STATION BRUNSWICK, MAINE
USEPA IDENTIFICATION NUMBER ME8170022018
JULY 2010

**BUILDING INSPECTION FORM
RCRA PARTIAL CLOSURE PROGRAM
NAS BRUNSWICK
BRUNSWICK, MAINE
CTO WE22**

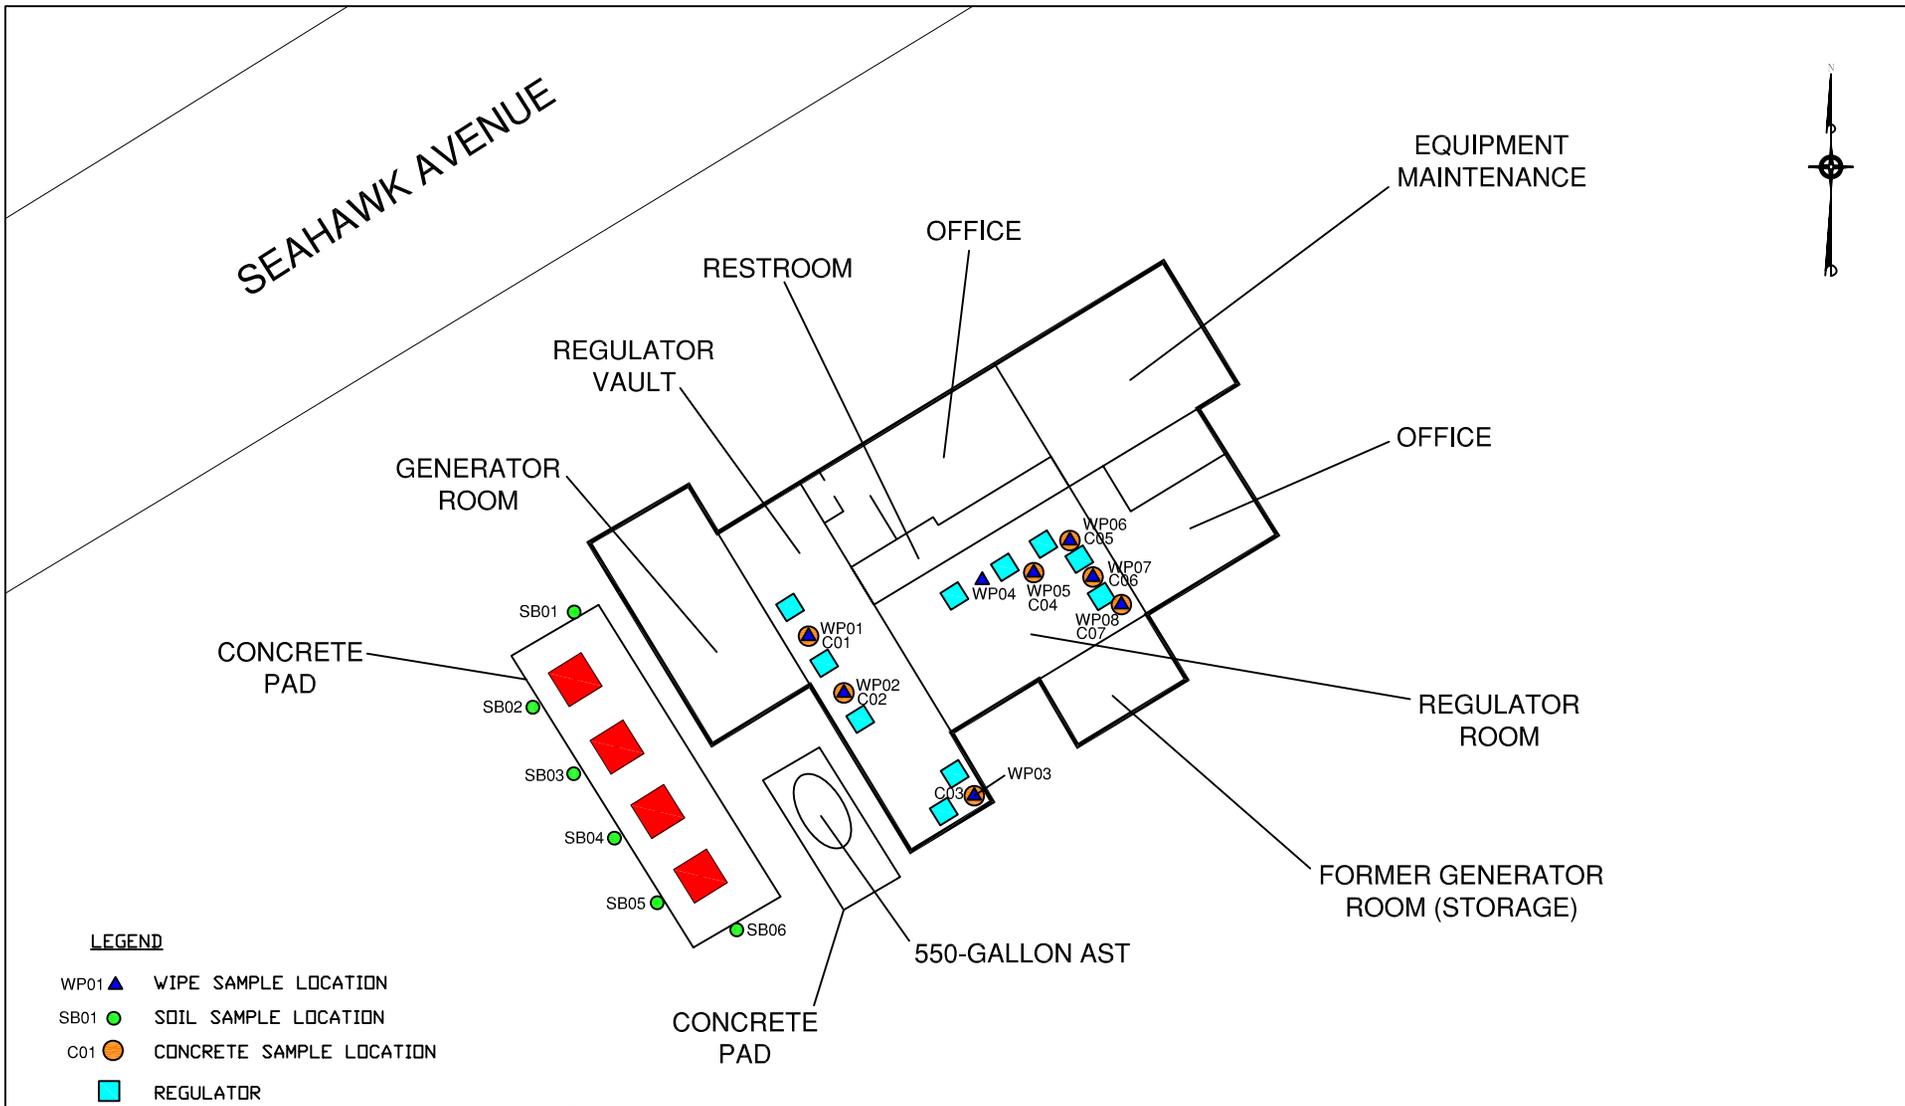
SCALE AS NOTED	
FILE \\.\NASB_BLDG_209_FP.DWG	
REV 0	DATE 07/01/10
FIGURE NUMBER FIGURE NO. 3

As presented in Table 1, low levels of PCB were detected in two wipe samples: in one of the three wipe samples collected from the floor of the regulator vault room, and in one of the five wipe samples from the floor of the new regulator vault room. As shown in Table 2, PCBs were not detected in any of the soil samples collected adjacent to the Building 209 transformer pad. The EPA Regional Screening Levels (RSLs) for Residential Soil are included in Table 2 for informational purposes (EPA, 2009).

Due to the detection of PCBs in two of the wipe samples collected from the floor of the regulator vault rooms (NASB-B209-WP03 and NASB-B209-WP04, as described above and shown on Table 1), bulk sampling of the porous concrete flooring in these two rooms was required to determine if PCB-contaminated concrete is present. On June 17, 2010, seven bulk concrete samples were collected from the regulator vault room floor and the new regulator vault room floor. The samples were collected adjacent to seven of the eight the previously collected wipe sample locations and are shown on Figure 3 (A floor covering is installed over the concrete floor at one of the wipe sample locations and therefore this location was not sampled.). Concrete samples were collected in accordance with the *USEPA Region I Draft Standard Operating Procedure (SOP) for Sampling Concrete in the Field*, dated December 12, 1997. An electric-powered hammer drill equipped with a 1/2-inch carbide drill bit was used to drill five 1/2-inch deep holes at each of the seven concrete sample locations. At each sample location, pulverized concrete was placed into a four-ounce amber jar using a dedicated stainless steel scoopula. After each use, the drill bit was decontaminated using a liquid Alconox solution and was rinsed with de-ionized water prior to collection of the next sample.

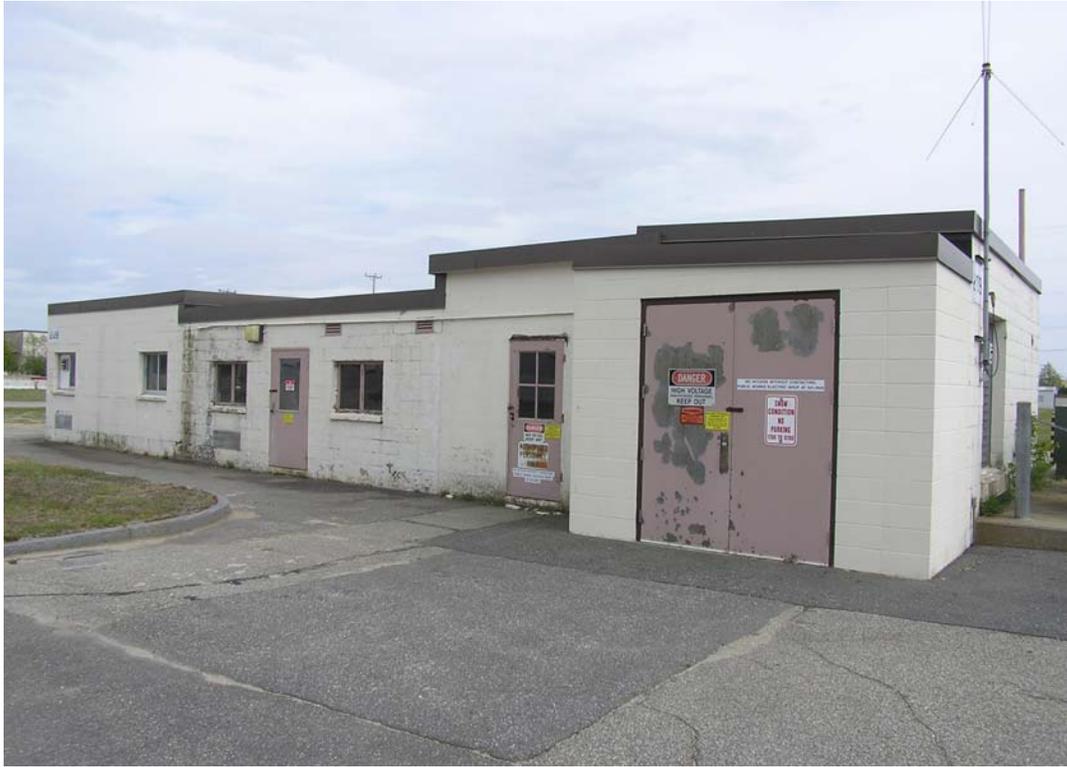
No. 1 Building 209 – NAS Brunswick
Electric Distribution Building exterior – north elevation

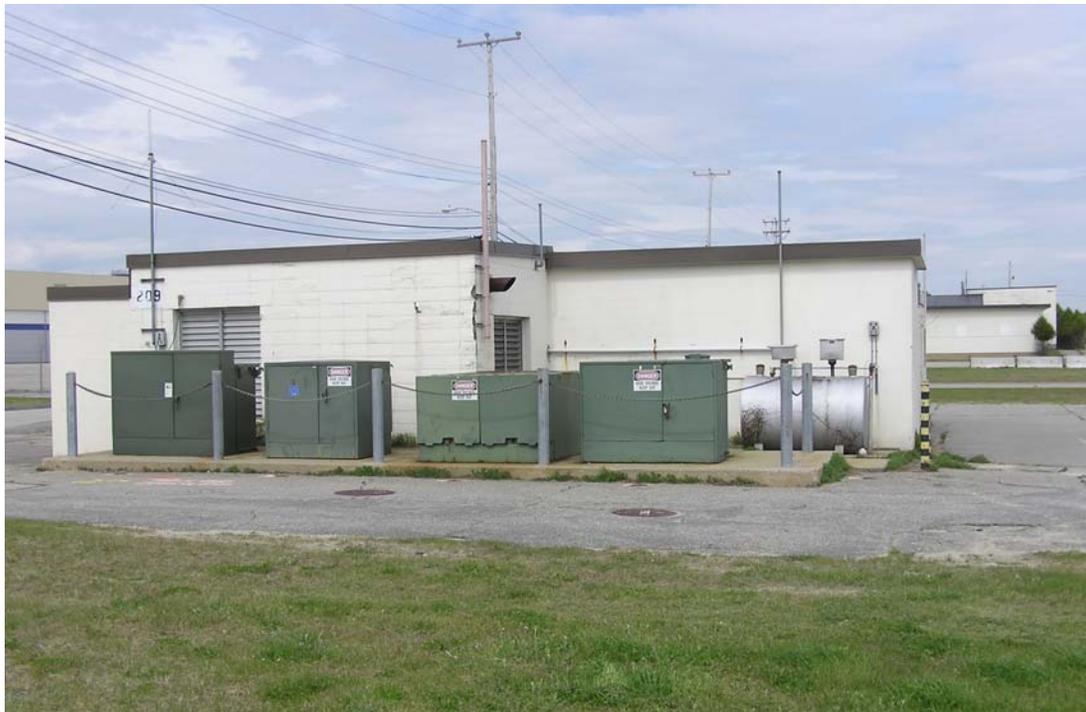
- No hazardous waste storage or accumulation areas were observed.
- Four pad-mounted transformers were observed west of the building. Ten electrical regulators were observed inside the building. No evidence of a past leak from these transformers was observed.

No. 2 Building 209 – NAS Brunswick
Electric Distribution Building exterior – west elevation

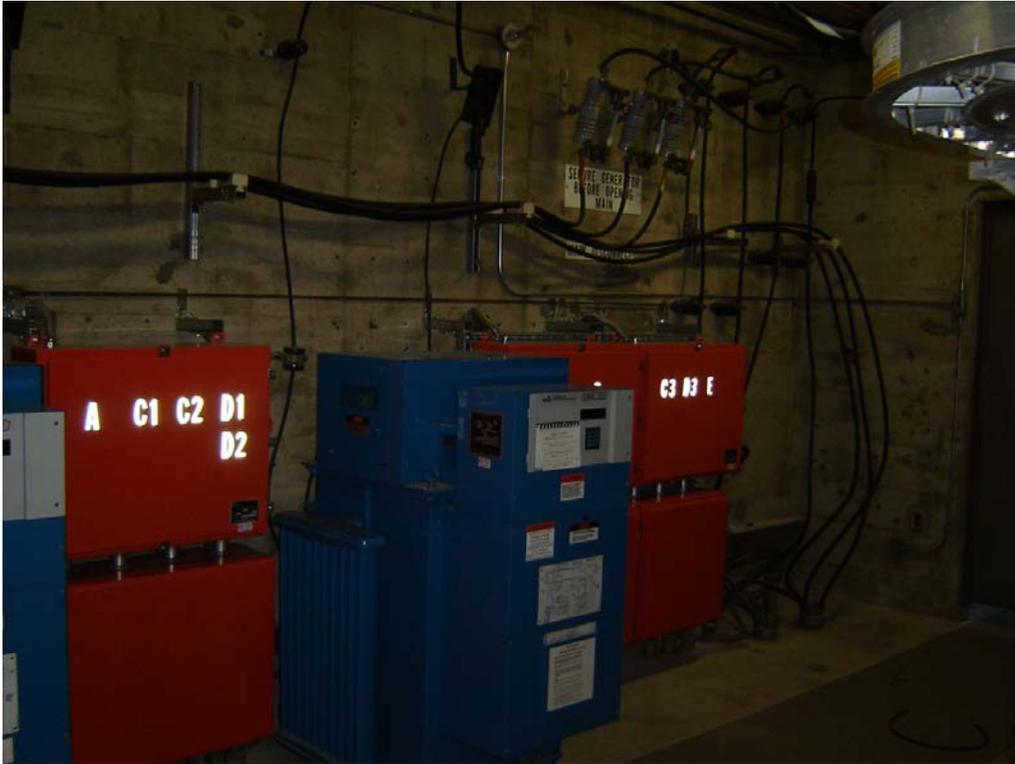
No. 3 Building 209 – NAS Brunswick
Electric Distribution Building – regulator vault room

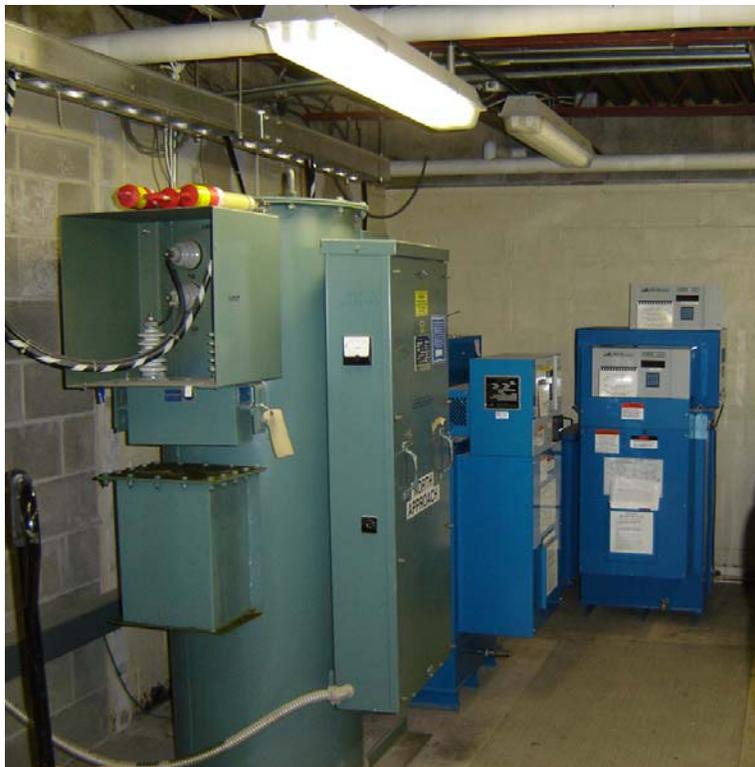
No. 4 Building 209 – NAS Brunswick
Electric Distribution Building – new regulator vault room

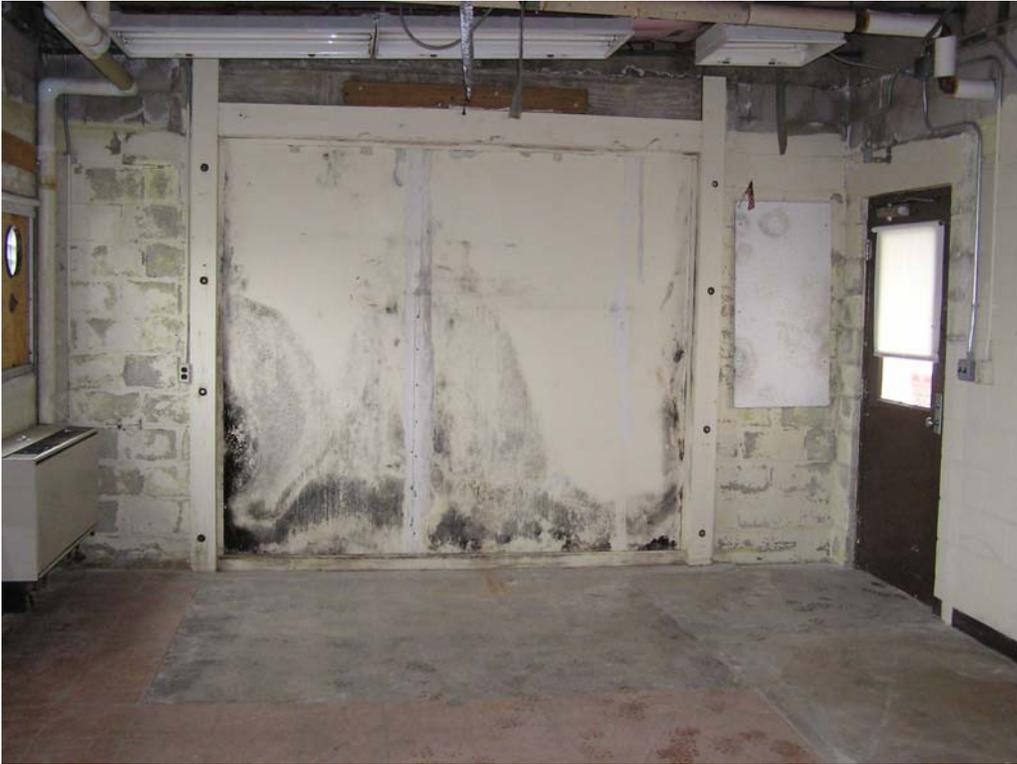
- Evidence of suspected mold growth (black spots and musty odor) was observed on the interior office/storage room (former equipment maintenance room) east wall.

A suspected mold condition was observed in the office/storage room, as discussed in Section 4.

No. 5 Building 209 – NAS Brunswick April 27, 2010
Electric Distribution Building interior – office/storage room (former equipment maintenance room) east wall

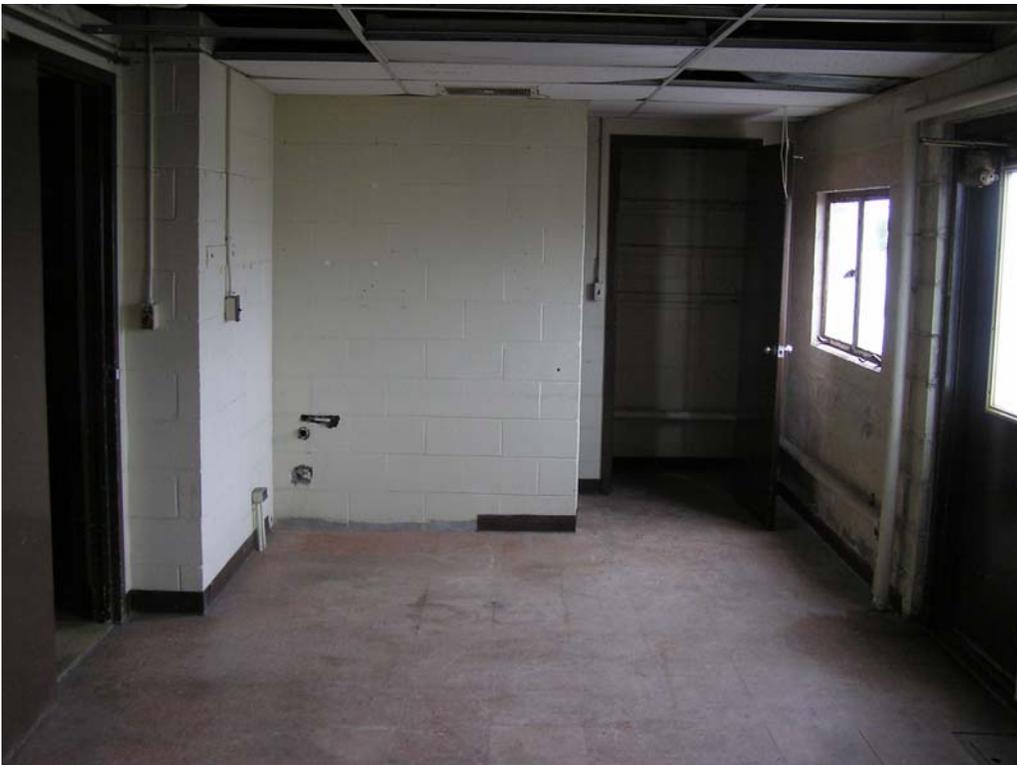
No. 6 Building 209 – NAS Brunswick April 27, 2010
Electric Distribution Building interior – office
