FINAL RESOURCE CONSERVATION AND RECOVERY ACT PARTIAL CLOSURE REPORT
FOR HANGAR 6 WITH TRANSMITTAL LETTER NAS BRUNSWICK ME
8/24/2010
NAS BRUNSWICK

Subj: Final RCRA Partial Closure Report for Hangar 6

RCRA PARTIAL CLOSURE REPORT
for
HANGAR 6 – AIRCRAFT MAINTENANCE HANGAR PARCEL
NAVAL AIR STATION BRUNSWICK, MAINE
USEPA IDENTIFICATION NUMBER ME8170022018
AUGUST 2010

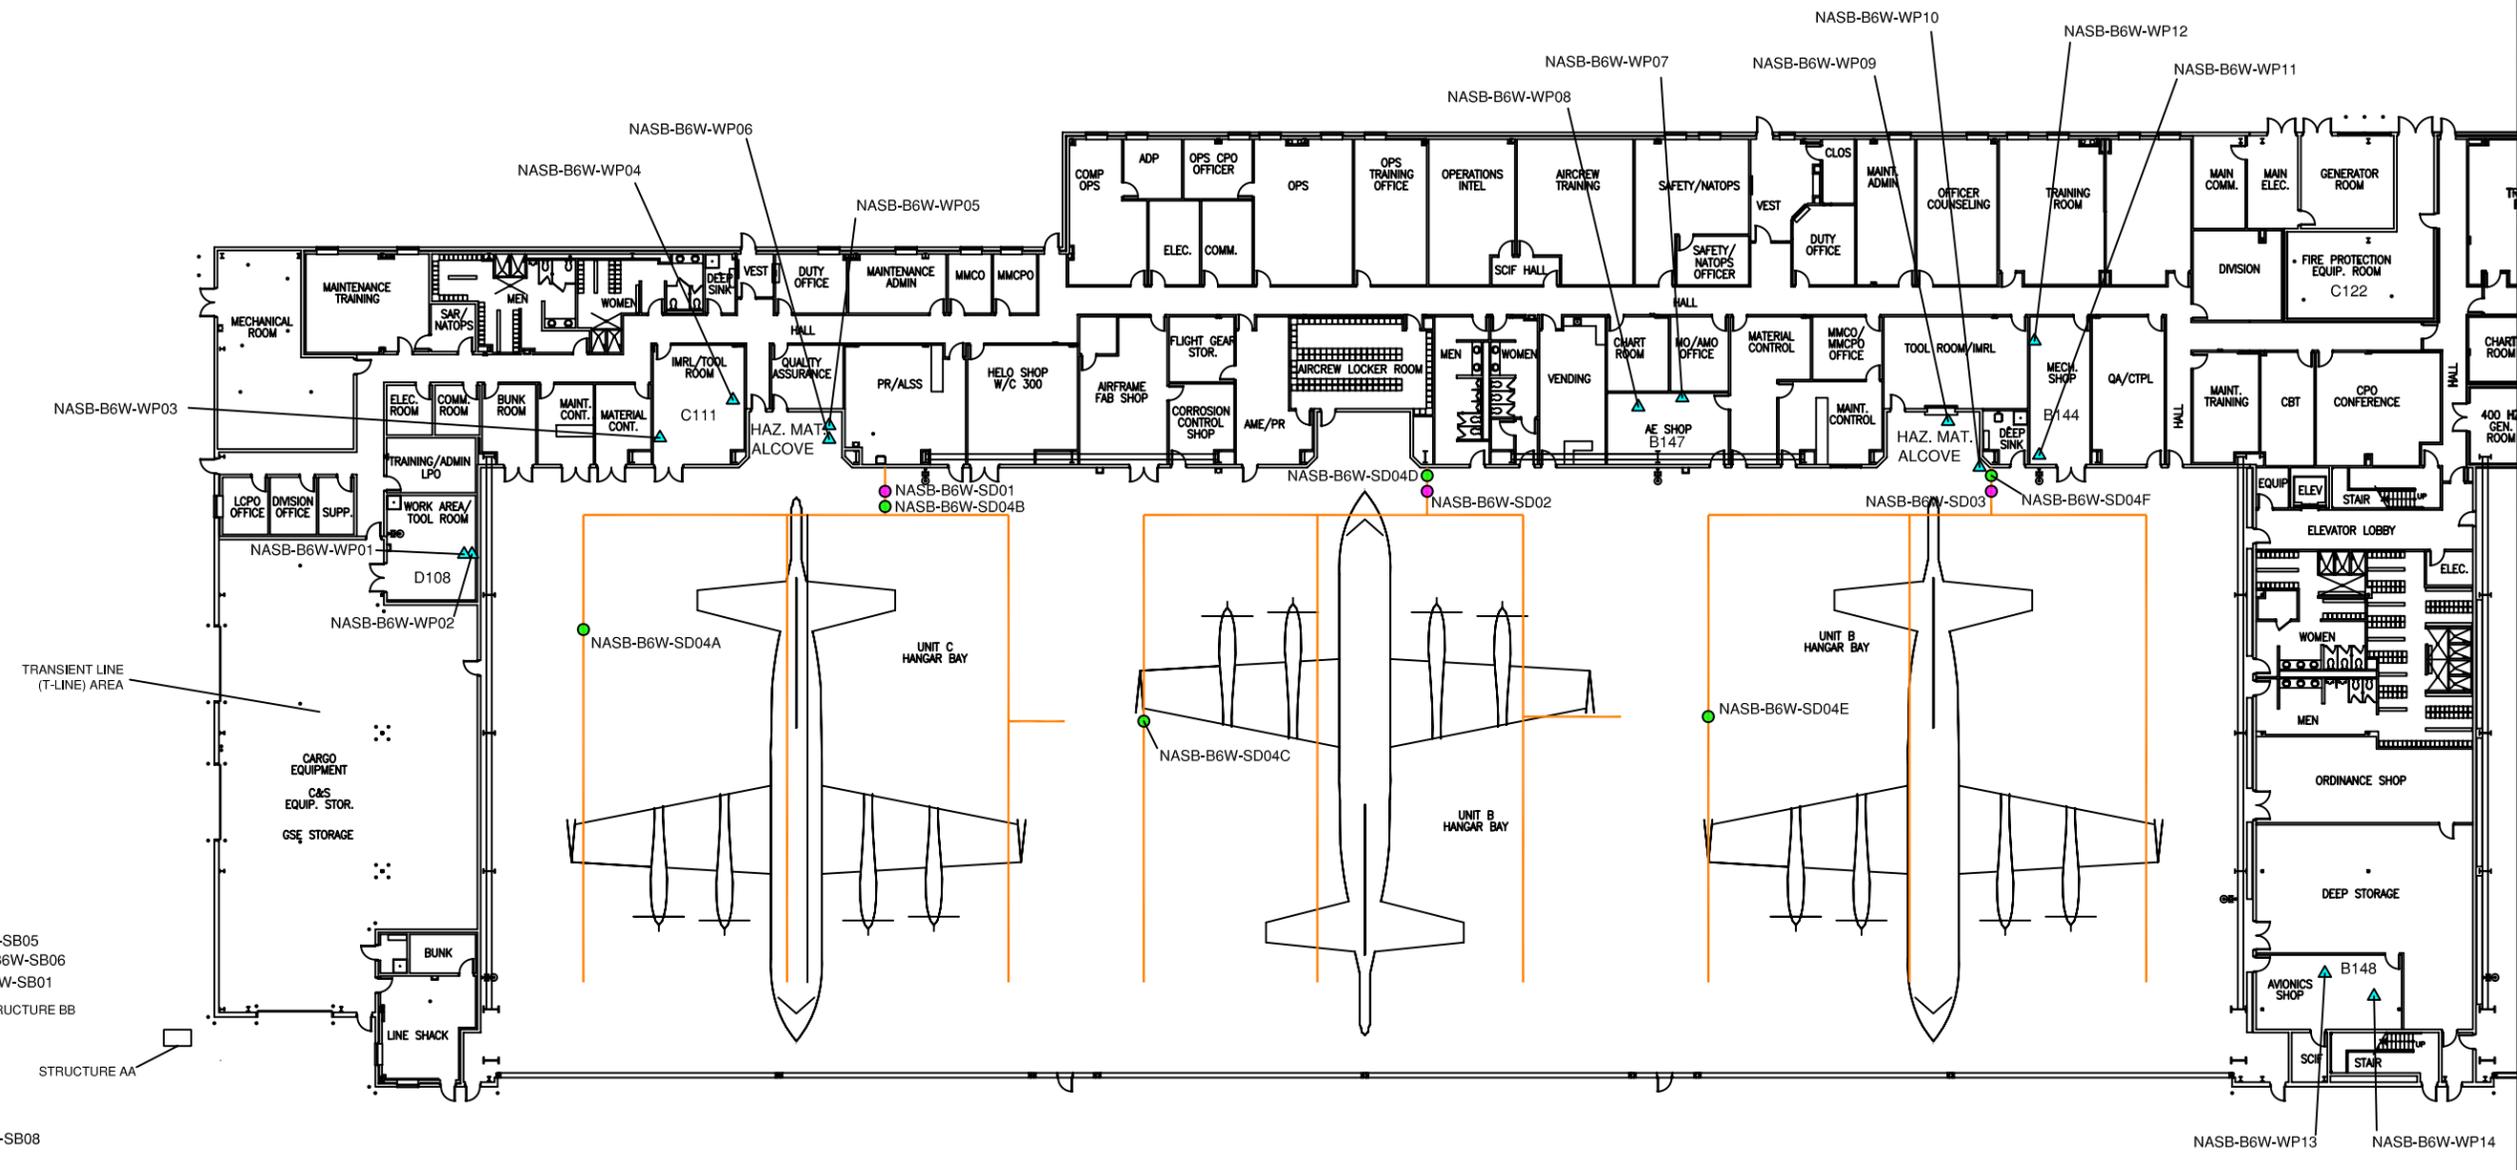
FILE \\.\NASB_H6_PRE_SAMP_W.DWG	SCALE AS NOTED
FIGURE NUMBER 3A	REV DATE 0 08/05/10

Hazardous materials storage area, in front of Room C110 (floor)	The lead level in one of two samples, $46 \mu\text{g}/\text{ft}^2$ in sample B6W-WP05, exceeds the criterion
Hazardous materials storage area, in front of Room B140 (floor)	The lead level in one of two samples, $44 \mu\text{g}/\text{ft}^2$ in sample B6W-WP09, exceeds the criterion

Based on these analytical results, it was concluded that floor-cleaning at the hazardous materials storage areas in front of Rooms C110 and B140 was required to remove surface residue with lead at levels exceeding the MEDEP floor criterion ($40 \mu\text{g}/\text{ft}^2$). In addition, as shown in Table 1, cadmium and chromium levels in wipe samples collected from the surface of a work bench in Room D108 exceed the World Trade Center Settled Dust Screening Values, indicating cleaning or removal and disposal of the bench is required for closure.

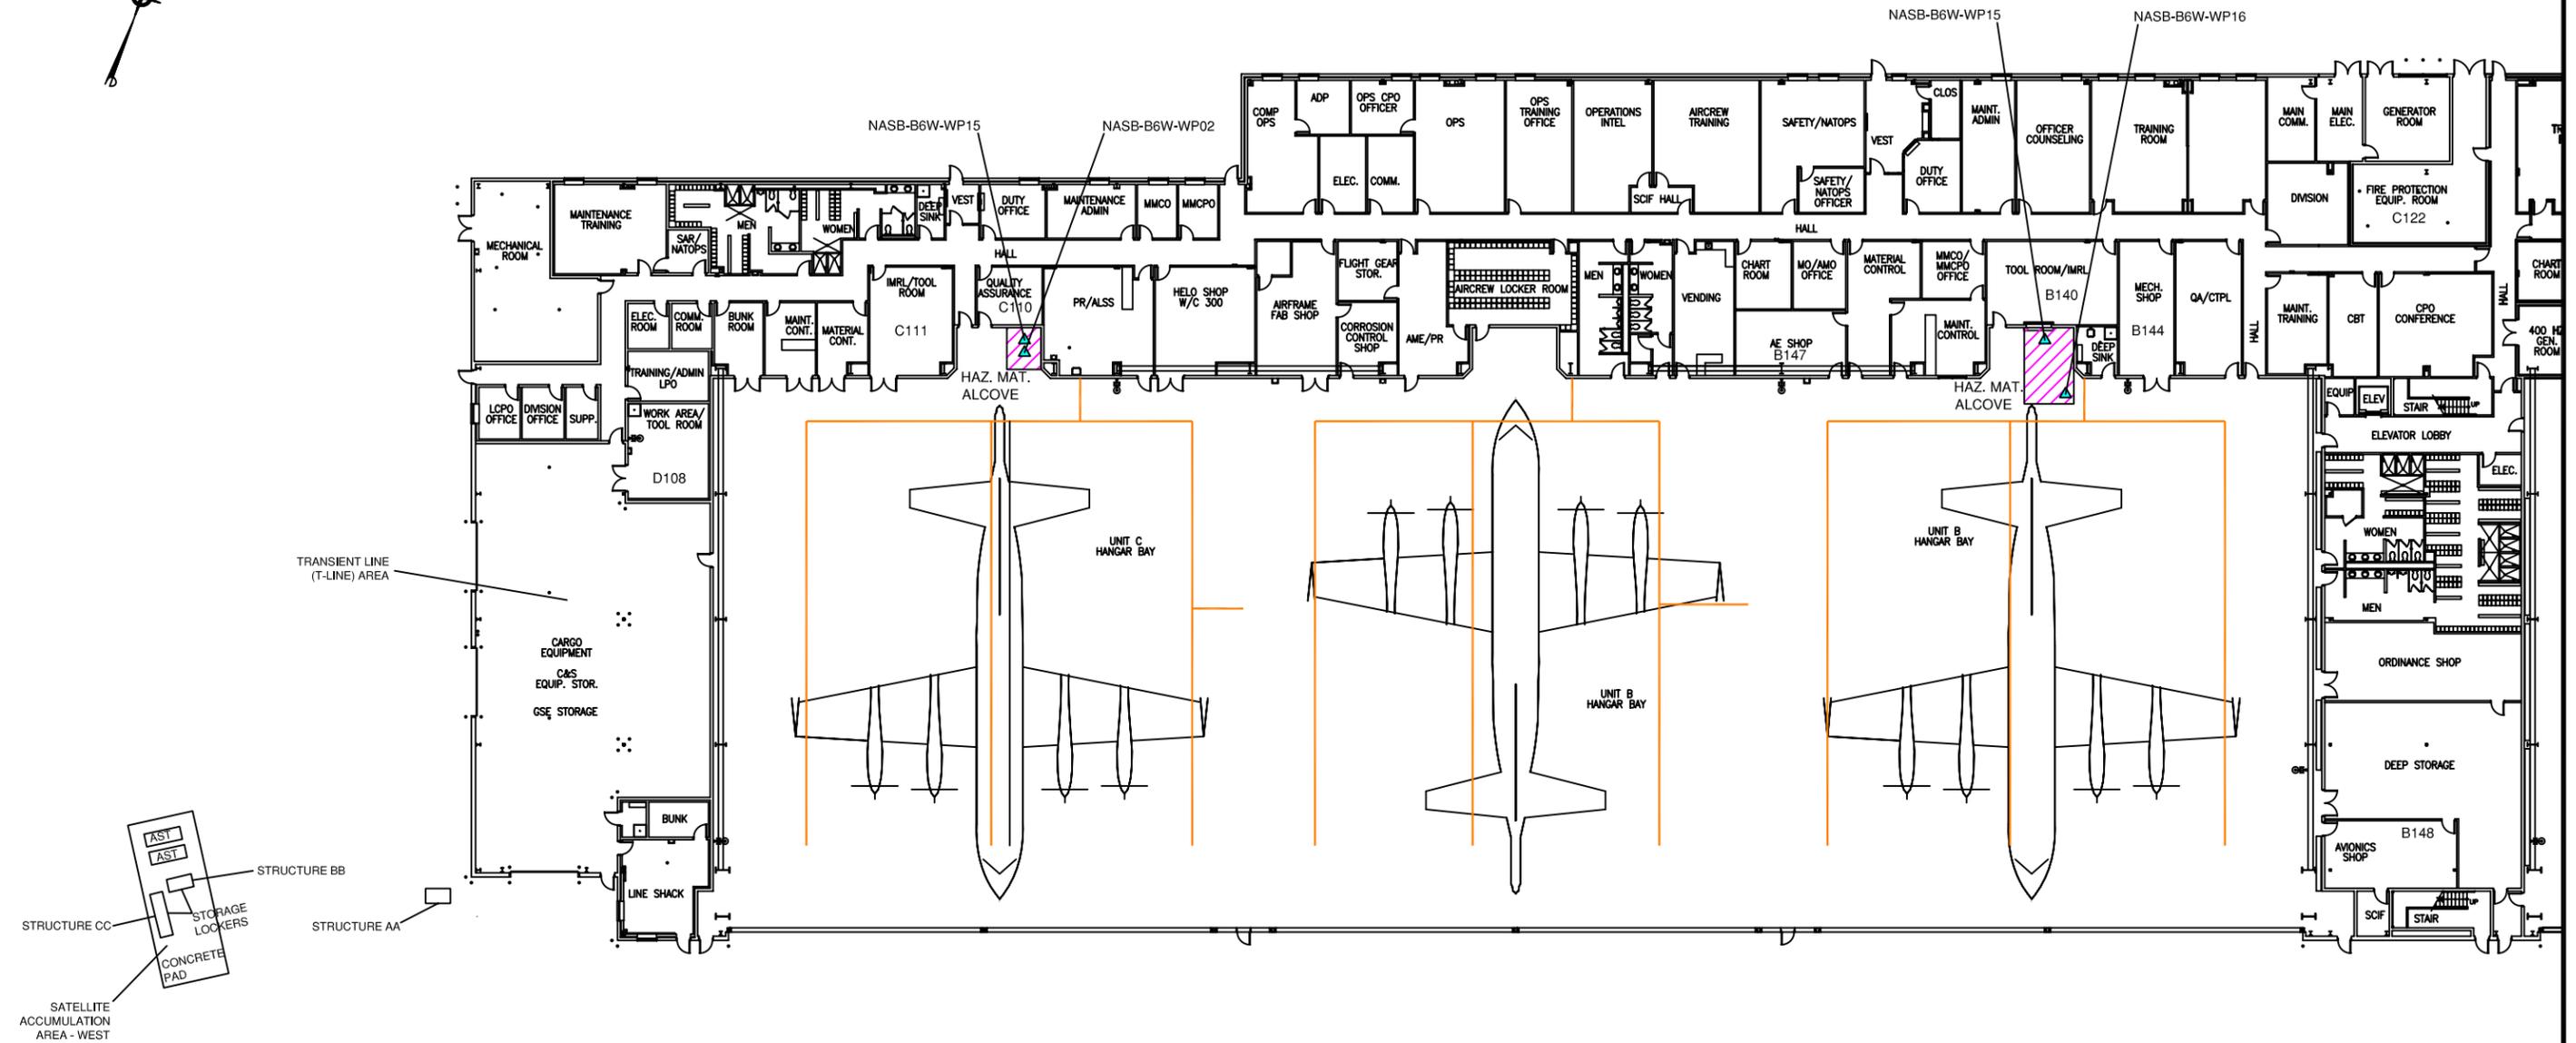
FILE \\.\NASB_H6_POST_SAMP_W.DWG	SCALE AS NOTED
FIGURE NUMBER 4	REV DATE 0 08/05/10

Location	Sample ID ⁽¹⁾	Sample Date	Lead ($\mu\text{g}/\text{ft}^2$)
<u>Hangar 6 West</u>			
Hangar hazardous materials storage area (in front of Room B140)	B6W-WP15	7/21/10	1.8 J
	B6W-WP16	7/21/10	2.9 J
Hangar hazardous materials storage area (in front of Room C110)	B6W-WP17	7/22/10	4.0 J
	B6W-WP18	7/22/10	4.8

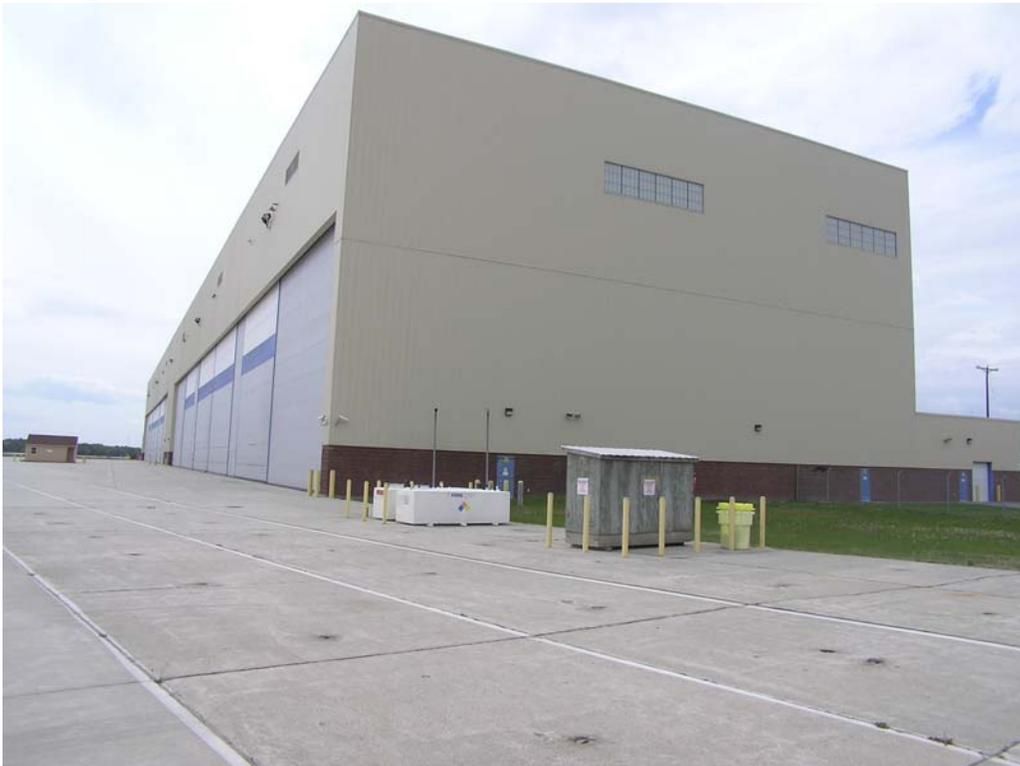
No. 11 Hangar 6 – NAS Brunswick
Southeast elevation (SAA in foreground)

- No visual staining, cracking, spalling, or discoloration of the concrete was noted at the SAAs. The expansion joints appeared in good condition. The vegetation adjacent to the Hangar 6 SAA-West showed signs of distress on the western side of the SAA concrete pad. Vegetated areas north of the Hangar 6 SAA-East did not show signs of distress.

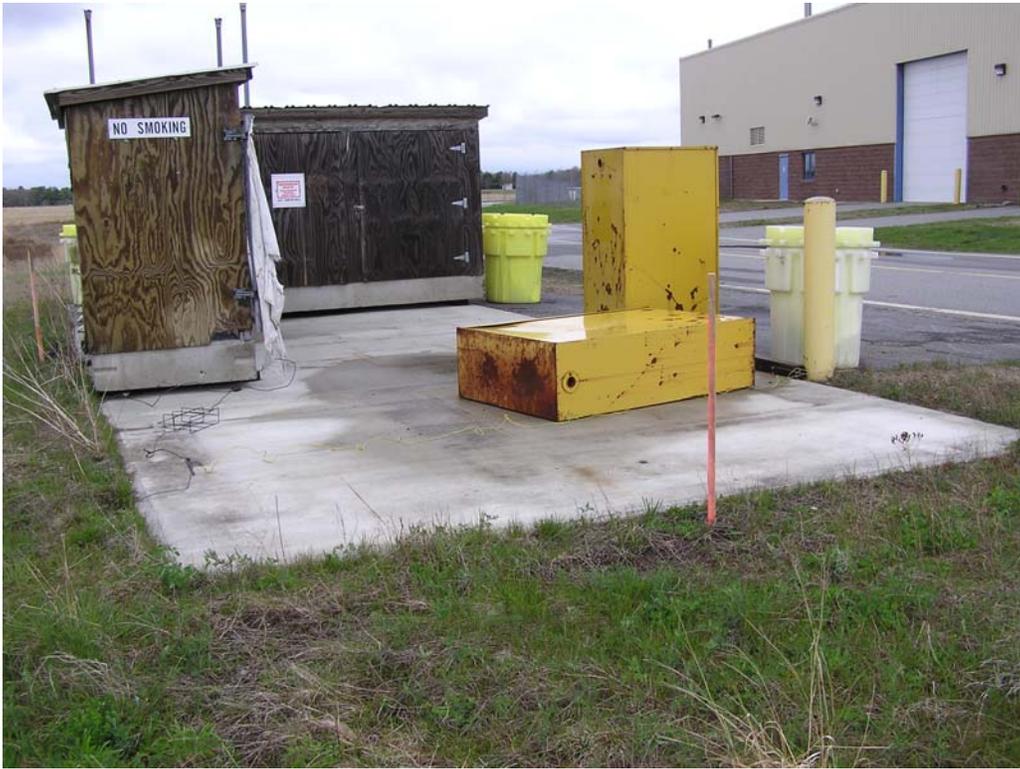
No. 13
Hangar 6 West SAA

In three of the samples collected from the Hangar 6 West SAA (SB01-0612, SB04-0024, and SB08-0024), arsenic was detected at concentrations ranging from 27 to 34 mg/kg, exceeding the MEDEP Background Soil RAG for arsenic of 9 mg/kg. In nine of the soil samples, arsenic exceeded the MEDEP Outdoor Commercial Worker RAG of 4.2 mg/kg, this criterion equaling nearly one-half the MEDEP background concentration for arsenic. According to the Maine RAGs for Soil Contaminated with Hazardous Substances, if arsenic is identified in on-site soil at levels above the RAG, a determination is to be made as to whether the arsenic was released by site-related activities or whether it is naturally-occurring, or both. Arsenic introduced through site-related activities must be reduced to the greater of the RAG or background concentration, which would be the background concentration of 9 mg/kg arsenic (MEDEP, 2010). The exceedances of the MEDEP background concentration for arsenic are attributed to anthropogenic sources resulting from the Navy's past use of arsenical herbicides, pesticides, and rodenticides. Therefore, no further action is recommended for either the Hangar 6 East or Hangar 6 West SAAs.
