REVISED FINAL RESOURCE CONSERVATION AND RECOVERY ACT PARTIAL CLOSURE  
REPORT FOR BUILDING 594 WITH TRANSMITTAL LETTER NAS BRUNSWICK ME  
8/24/2010  
NAS BRUNSWICK

Subj: Revised Final RCRA Partial Closure Report for Building 594

**RCRA PARTIAL CLOSURE REPORT  
for  
BUILDING 594 – AIR OPERATIONS RADAR TOWER  
NAVAL AIR STATION BRUNSWICK, MAINE  
USEPA IDENTIFICATION NUMBER ME8170022018  
AUGUST 2010**

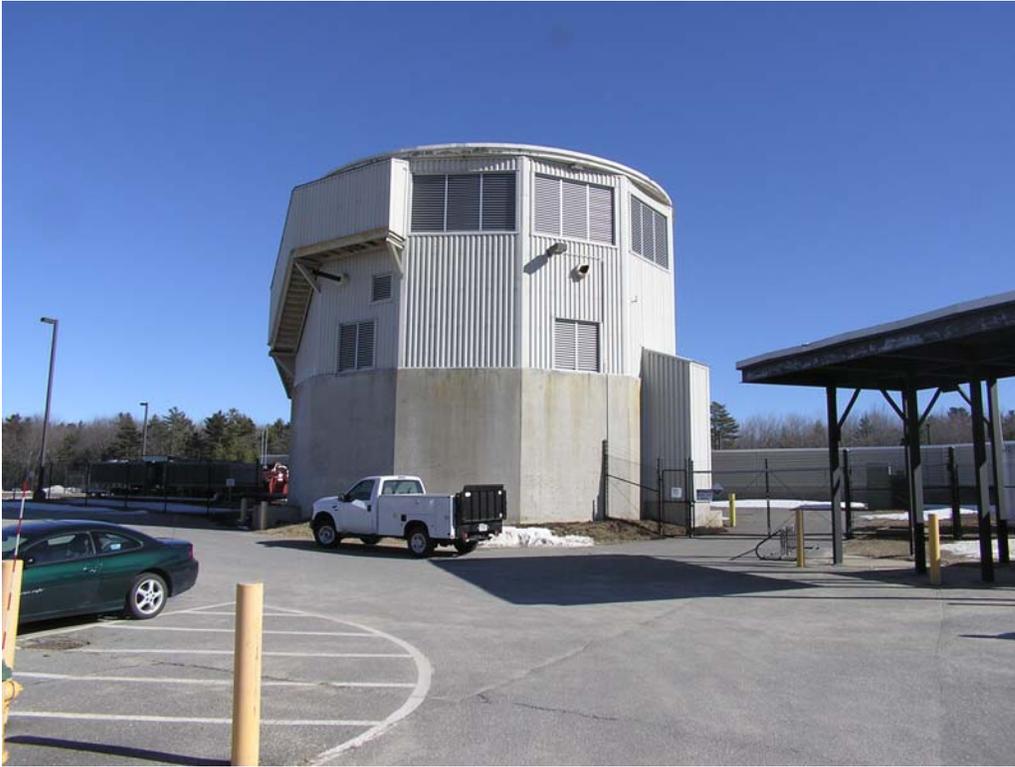
No. 1 Building 594 – NAS Brunswick  
Air Operations Radar Tower southwest elevation

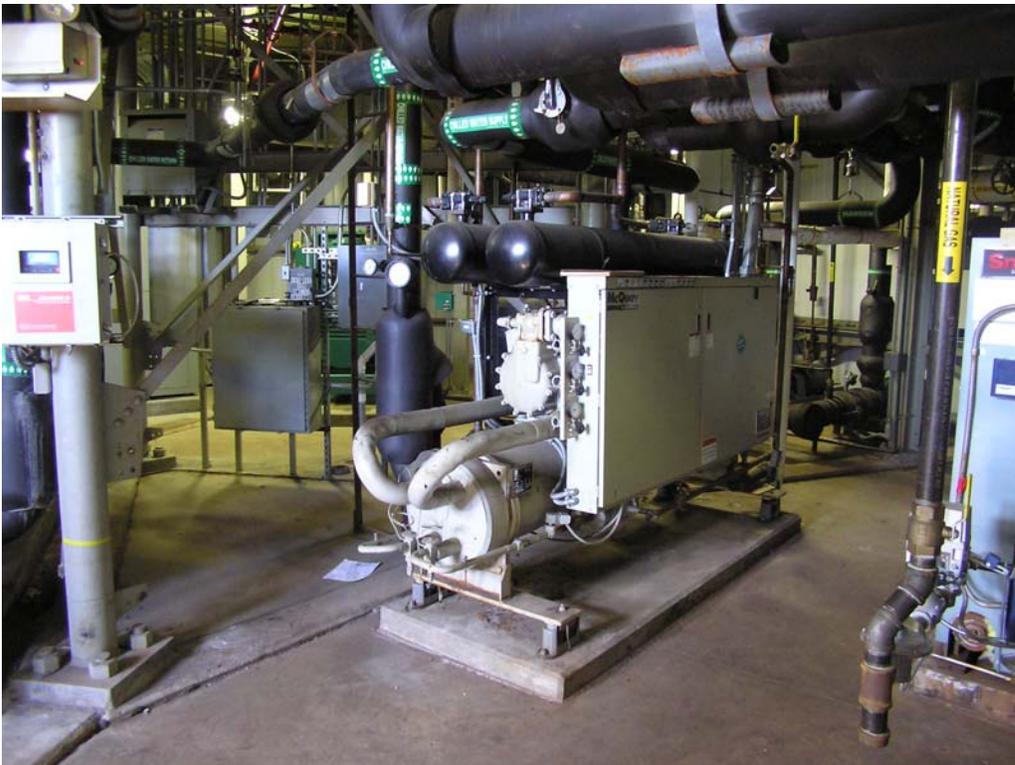
No. 2 Building 594 – NAS Brunswick  
Air Operations Radar Tower first floor interior

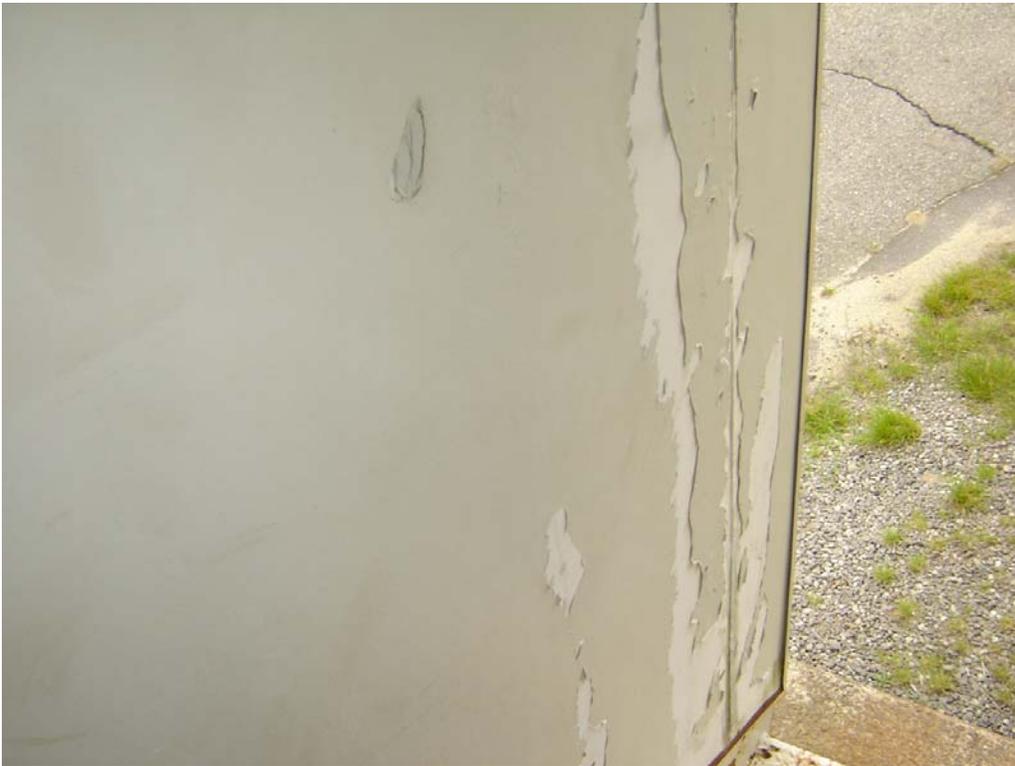
No. 3 Building 594 – NAS Brunswick  
Air Operations Radar Tower southwest elevation

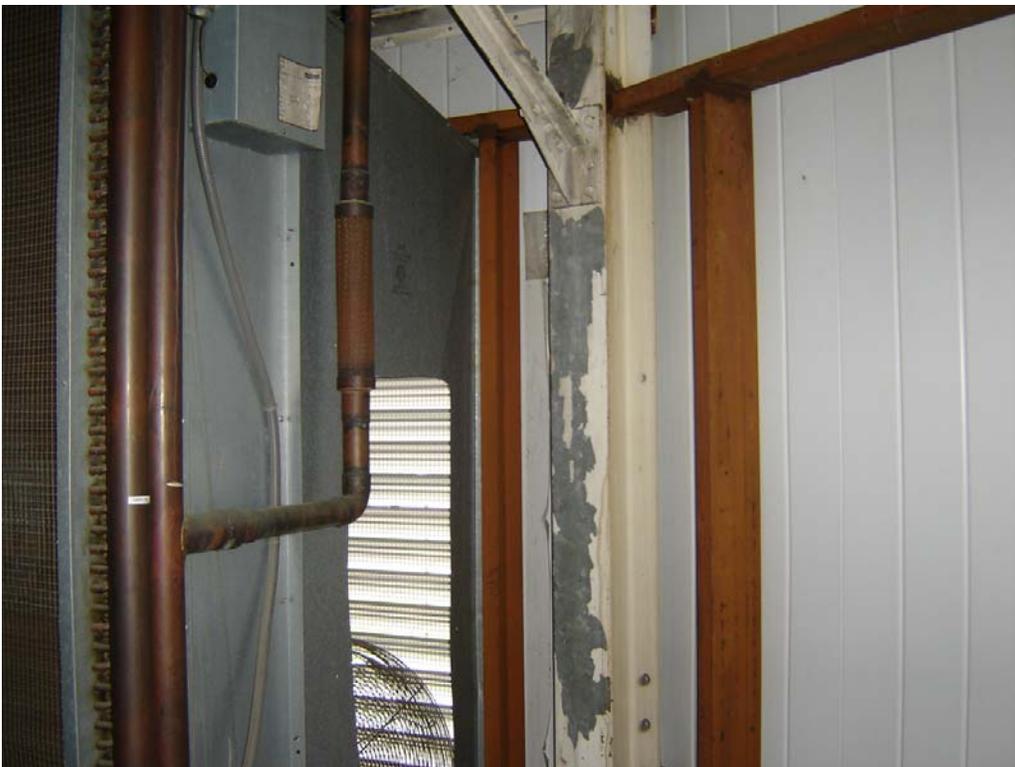
No. 4 Building 594 – NAS Brunswick  
Air Operations Radar Tower first floor interior

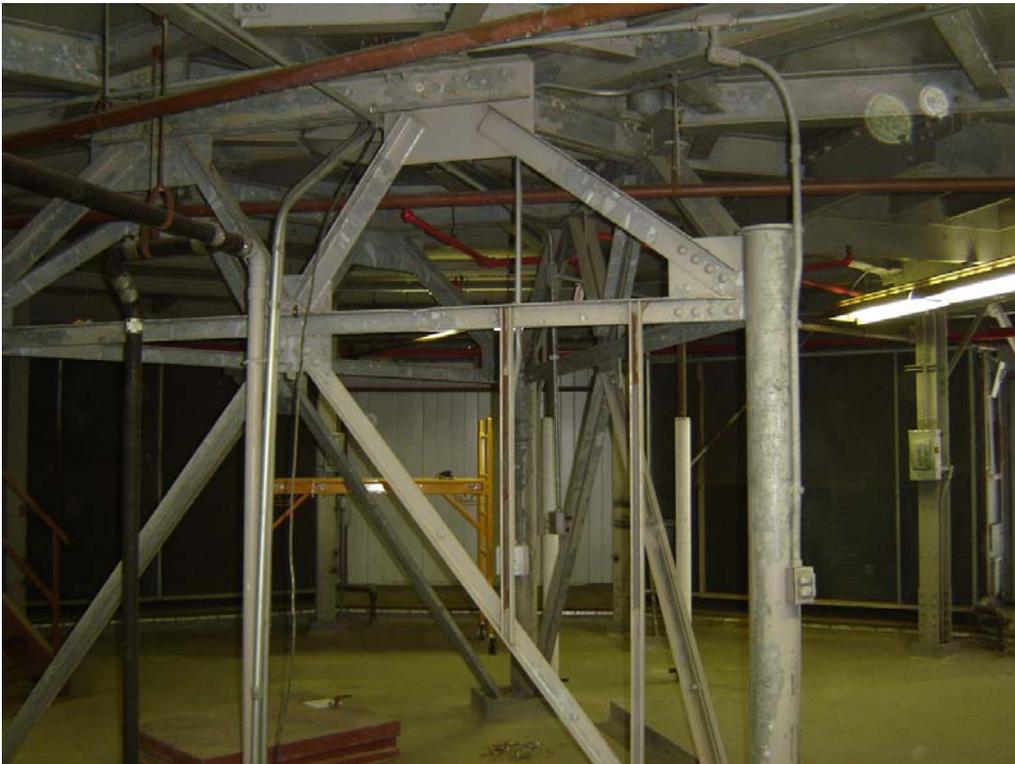
Flaking paint chips were observed in the second level and the entry that surrounds the building and may be lead based paint.

No. 6 Building 594 – NAS Brunswick  
Air Operations Radar Tower second level following loose paint chip and paint chip removal

Tetra Tech's cleaning subcontractor (Global Remediation Services, Inc.) performed loose paint and paint-chip removal activities at the Building 594 second level and stairway on July 22 and 23, 2010. All loose paint was manually scraped off using metal scrapers and wire brushes. Paint chips and dust were then swept and then vacuumed with a HEPA vacuum, placed in a 30-gallon drum (one drum generated) and transferred to the NAS Brunswick hazardous waste department for disposal. Upon completion, the Tetra Tech field representative performed a visual inspection of the loose paint and paint-chip removal areas. TCLP analysis of the removed paint-chip waste (Table 2) showed that the material does not exhibit the "toxicity characteristic" and, therefore is not subject to hazardous waste handling and disposal requirements.
