FINAL RESOURCE CONSERVATION AND RECOVERY ACT PARTIAL CLOSURE REPORT
FOR BUILDING 20 WITH TRANSMITTAL LETTER NAS BRUNSWICK ME
11/5/2010
NAS BRUNSWICK

RCRA PARTIAL CLOSURE REPORT
for
BUILDING 20 – NAVY COLLEGE OFFICE PARCEL
NAVAL AIR STATION BRUNSWICK, MAINE
USEPA IDENTIFICATION NUMBER ME8170022018
OCTOBER 2010

**HWSA INSPECTION REPORT
HAZARDOUS WASTE STORAGE AREAS CLOSURE
NAS BRUNSWICK
BRUNSWICK, MAINE
CTO WE22**

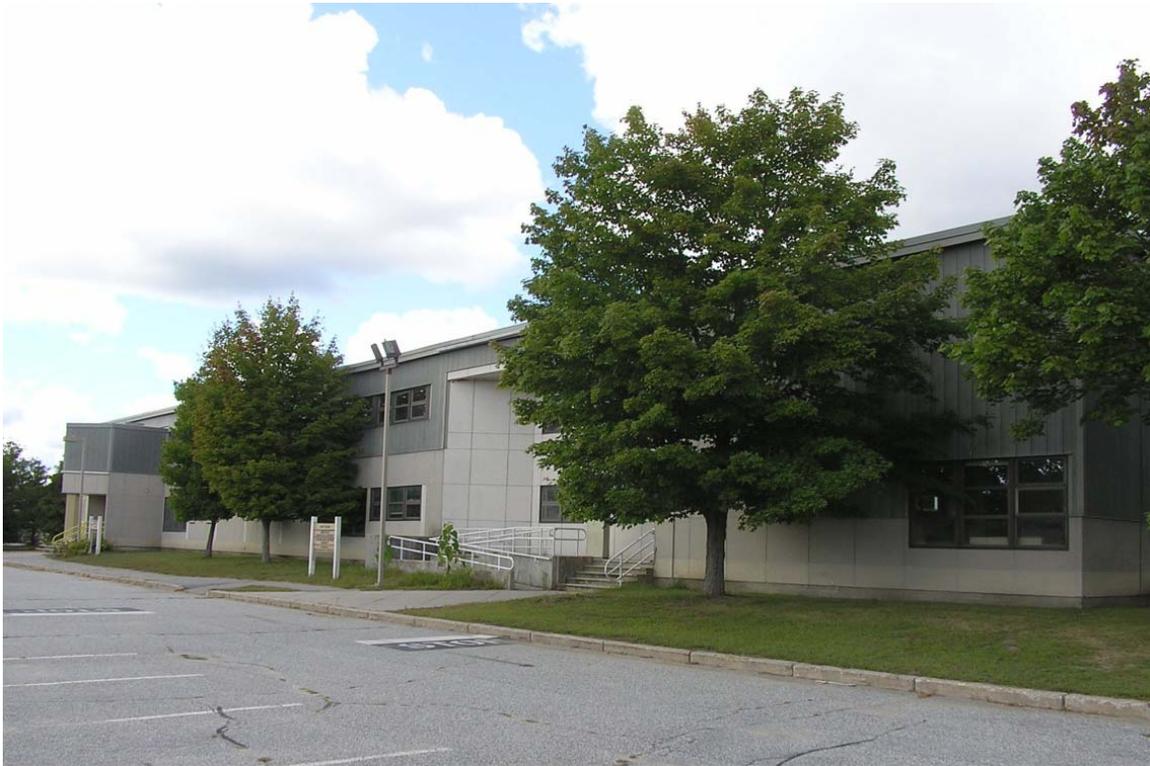
No. 1 Building 20 – NAS Brunswick September 9, 2010
Building 20 south elevation (front facing Building 11 Parking Area), with main entrance in foreground

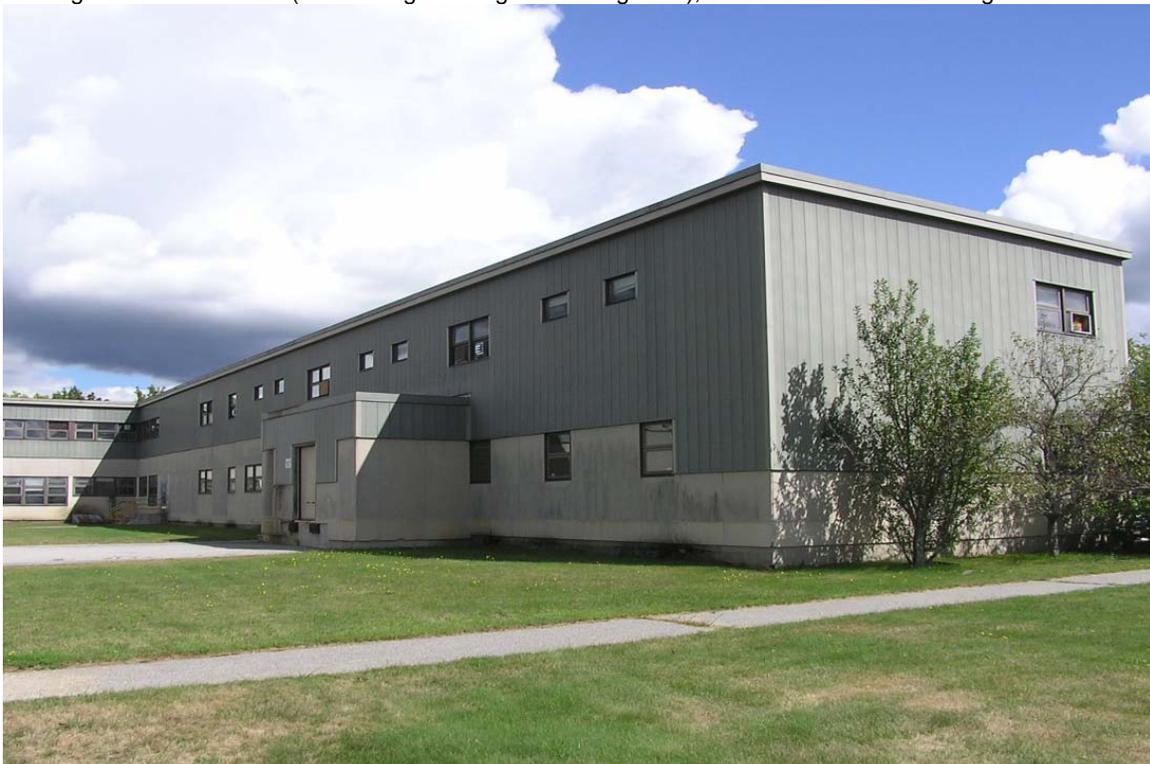
No. 2 Building 20 – NAS Brunswick September 9, 2010
Building 20 northwest elevation (rear), with Boiler Room on far left-hand side of photo

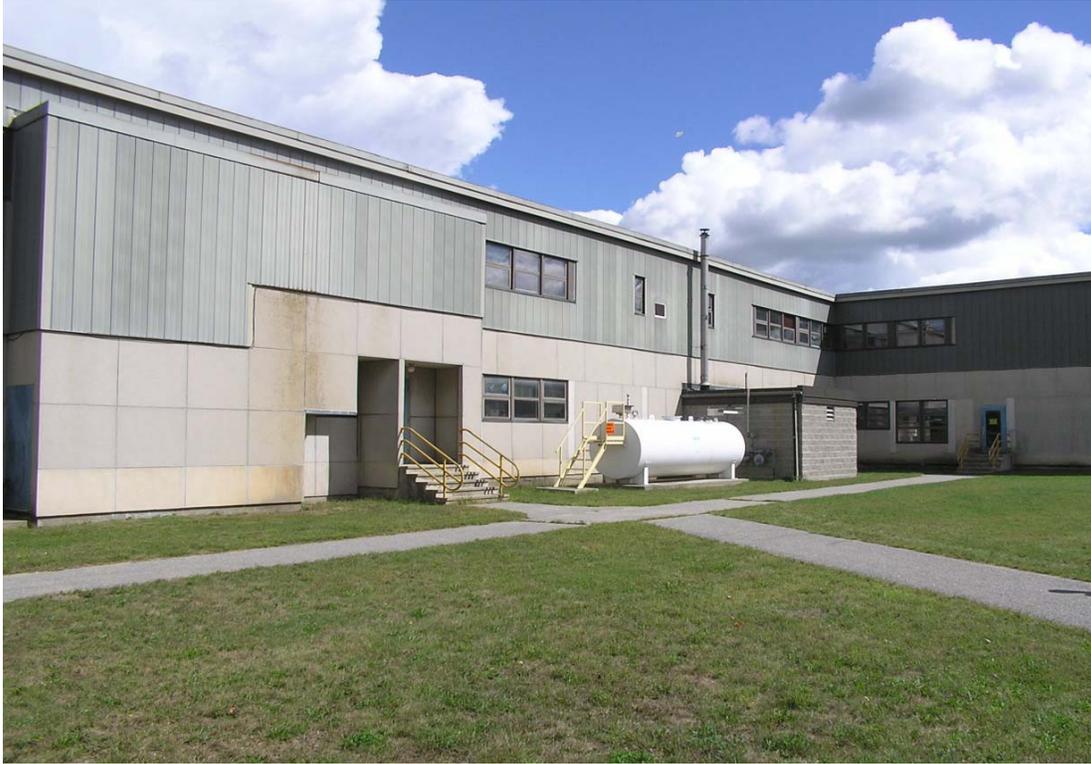
No. 3 Building 20 – NAS Brunswick September 9, 2010
Building 20 west elevation (rear), with closed white AST in foreground and Boiler Room in background of photo

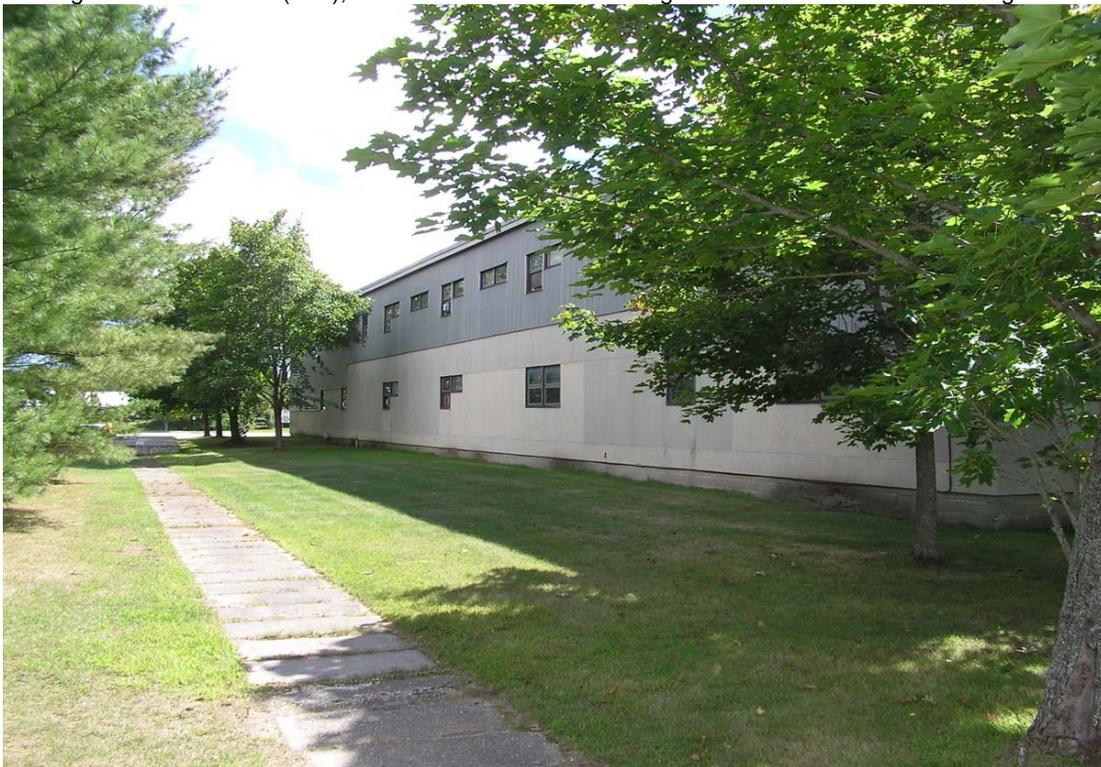
No. 4 Building 20 – NAS Brunswick September 9, 2010
Building 20 east elevation (view south), with concrete sidewalk covering pipe trench system

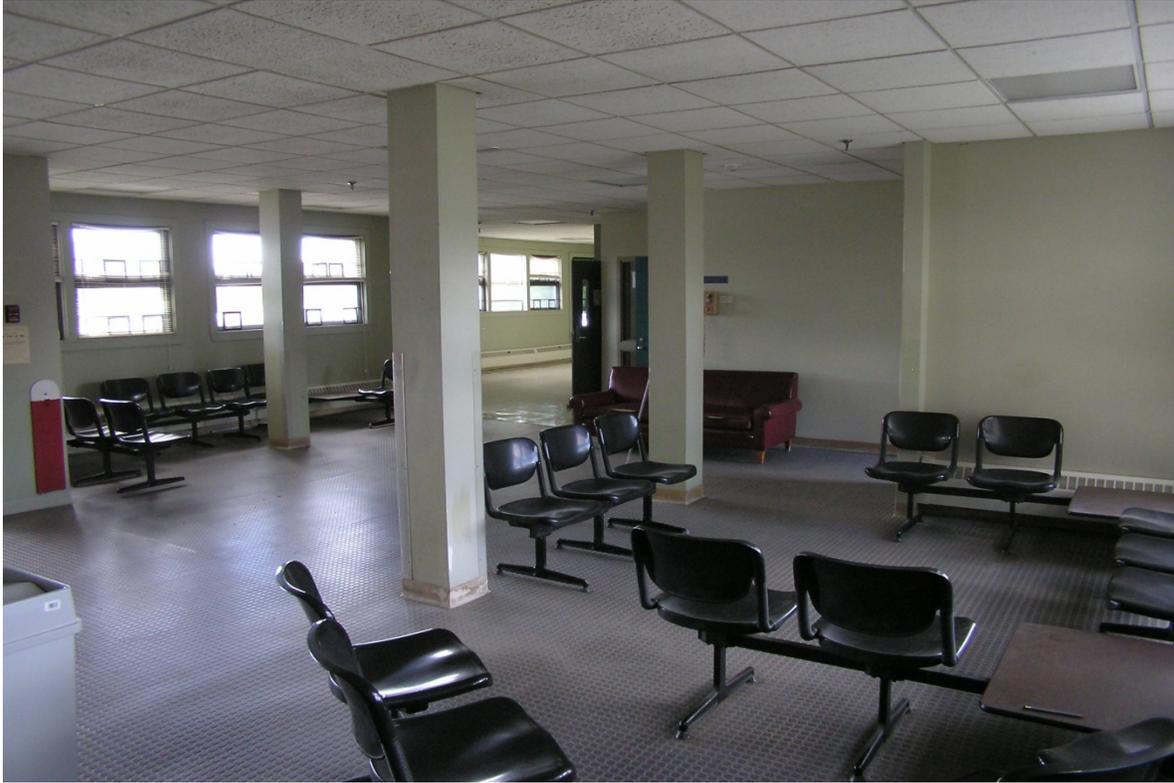
No. 5 Building 20 – NAS Brunswick September 9, 2010
Building 20 1st floor Lobby area, adjacent to main entrance in southeast corner of the structure

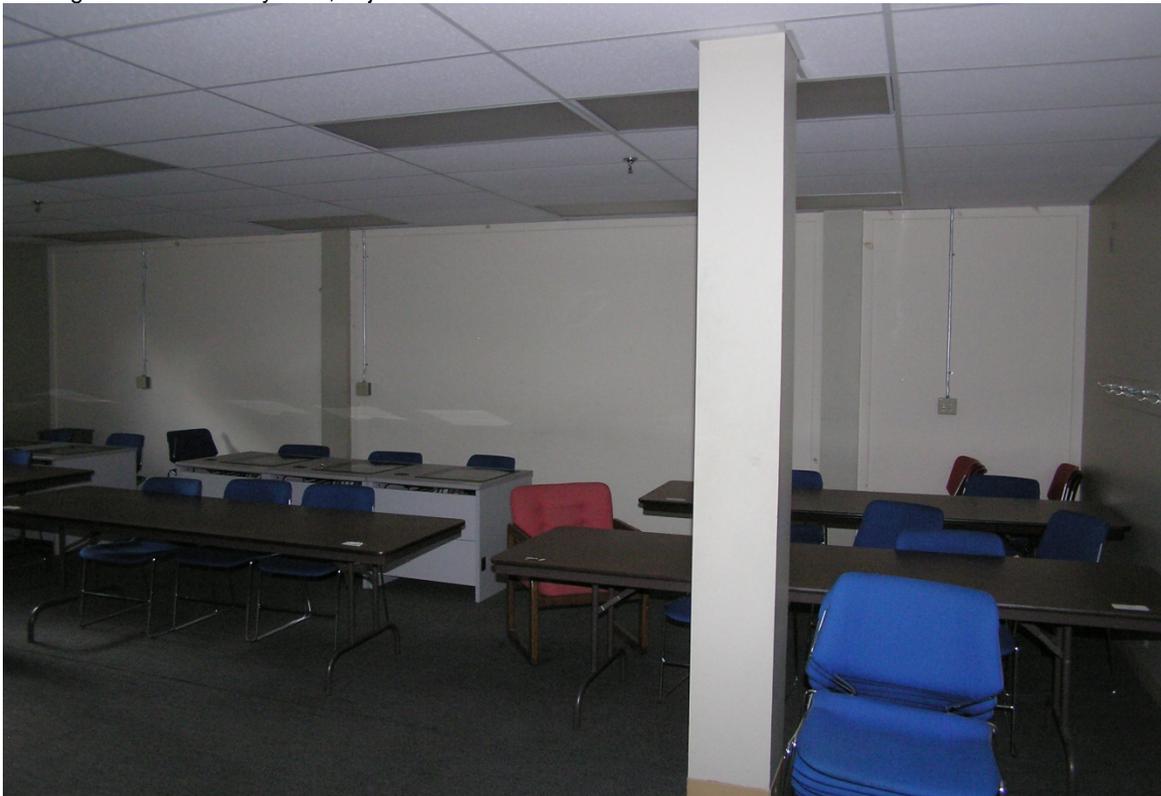
No. 6 Building 20 – NAS Brunswick September 9, 2010
Building 20 1st floor Computer Laboratory

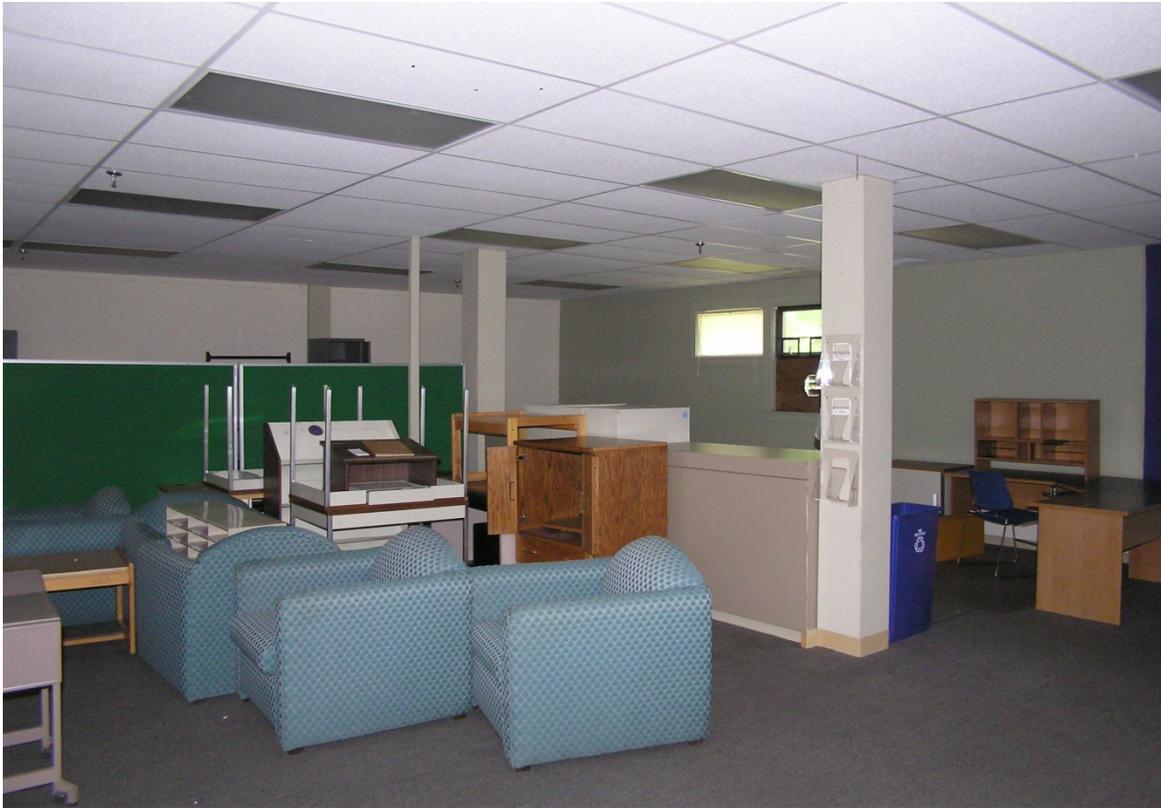
No. 7 Building 20 – NAS Brunswick
Building 20 2nd floor class room

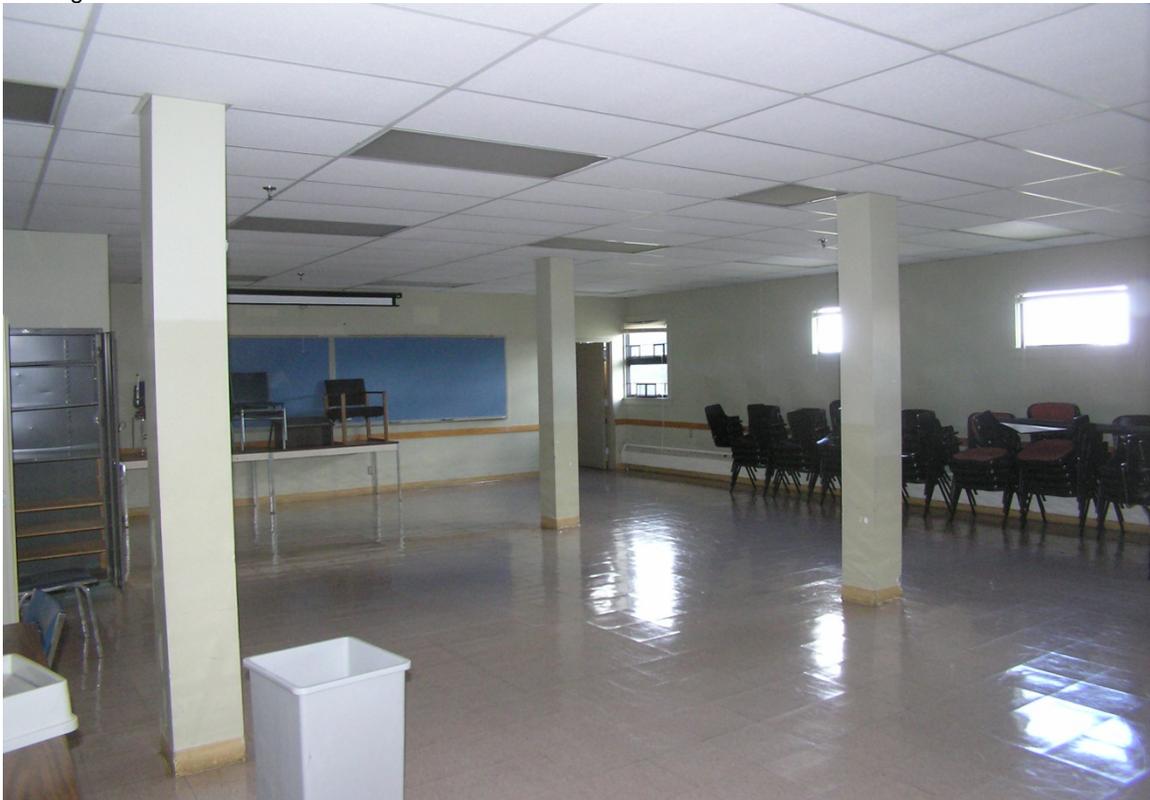
No. 8 Building 20 – NAS Brunswick
Building 20 2nd floor class room

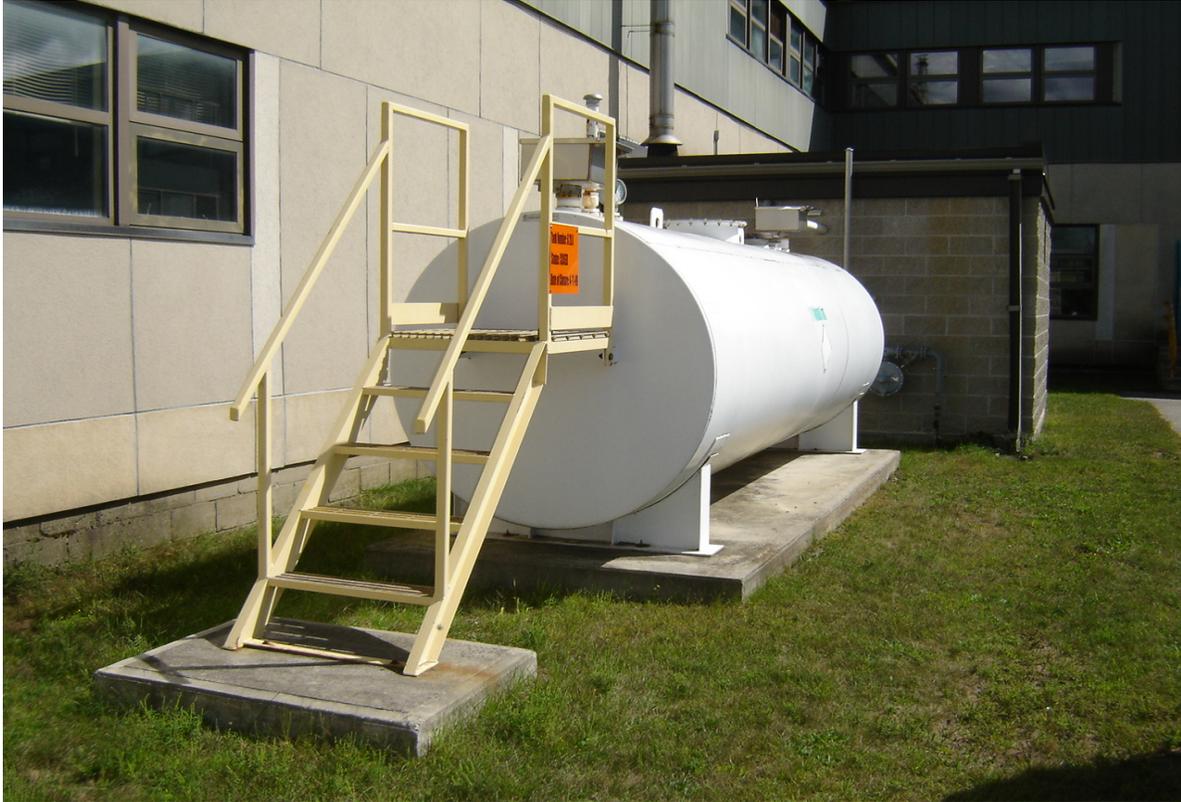
A 3,000-gallon closed above ground storage tank (AST), number A 20.0 was observed and appeared to be in good condition with no significant corrosion and no peeling/chipping paint observed. No petroleum stains were observed on the AST or associated concrete pad. The AST was reported as closed, per the tank identification sign, on April 11, 2009.

No. 9 Building 20 – NAS Brunswick September 9, 2010
Building 20 closed AST (No. A 20.0, Closed 4/11/09), with Boiler Room in background

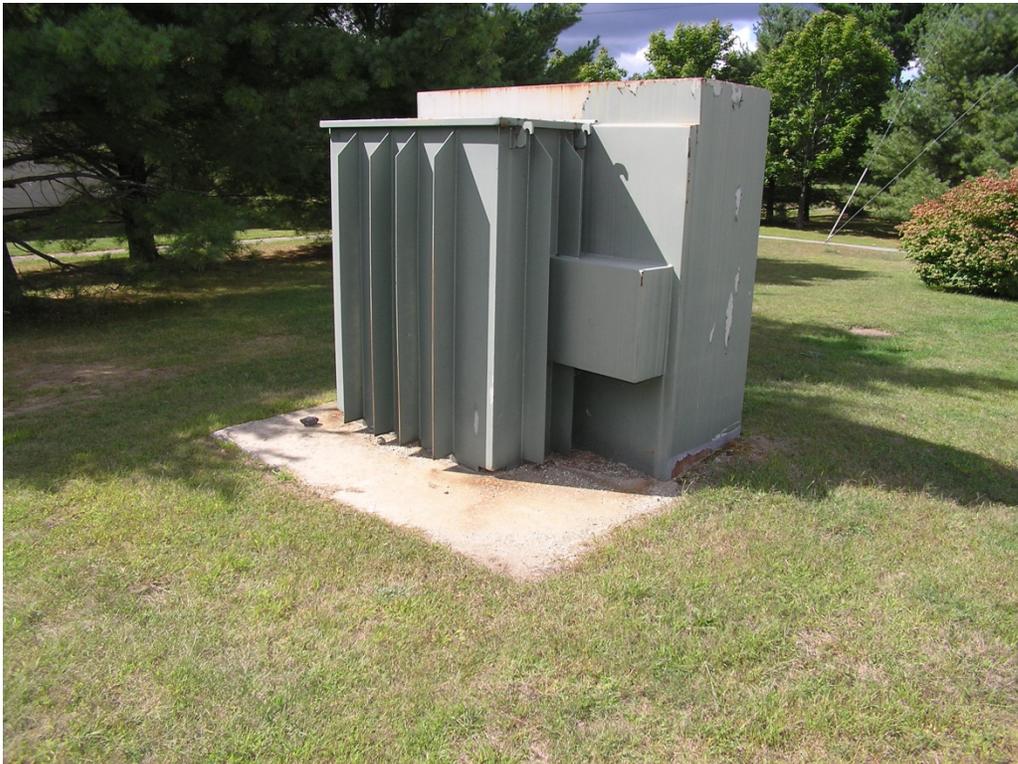
One pad-mounted transformer was observed onsite, on the eastern side of Building 20. This transformer was labeled indicating it serviced Buildings 20 and 614; 614 is the former Swimming Pool Building that was razed in 1997 (approximately). According to NASB records the observed 225 KVA transformer was reported to have been manufactured in 1987 by RTE with S/N 886000114, and containing mineral oil. No signs of a past release (staining, unusual odors, stressed vegetation, etc.) were observed.

The observed transformer was a replacement for a 5 KVA transformer (s/n 2643-3) removed December 31, 1991 for disposal (Manifest #MEA028600), per NASB records. The 5 KVA transformer insulating fluid reportedly had a PCB concentration of 310 ppm.

No. 10 Building 20 – NAS Brunswick September 9, 2010
Transformer located east of Building 20 (view south), for service to Building 20 and former Building 614 (razed)
