FINAL RESOURCE CONSERVATION AND RECOVERY ACT PARTIAL CLOSURE REPORT
FOR BUILDING 42 WITH TRANSMITTAL LETTER NAS BRUNSWICK ME
11/5/2010
NAS BRUNSWICK

Subj: Revised Final RCRA Partial Closure Report for Building 42

**RCRA PARTIAL CLOSURE REPORT
for
BUILDING 42 PARCEL – PUMP HOUSE PARCEL
NAVAL AIR STATION BRUNSWICK, MAINE
USEPA IDENTIFICATION NUMBER ME8170022018
NOVEMBER 2010**

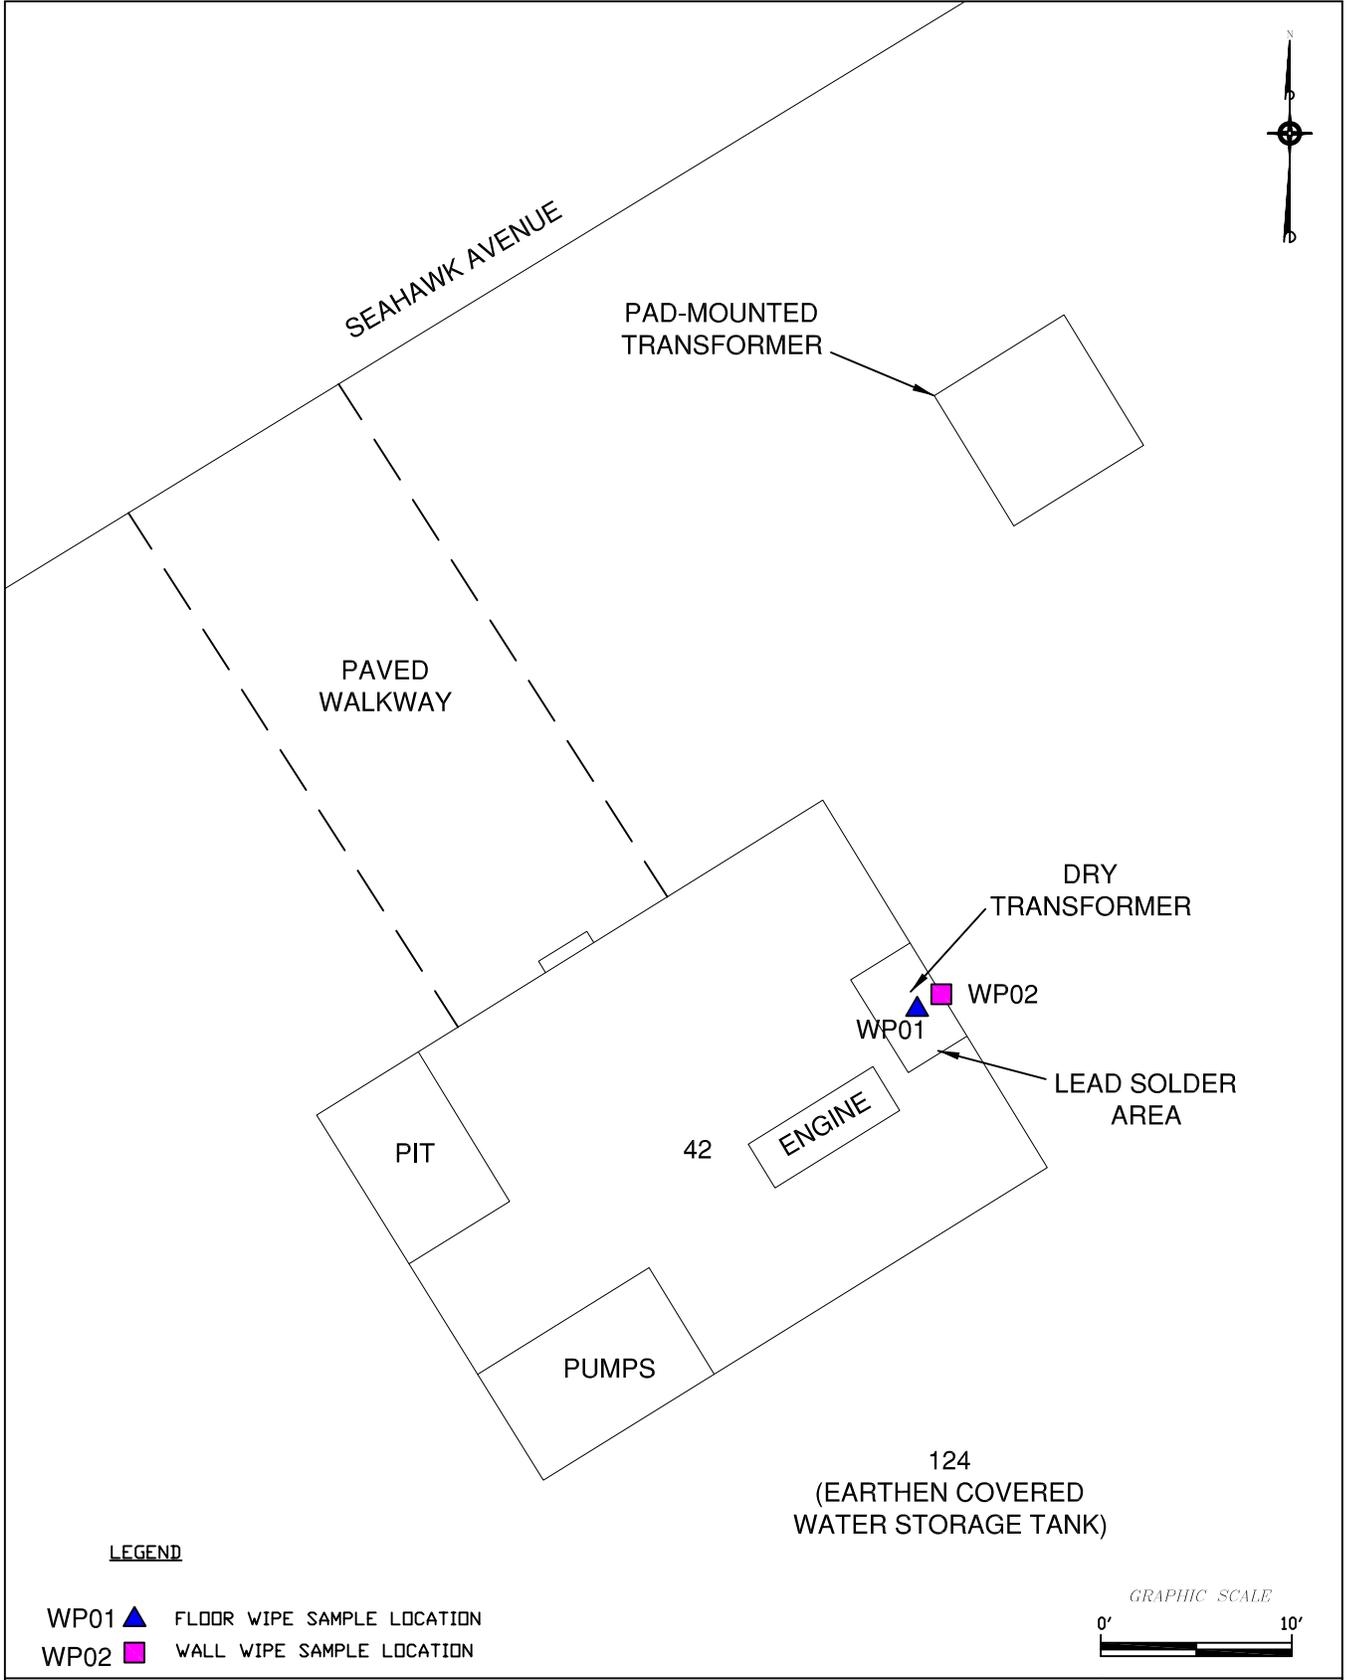
**PRE-CLEANING SAMPLE LOCATIONS
 BUILDING 42 - PUMP HOUSE PARCEL
 RCRA PARTIAL CLOSURE REPORT
 NAVAL AIR STATION BRUNSWICK, MAINE**

On October 7, 2009, Tetra Tech collected wipe samples from two locations at the lead work area, as shown on Figure 3. NASB-B42-WP01 was collected from the floor directly in front of the lead work area, and NASB-B42-WP02 was collected from the wall of the lead work area.

Lead was detected in the floor wipe sample at a level of 8,268 $\mu\text{g}/\text{ft}^2$, which exceeds the MEDEP lead criteria for floors (40 $\mu\text{g}/\text{ft}^2$). As shown in Table 1, all levels of other detected metals are below the screening values, with the exception of arsenic in the floor sample, which slightly

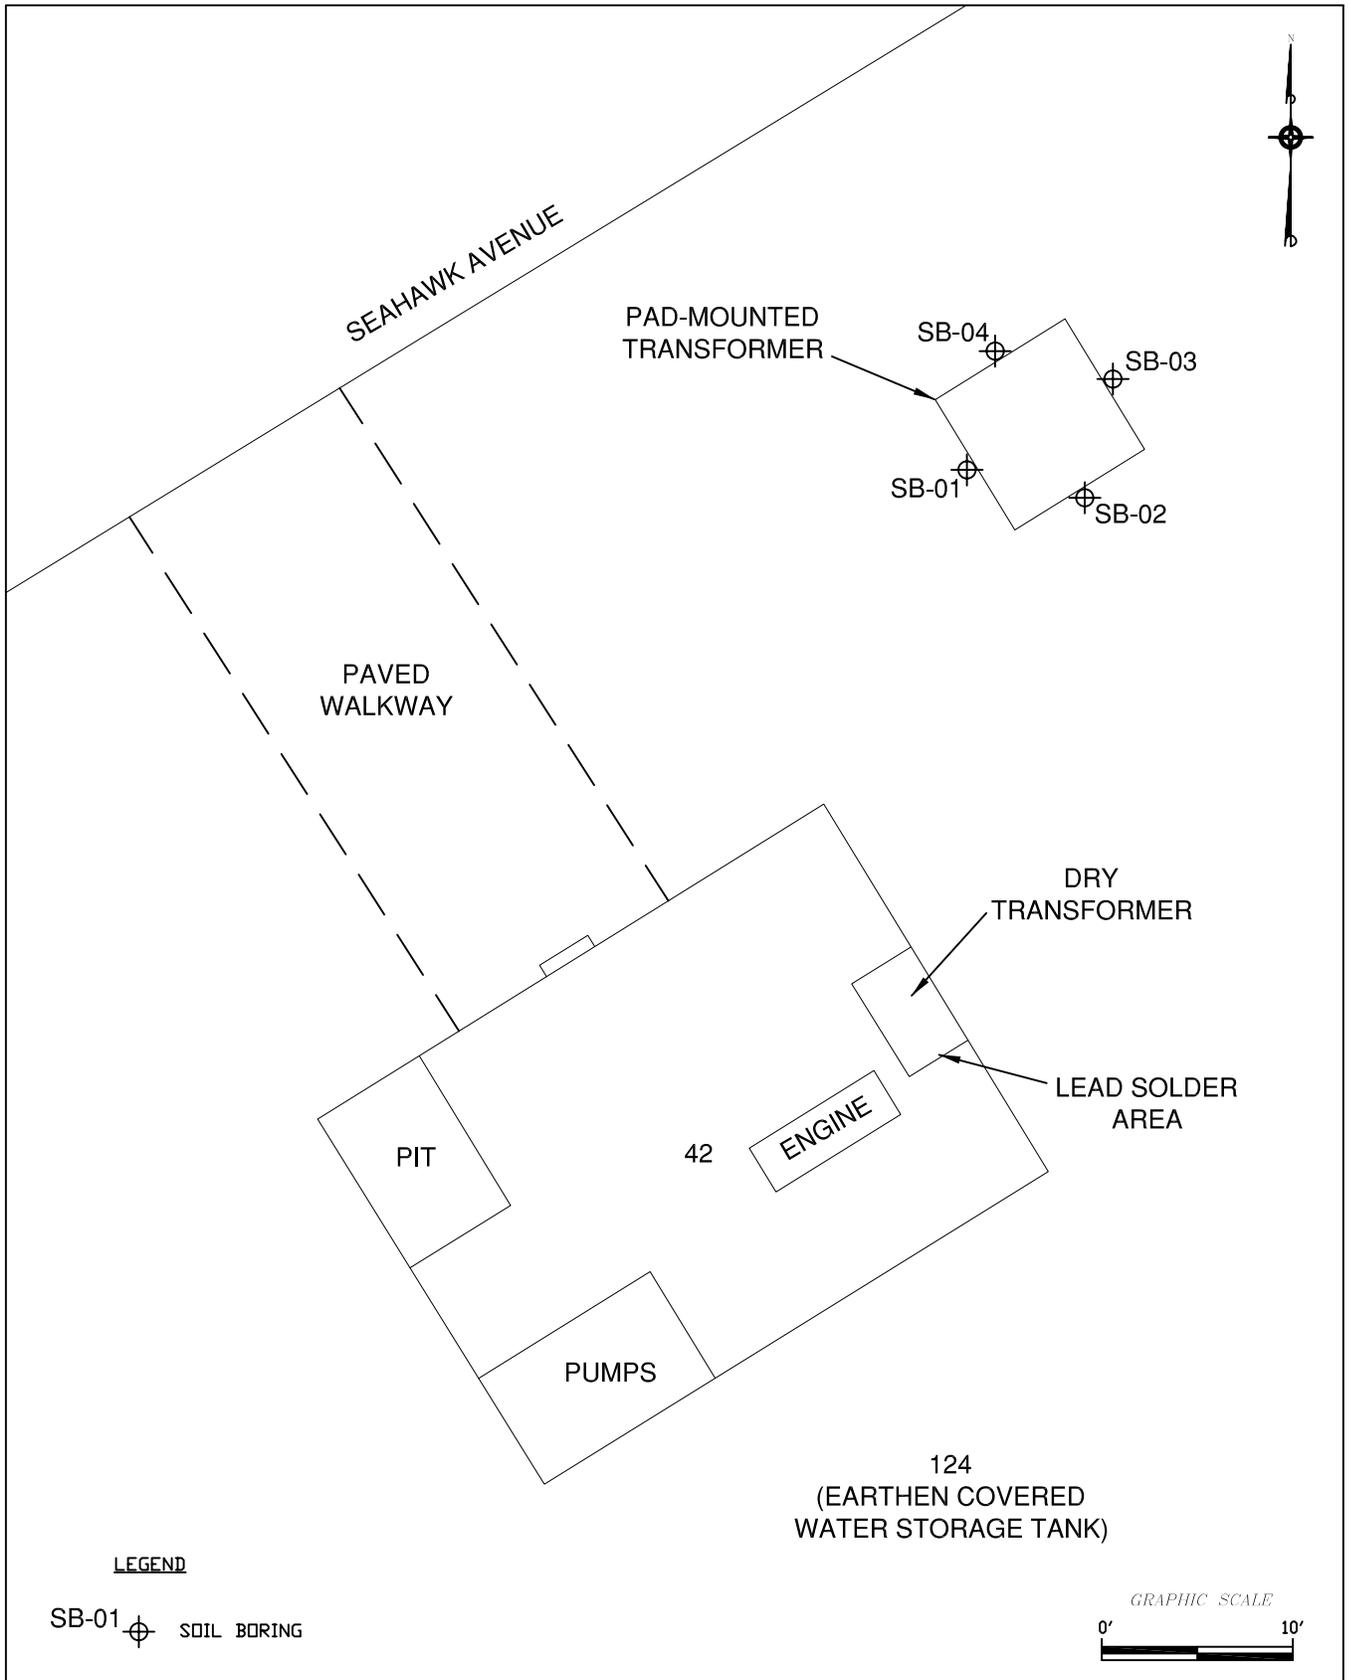
**SOIL BORING LOCATIONS
BUILDING 42 - PUMP HOUSE PARCEL
RCRA PARTIAL CLOSURE REPORT
NAVAL AIR STATION BRUNSWICK, MAINE**

The pad-mounted transformer, located in the northeast section of the parcel, could potentially have been a historical source of PCB soil contamination in the event of a transformer leak. On May 5, 2010, Tetra Tech collected surface soil samples from four locations around the transformer pad (Figure 4). A hand auger was used for collection of four samples from 0 to 6 inches below ground surface (bgs) and four samples from 6 to 24 inches bgs.

All soil samples were submitted for PCB analysis by Analytics Environmental Laboratory. Soil sample PCB results were compared to the MEDEP RCRA standard for total PCBs in soil of 1 part per million (ppm), and for information purposes, the EPA Regional Screening Levels (RSLs) for residential soil. As presented in Table 2, PCBs were not detected in any soil sample.

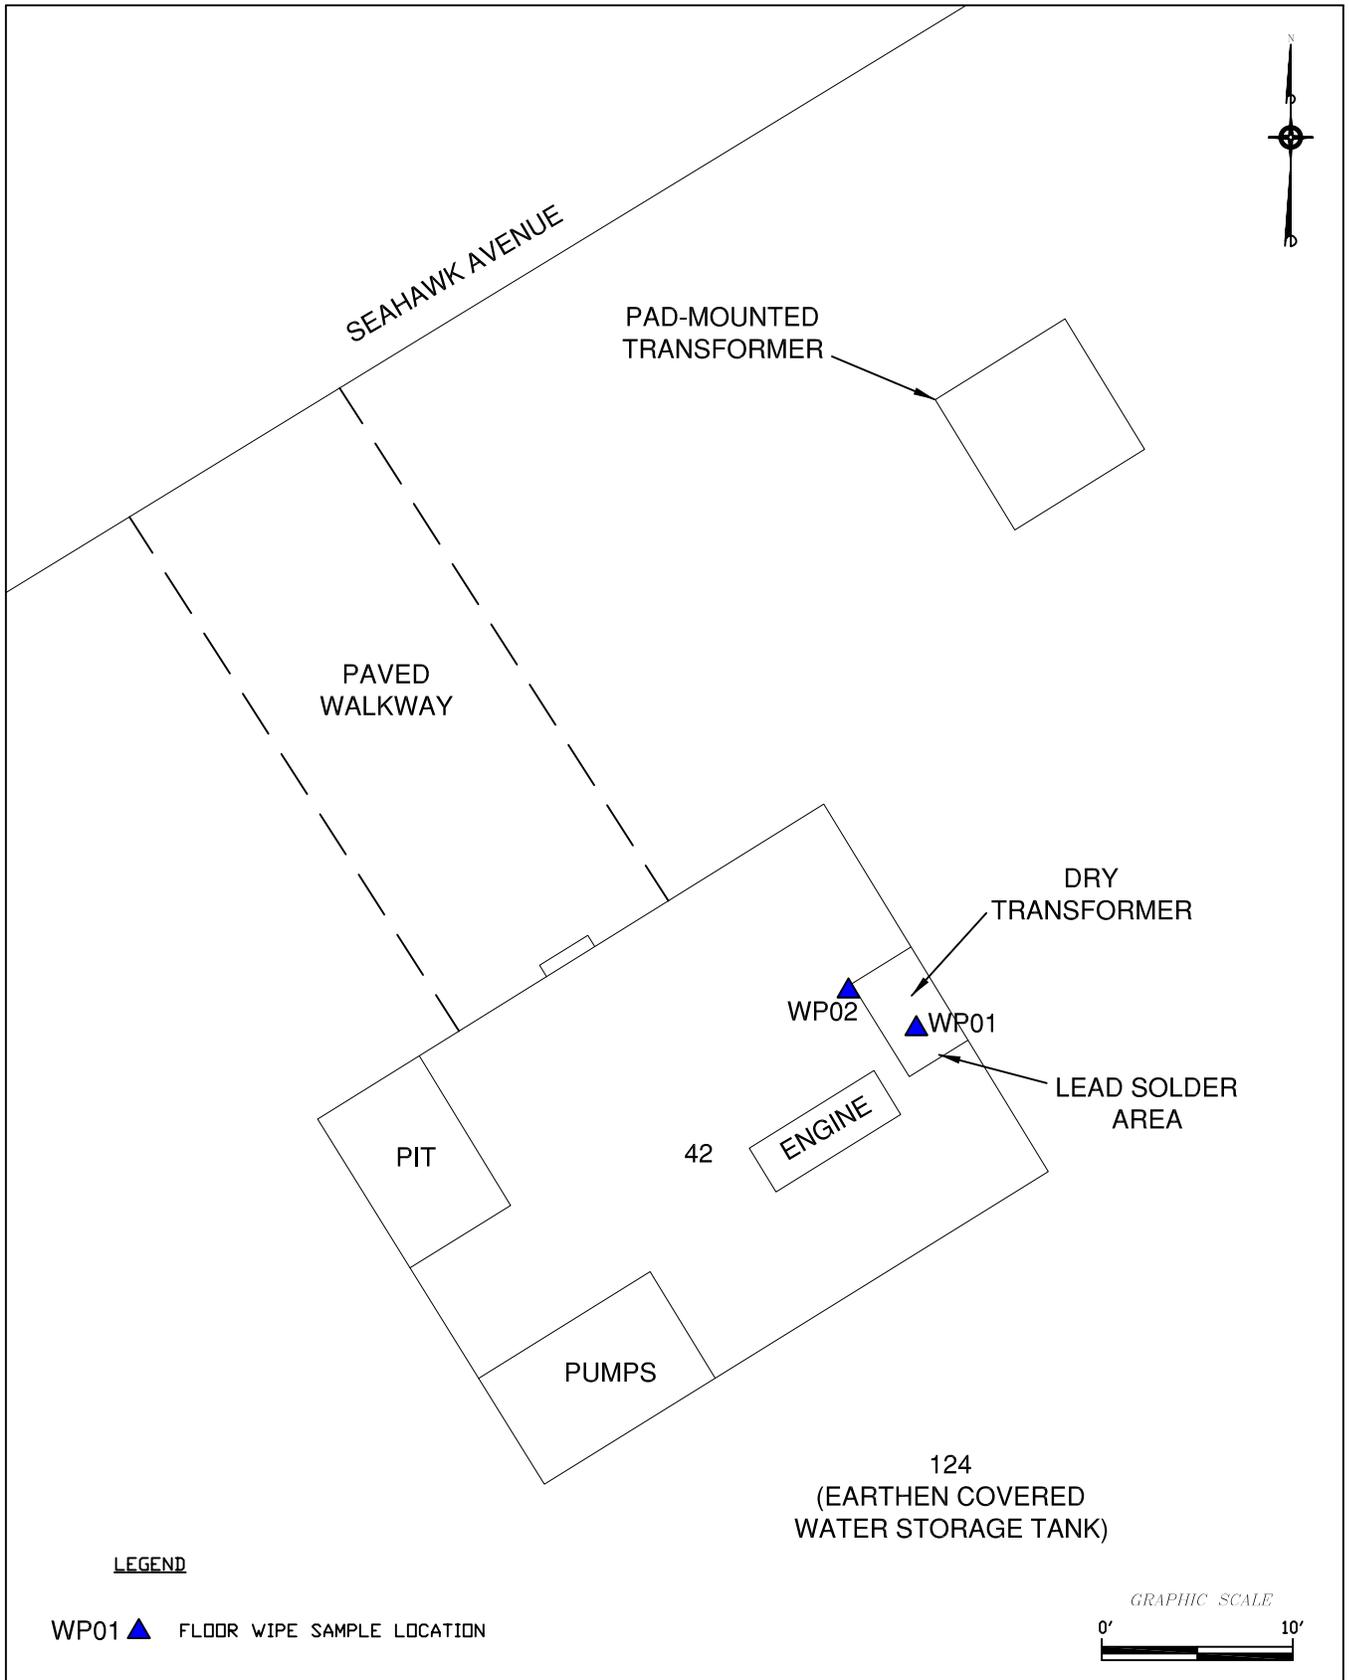
POST-CLEANING SAMPLE LOCATIONS
 BUILDING 42 - PUMP HOUSE PARCEL
 RCRA PARTIAL CLOSURE REPORT
 NAVAL AIR STATION BRUNSWICK, MAINE

On March 23, 2010, two confirmatory wipe samples were collected from the dried floor for lead analysis by Analytics Environmental Laboratory. Confirmation sample results are provided in Table 1 (see Figure 5 for sample locations). As shown in Table 1, lead levels in both samples are less than the MEDEP floor lead criterion.

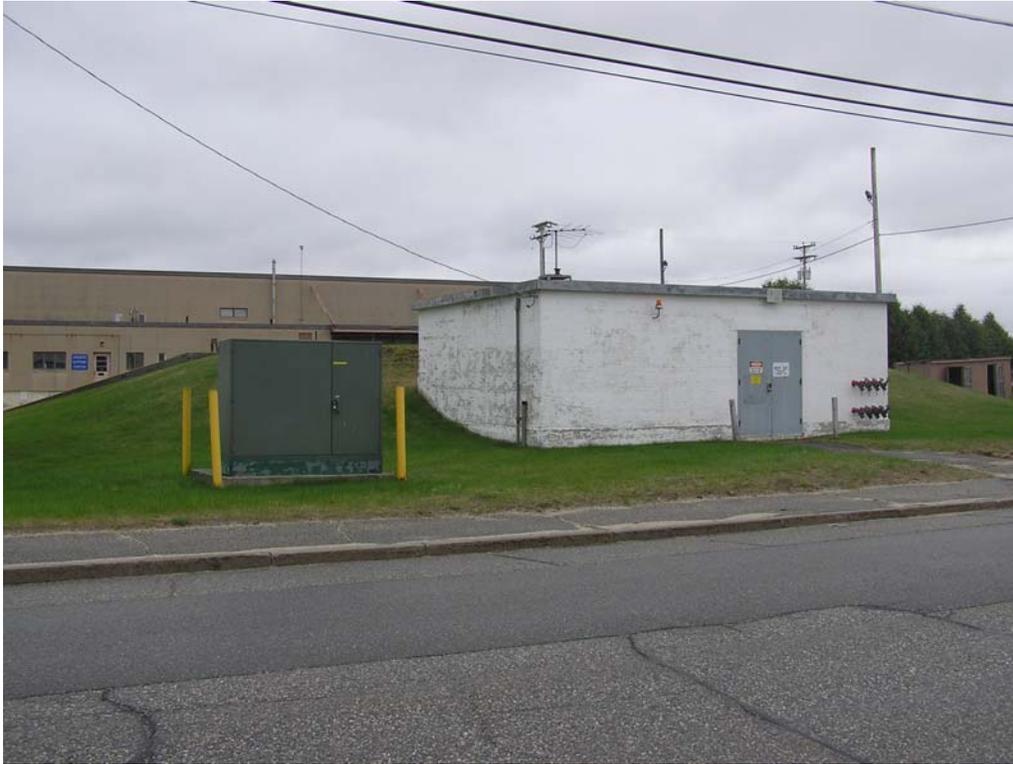
No. 1 Building 42 – NAS Brunswick April 27, 2010
Pump House north elevation; transformer at left and the water storage tank (Building 124) in background

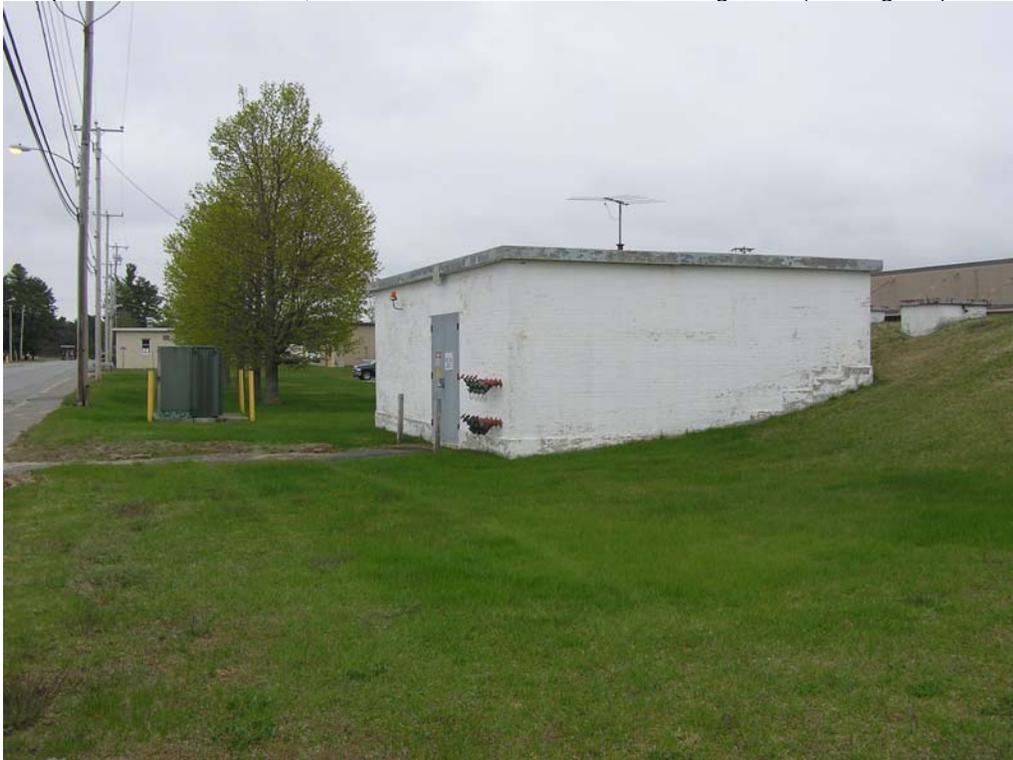
No. 2 Building 42 – NAS Brunswick April 27, 2010
Pump House east elevation; water storage tank (Building 124) at right and transformer in right background

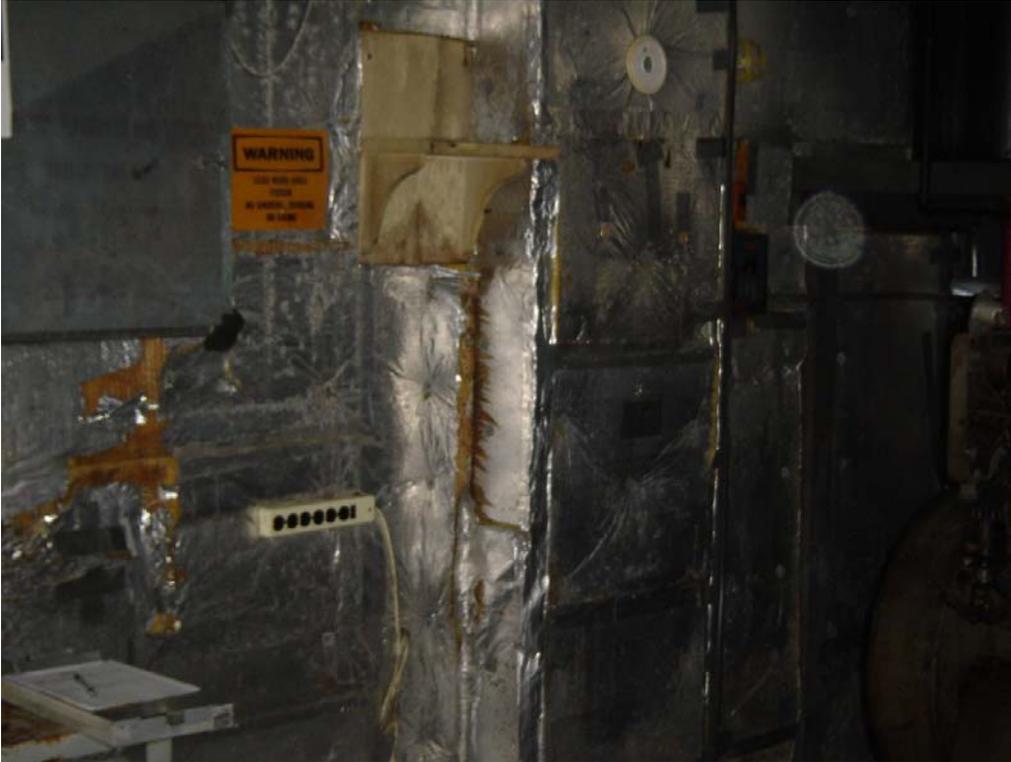
- At the time of inspection, Building 42 was not occupied and in fair condition. Water pumps and associated equipment were present.
- Potential evidence of current or past hazardous waste generation was observed, specifically, a “Lead Work Area” sign was observed on the eastern interior wall. According to NASB personnel, the area was used as a workshop by base electricians and soldering may have occurred there.

exceeds its screening criterion. Based on the analytical results, cleaning of the floor in the Building 42 lead work area was required to remove lead-contaminated residue exceeding the associated MEDEP criterion for dust on floors.

No. 3 Building 42 – NAS Brunswick June 30, 2009
Pump House lead work area on eastern interior wall

Tetra Tech's cleaning subcontractor (Global Remediation Services [Global]) performed floor-cleaning activities at Building 42 on March 22, 2010. Prior to cleaning, floor openings were covered and sealed with polyethylene sheeting. The floor was then manually swept and then vacuumed with a high-efficiency particulate air (HEPA) vacuum. After sweeping and vacuuming, floors were sprayed with a 2-percent, lead-specific detergent solution, scrubbed, and pressure-washed, using a 5,000-pounds-per-square-inch (psi) steam cleaner. All cleaning wastewater was containerized using a wet-vacuum, placed in a 55-gallon drum (15 gallons generated), and transferred to the NAS Brunswick hazardous waste department for disposal. Upon completion, the Tetra Tech field representative performed a visual inspection of the cleaned area.

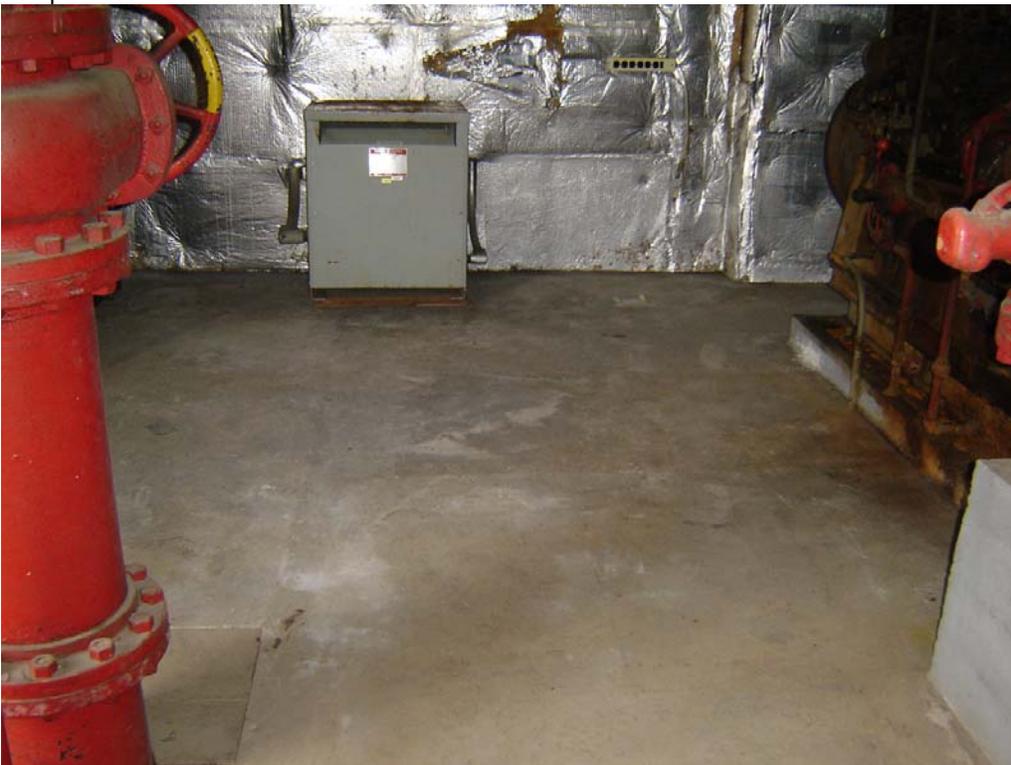
No. 4 Building 42 – NAS Brunswick March 22, 2010
Pump House floor in front of lead work area post-cleaning

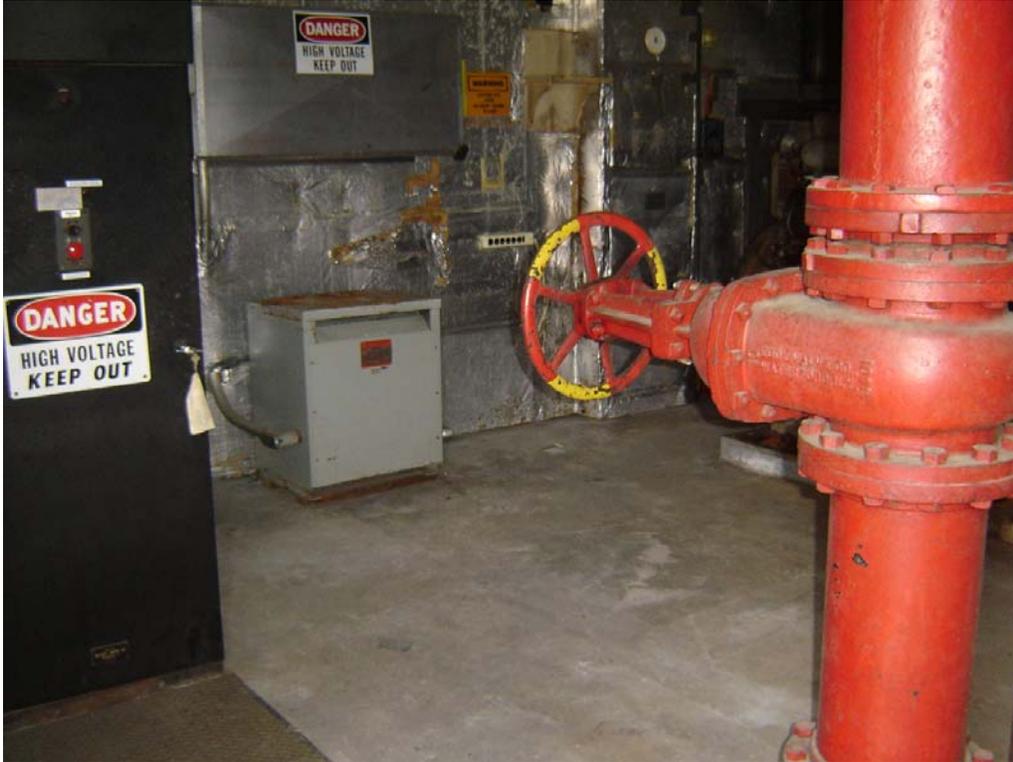
No. 5 Building 42 – NAS Brunswick
Pump House floor in front of lead work area post-cleaning

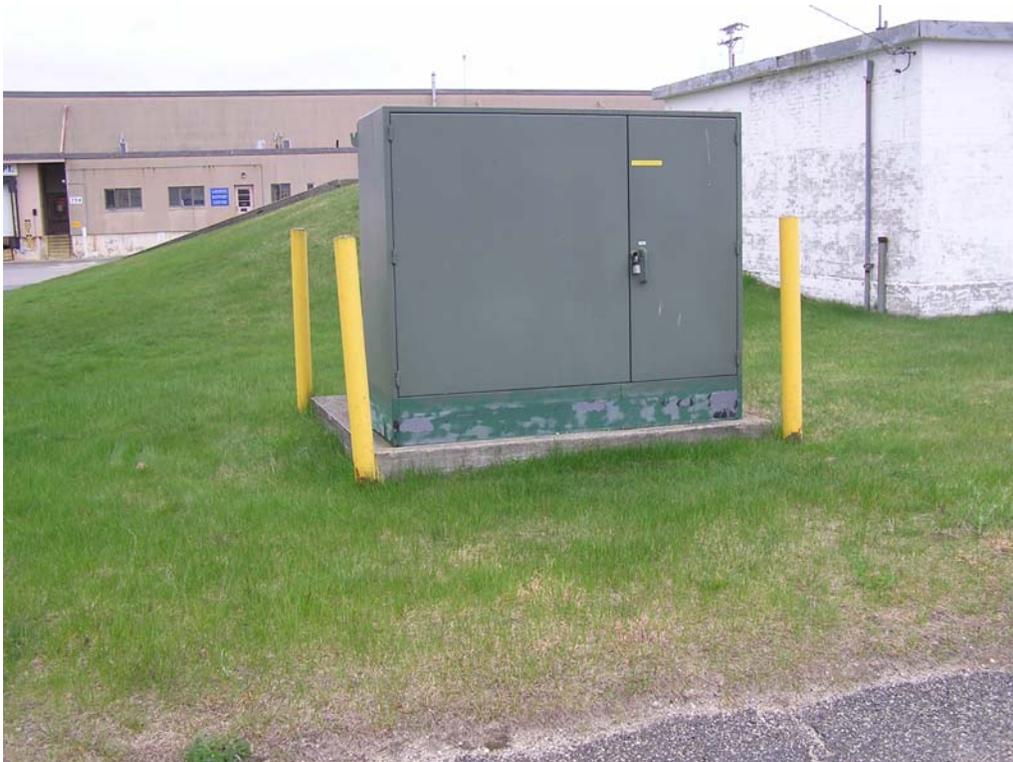
- No hazardous waste storage or accumulation areas were observed.
- A dry type electrical transformer was observed along the eastern interior wall.
- One pad-mounted transformer was observed in the northeast section of the parcel. No evidence of a past leak from this transformer was observed.

No. 6 Building 42 – NAS Brunswick
Pad-mounted transformer located northeast of Pump House (Building 42)
