FINAL RESOURCE CONSERVATION AND RECOVERY ACT PARTIAL CLOSURE REPORT
FOR BUILDING 104 WITH TRANSMITTAL LETTER NAS BRUNSWICK ME
11/8/2010
NAS BRUNSWICK

RCRA PARTIAL CLOSURE REPORT
for
BUILDING 104 – DYERS GATE MECHANICAL SECURITY BARRIERS
NAVAL AIR STATION BRUNSWICK, MAINE
USEPA IDENTIFICATION NUMBER ME8170022018
NOVEMBER 2010

**HWSA INSPECTION FORM
HAZARDOUS WASTE STORAGE AREAS CLOSURE
NAS BRUNSWICK
BRUNSWICK, MAINE
CTO WE22**

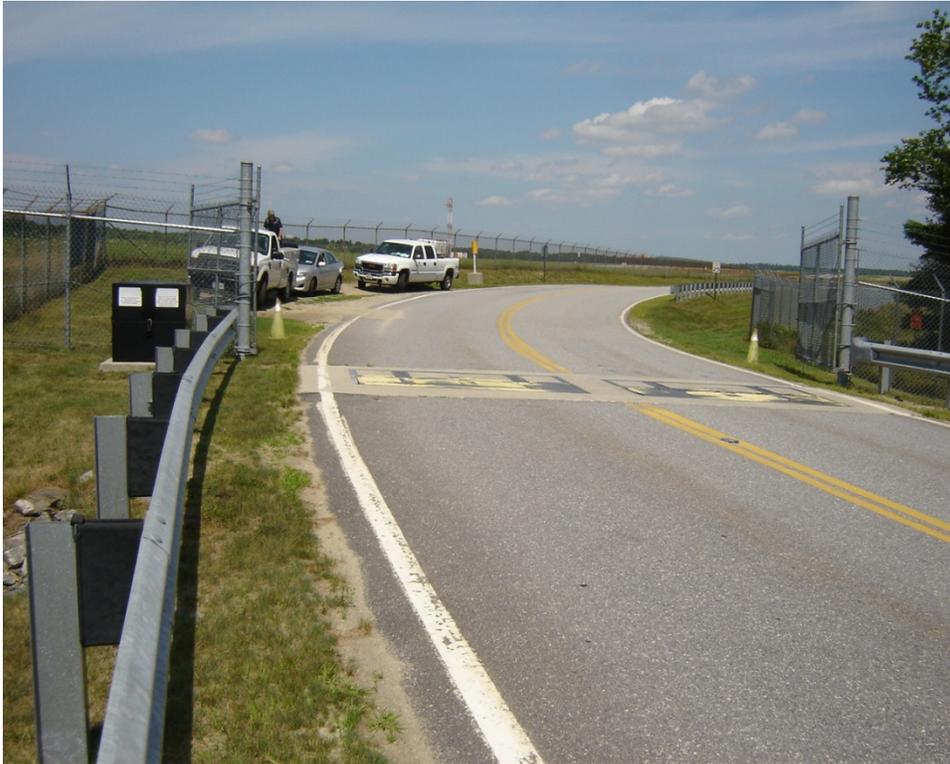
No. 1 Building 104 – NAS Brunswick July 22, 2010
Dyers Gate Mechanical Security Barriers, view of hydraulic security gate from Orion Street looking north; barrier control box located left of guard rail

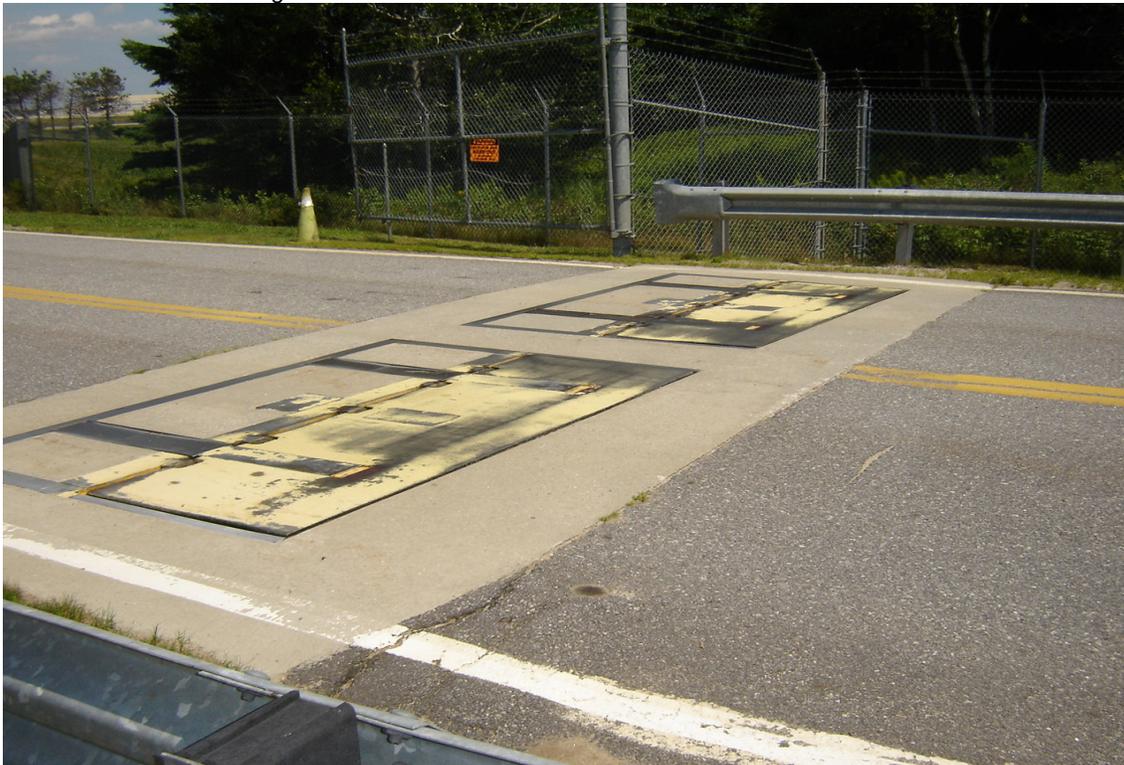
No. 2 Building 104 – NAS Brunswick July 22, 2010
Dyers Gate Mechanical Security Barriers, hydraulic security gate within Orion Street, looking northeast

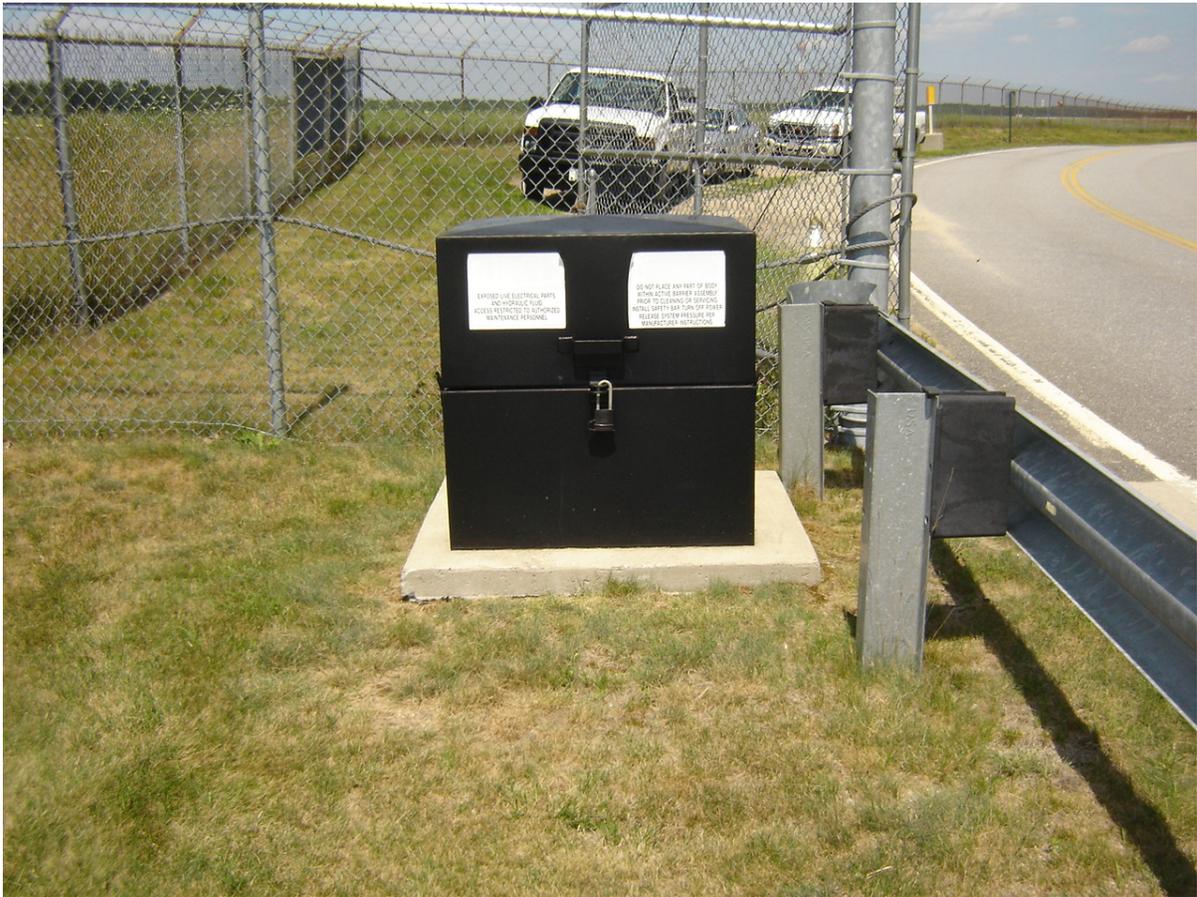
No. 3 Building 104 – NAS Brunswick
Dyers Gate Mechanical Security Barriers, barrier control box
