FINAL RESOURCE CONSERVATION AND RECOVERY ACT PARTIAL CLOSURE REPORT
FOR BUILDINGS 642 AND 643 WITH TRANSMITTAL LETTER NAS BRUNSWICK ME
12/1/2010
NAS BRUNSWICK

Subj: Final RCRA Partial Closure Report for Buildings 642 and 643

RCRA PARTIAL CLOSURE REPORT
for
BUILDING 642 – WEAPONS ADMINISTRATION
BUILDING 643 – SENTRY HOUSE
NAVAL AIR STATION BRUNSWICK, MAINE
USEPA IDENTIFICATION NUMBER ME8170022018
NOVEMBER 2010

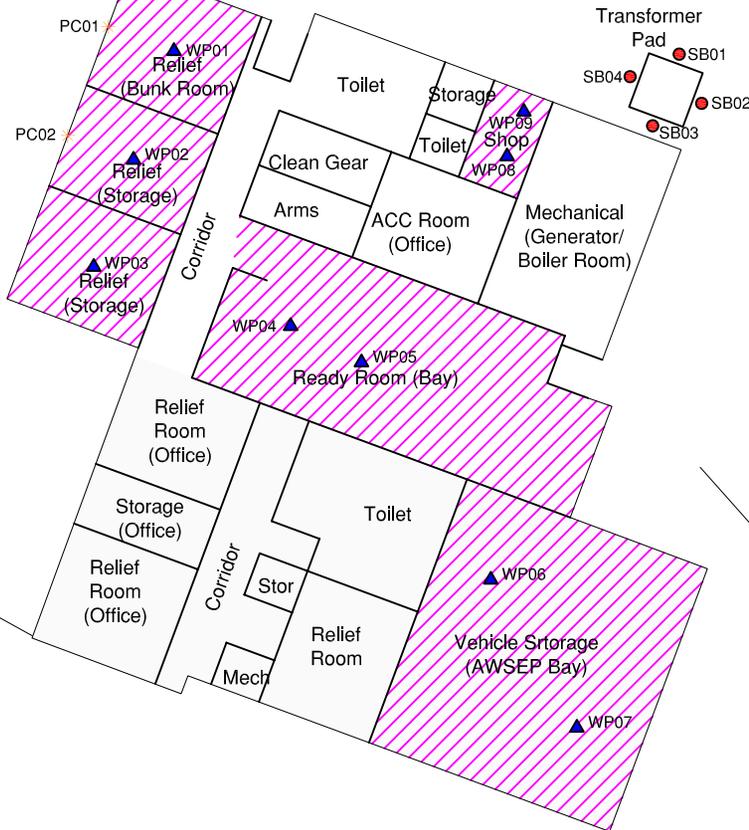
INVESTIGATION SAMPLE LOCATIONS
BUILDING 642 - WEAPONS ADMINISTRATION AND
BUILDING 643 WEAPONS AREA SENTRY HOUSE
RCRA PARTIAL CLOSURE REPORT
NAVAL AIR STATION BRUNSWICK, MAINE

On June 17, 2010, floor-wipe samples were collected from nine locations in Building 642, as shown on Figure 3. Wipe samples were submitted for RCRA metals and semi-volatile organic compound (SVOC) analysis by Tetra Tech's subcontracted analytical laboratory, Analytix. The resulting analytical data underwent limited data validation consisting of field duplicate evaluation, blank contamination evaluation, and completeness evaluation.

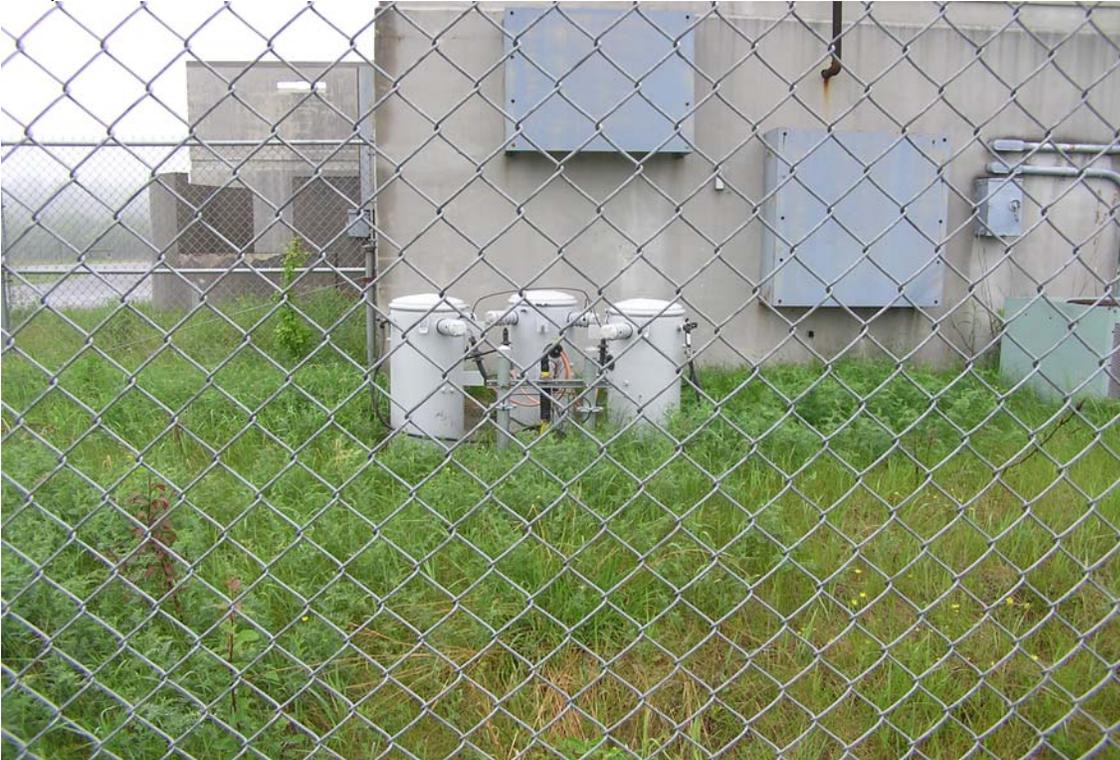
- Three pole-style transformers were observed mounted on a pad located on the southeast side of Building 642.

Three pole-style transformers were observed mounted on a pad located on the north side of Building 642. The transformers are not in the NASB transformer database. New 75 kVa transformer indicated on 1976 plans in approximate location of current transformers. Considering the age of Building 642, the transformers may be a potential source of PCB contamination if a leak has occurred.

No. 2 Building 642 Weapons Administration – NAS Brunswick
Weapons Administration transformers mounted on a concrete pad at the northeast corner

Based on the records research findings, site visit observations, and sampling results, it was determined that neither further investigation nor sampling of the transformer area at Building 642 is required to complete the MEDEP hazardous waste closure requirements.

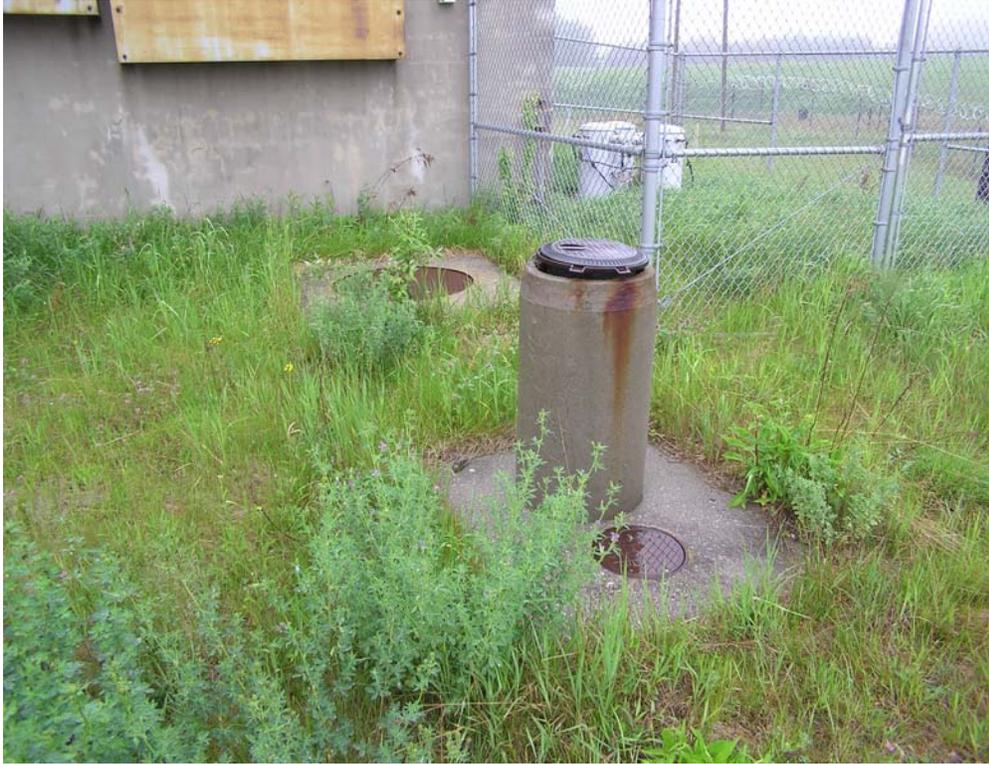
- The contents stored in the storage rooms are unknown.
- UST filler pipes were observed on the east corner of the building. No evidence of a past leak from this UST was observed.

No. 3 Building 642 Weapons Administration – NAS Brunswick June 3, 2010
Weapons Administration underground storage tank filler pipes located on the east side of the building

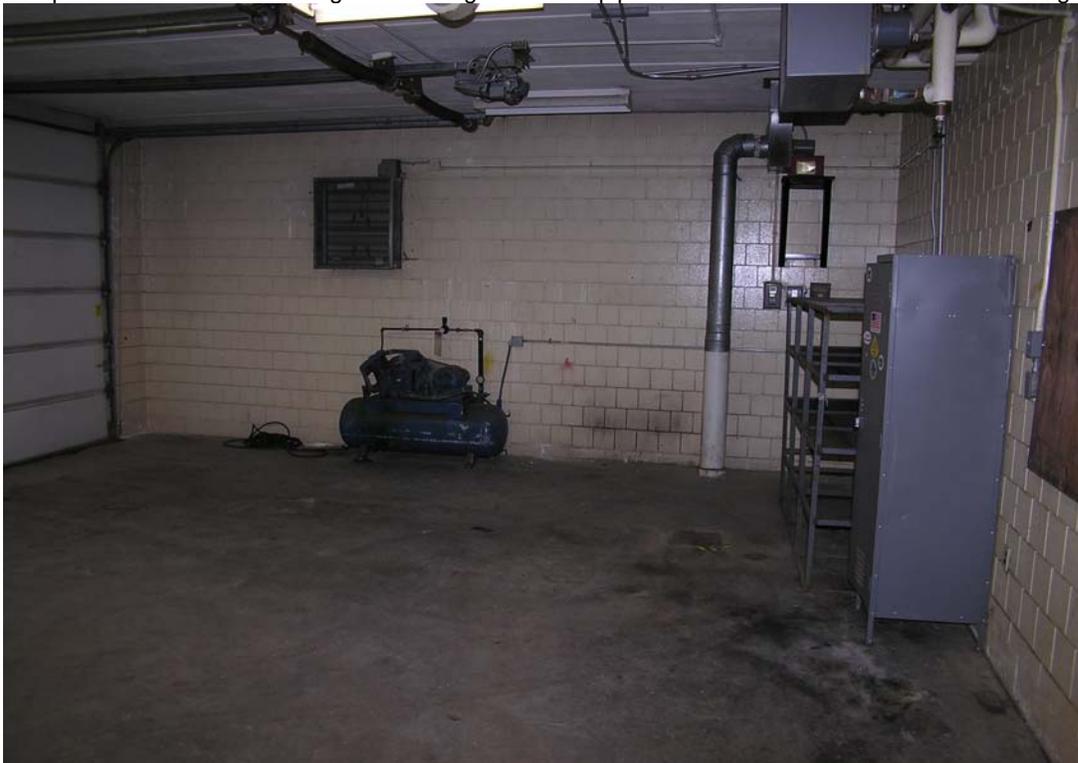
Based site visit observations and sampling results, hazardous waste residue was generated at Building 642 in the form of lead-contaminated settled dust from small arms maintenance and vehicle storage and maintenance activities associated with operations conducted at the former security building. The areas impacted by lead-dust were also addressed by the closure actions described in Section 6.0.

No. 4 Building 642 Weapons Administration – NAS Brunswick June 3, 2010
Weapons Administration vehicle storage bay

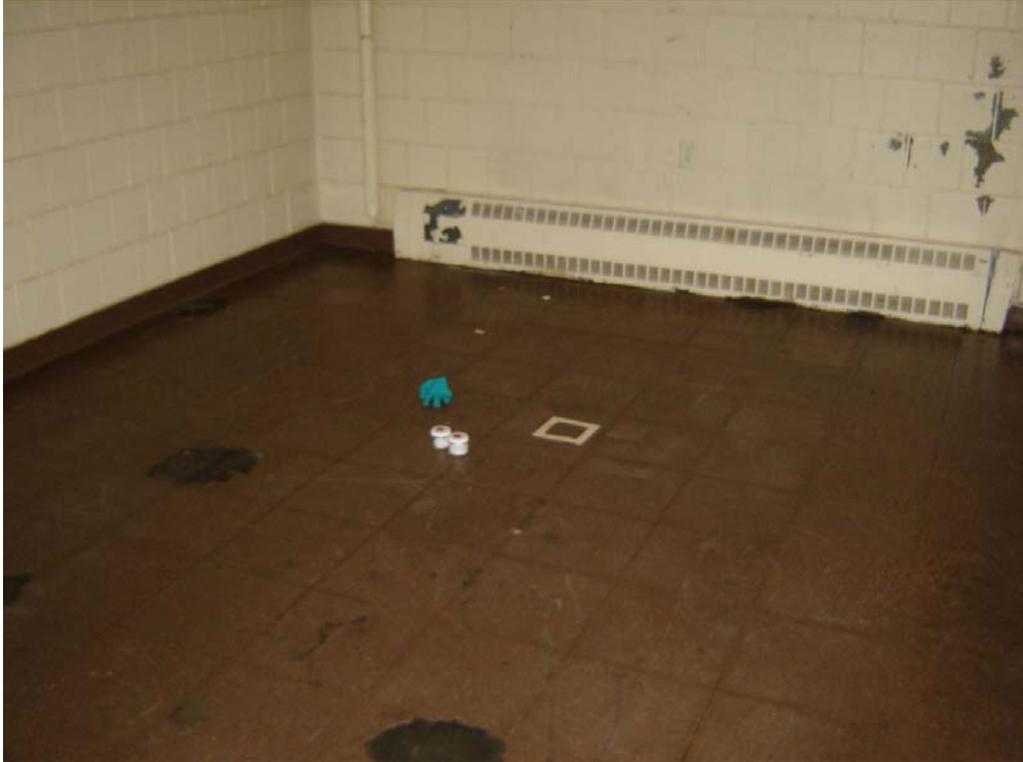
As shown in Table 3, lead was detected in each of the nine floor-wipe samples at levels exceeding the MEDEP criterion for floors (40 µg/ft²). Cadmium was also detected in four wipe samples at levels which exceed the WTC criterion. All levels of other detected metals in these samples were below the screening values. Based on the analytical results, cleaning of Building 642 was required to remove lead-contaminated residue exceeding the associated MEDEP criterion for dust on floors (discussed in Section 6).

No. 7 Building 642 Weapons Administration – NAS Brunswick October 1, 2010
Weapons Administration storage room #1 showing wipe sample location (B642-WP012)

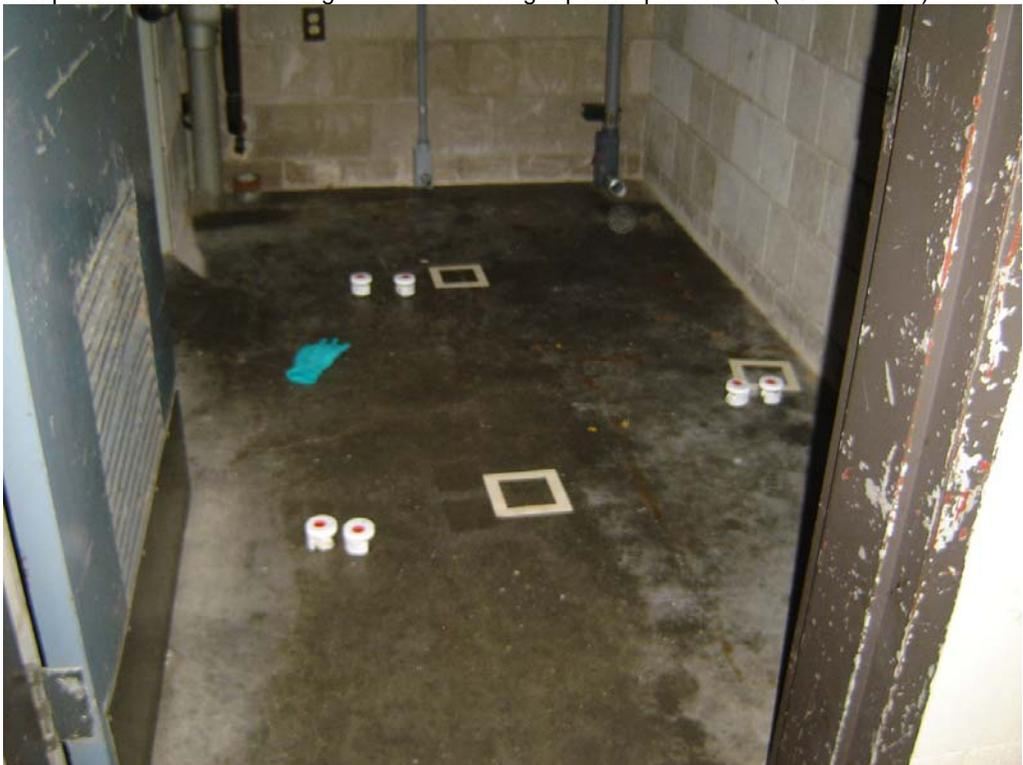
No. 8 Building 642 Weapons Administration – NAS Brunswick October 1, 2010
Weapons Administration shop showing wipe sampling locations (B642-WP21 and B642-WP20)

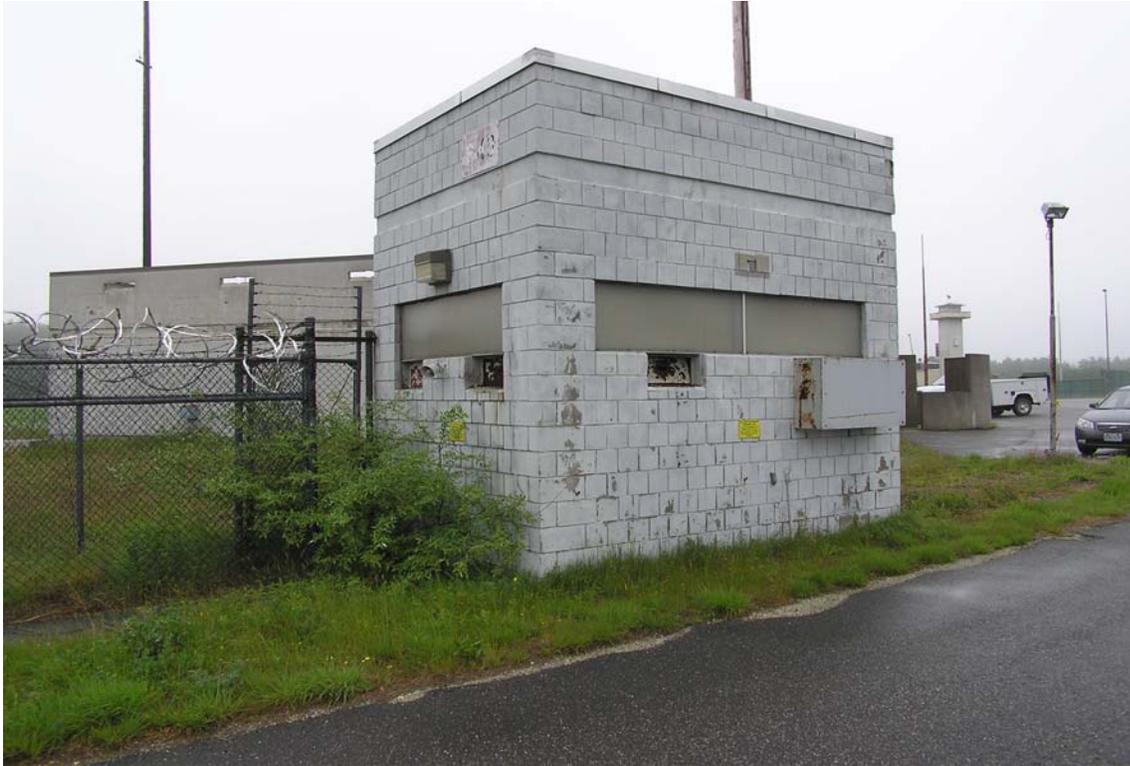
At the time of inspection, Building 643 was vacant and in very poor condition. The interior consisted of one room.

No. 1 Building 643 Weapons Area Sentry House – NAS Brunswick June 3, 2010
Sentry House - southwest elevation

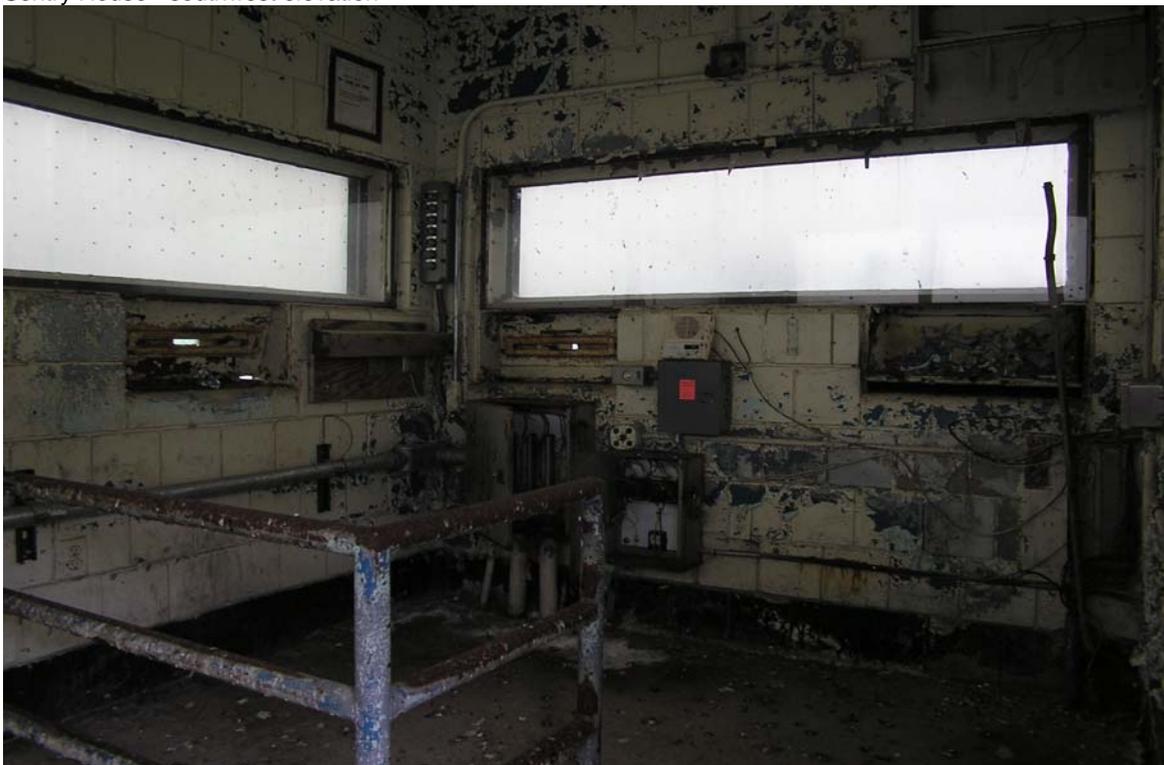
As presented in Table 1, total metals concentrations of chromium and lead in the Building 643 paint-chip sample exceeded 20 times the TCLP limit; PCBs were not detected. Based on these results, it was determined that loose paint and paint chip removal was required at Building 643 to complete the MEDEP hazardous waste closure requirements (discussed in Section 6).

Peeling paint (possibly containing lead) was observed on the exterior and interior of the building.

No. 2 Building 643 Weapons Area Sentry House – NAS Brunswick June 3, 2010
Sentry House interior view (prior to loose paint removal)

On September 29 and 30, 2010, Tetra Tech's cleaning subcontractor, Global, performed clean-up activities for loose and flaking paint located in Building 643. Loose paint was removed using scrapers and wire brushes. All cleaning waste was vacuumed using a HEPA vacuum, placed in a 55-gallon drum, and transferred to the NAS Brunswick hazardous waste department for disposal. Upon completion, the Tetra Tech field representative performed a visual inspection of the cleaned area.
