FINAL RESOURCE CONSERVATION AND RECOVERY ACT PARTIAL CLOSURE REPORT  
FOR BUILDING 86 WITH TRANSMITTAL LETTER NAS BRUNSWICK ME  
12/1/2010  
NAS BRUNSWICK

Subj: Final RCRA Partial Closure Report for Building 86

**RCRA PARTIAL CLOSURE REPORT  
for  
BUILDING 86 – GROUND SUPPORT EQUIPMENT (GSE) MAINTENANCE SHOP PARCEL  
NAVAL AIR STATION BRUNSWICK, MAINE  
USEPA IDENTIFICATION NUMBER ME8170022018  
NOVEMBER 2010**

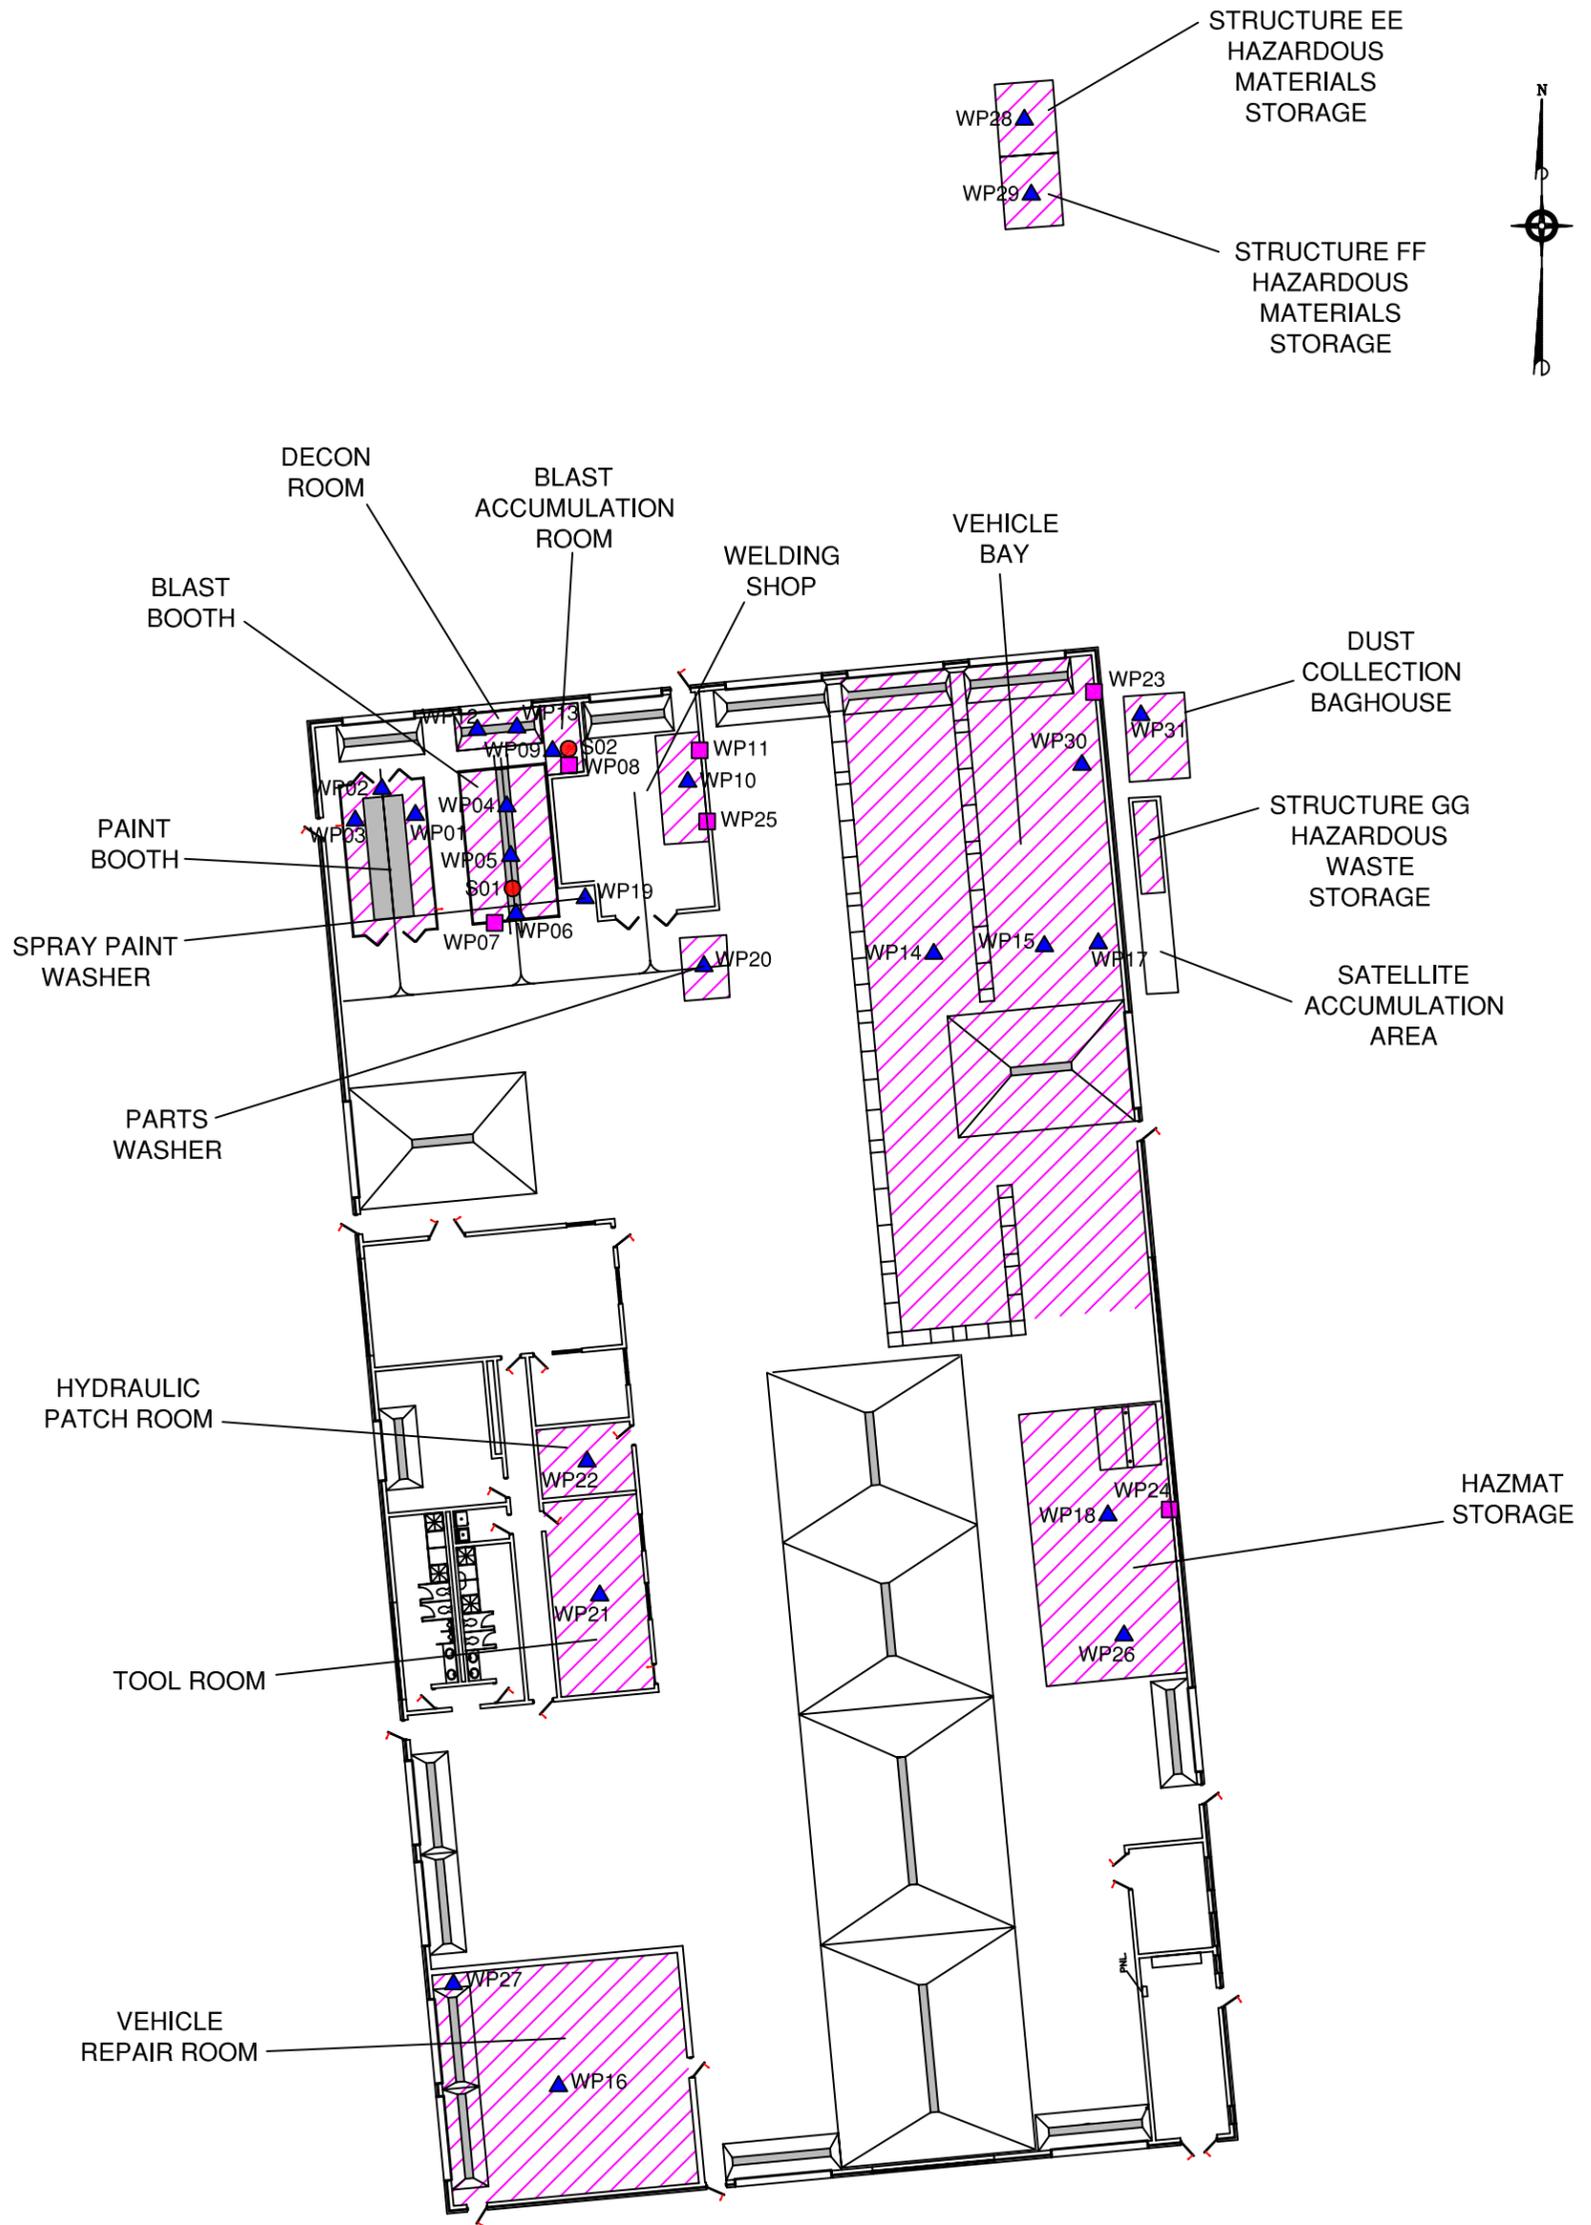
INVESTIGATION SAMPLE LOCATIONS  
 BUILDING 86 – GROUND SUPPORT  
 EQUIPMENT MAINTENANCE SHOP PARCEL  
 RCRA PARTIAL CLOSURE REPORT  
 NAVAL AIR STATION, MAINE

Lead levels in the majority of floor wipe samples were found to exceed the MEDEP criterion (40  $\mu\text{g}/\text{ft}^2$ ), with levels ranging from 28 to 440  $\mu\text{g}/\text{ft}^2$ . Lead levels in three of the six “wall” wipe samples exceeded the MEDEP criterion (250  $\mu\text{g}/\text{ft}^2$ ). It is noted that the two highest levels, by far the highest concentrations, were the “wall” wipe samples collected from a beam and a duct,

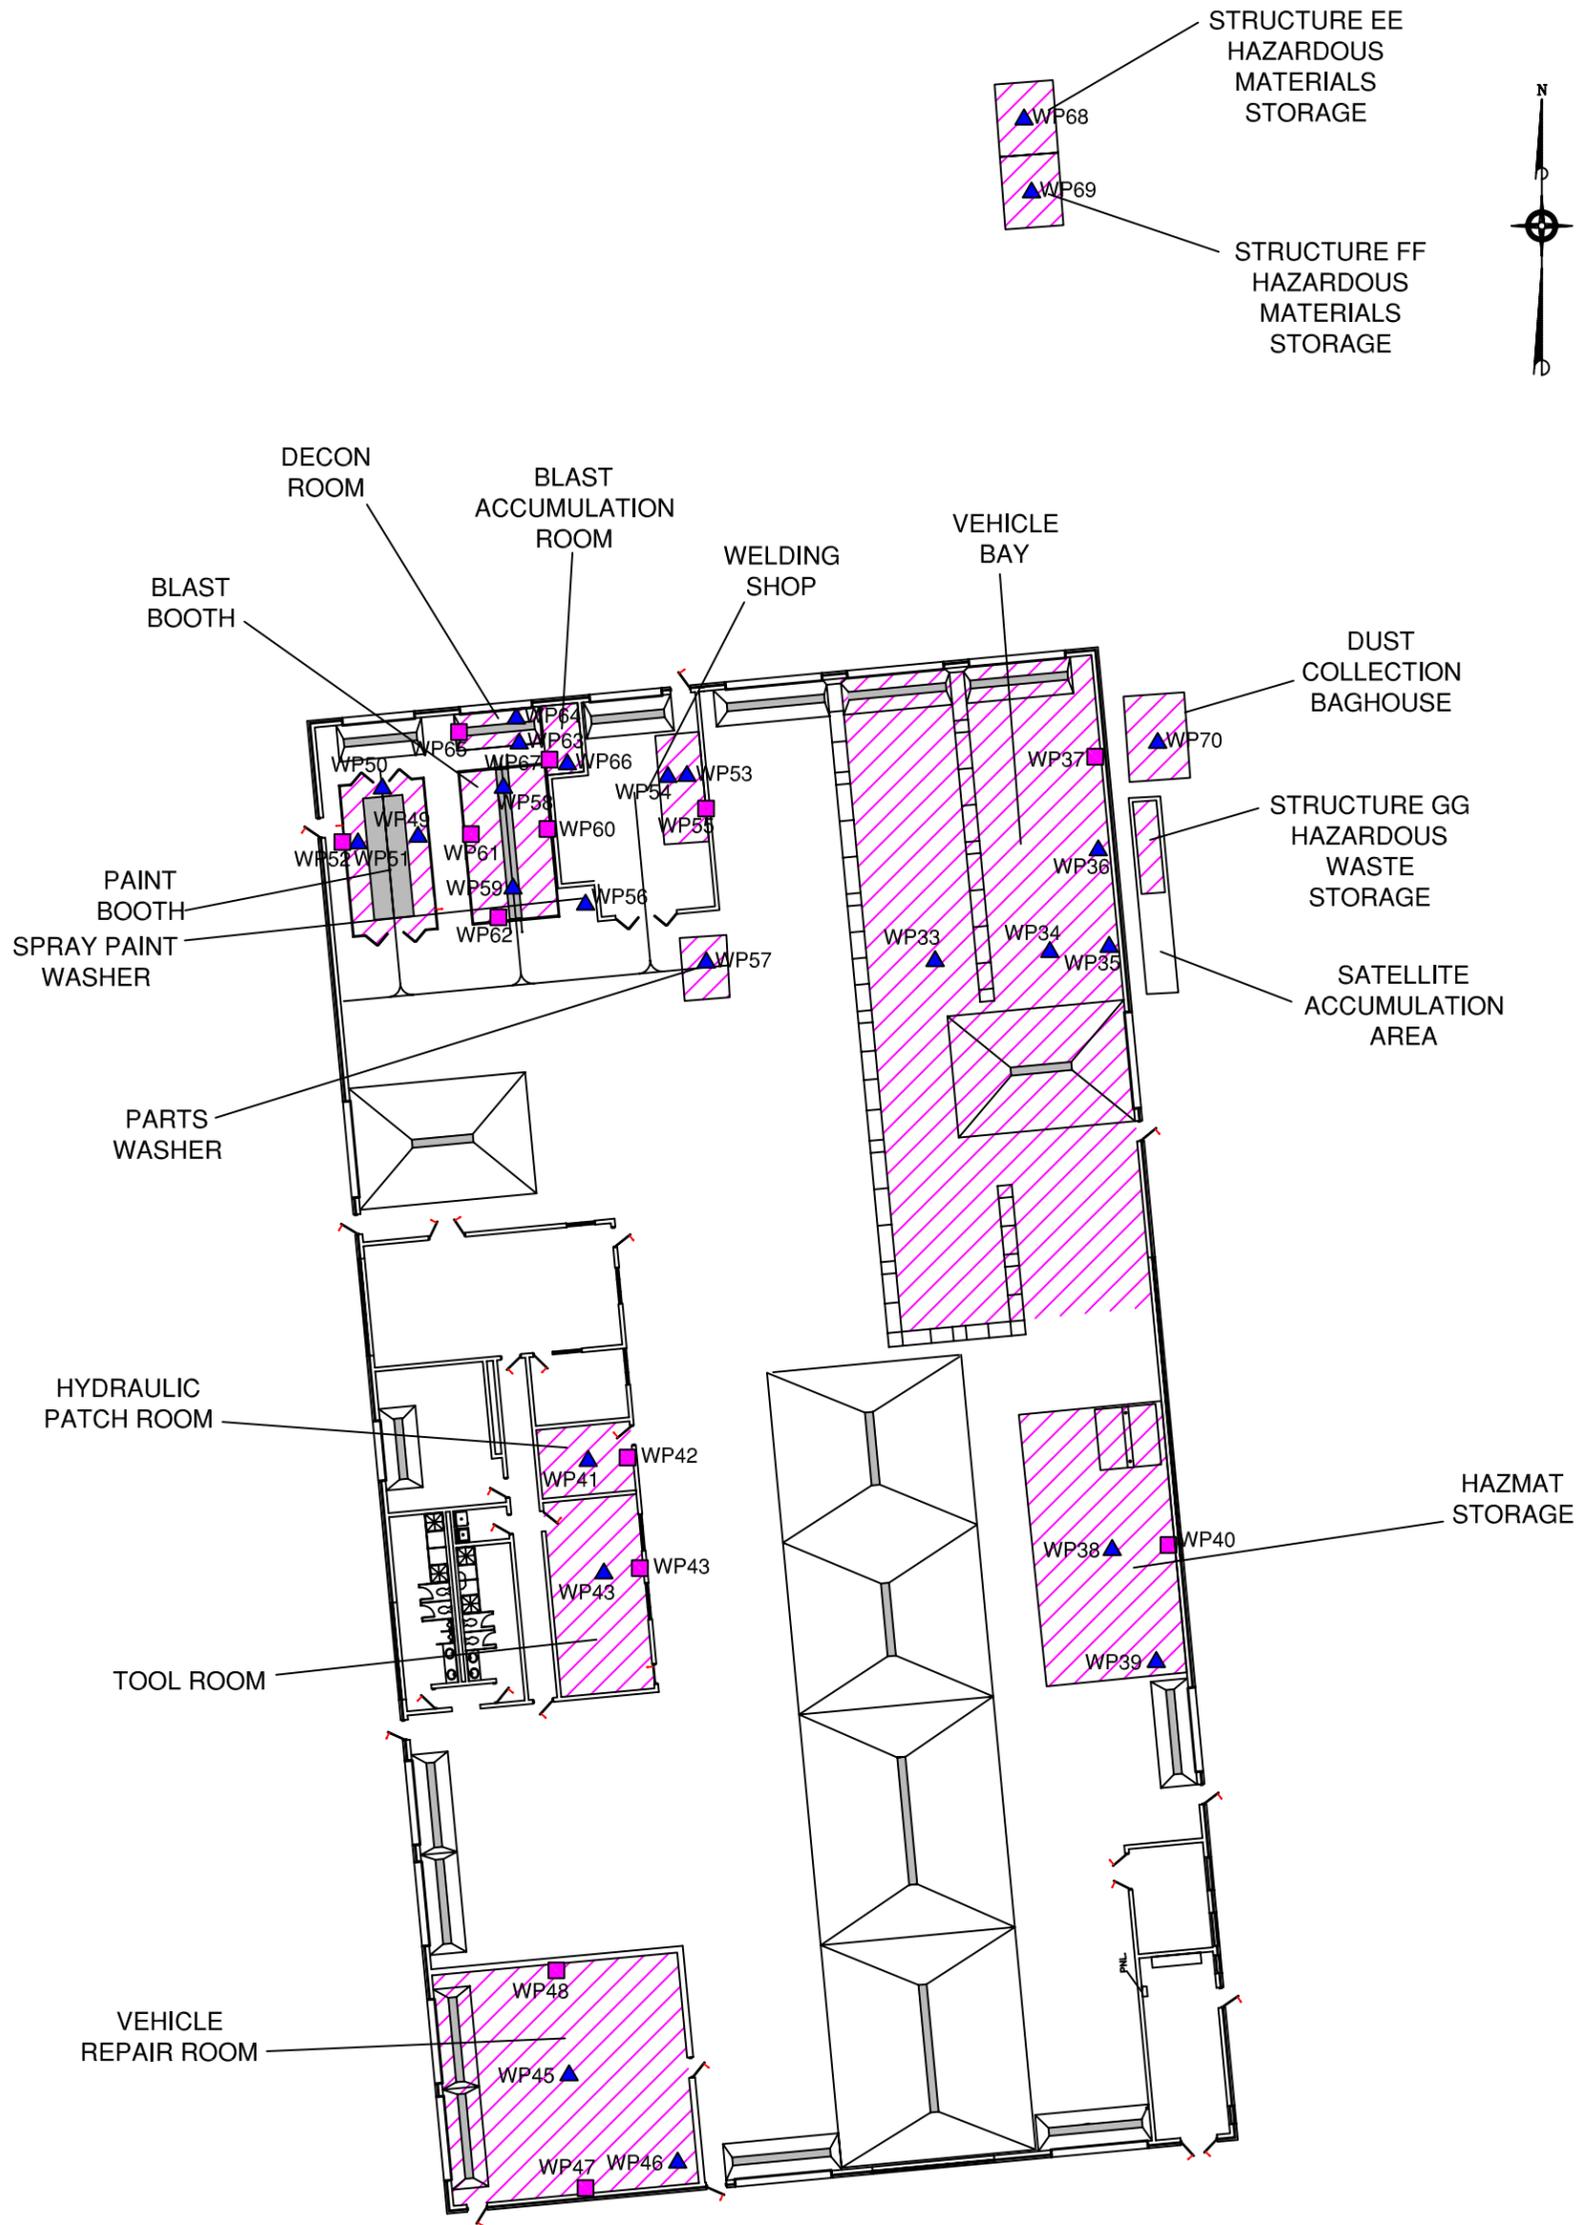
POST-CLEANING SAMPLES – EVENT 1  
 BUILDING 86 – GROUND SUPPORT  
 EQUIPMENT MAINTENANCE SHOP PARCEL  
 RCRA PARTIAL CLOSURE REPORT  
 NAVAL AIR STATION, MAINE

After the work areas were allowed to dry, post-cleaning confirmatory sampling was conducted. Twenty-four post-cleaning wipe samples were collected from the floor and 14 from the walls (Figure 4). As shown in Table 3, analytical results indicated that lead exceeded the applicable MEDEP criterion of 40  $\mu\text{g}/\text{ft}^2$  in the majority of the post-cleaning confirmation wipe samples in the vehicle bay, hazardous materials/waste storage area, tool room, vehicle repair room, welding shop, former parts washer, and Structure EE. Lead levels in confirmatory samples from wall locations did not exceed the associated MEDEP criterion (250  $\mu\text{g}/\text{ft}^2$ ), except in one sample from the welding shop.

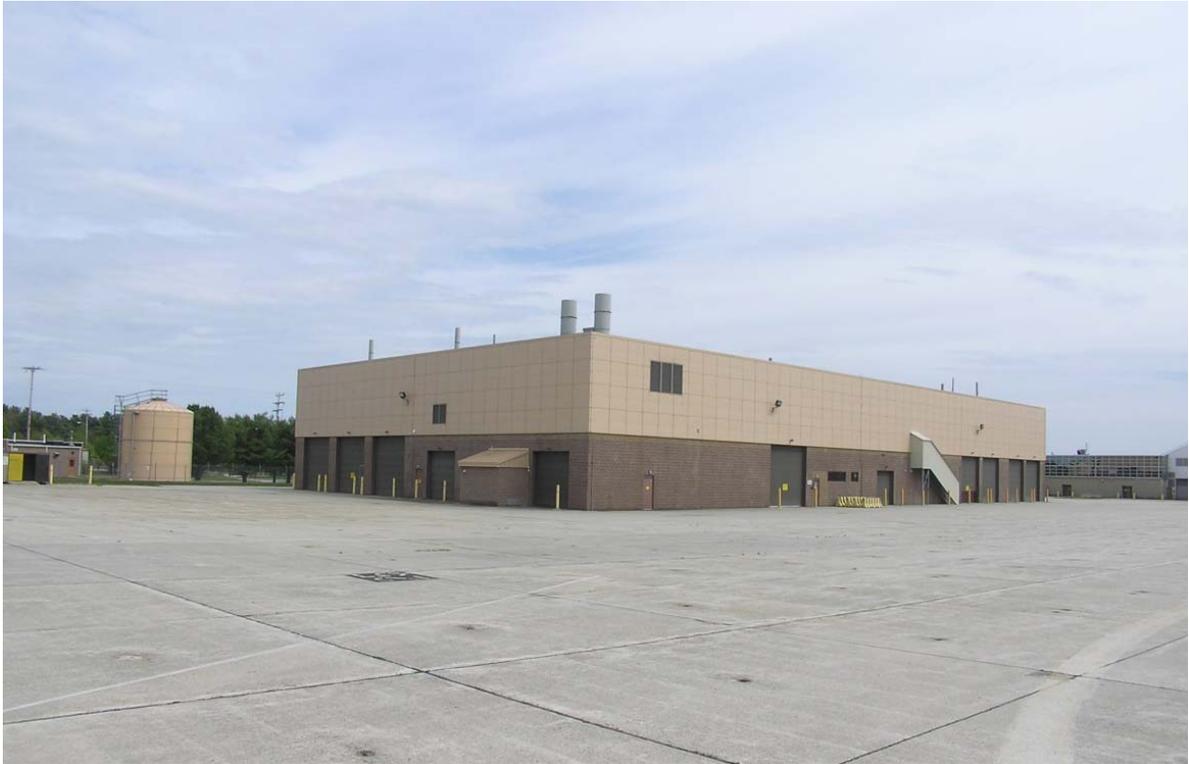
No. 1 Building 86 – NAS Brunswick May 12, 2010  
GSE Maintenance Shop northwest elevation; Structures EE and FF and Waste Glycol tank at left of frame

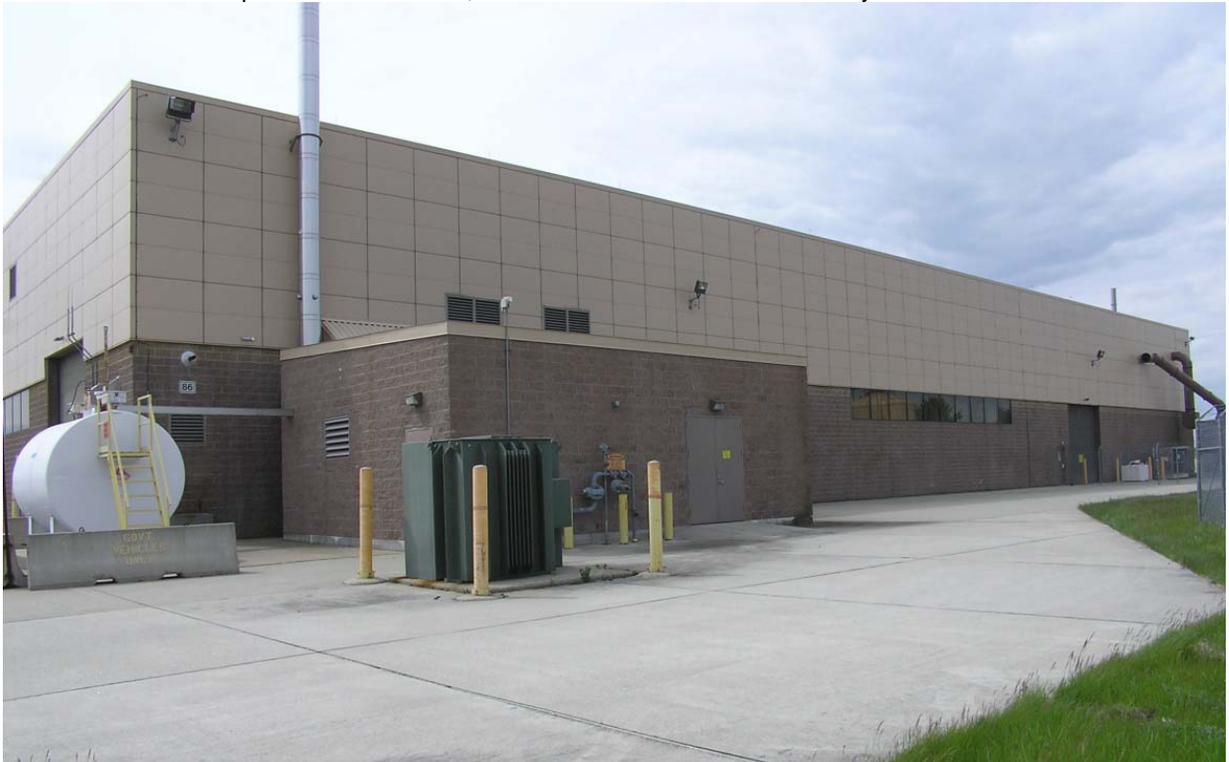
No. 2 Building 86 – NAS Brunswick May 12, 2010  
GSE Maintenance Shop east elevation; non-PCB transformer and closed heating oil AST in left foreground

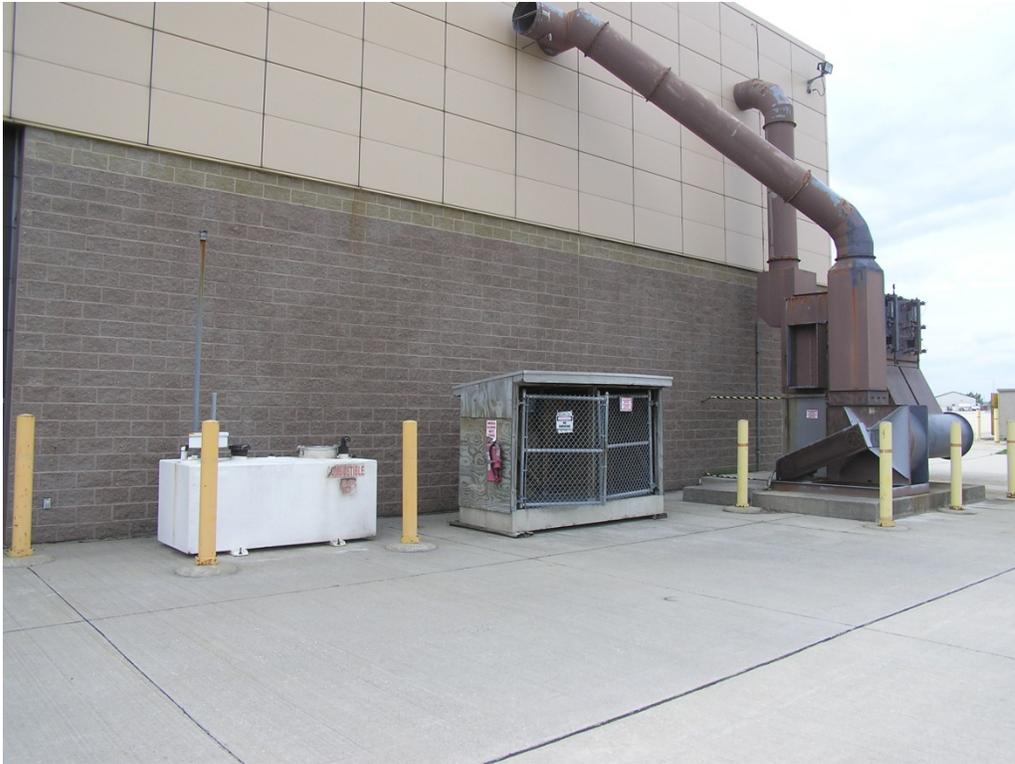
No. 7 Building 86 – NAS Brunswick June 8, 2010  
Satellite accumulation area; waste oil tank, hazardous waste storage shed (Structure GG), and blast media air scrubber (from to right)

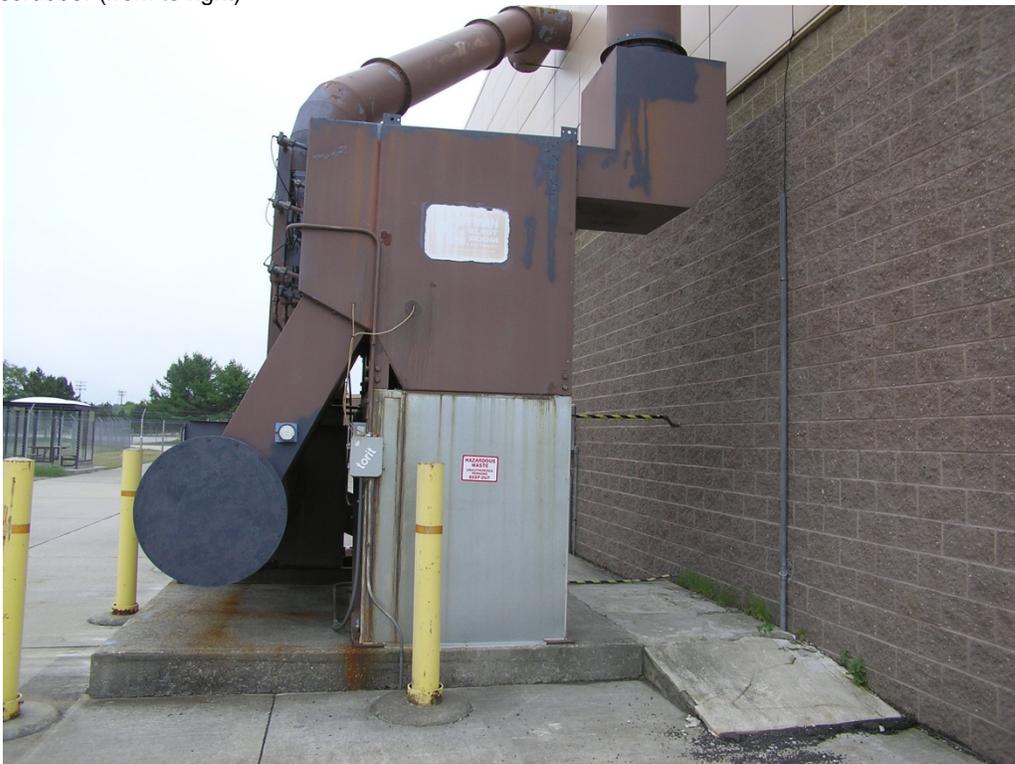
On February 17, 2004, a fire alarm was triggered by the smoke detector in the air handling system of the blast booth at Building 86, however no evidence of fire was found in the building or the ductwork for the blast booth. On February 19, 2004, personnel from the Safety and Industrial

No. 8 Building 86 – NAS Brunswick May 12, 2010  
Blast booth dust collector bag house and scrubber unit

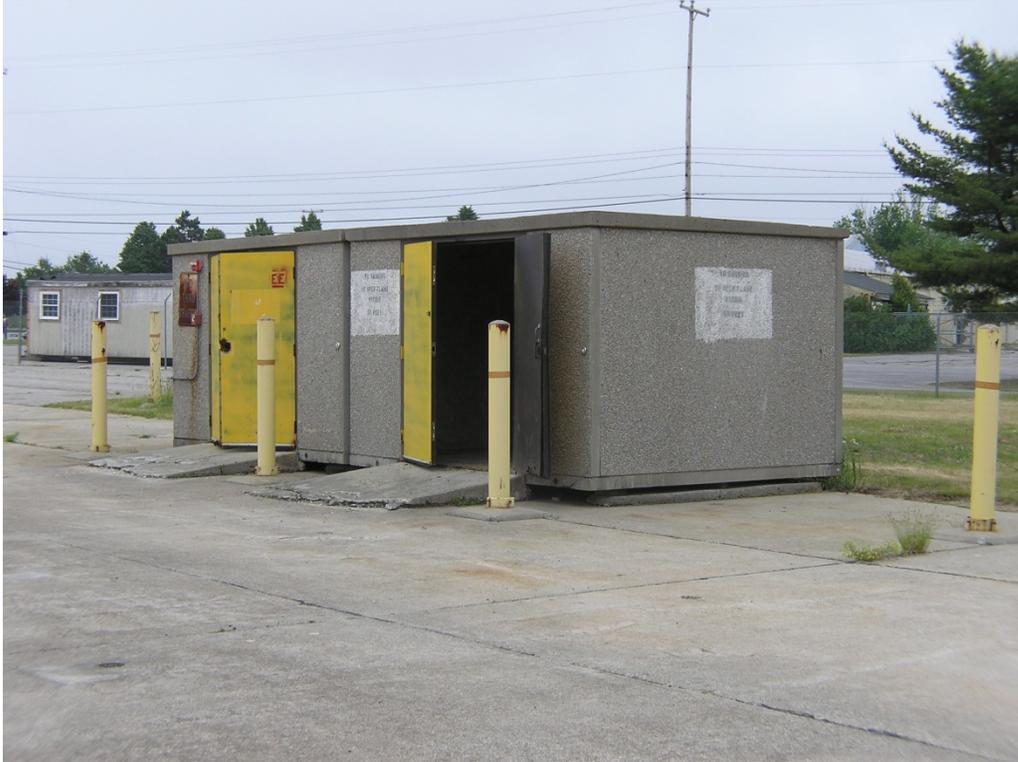
No. 9 Building 86 – NAS Brunswick June 8, 2010  
Hazardous materials storage sheds (Structures EE and FF) northeast of GSE Maintenance Shop

Based on the investigation results, closure remedial actions were undertaken at Building 86 to remove waste residues as required to achieve MEDEP hazardous waste closure requirements. Remedial actions consisted of the cleaning of floors and walls in the paint booth, blast booth, blast booth accumulation room, blast booth decontamination room, welding shop, parts washer area, vehicle bay, hazardous materials/waste storage area, hydraulic patch room, tool room, vehicle repair room, external dust collection room, and Structures EE and FF.

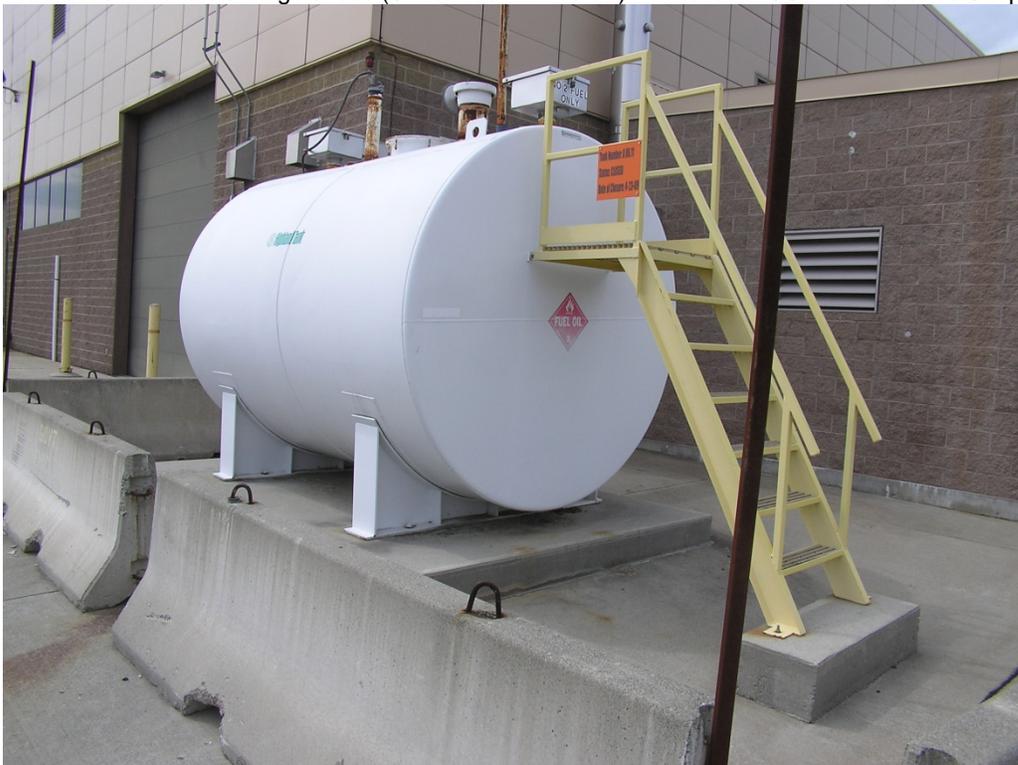
No. 10 Building 86 – NAS Brunswick May 12, 2010  
Closed heating oil AST at southeast corner of Building 86

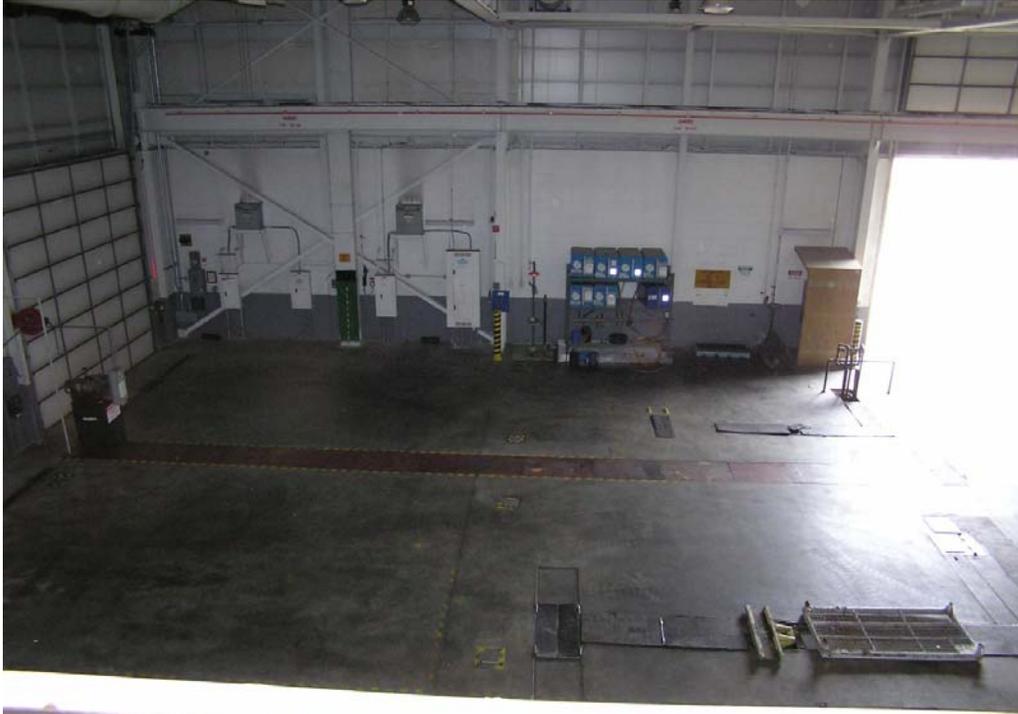
Potential hazardous waste residue was observed in the paint booth, blast booth, blast booth media collection room, decontamination room, and staining was observed in the main maintenance bays.

No. 11 Building 86 – NAS Brunswick  
Northeast repair bays in GSE Maintenance Shop

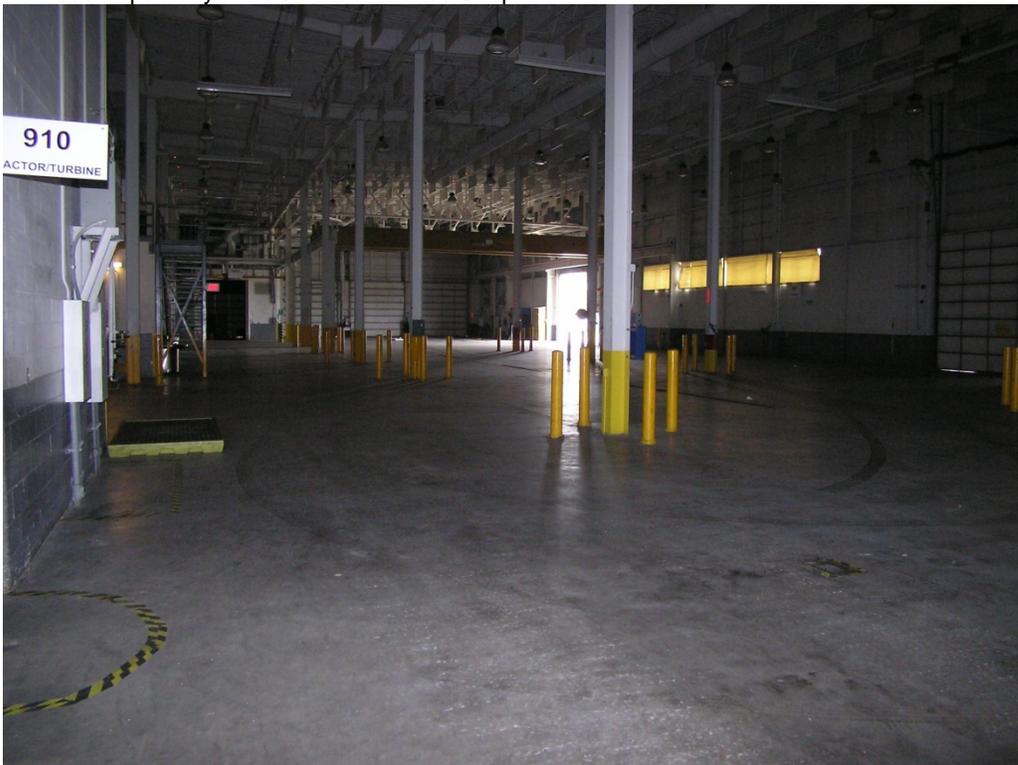
No. 12 Building 86 – NAS Brunswick  
Northern and central portion of main vehicle repair bays in GSE Maintenance Shop

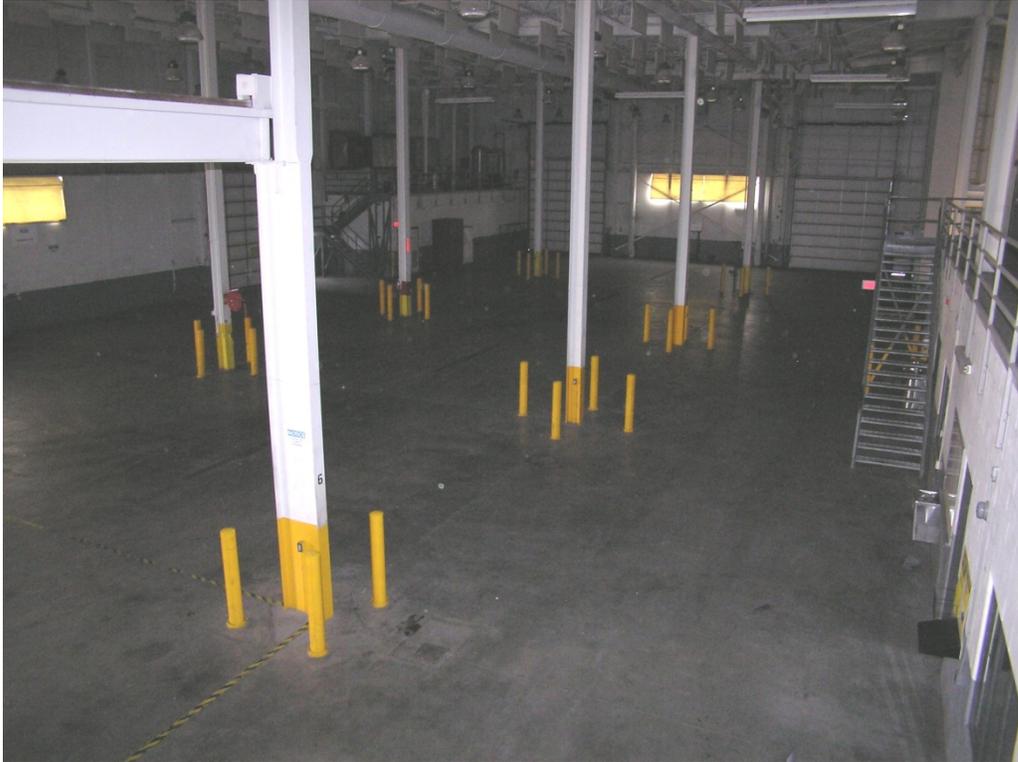
No. 13 Building 86 – NAS Brunswick May 12, 2010  
Southern and central portion of main vehicle repair bays in GSE Maintenance Shop

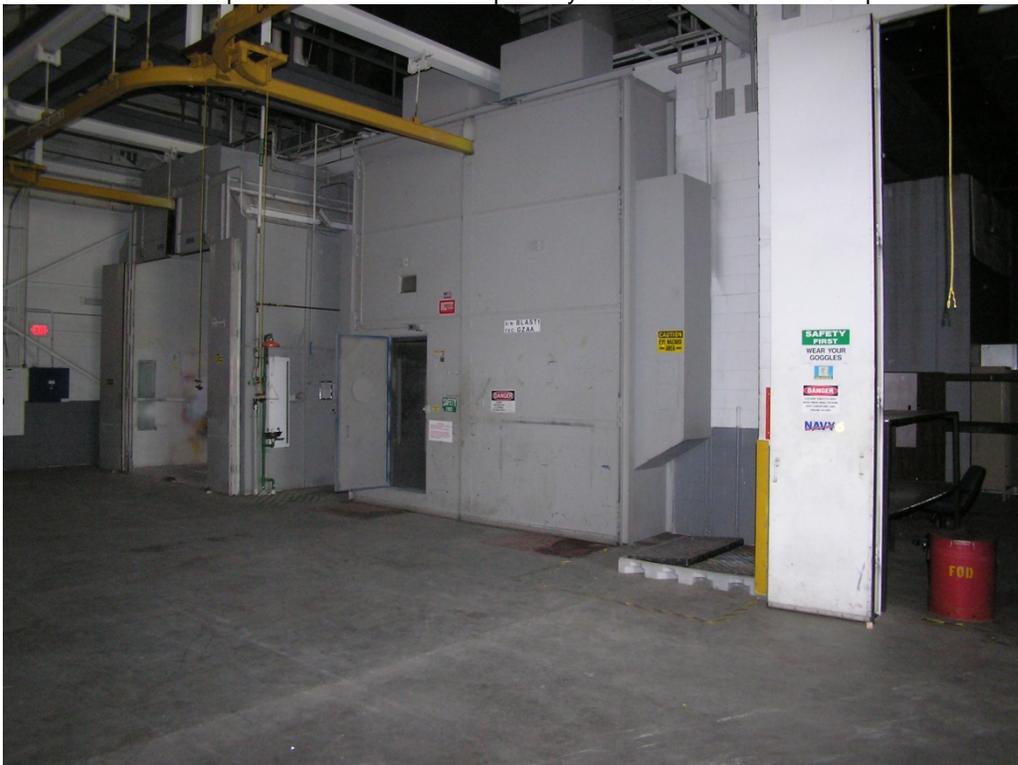
No. 14 Building 86 – NAS Brunswick May 12, 2010  
Paint booth, blast booth, paint sprayer washer area, and welding shop (from left to right).

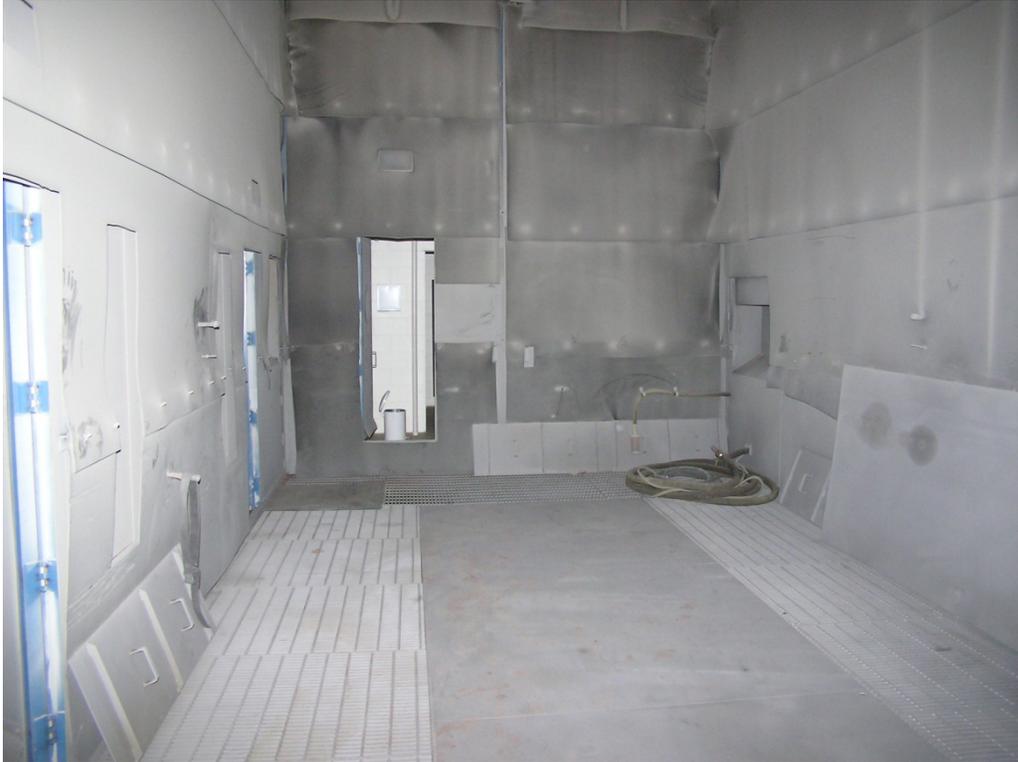
No. 15 Building 86 – NAS Brunswick  
Blast booth interior prior to decontamination activities

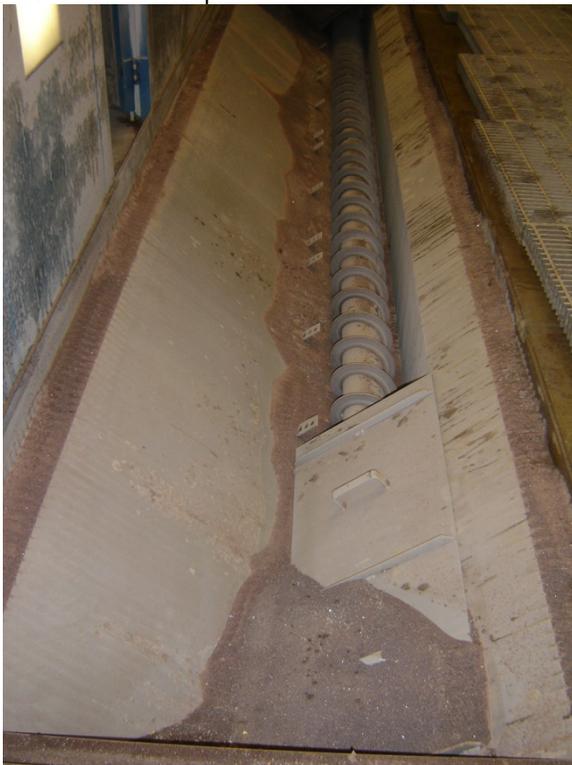
No. 16 Building 86 – NAS Brunswick  
Blast booth west trench prior to cleaning

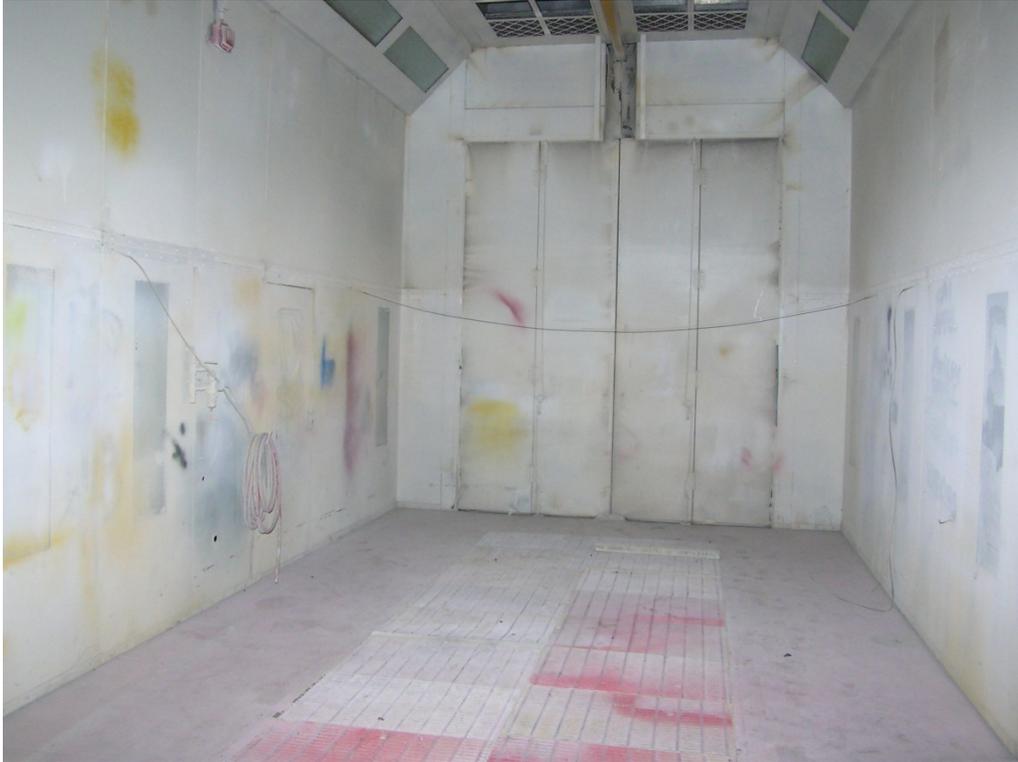
No. 17 Building 86 – NAS Brunswick January 21, 2010  
Paint booth interior prior to decontamination activities

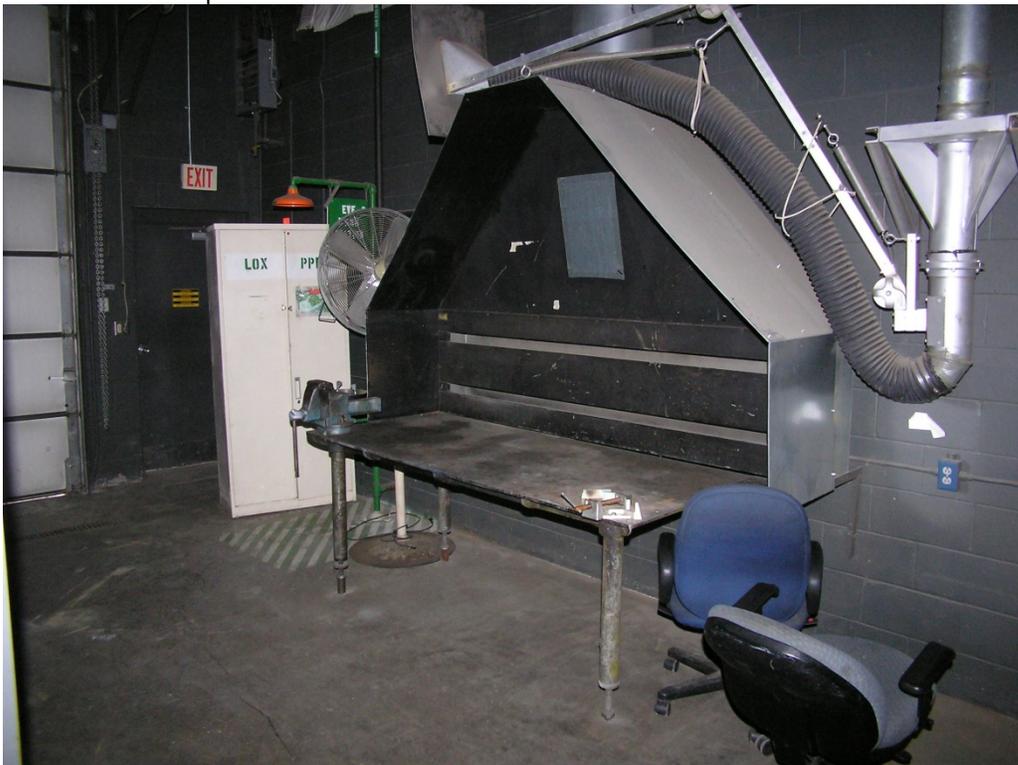
No. 18 Building 86 – NAS Brunswick June 2, 2010  
Welding shop interior prior to decontamination activities

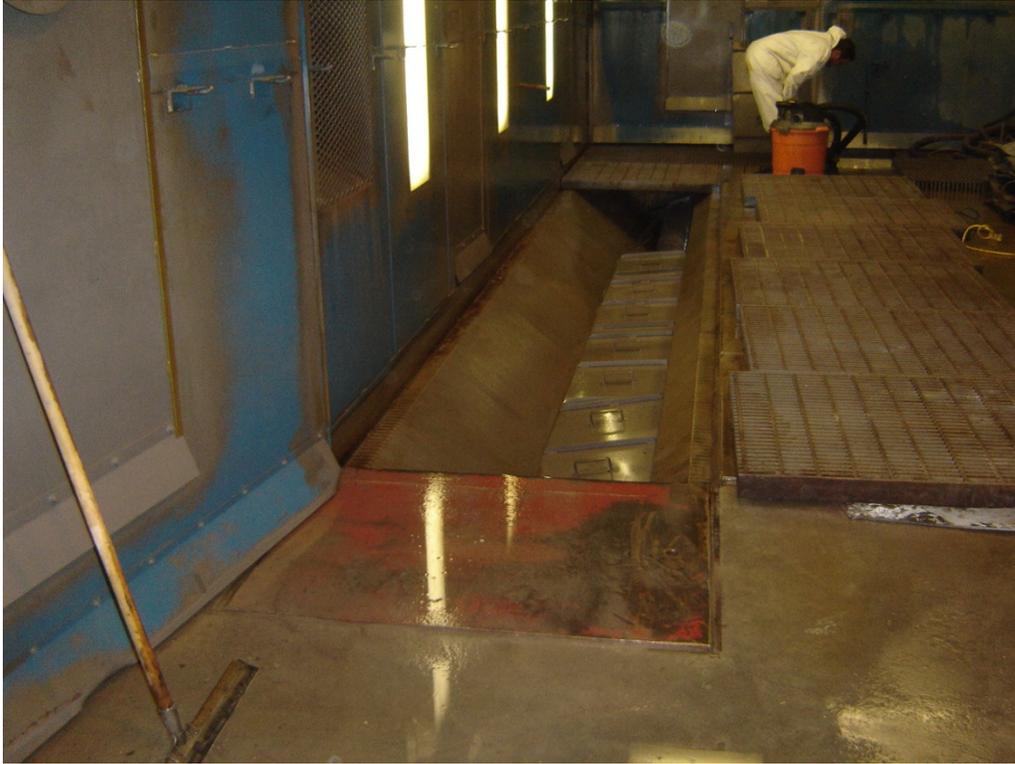
No. 19 Building 86 – NAS Brunswick  
Blast booth west trench after cleaning

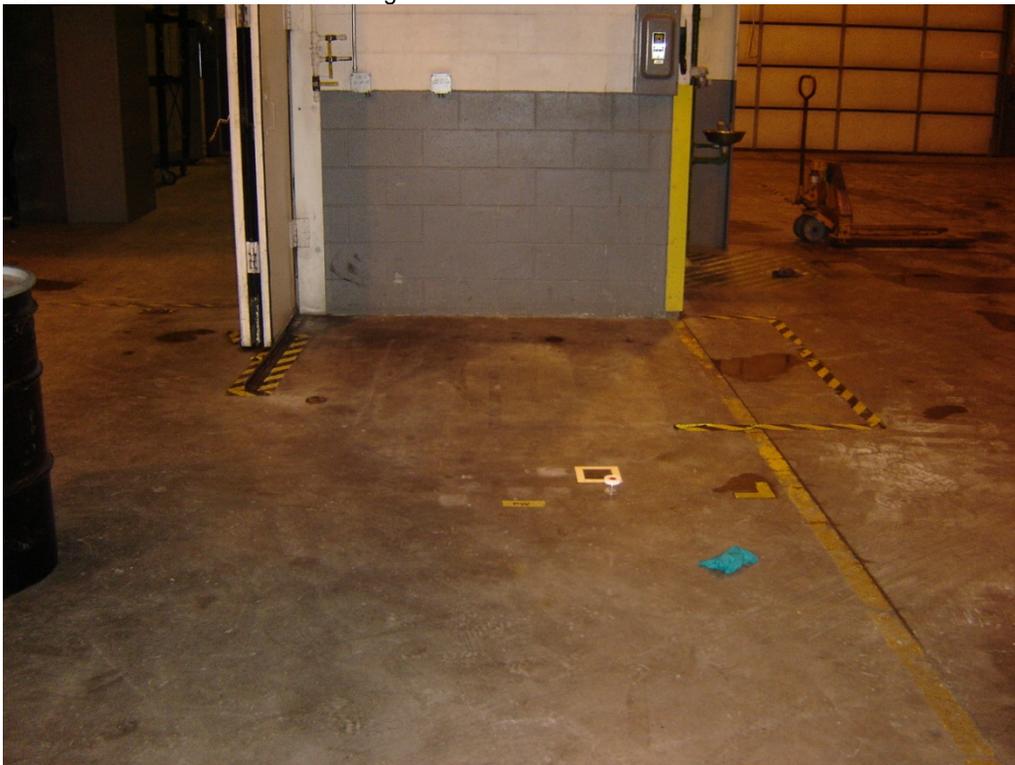
No. 20 Building 86 – NAS Brunswick  
Former aqueous parts washer after decontamination activities
