FINAL RESOURCE CONSERVATION AND RECOVERY ACT PARTIAL CLOSURE REPORT  
FOR BUILDING 585 WITH TRANSMITTAL LETTER NAS BRUNSWICK ME  
12/10/2010  
NAS BRUNSWICK

**RCRA PARTIAL CLOSURE REPORT**  
**for**  
**BUILDING 585 – CHAPEL**  
**NAVAL AIR STATION BRUNSWICK, MAINE**  
**USEPA IDENTIFICATION NUMBER ME8170022018**  
**DECEMBER 2010**

**HWSA INSPECTION REPORT  
HAZARDOUS WASTE STORAGE AREAS CLOSURE  
NAS BRUNSWICK  
BRUNSWICK, MAINE  
CTO WE22**

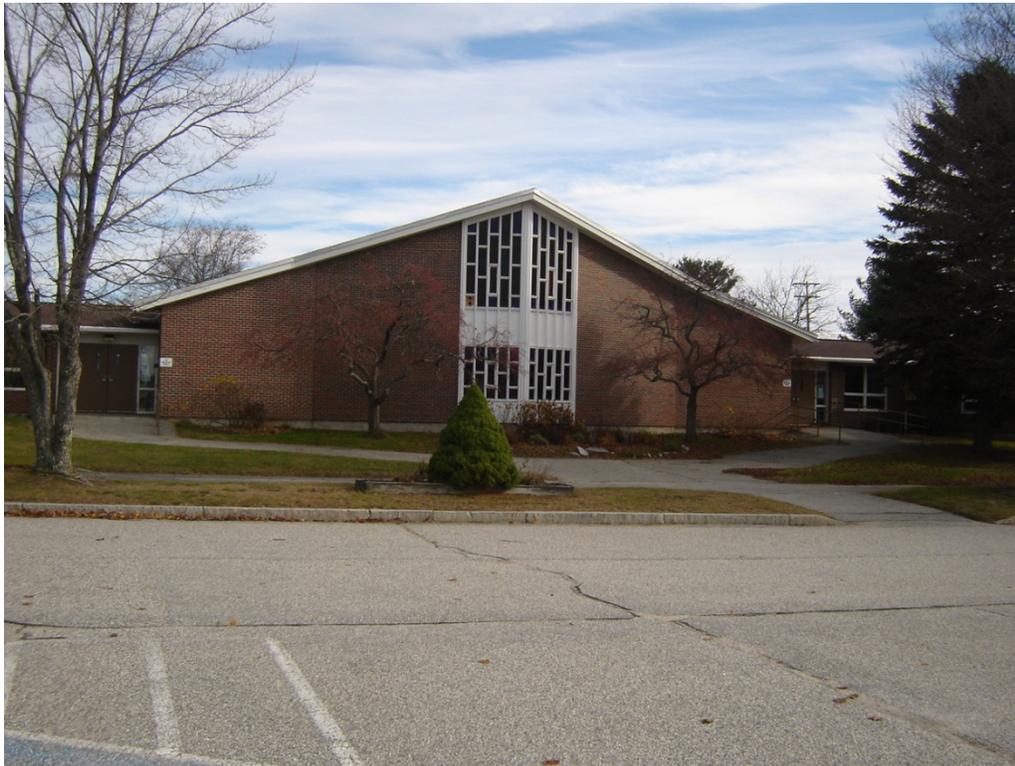
No. 1 Building 585 – Chapel Parcel, NAS Brunswick November 10, 2010  
Chapel west elevation (front entrance and mezzanine area, view from parking lot)

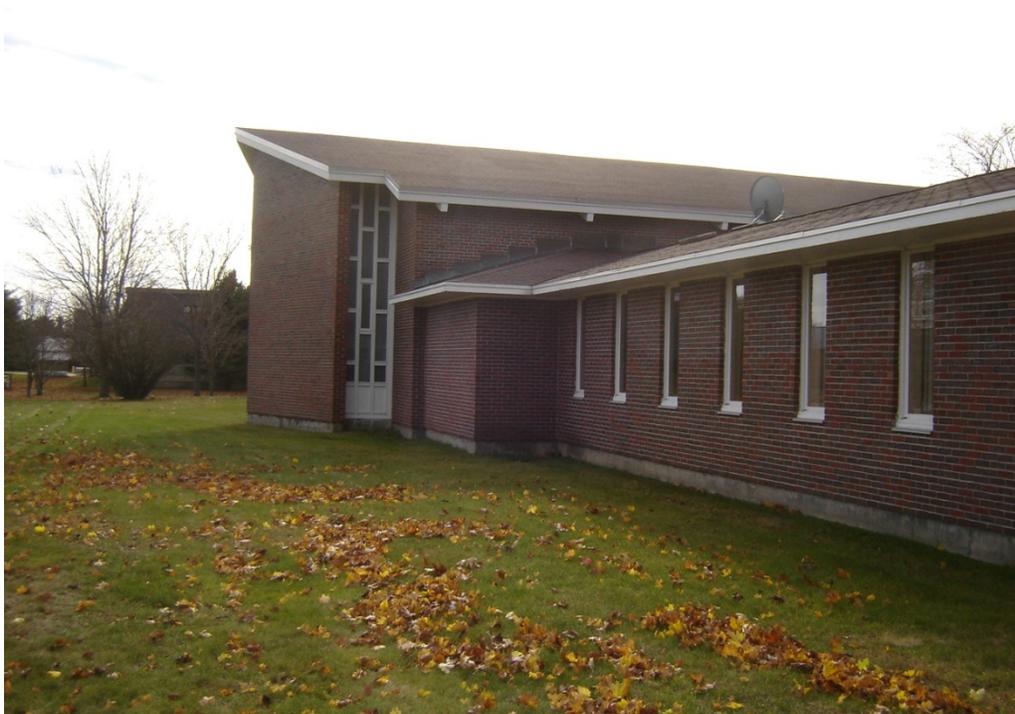
No. 2 Building 585 – Chapel Parcel, NAS Brunswick November 10, 2010  
Chapel east elevation (east portion of parcel, view from north)

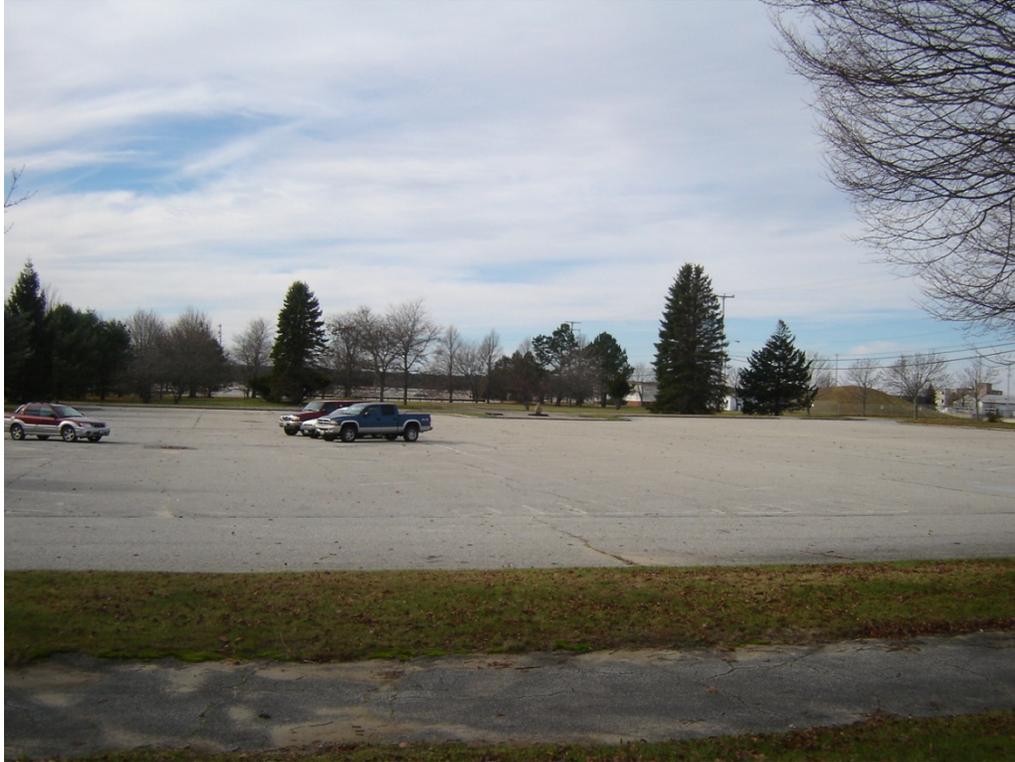
No. 3 Building 585 – Chapel Parcel, NAS Brunswick  
Chapel parking lot (view from east)

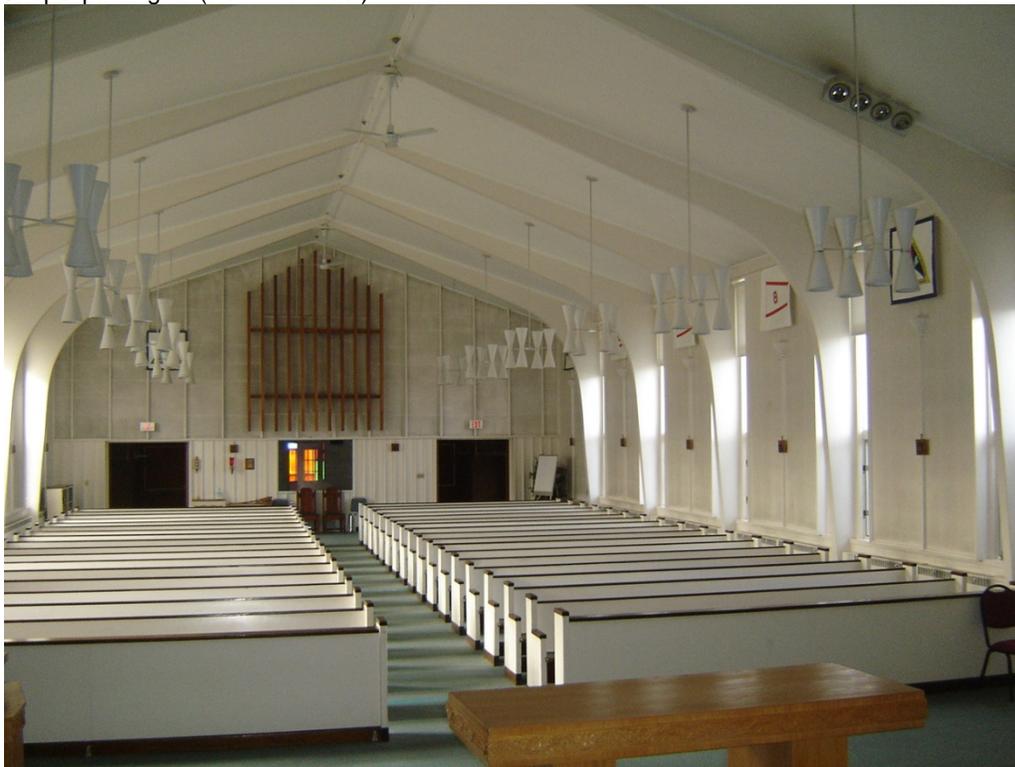
No. 4 Building 585 – Chapel Parcel, NAS Brunswick  
Chapel interior (main chapel facing towards the west)

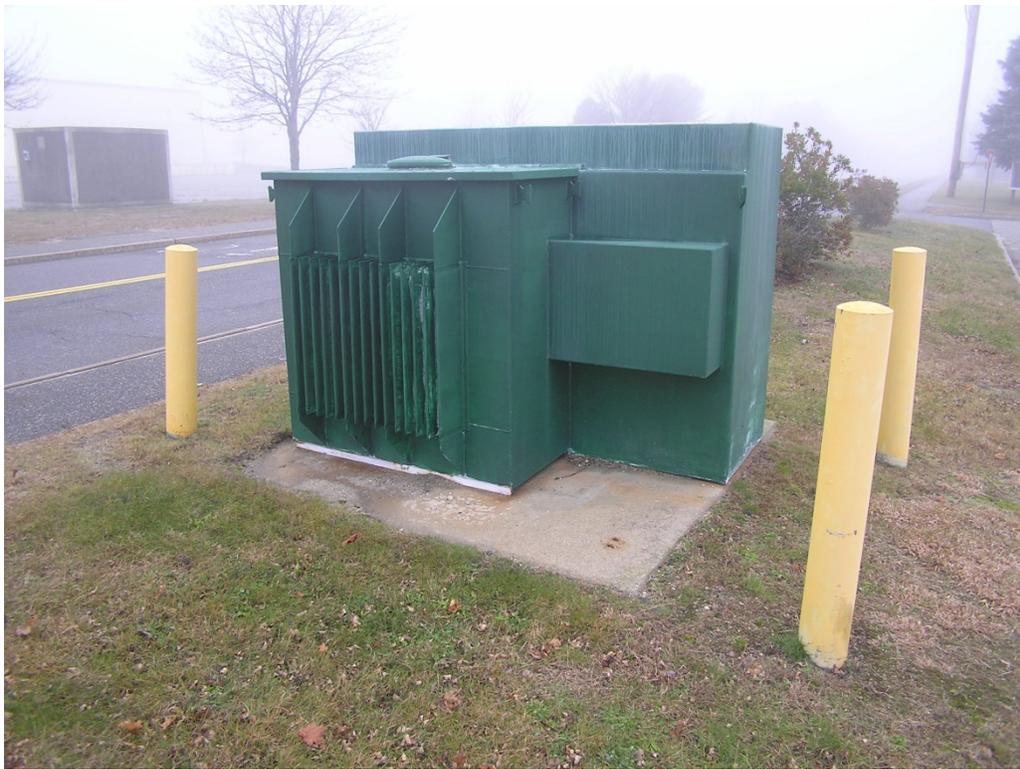
- One concrete-pad-mounted transformer was identified in the north-central portion of the parcel, at the northern edge of the parking lot. No staining or other evidence of a release from this transformer was observed.

One pad-mounted transformer was observed to the north of the parking lot on this parcel. There was no staining or any visible evidence of a release in this area.

No. 5 Building 585 – Chapel Parcel, NAS Brunswick  
Transformer located north of Building 585 parking lot (view northeast)

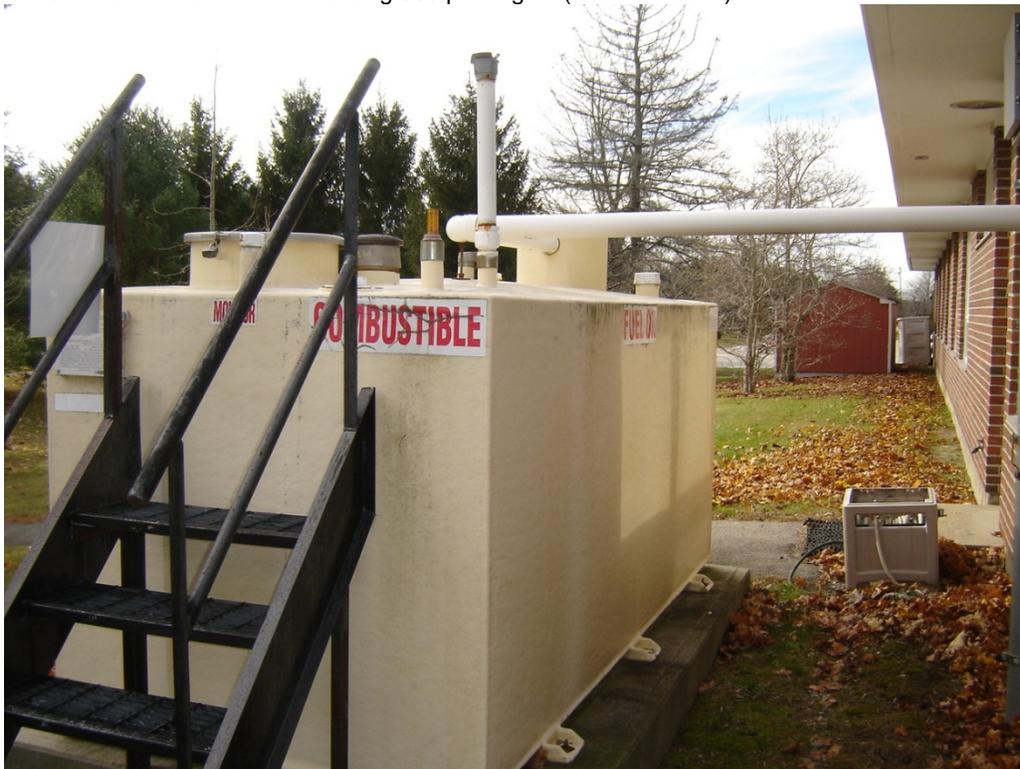
- One closed 1,000-gallon AST was identified at the southeast corner of Building 585. The date of closure listed on the tank was April 15, 2009 (the NAS Brunswick AST/UST database listed the closure date as April 10, 2009). The tank appeared to be in good condition and no evidence of a past leak from this AST was observed.

No. 6 Building 585 – Chapel Parcel, NAS Brunswick  
Building 585 closed AST (No. A 585.0), with storage shed Structures III and JJJ in background

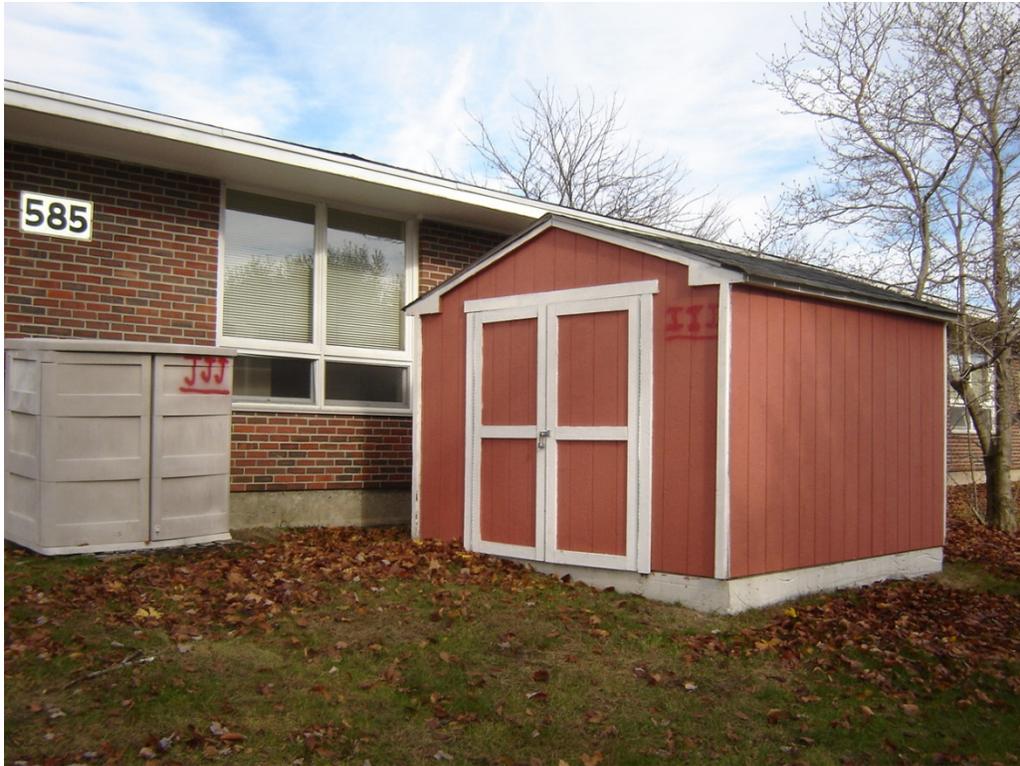
Two additional structures were located on the parcel, to the south west corner of the Chapel building. Structure III, a small plastic storage shed was empty. Structure JJJ was a wooden storage shed and appeared to be in good condition also.

No. 7 Building 585 – Chapel Parcel, NAS Brunswick November 10, 2010  
Storage sheds III and JJJ located near the southwest corner of Building 585

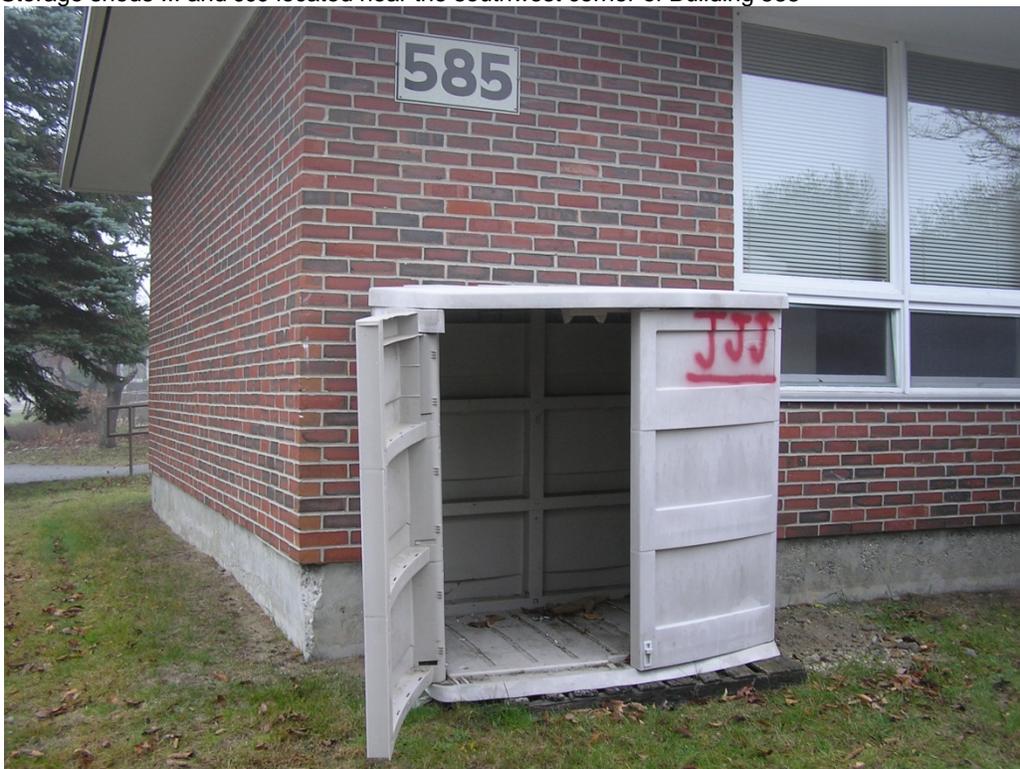
No. 8 Building 585 – Chapel Parcel, NAS Brunswick November 23, 2010  
Structure JJJ interior

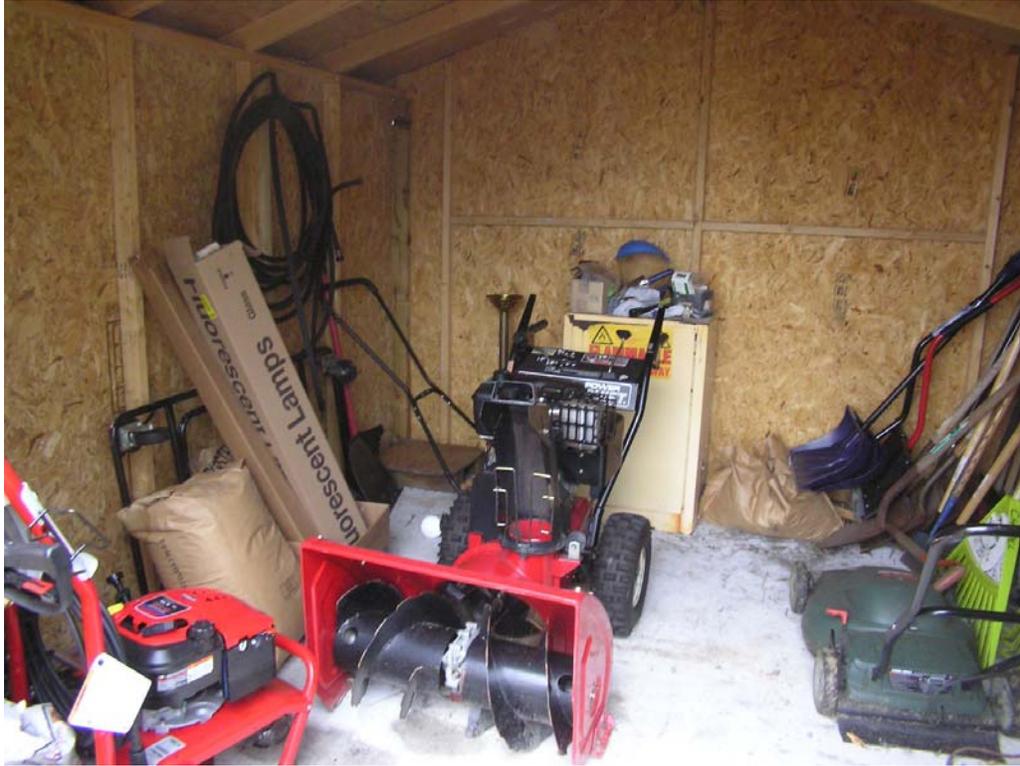
No. 9 Building 585 – Chapel Parcel, NAS Brunswick November 23, 2010  
Structure III interior with maintenance equipment and empty flammables storage cabinet
