FINAL RESOURCE CONSERVATION AND RECOVERY ACT PARTIAL CLOSURE REPORT
FOR BUILDINGS 34 AND 78 WITH TRANSMITTAL LETTER NAS BRUNSWICK ME
12/20/2010
NAS BRUNSWICK

RCRA PARTIAL CLOSURE REPORT
for
BUILDING 34 – GOLF SHED
BUILDING 78 – GOLF CLUBHOUSE
NAVAL AIR STATION BRUNSWICK, MAINE
USEPA IDENTIFICATION NUMBER ME8170022018
DECEMBER 2010

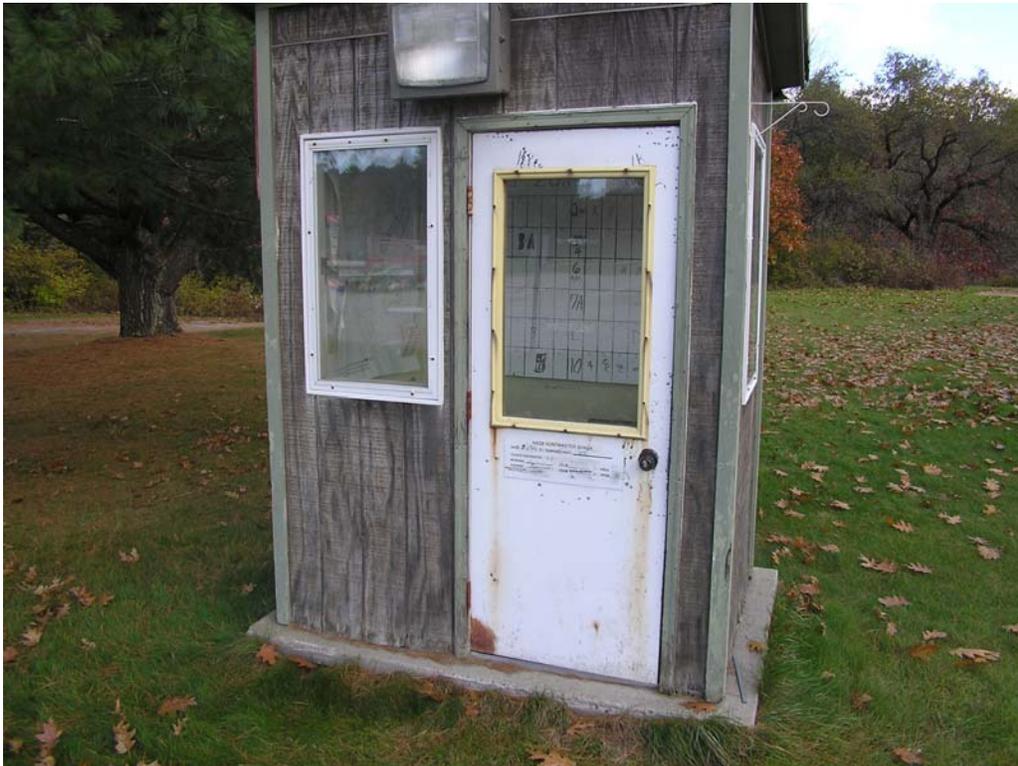
- At the time of inspection, Building 34 was unoccupied and in fair condition.
- No evidence of current or past hazardous waste generation activities was observed.
- No signs of a past release (staining, unusual odors, stressed vegetation, etc.) were observed.
- No modifications to the structure, which may conceal signs of a past release, were observed.
- No peeling or flaking paint was observed on the exterior or interior of the building.

No 1 Buildings 34 and 78, NAS Brunswick
Building 34 – Golf Shed exterior

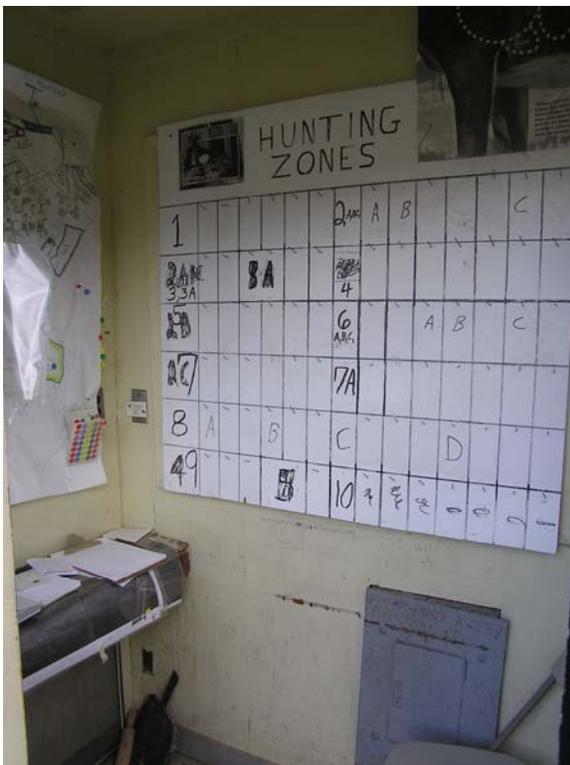
No 2 Buildings 34 and 78, NAS Brunswick
Building 34 – Golf Shed interior

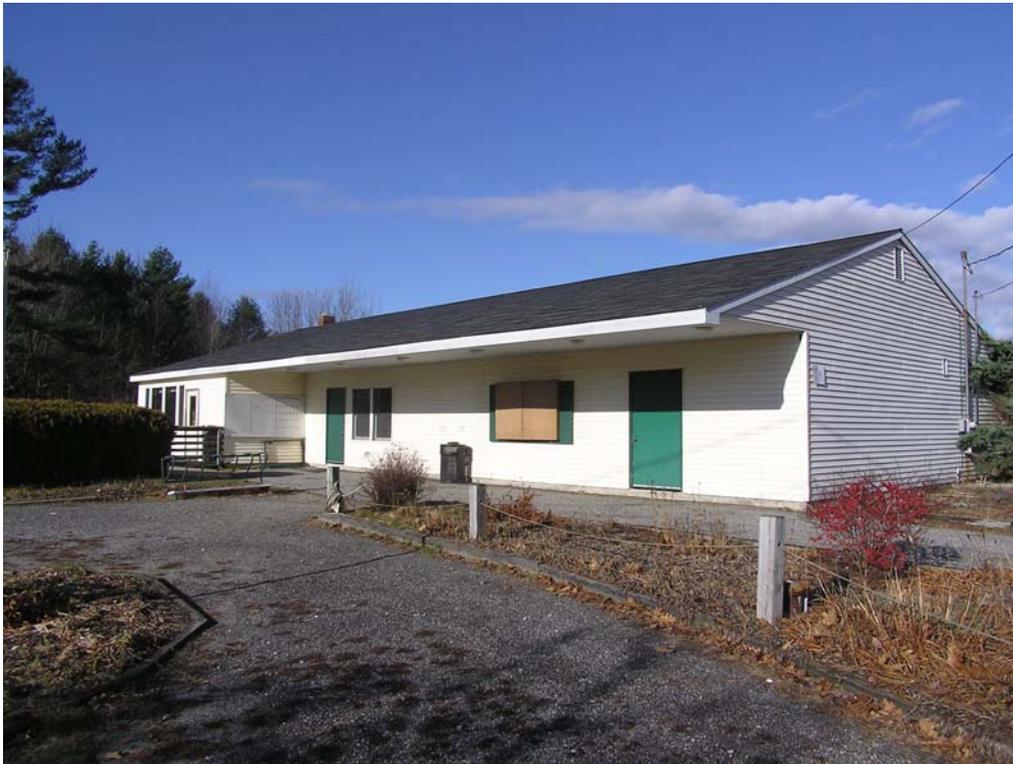
- At the time of inspection, Building 78 was unoccupied and in fair condition.
- No evidence of current or past hazardous waste generation activities was observed.

No 3 Buildings 34 and 78, NAS Brunswick
Building 78 – Golf Clubhouse southeastern elevation

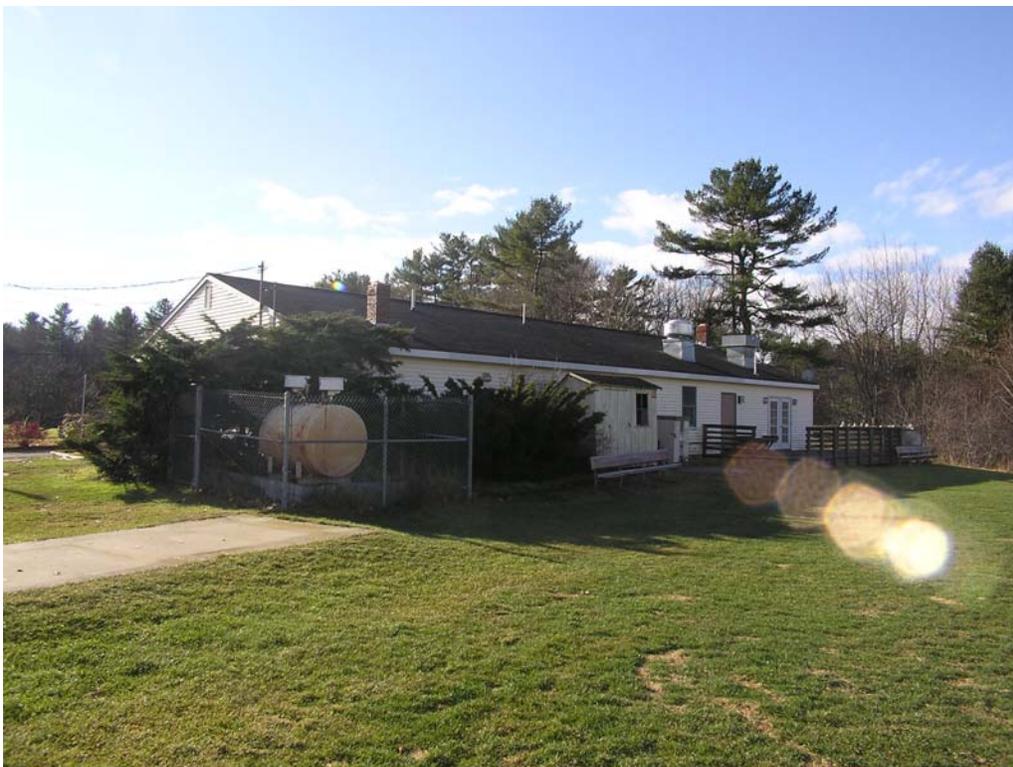
No 4 Buildings 34 and 78, NAS Brunswick
Building 78 – Golf Clubhouse northeastern elevation

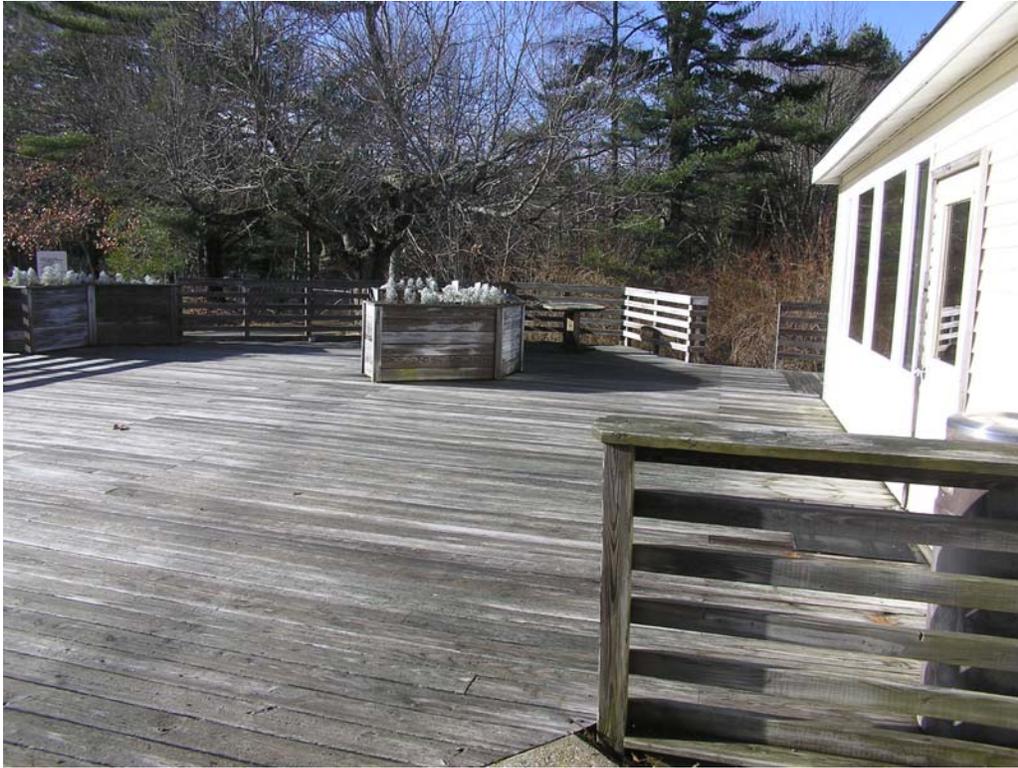
No 5 Buildings 34 and 78, NAS Brunswick December 2, 2010
Building 78 – Golf Clubhouse deck area (southwest side of building)

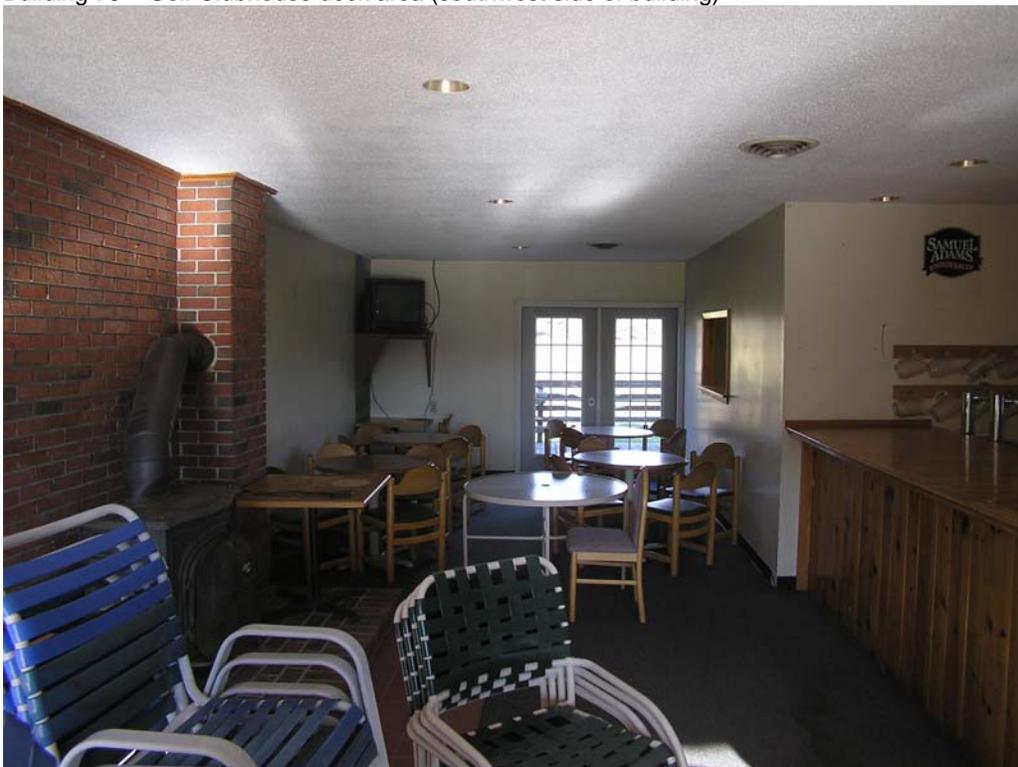
No 6 Buildings 34 and 78 – Golf Course Buildings December 2, 2010
Building 78 – Golf Clubhouse dining area

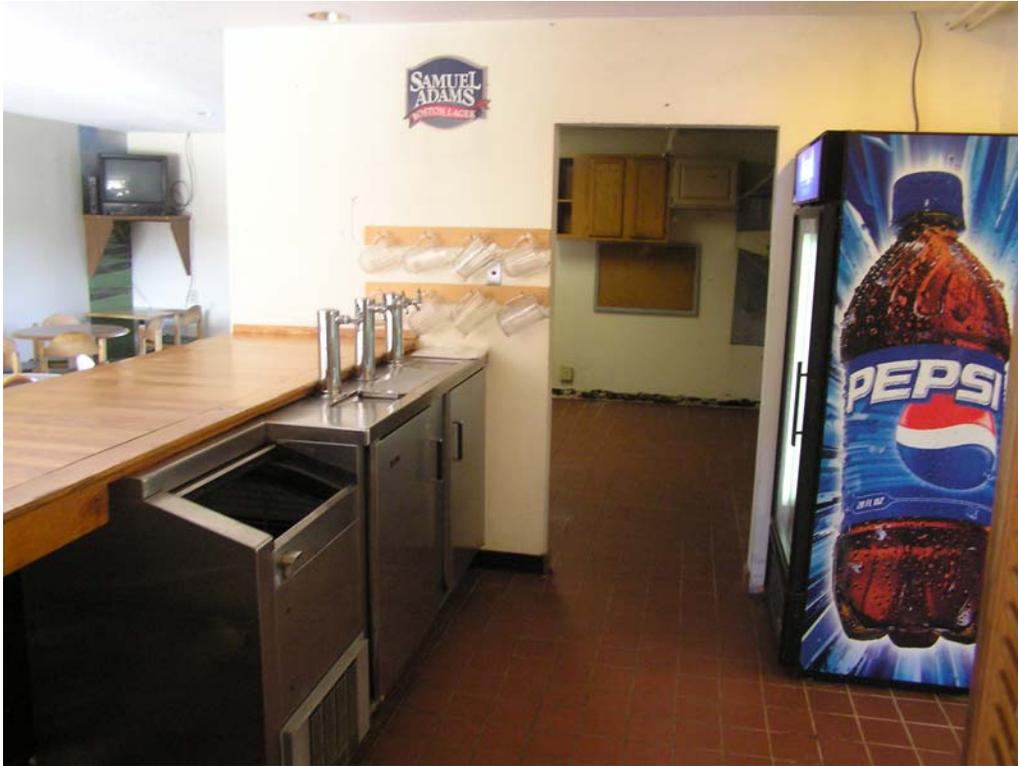
No 7 Buildings 34 and 78, NAS Brunswick
Building 78 – Golf Clubhouse bar and kitchen area

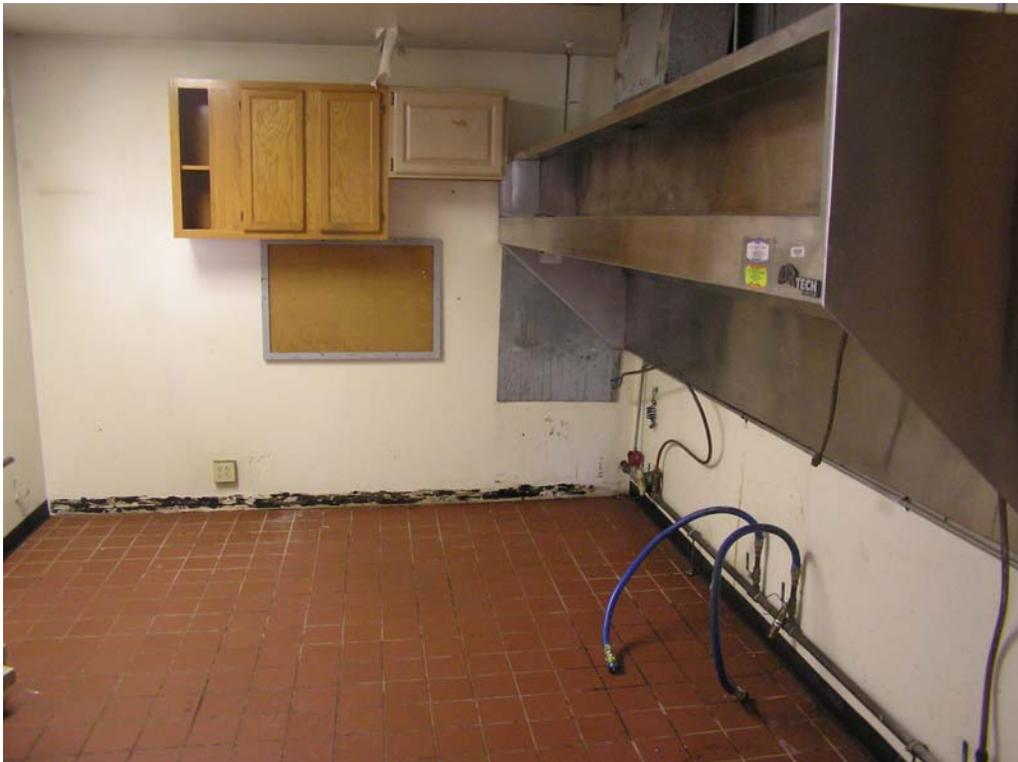
- No signs of a past release (staining, unusual odors, stressed vegetation, etc.) were observed.
- No modifications to the structure, which may conceal signs of a past release, were observed.
- An OWS, or grease trap, was observed under the sink in the kitchen.
- No peeling or flaking paint was observed on the exterior or interior of the building.
- Structure A5 was empty and was in poor condition; no evidence of hazardous waste residues was observed.

No. 8 Buildings 34 and 78, NAS Brunswick
Building 78 – Golf Clubhouse kitchen area

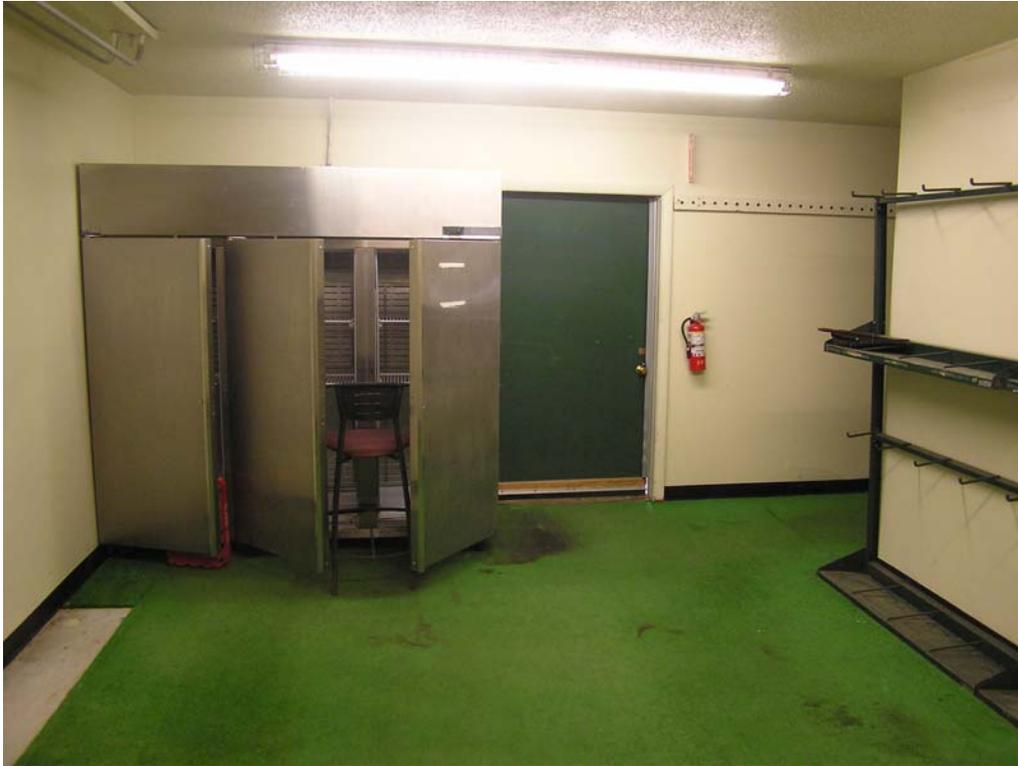
No 9 Buildings 34 and 78, NAS Brunswick
Building 78 – Golf Clubhouse equipment and food storage area

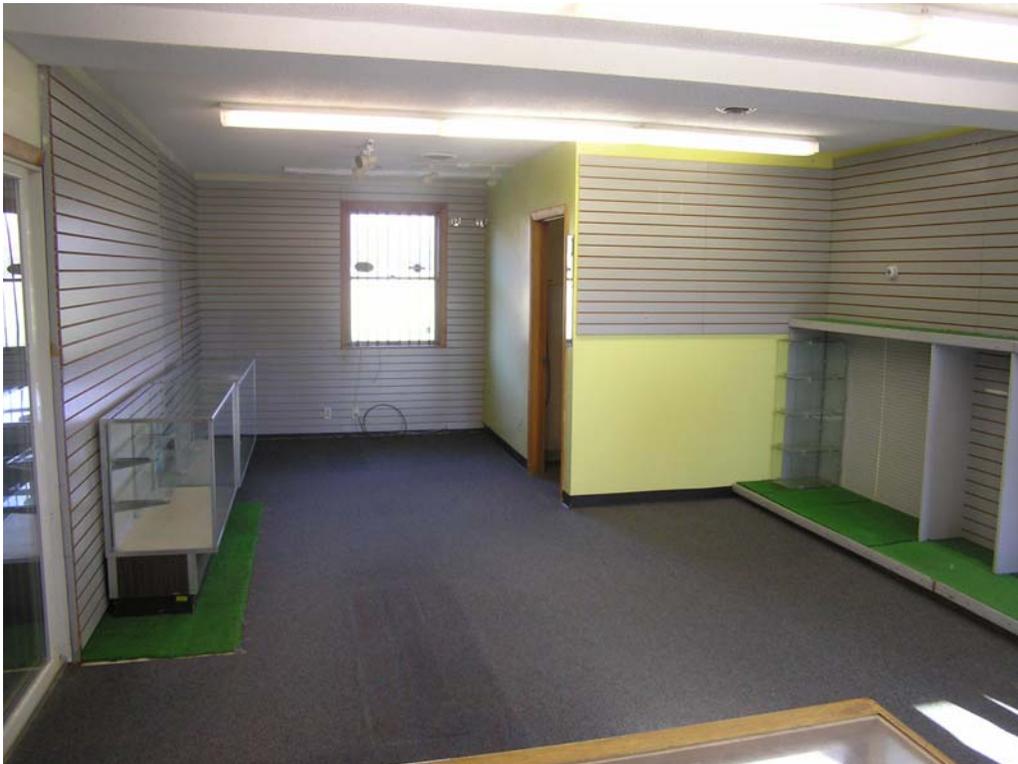
No 10 Buildings 34 and 78, NAS Brunswick
Building 78 – Golf Clubhouse retail store area

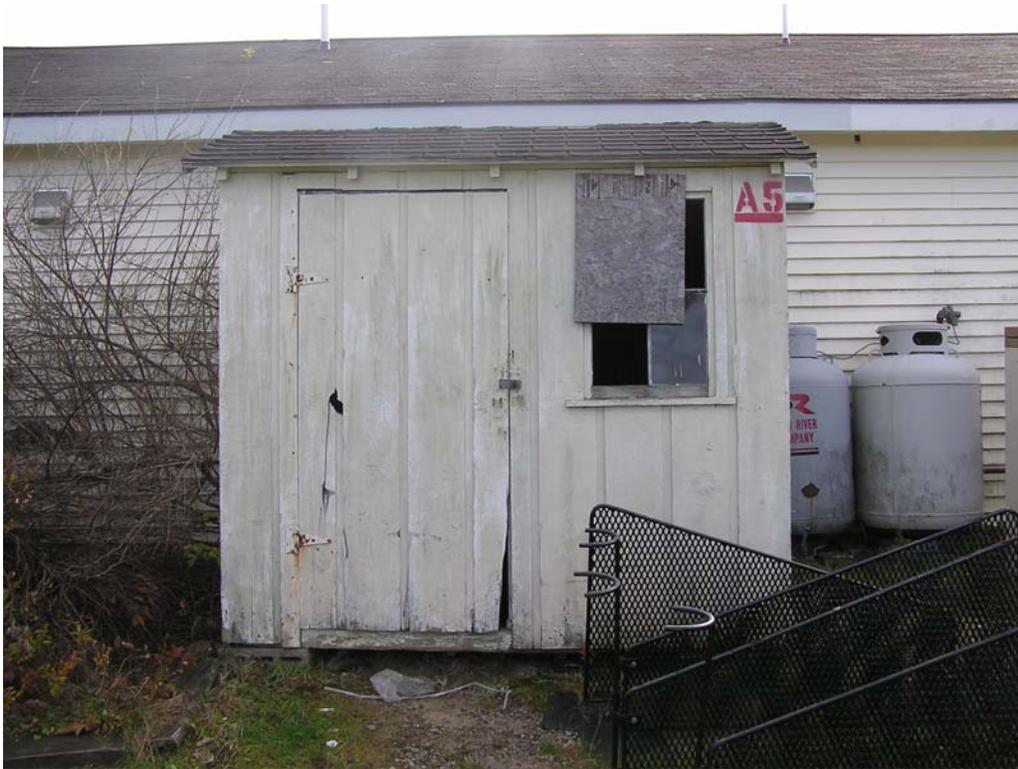
No 11 Buildings 34 and 78, NAS Brunswick December 2, 2010
Structure A5 – Sporting goods storage shed exterior

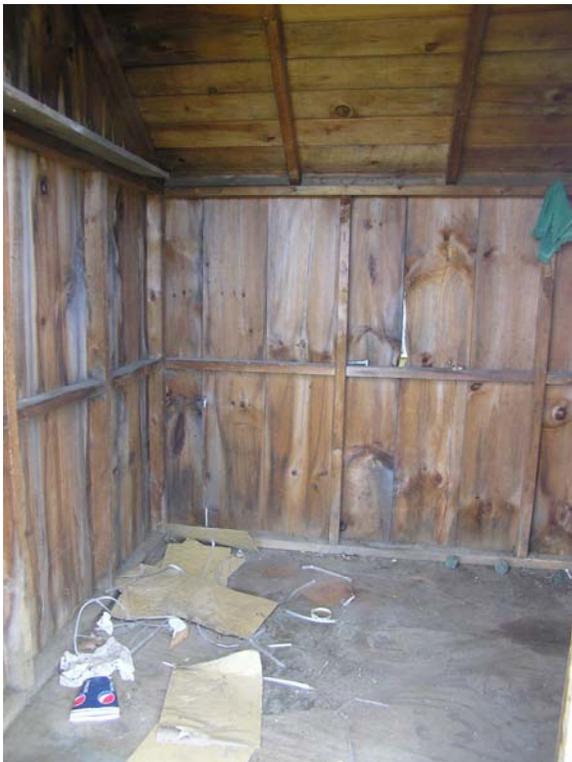
No 12 Buildings 34 and 78, NAS Brunswick December 2, 2010
Structure A5 – Sporting goods storage shed interior
