FINAL RESOURCE CONSERVATION AND RECOVERY ACT PARTIAL CLOSURE REPORT
FOR BUILDING 592 WITH TRANSMITTAL LETTER NAS BRUNSWICK ME
1/26/2011
NAS BRUNSWICK

Subj: Final RCRA Partial Closure Report for Building 592

**RCRA PARTIAL CLOSURE REPORT
for
BUILDING 592 – VETERINARY CLINIC PARCEL
NAVAL AIR STATION BRUNSWICK, MAINE
USEPA IDENTIFICATION NUMBER ME8170022018
JANUARY 2011**

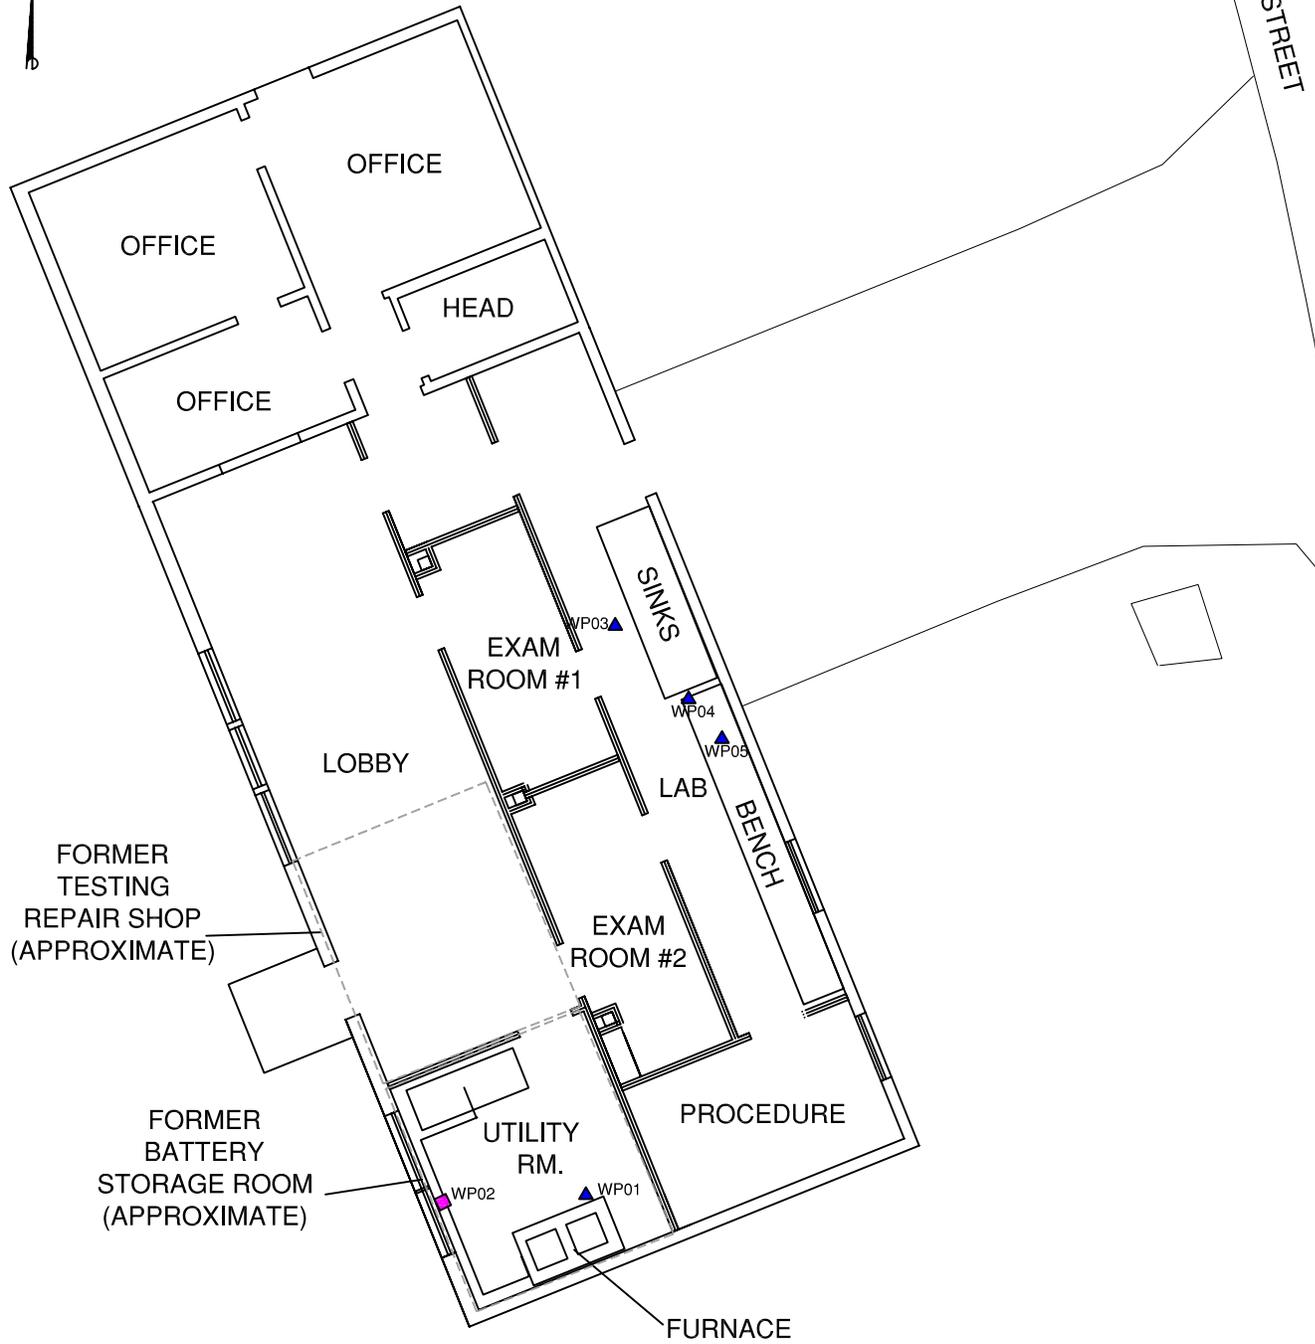
PRE-CLEANING SAMPLE LOCATIONS
BUILDING 592 - VETERINARY CLINIC PARCELRCRA
PARTIAL CLOSURE REPORT
NAVAL AIR STATION BRUNSWICK, MAINE

As shown in Table 2, in the former furnace room, lead exceeded the applicable MEDEP criteria in the wall sample and in the floor-wipe sample and duplicate. All levels of other detected metals were below the screening values. Based on the analytical results, cleaning of Building 592 was required to remove lead-contaminated residue from the furnace room exceeding the associated MEDEP criterion for dust on floors and walls (discussed in Section 6).

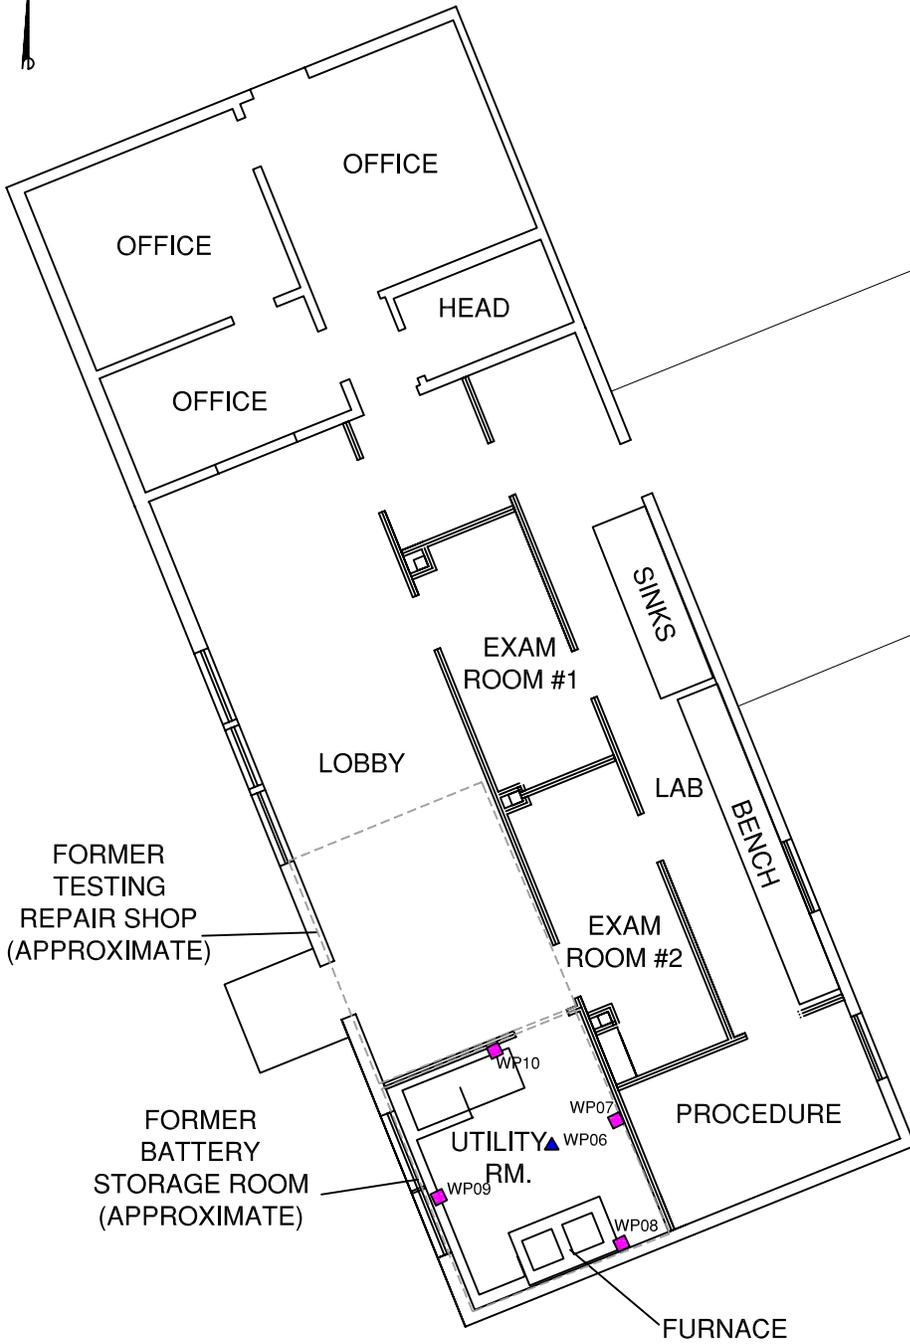
SCALE AS NOTED	
FILE \\NASB_BLDG_592_POST.DWG	
REV 0	DATE 01/21/11
FIGURE NUMBER 3

The lead level ($49 \mu\text{g}/\text{ft}^2$) in the post-cleaning confirmatory wipe sample collected from the furnace room floor just slightly exceeded the associated MEDEP floor criterion of $40 \mu\text{g}/\text{ft}^2$. Lead levels were below the MEDEP criterion for walls in each of the post-cleaning wall-wipe samples, as shown in Table 3. Additional closure action is not warranted at Building 592, since the level of lead in the floor-wipe sample collected after cleaning of the furnace room was only slightly above the MEDEP criterion, and the lead levels in the post-cleaning wall-wipe samples were very low, near the detection limit, when detected.

Post-cleaning, confirmatory floor- and wall-wipe samples were collected from each of the cleaned rooms on January 11, 2011 (Figure 4). Samples were submitted to Katahdin Analytical Services of Scarborough, Maine (Katahdin) for lead analysis. The resulting analytical data underwent limited data validation consisting of blank contamination evaluation and completeness evaluation. The January 11, 2011 wipe sample results are included in Table 3.

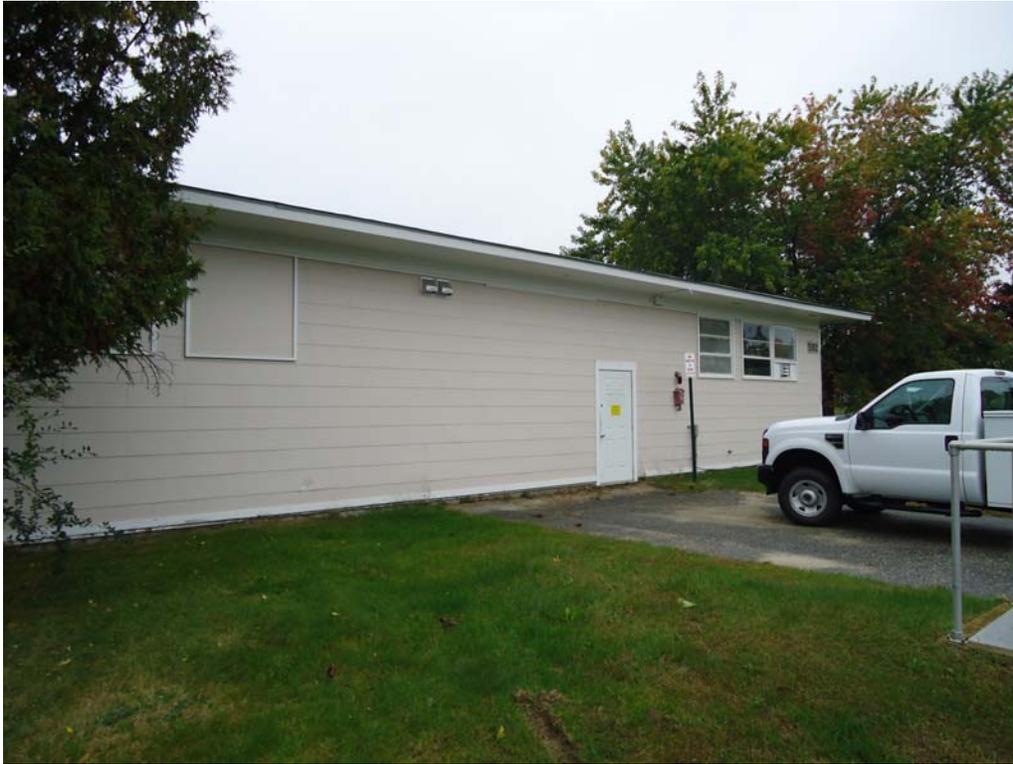
- Two metal access plates were identified on the northeast and the southeast sides of the building, along Pegasus Street, which enabled access to underground telephone or electrical cables.

No. 1 Building 592 – Veterinary Clinic Building, NAS Brunswick September 30, 2010
Building 592 east elevation showing metal access plate in right foreground

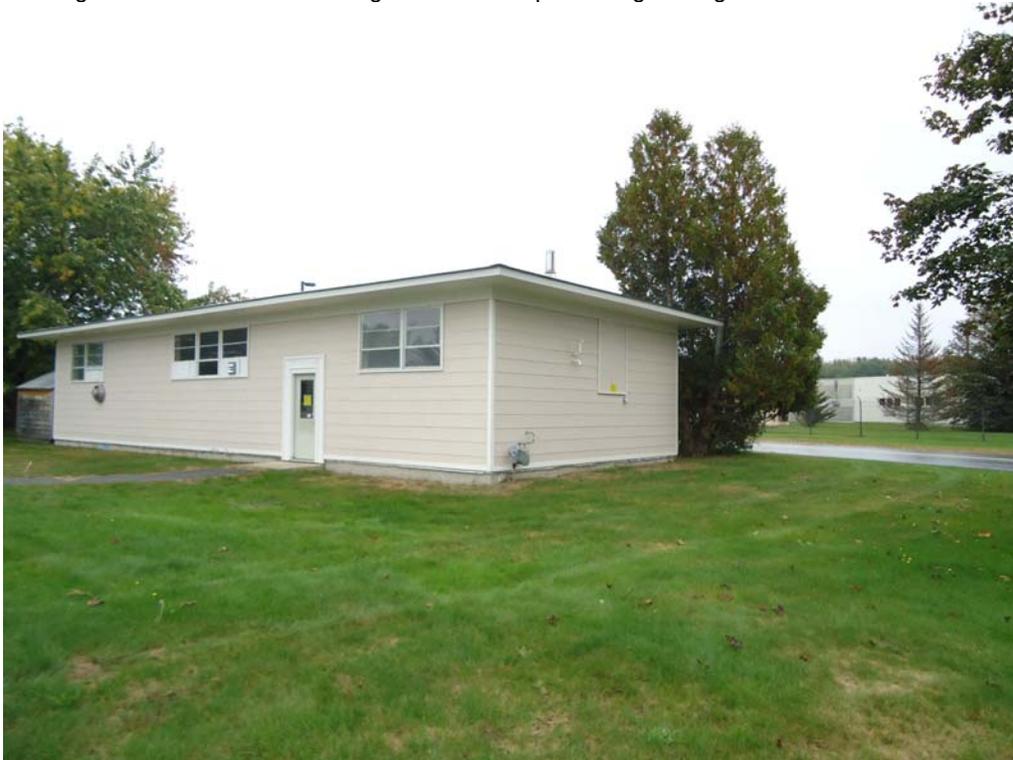
- Structure MMM (Storage Shed), a wooden structure with asphalt shingles, was observed on the north side of Building 592. According to NAS Brunswick Environmental Department personnel, the interior was used to store various landscaping equipment, including lawn mowers.

No. 2 Building 592 – Veterinary Clinic Building, NAS Brunswick September 30, 2010
Veterinary Clinic Building southwest elevation; Structure MMM (Storage Shed) visible in left background

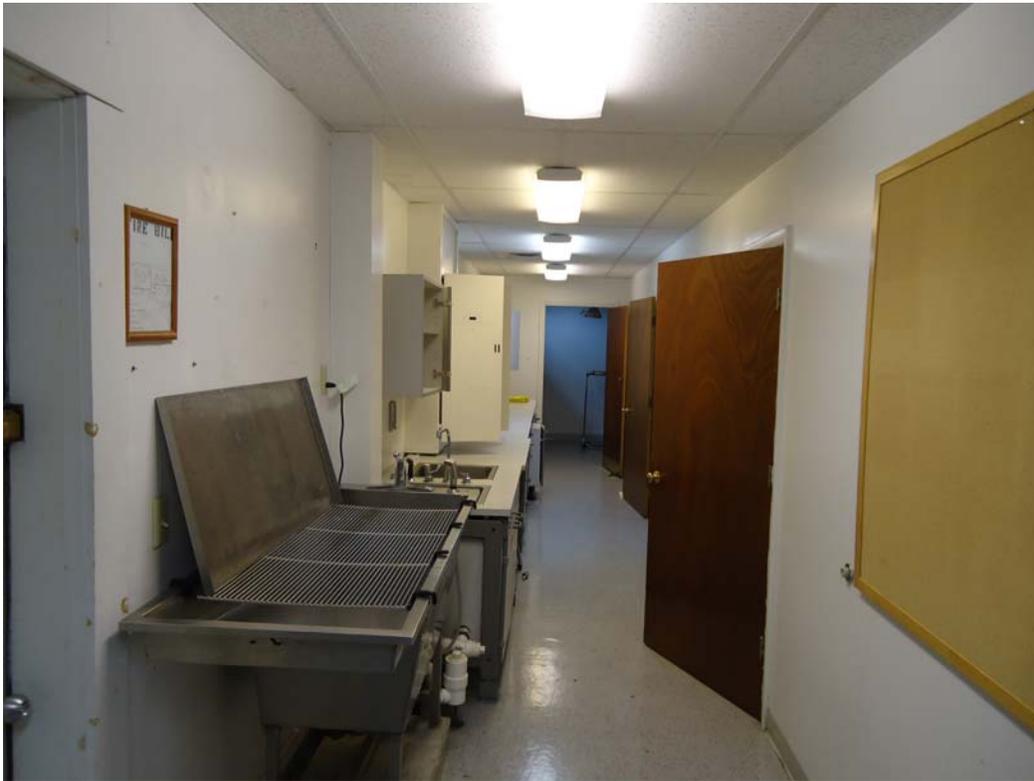
- A bench was observed in the laboratory, which was used to conduct laboratory testing, according to NAS Brunswick Environmental Department personnel.

No. 3 Building 592 – Veterinary Clinic Building, NAS Brunswick September 30, 2010
Veterinary Clinic Building - laboratory area; stainless steel sink in left foreground and work bench in background

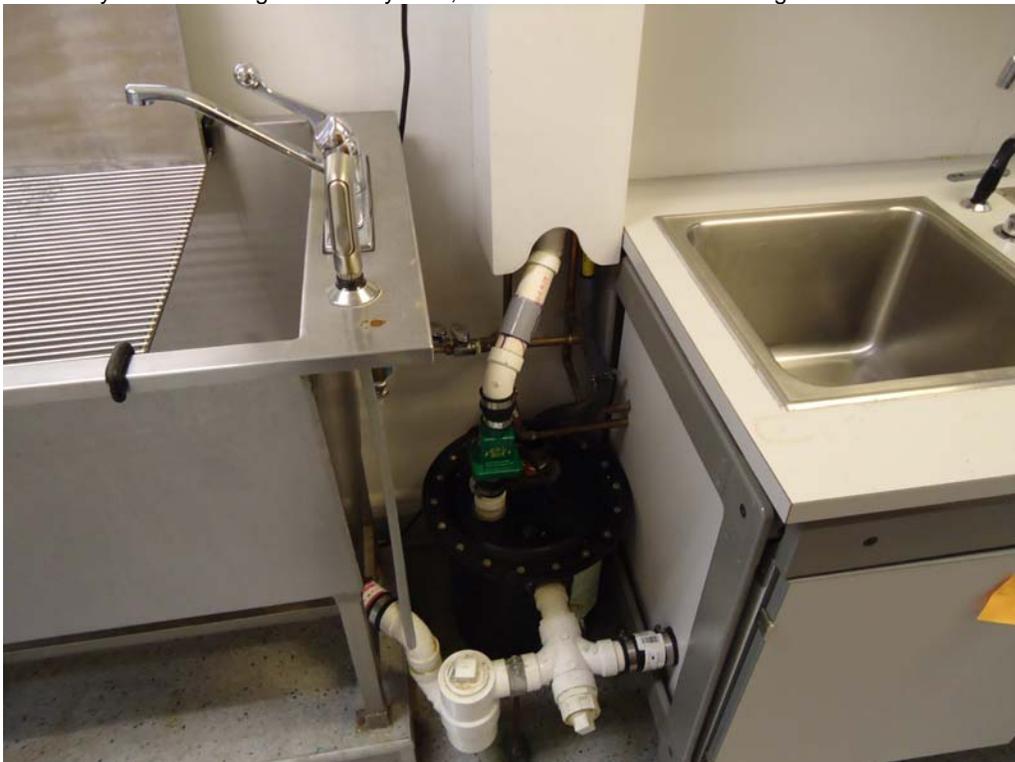
- The interior of Building 592 included a laboratory, exam rooms, restrooms, office space, and a furnace room in the southwest corner.
- A macerator pump, through which the laboratory sink discharged, was observed on the floor adjacent to the sink; the macerator pump grinds waste down to small particle size prior to discharging to the sanitary sewer system.

No. 4 Building 592 – Veterinary Clinic Building, NAS Brunswick September 30, 2010
Veterinary Clinic Building - laboratory area; stainless steel sink at left drains to macerator pump (center)

According to NAS Brunswick Environmental Department personnel, the macerator pump has been temporarily removed and cleaned; the pump will be retained for future use.

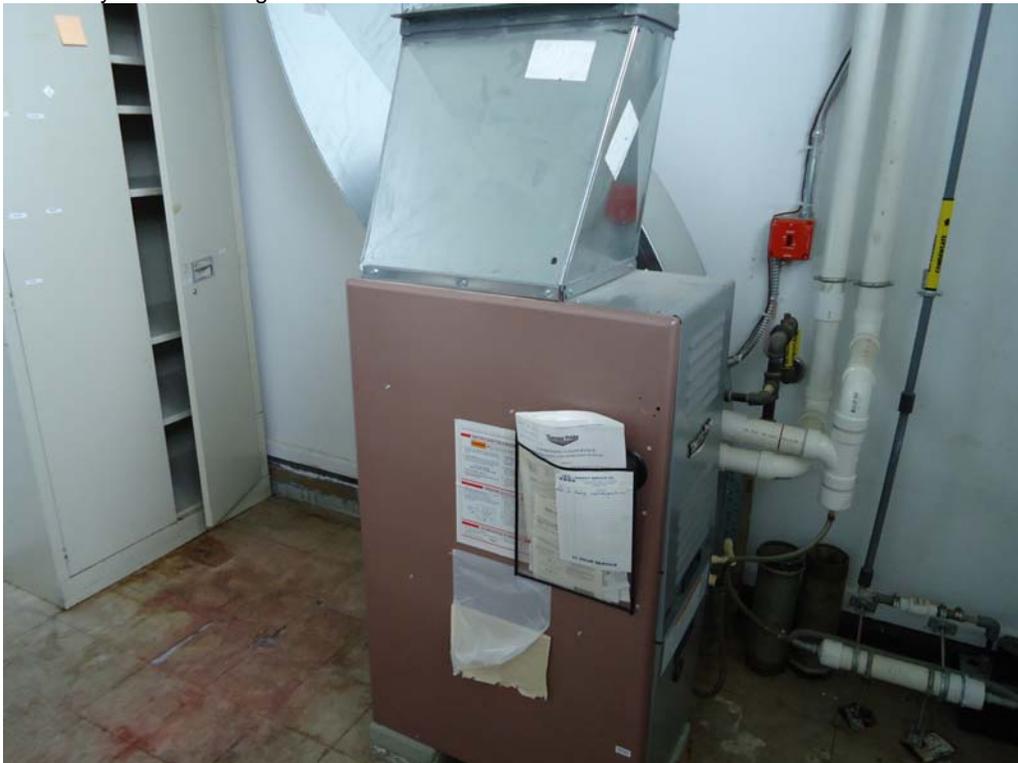
- No signs of a past release (unusual odors, stressed vegetation, etc.) were observed.
- Red staining was observed on the floor of the furnace room.
- No modifications to the structure, which may conceal signs of a past release, were observed.

Based on site visit observations and sampling results, hazardous waste residue was generated at Building 592 in the form of lead-contaminated settled dust in the furnace room. The areas impacted by lead-dust were also addressed by the closure actions described in Section 6.0.

No. 6 Building 592 – Veterinary Clinic Building, NAS Brunswick
Veterinary Clinic Building furnace room; red stains visible on floor

Tetra Tech's cleaning subcontractor (TK&K Services [TK&K]) performed floor- and wall-cleaning activities at Building 592, based on lead criteria exceedances in wipe samples, as discussed in Section 4. On January 11, 2011, cleaning activities were conducted in the former furnace room. The floors were manually swept and then vacuumed with a high-efficiency particulate air (HEPA) vacuum. After sweeping and vacuuming, floors and walls were sprayed with a 2-percent, lead-specific detergent solution, scrubbed, and pressure-washed, using a 5,000-pounds-per-square-inch (psi) steam cleaner. All cleaning wastewater was containerized using a wet-vacuum, placed in a 55-gallon drum, and transferred to the NAS Brunswick hazardous waste department for disposal. Upon completion, the Tetra Tech field representative performed a visual inspection of the cleaned areas.
