FINAL RESOURCE CONSERVATION AND RECOVERY ACT PARTIAL CLOSURE REPORT
FOR BUILDING 19 WITH TRANSMITTAL LETTER NAS BRUNSWICK ME
2/11/2011
NAS BRUNSWICK

RCRA PARTIAL CLOSURE REPORT
for
BUILDING 19 – SEABEE/PUBLIC WORKS SHOPS
NAVAL AIR STATION BRUNSWICK, MAINE
USEPA IDENTIFICATION NUMBER ME8170022018
FEBRUARY 2011

**HWSA INSPECTION FORM
HAZARDOUS WASTE STORAGE AREAS CLOSURE
NAS BRUNSWICK
BRUNSWICK, MAINE
CTO WE22**

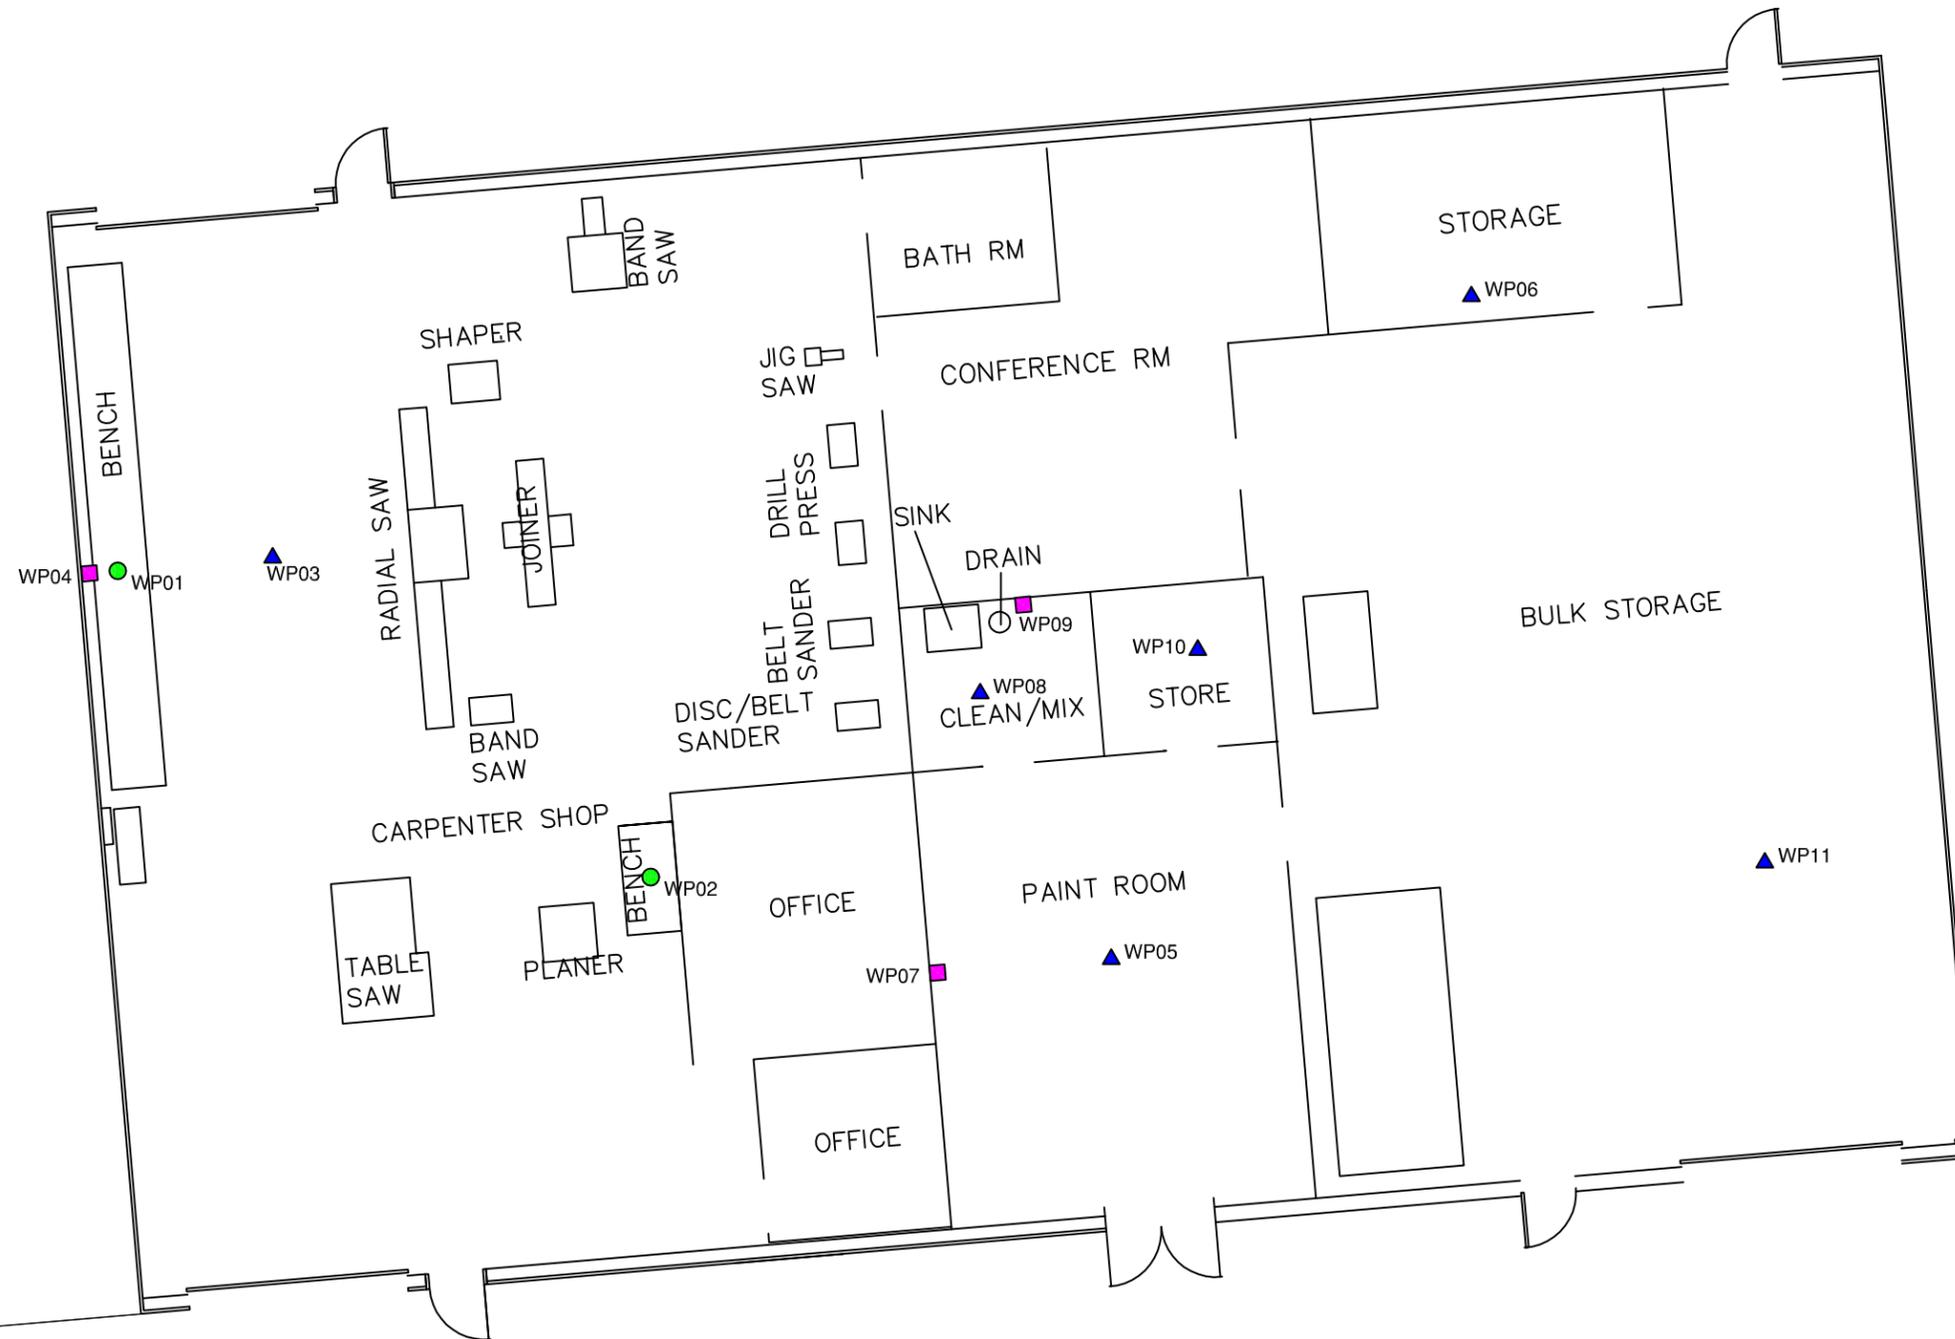
| FIGURE NUMBER FIGURE NO. 3 | REV DATE 0 02/07/11 |

- In the "storage" room (Figure 3), staining was observed on the floor on the eastern side.
- In the "store" room, staining was observed on the northern corner of the floor (on the other side of the "clean/mix" room).

On October 20, 2010, wipe samples were collected from 11 locations in Building 19, including work benches, floors, and walls, as shown on Figure 3. Wipe samples were submitted for RCRA metals and semi-volatile organic compound (SVOC) analysis by Tetra Tech's subcontracted analytical laboratory, Analytics Environmental Laboratory. The resulting analytical data underwent limited data validation consisting of field duplicate evaluation, blank contamination evaluation, and completeness evaluation.

As shown in Table 1, lead was detected in all of the bench surface and floor-wipe samples collected from the carpentry shop, the paint shop, and the bulk storage area. Lead levels in these samples ranged from 42 $\mu\text{g}/\text{ft}^2$ (paint room floor) to 1,500 $\mu\text{g}/\text{ft}^2$ (stained area on the floor of the bulk storage room) and exceeded the MEDEP criterion for floors (40 $\mu\text{g}/\text{ft}^2$). In all wall-wipe samples, lead levels were below the MEDEP criterion for walls. All levels of other detected metals were below the WTC screening values.

Based on the analytical results, cleaning of Building 19 (discussed in Section 6) was required to remove lead-contaminated residue from the carpentry shop, the paint shop, and the bulk storage area, where lead residue was present at levels that exceeded the associated MEDEP criterion for dust on floors. SVOCs including butyl benzyl phthalate, di-n-butyl phthalate, and di-n-octyl phthalate were also detected in wipe samples collected from the paint shop and bulk storage area.

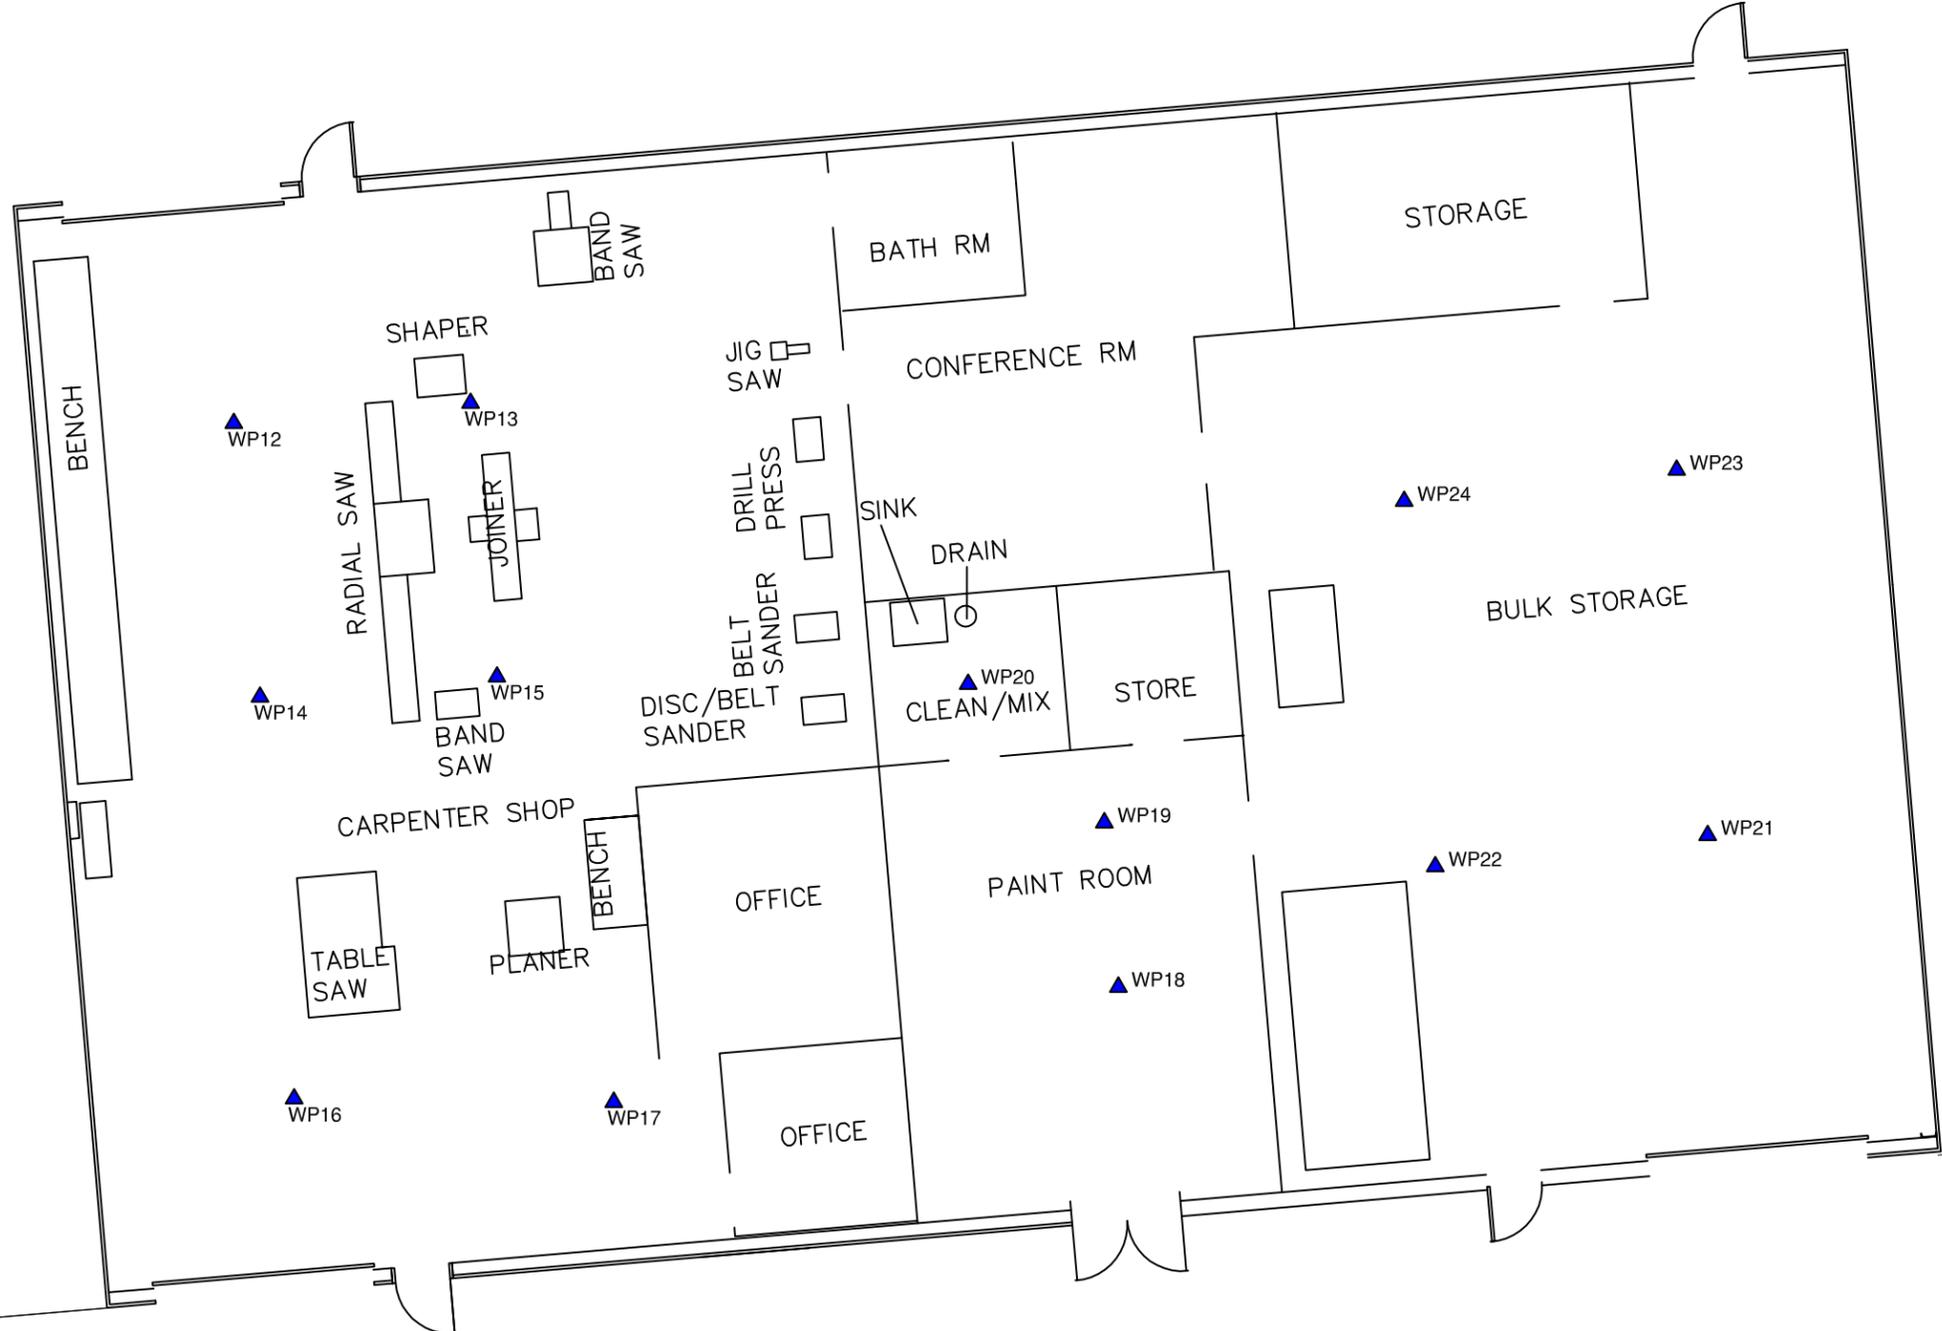
Thirteen (plus two duplicate) post-cleaning, confirmatory floor-wipe samples were collected from the cleaned rooms on January 13, 2011 (Figure 4). Samples were submitted to Tetra Tech's subcontracted analytical laboratory, Katahdin Analytical Services of Scarborough, Maine (Katahdin) for lead analysis. The resulting analytical data underwent limited data validation consisting of blank contamination, field duplicate evaluation, and completeness evaluation. The January 13, 2011 wipe sample results are included in Table 2.

The two post-cleaning confirmatory wipe samples from the "paint room" floor and the sample from the "clean/mix" room floor were below the MEDEP floor criterion.

In the carpentry shop, post-cleaning confirmatory wipe samples were collected from six locations on the carpentry shop floor (plus one duplicate sample). With the exception of one location (B19-WP13), the post-cleaning lead levels did not exceed the associated MEDEP floor criterion of 40 $\mu\text{g}/\text{ft}^2$. At B19-WP13, the lead level in the floor-wipe sample and its duplicate sample exceeded the criterion, at 64.1 and 52 $\mu\text{g}/\text{ft}^2$. However, the average lead level for all post-cleaning samples collected from the carpentry shop is 26.9 $\mu\text{g}/\text{ft}^2$, which is below the associated MEDEP floor criterion of 40 $\mu\text{g}/\text{ft}^2$.

In the bulk storage room, post-cleaning confirmatory wipe samples were collected from four locations on the "bulk storage" room floor (plus one duplicate sample). With the exception of two locations (B19-WP21 and B19-WP22), the post-cleaning lead levels did not exceed the associated MEDEP floor criterion of 40 $\mu\text{g}/\text{ft}^2$. At B19-WP21 the floor-wipe sample lead level of 40.9 $\mu\text{g}/\text{ft}^2$ slightly exceeded the criterion, while at B19-WP22, the floor-wipe sample lead level of 62.2 $\mu\text{g}/\text{ft}^2$ exceeded the criterion, but its duplicate sample result (22.3 $\mu\text{g}/\text{ft}^2$) did not exceed the criterion. The average lead level for all post-cleaning samples collected from the bulk storage room floor was 32.9 $\mu\text{g}/\text{ft}^2$, below the associated MEDEP floor criterion of 40 $\mu\text{g}/\text{ft}^2$.

Since the average lead levels in the carpentry shop and bulk storage room do not exceed the MEDEP floor criterion, additional closure action is not warranted at Building 19.

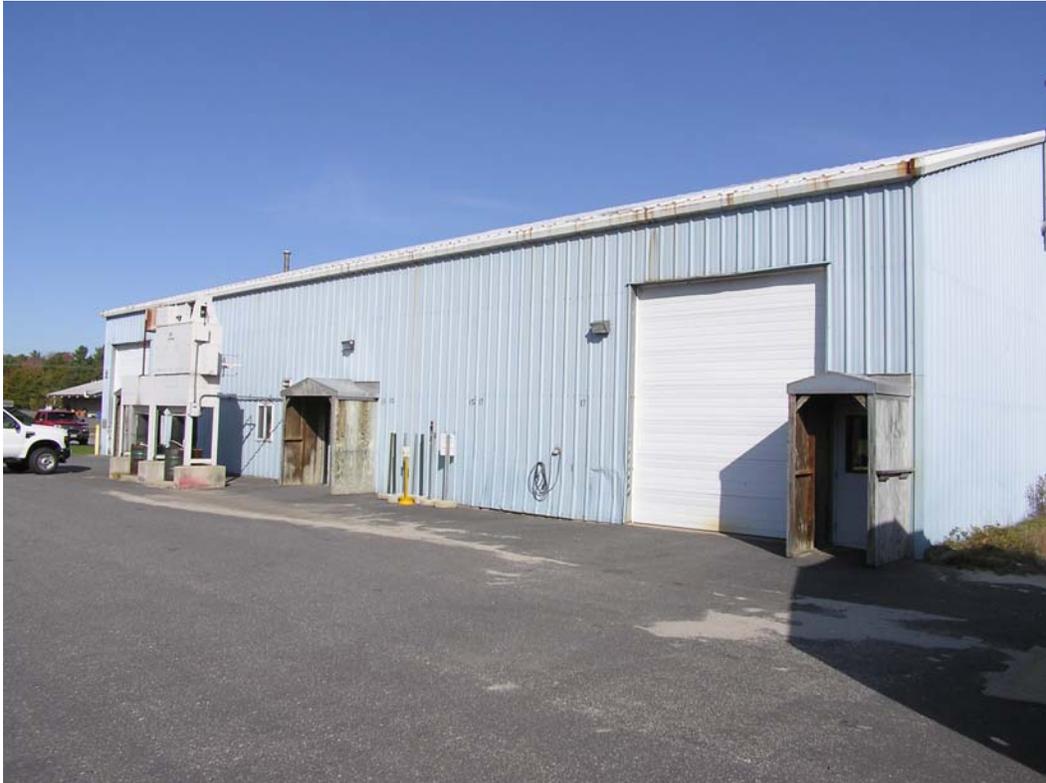
No. 1 Building 19 – SeaBee/Public Works Shops, NAS Brunswick
SeaBee/Public Works Shops southwest elevation

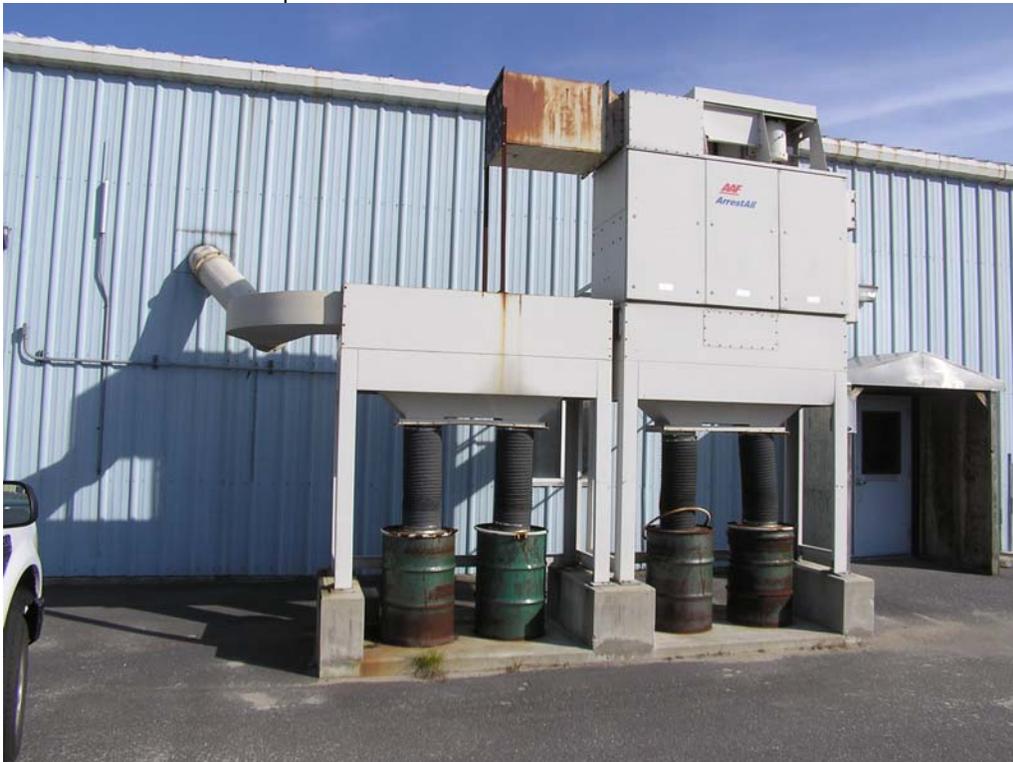
- A sawdust collection system was installed in the carpentry shop. The collection system was located on the western exterior of the building and consisted of cyclones with four 55-gallon drums to capture the dust.

No. 2 Building 19 – SeaBee/Public Works Shops, NAS Brunswick
SeaBee/Public Works Shops elevation showing sawdust vacuum system

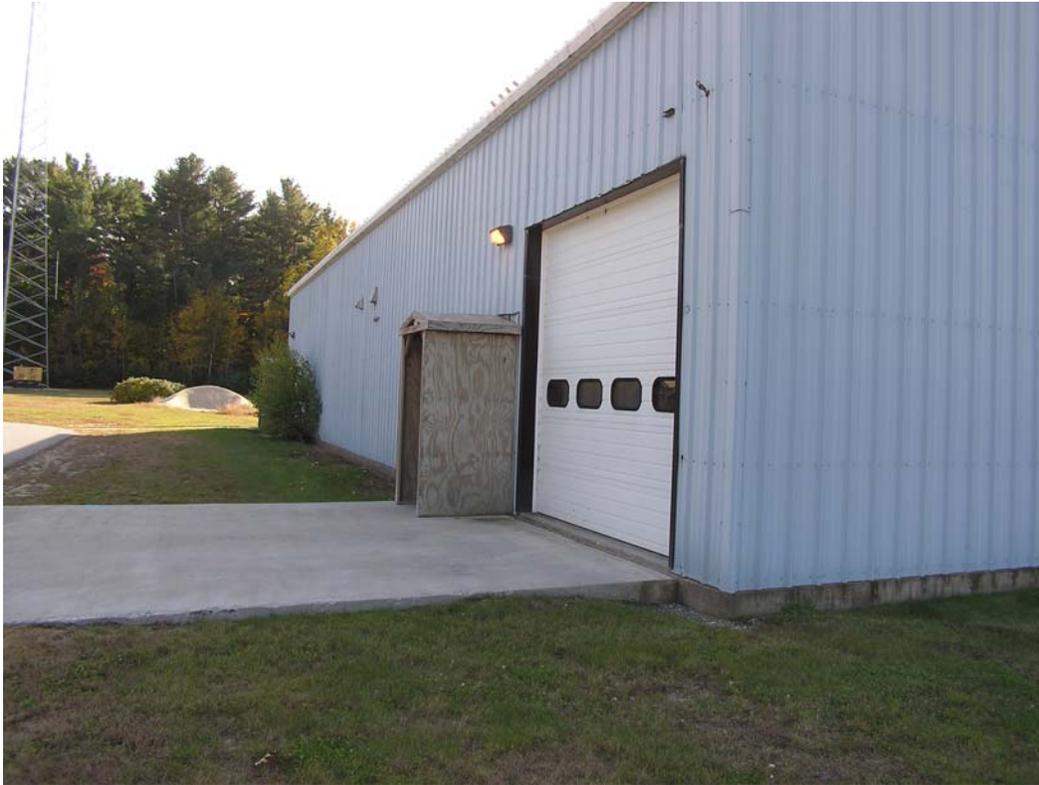
No. 3 Building 19 – SeaBee/Public Works Shops, NAS Brunswick
SeaBee/Public Works Shops northeast elevation

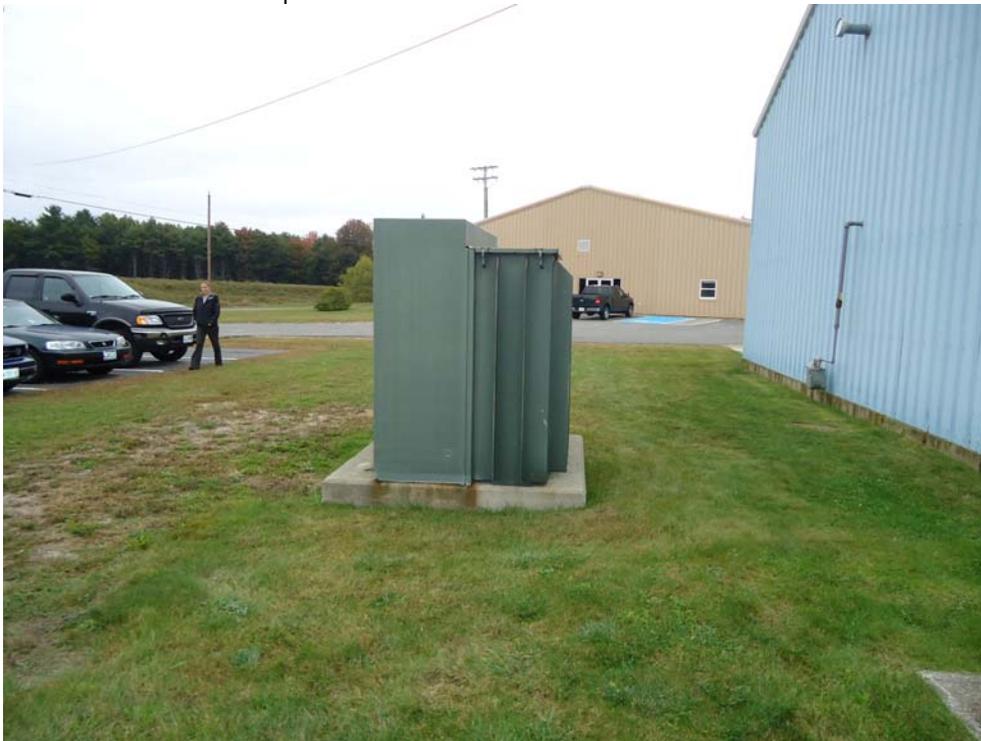
- One concrete-pad-mounted transformer was identified on the northern side of the building. No staining or other evidence of a release from this transformer was observed and it appeared to be in relatively good condition.

No. 4 Building 19 – SeaBee/Public Works Shops, NAS Brunswick
Transformer located on northern side of Building 19; Building 53 (Public Works Administration) in background

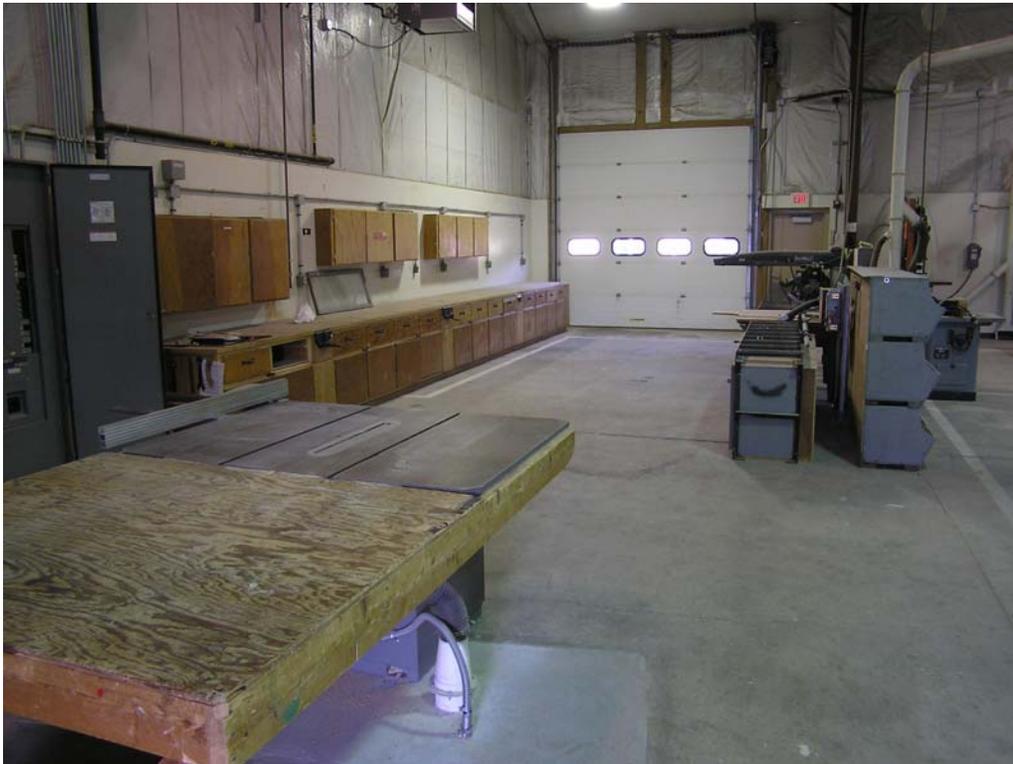
No. 5 Building 19 – SeaBee/Public Works Shops, NAS Brunswick October 20, 2010
North side of carpenter shop with table saw in left foreground; large workbench is visible along the northern side of the room adjacent to the overhead door

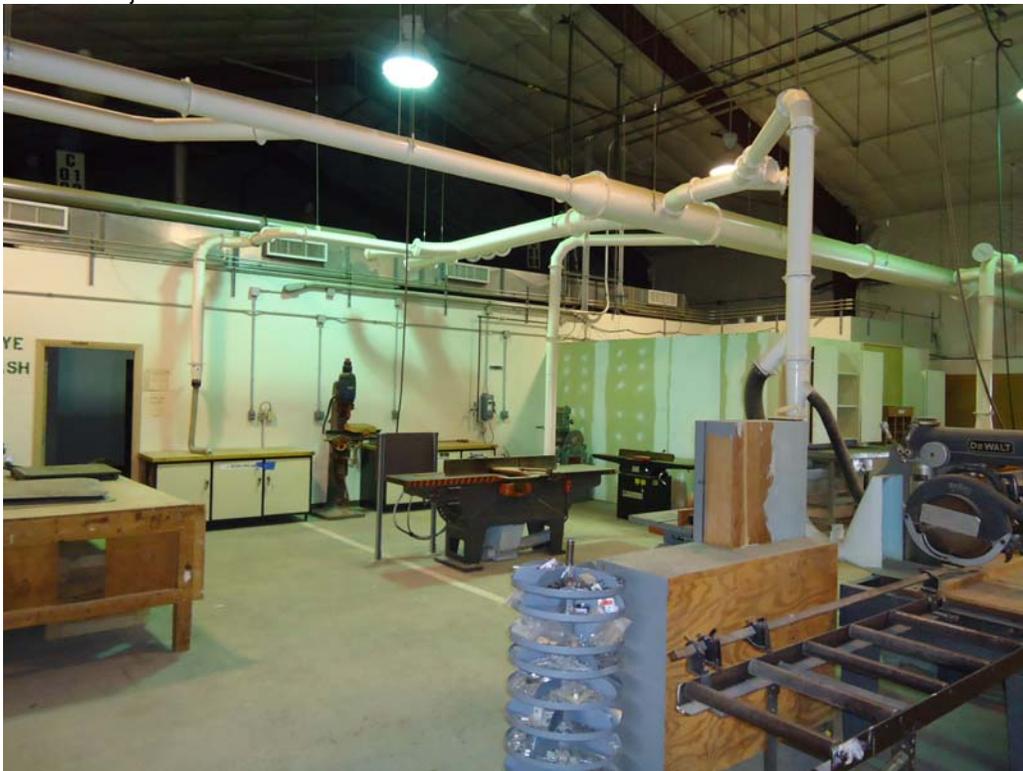
No. 6 Building 19 – SeaBee/Public Works Shops, NAS Brunswick October 20, 2010
Carpenter shop looking west with overhead sawdust collection system piping

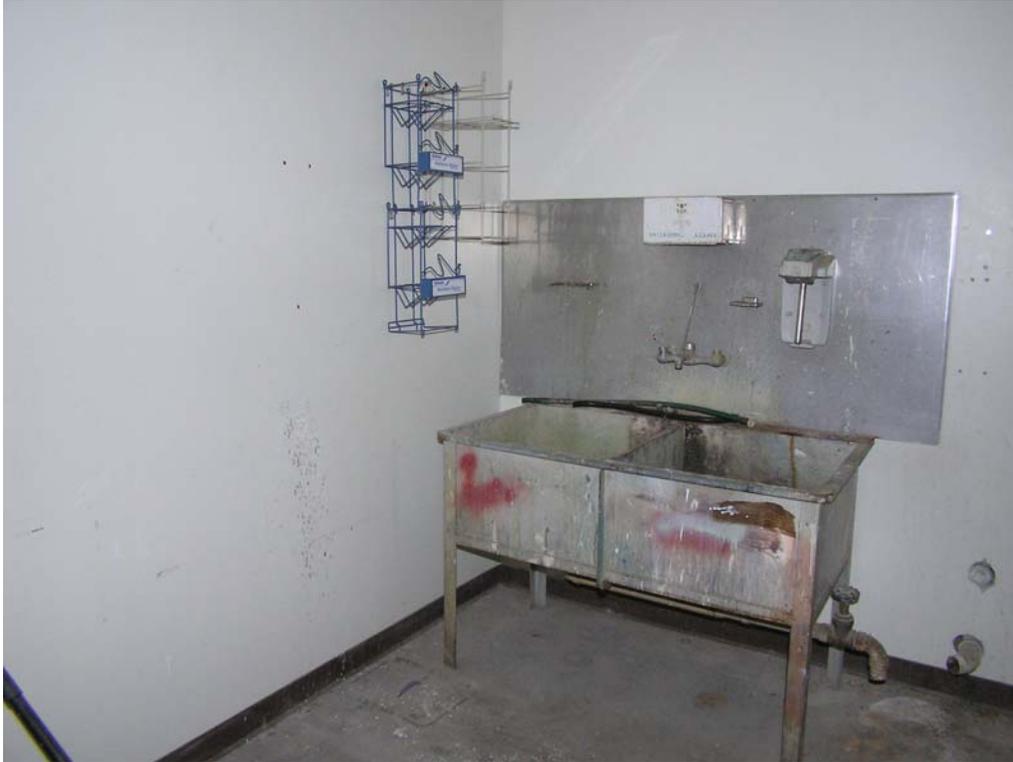
- Paint splatters and paint waste were observed in the sink of the clean/mix room. NAS Brunswick plans to remove and dispose of this sink in the near future.

- Paint splatters and paint waste were observed in the sink of the clean mix room and the interceptor trap located adjacent to the sink.
- No modifications to the structure, which may conceal signs of a past release, were observed.

No. 7 Building 19 – SeaBee/Public Works Shops, NAS Brunswick
Clean mix room sink after trap removal

- A former interceptor trap for the sink was removed and properly disposed of by NAS Brunswick.
- No modifications to the structure, which may conceal signs of a past release, were observed.

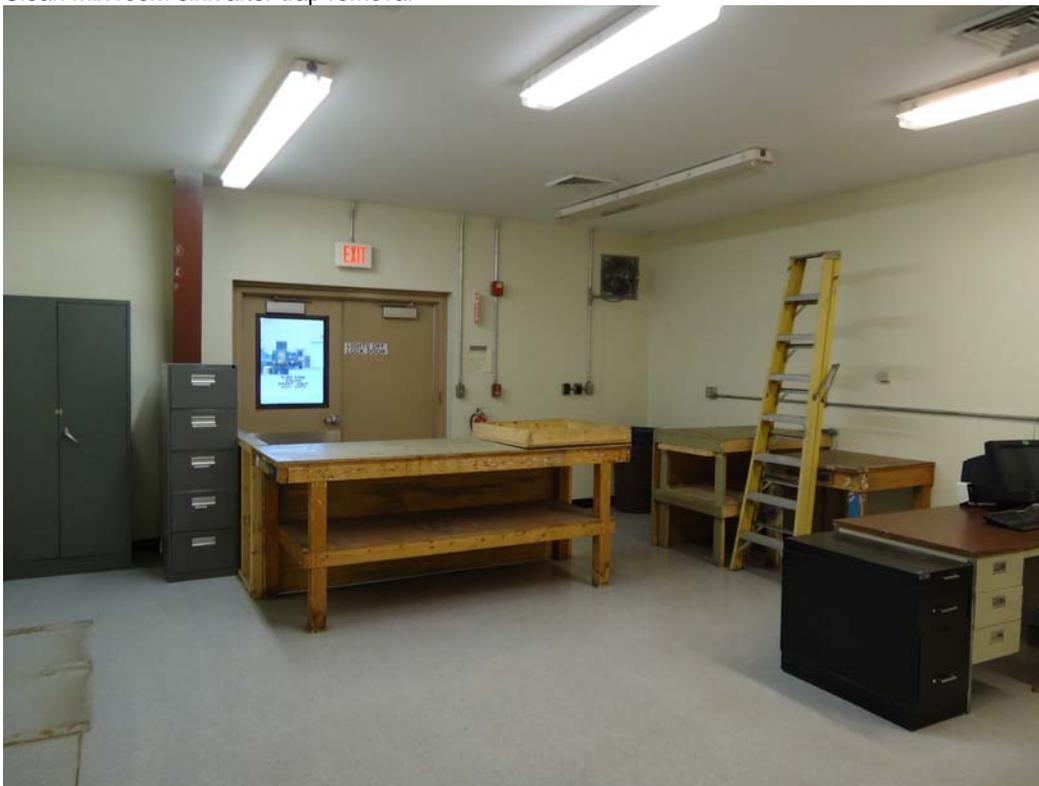
No. 8 Building 19 – SeaBee/Public Works Shops, NAS Brunswick
Paint room looking west; clean mix room behind the photo view

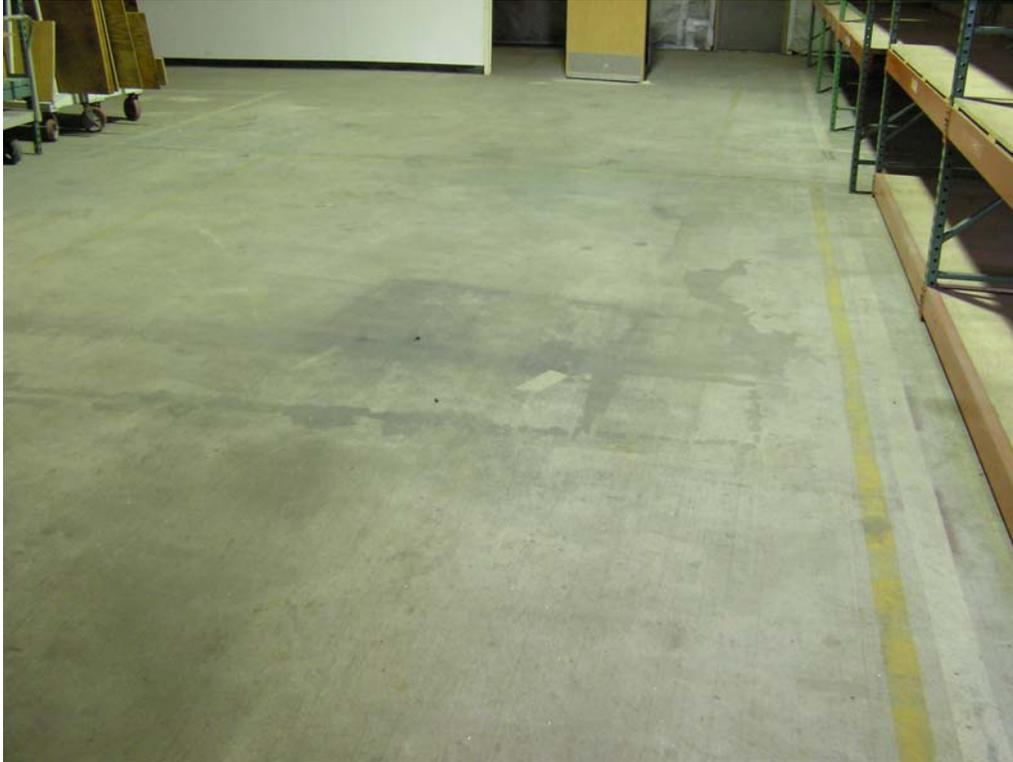
No. 9 Building 19 – SeaBee/Public Works Shops, NAS Brunswick
Bulk storage area; storage shelves located along right of frame

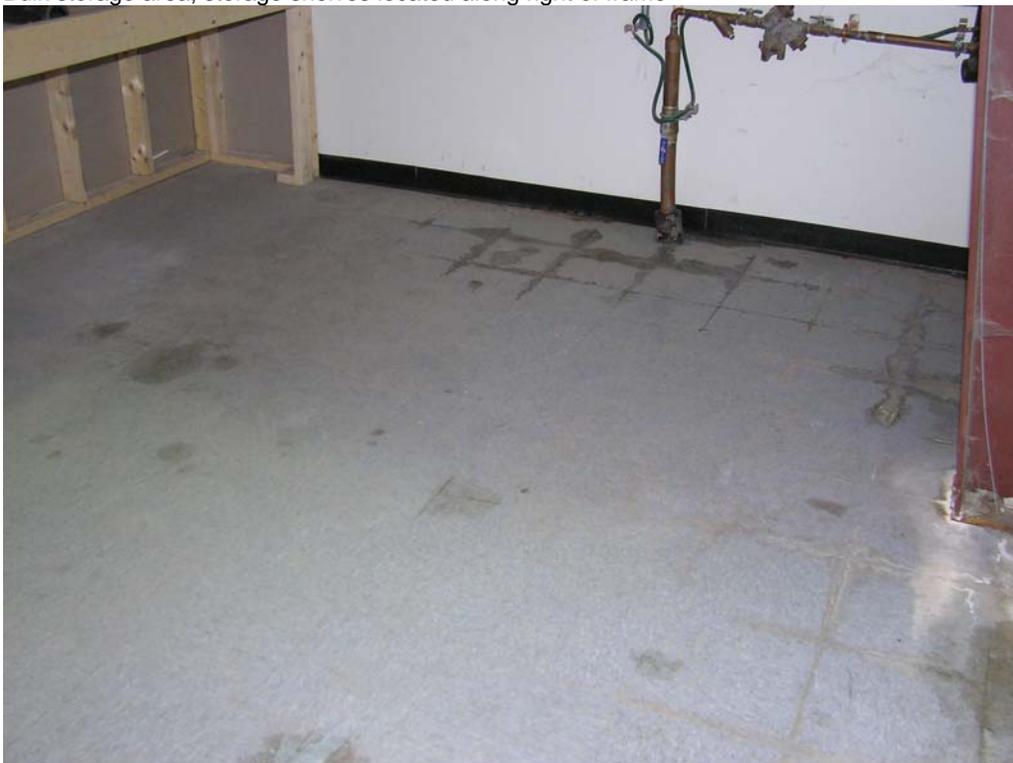
- Staining was observed on the floor of the "storage room" on the eastern side.
- Staining was observed on the floor of the "store" room in the northern corner on the other side of the clean mix room.

No. 10 Building 19 – SeaBee/Public Works Shops, NAS Brunswick
Storage room northern corner showing floor stains in the foreground
