FINAL RESOURCE CONSERVATION AND RECOVERY ACT PARTIAL CLOSURE REPORT
FOR BUILDING 404 WITH TRANSMITTAL LETTER NAS BRUNSWICK ME
3/14/2011
NAS BRUNSWICK

**RCRA PARTIAL CLOSURE REPORT
for
BUILDING 404 – NMCB-27/STORAGE
NAVAL AIR STATION BRUNSWICK, MAINE
USEPA IDENTIFICATION NUMBER ME8170022018
FEBRUARY 2011**

**HWSA INSPECTION REPORT
HAZARDOUS WASTE STORAGE AREAS CLOSURE
NAS BRUNSWICK
BRUNSWICK, MAINE
CTO WE22**

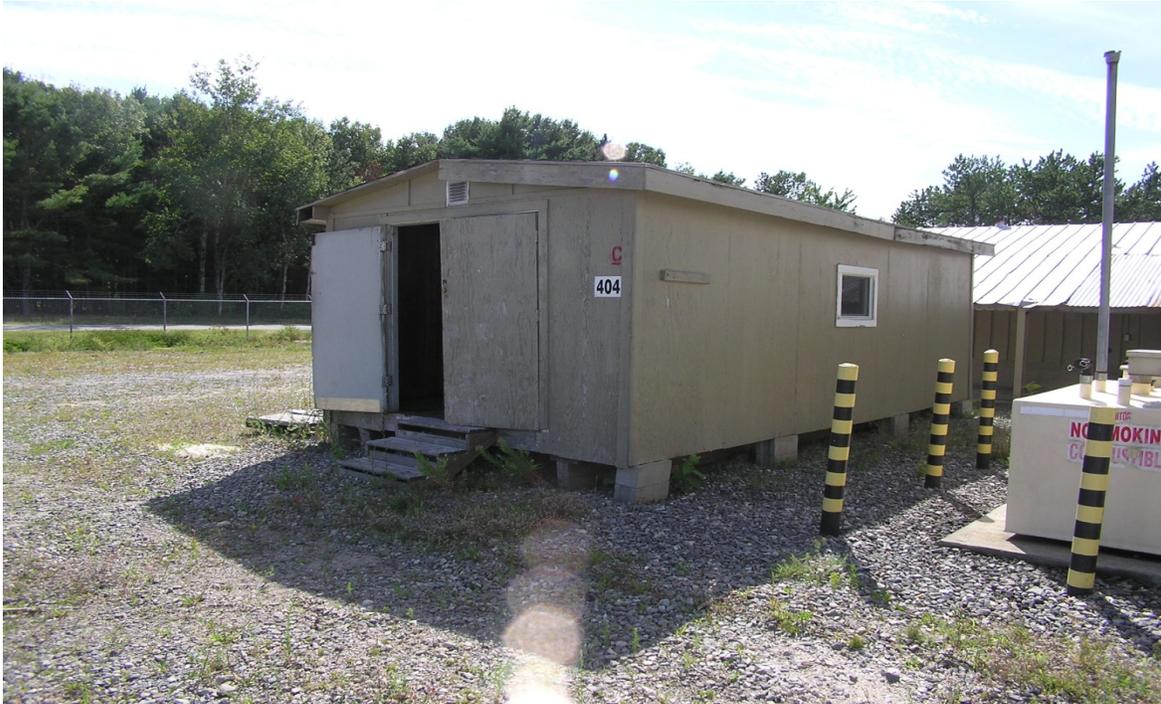
No. 1 Building 404 – Storage Building, NAS Brunswick August 12, 2010
Building 404 northeast elevation, with Building 635 (NMCB-27 Vehicle Maintenance Building) in background, and
250-gallon waste oil AST on right-hand side of photo

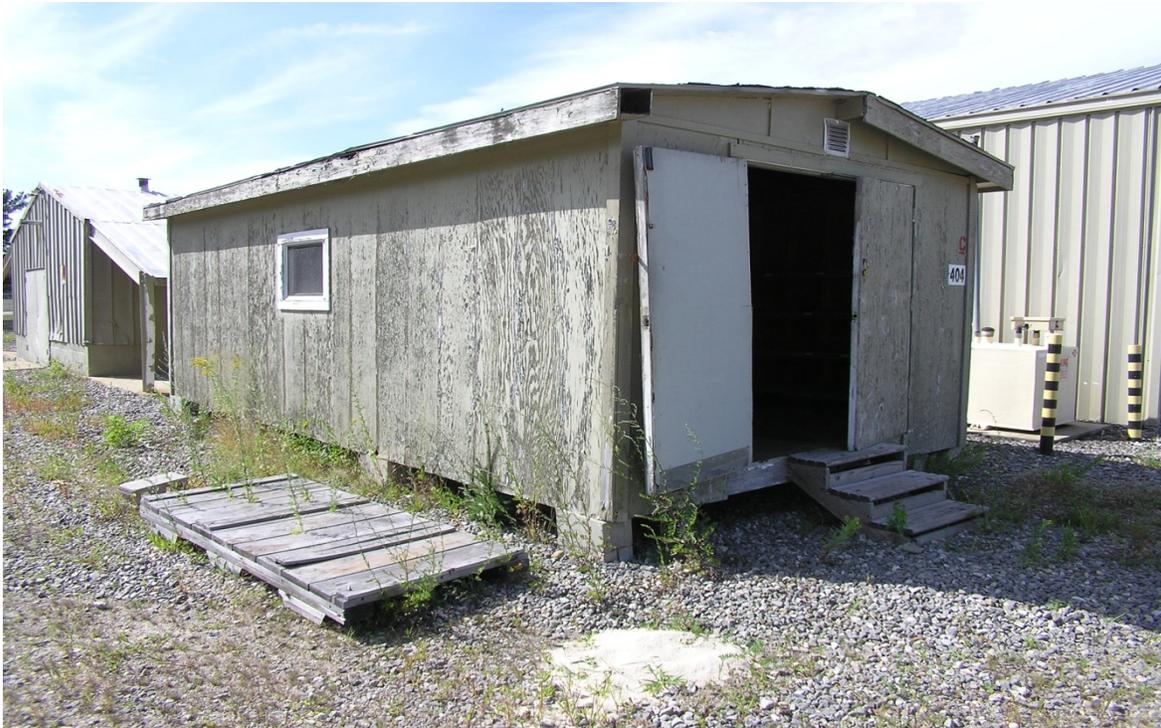
Surface coatings on the west and north exterior walls appeared to be in good condition, with no chipping or peeling of paint observed. However, the paint on the east and south exterior walls was flaking, and samples will be collected for total RCRA8 metals and PCBs. There is an insufficient quantity of flaking paint available for collection/analysis of TCLP Metals.

No. 2 Building 404 – Storage Building, NAS Brunswick August 12, 2010
Building 404 southeast elevation, with Building 635 and the waste oil AST in the background

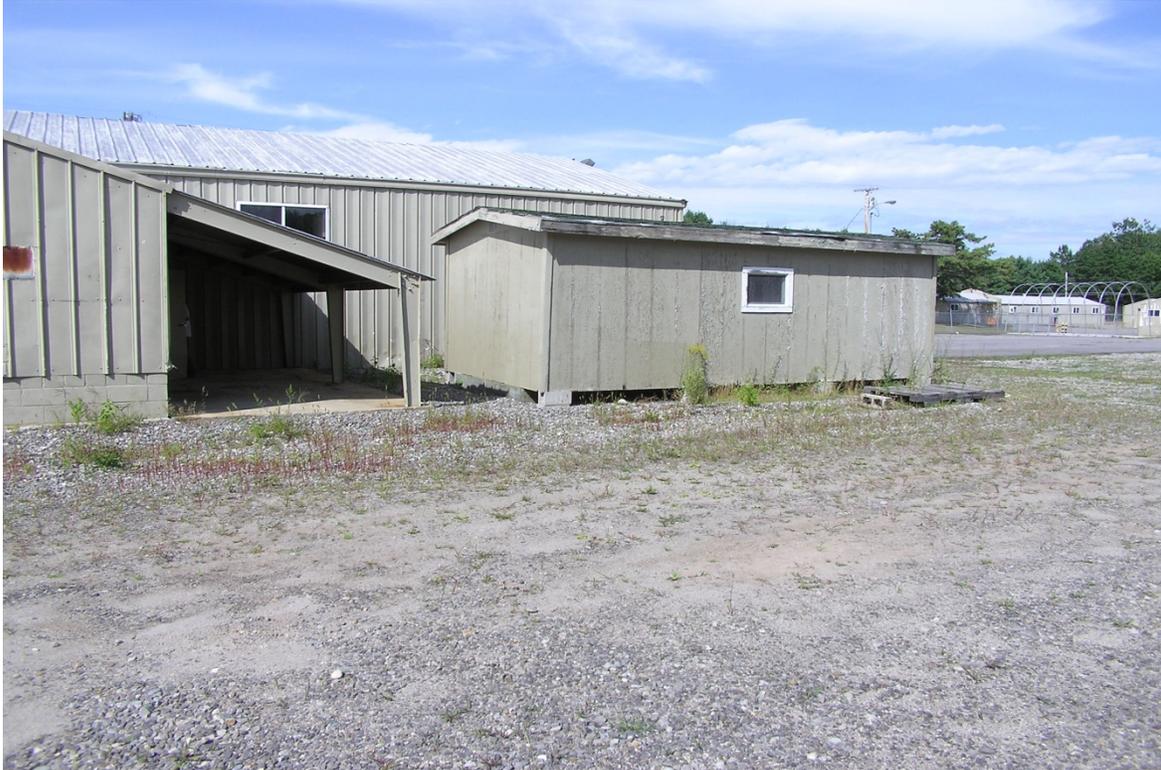
No. 3 Building 404 – Storage Building, NAS Brunswick August 12, 2010
Building 404 southwest elevation, with Building 635 in the background and left-hand side of photo

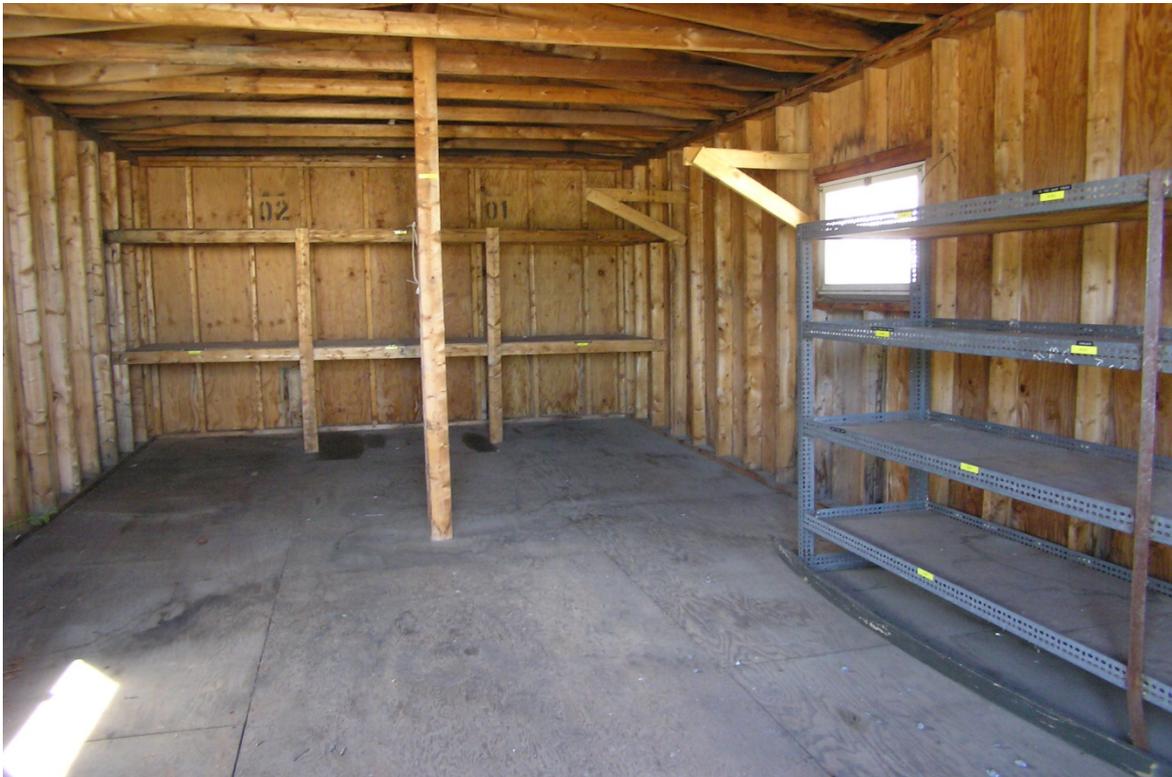
No. 4 Building 404 – Storage Building, NAS Brunswick August 12, 2010
Interior of Building 404, with staining attributable to water seepage present on the floor
