FINAL RESOURCE CONSERVATION AND RECOVERY ACT PARTIAL CLOSURE REPORT
FOR BUILDING 29 WITH TRANSMITTAL LETTER NAS BRUNSWICK ME
3/31/2011
NAS BRUNSWICK

Subj: Final RCRA Partial Closure Report for Building 29

RCRA PARTIAL CLOSURE REPORT
for
BUILDING 29 – AUTO HOBBY SHOP
NAVAL AIR STATION BRUNSWICK, MAINE
USEPA IDENTIFICATION NUMBER ME8170022018
MARCH 2011

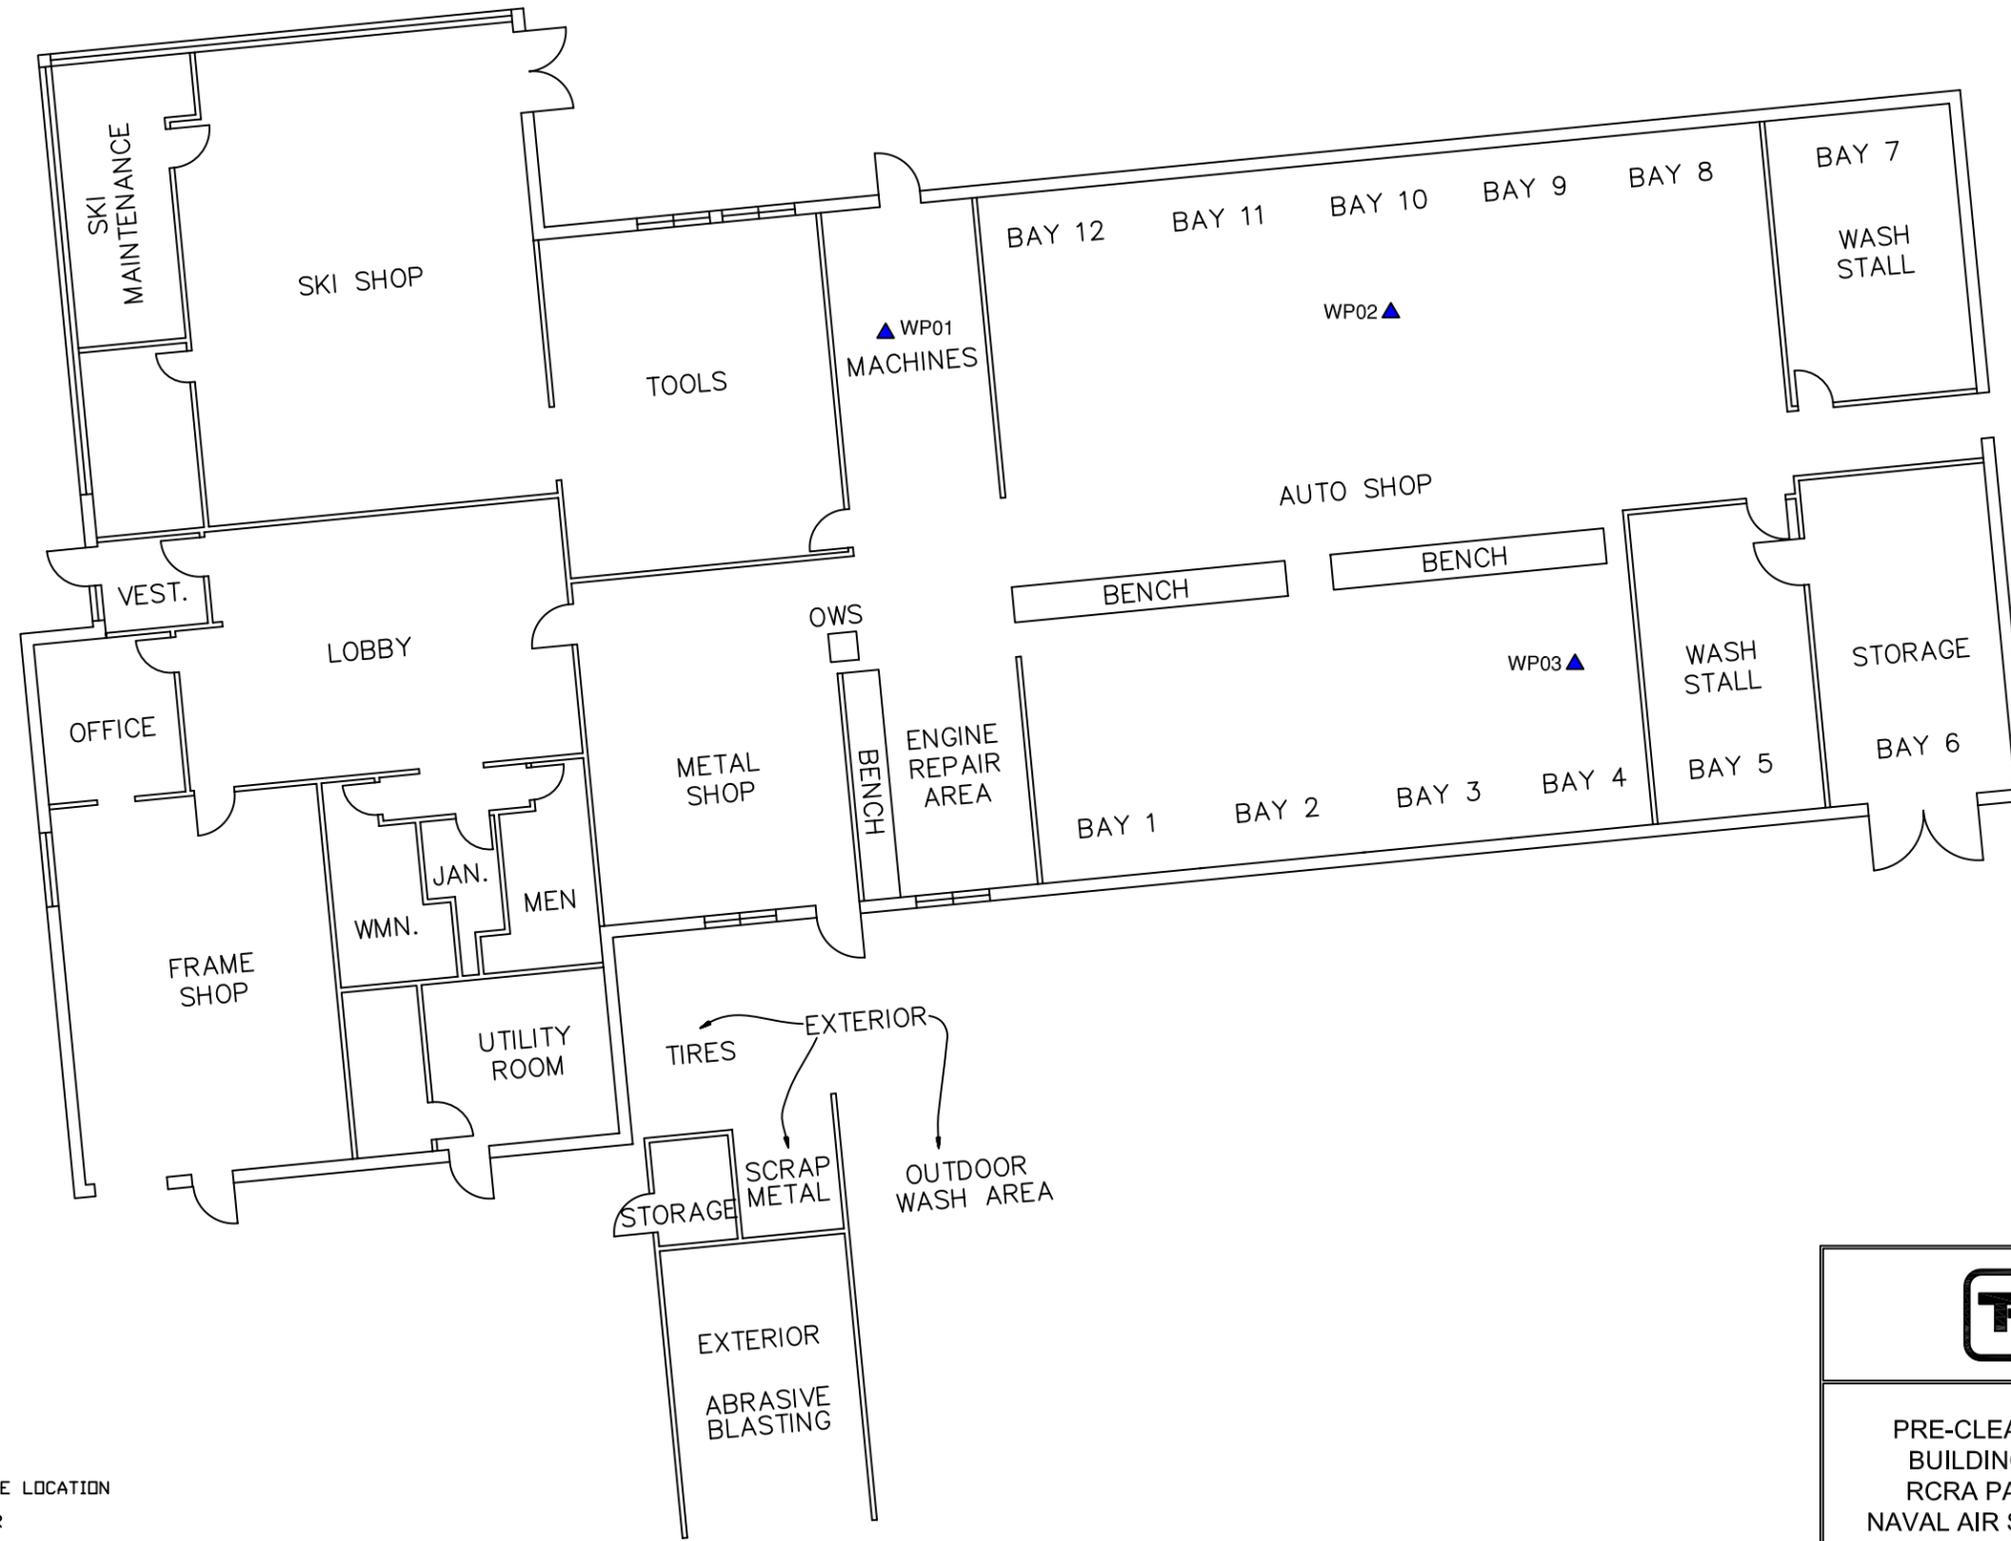
FIGURE NUMBER
 FIGURE NO. 3

On January 24, 2011, three pre-cleaning wipe samples from floors were collected from 3 locations in Building 29, including machine bay, repair bays 4 and 10, as shown on Figure 3. Wipe samples were collected with cotton gauze saturated with deionized water for RCRA metals analysis. A 10-centimeter (cm) by 10-cm sampling area was wiped with the cotton gauze while applying moderate pressure. Floor wipe samples were submitted for RCRA metals analysis, by

As shown in Table 2, lead exceeded the MEDEP criterion for floors ($40 \mu\text{g}/\text{ft}^2$) in all floor-wipe samples, ranging from $88 \mu\text{g}/\text{ft}^2$ (repair bay 10) to $140 \mu\text{g}/\text{ft}^2$ (machines bay). All levels of other detected metals were below the WTC screening values.

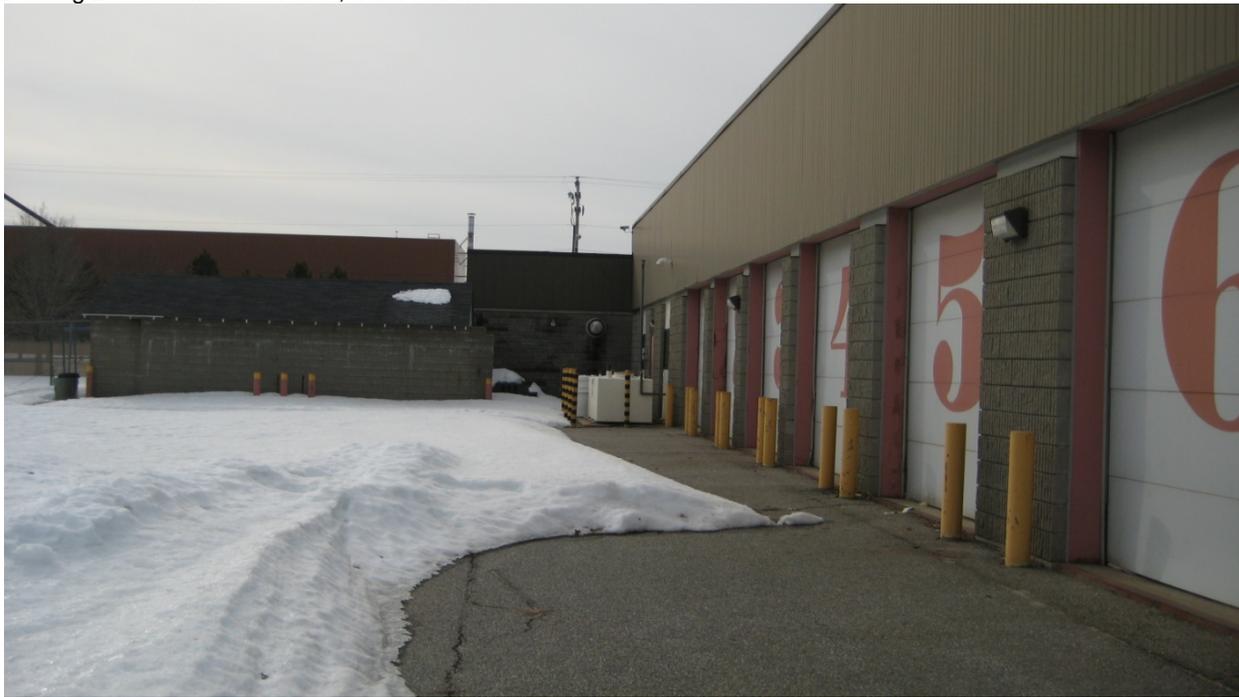
No. 2 Building 29 – Auto Hobby Shop, NAS Brunswick March 9, 2011
Building 29 south elevation and abrasive blasting shed east elevation, with 500-gallon waste oil AST

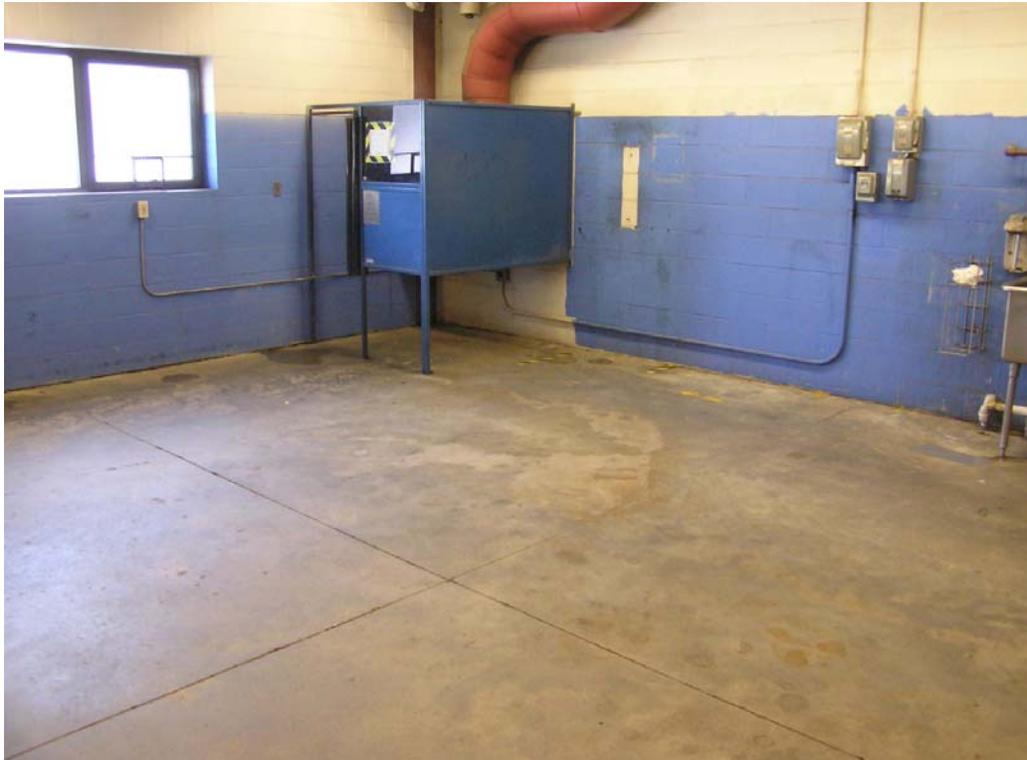
- No structural modifications, which could conceal signs of a past release, were observed.
- A vented, bench welding area was located in metal shop. Staining was observed on the floor of metal shop.

No. 3 Building 29 – Auto Hobby Shop, NAS Brunswick
Metal shop with welding booth area after cleaning

Tetra Tech's cleaning subcontractor (TK&K Services [TK&K]) performed floor- and wall- cleaning activities at Building 29 based on the site visit observations and records research findings, as discussed in Section 4. On January 21, 2011, cleaning activities were conducted in Building 29 including the repair bays, metal shop, engine repair area, machine bay and three ski shop rooms. The floors were manually swept and then vacuumed with a high-efficiency particulate air (HEPA) vacuum. After sweeping and vacuuming, the floor drains were covered and sealed (to prevent cleaning fluid from entering them). Floors and walls were then sprayed with a 2-percent, lead-specific detergent solution, scrubbed, and pressure-washed, using a 5,000-pounds-per-square-inch (psi) steam cleaner. All cleaning wastewater was containerized using a wet-vacuum, placed in a 55-gallon drum, and transferred to the NAS Brunswick hazardous waste department for

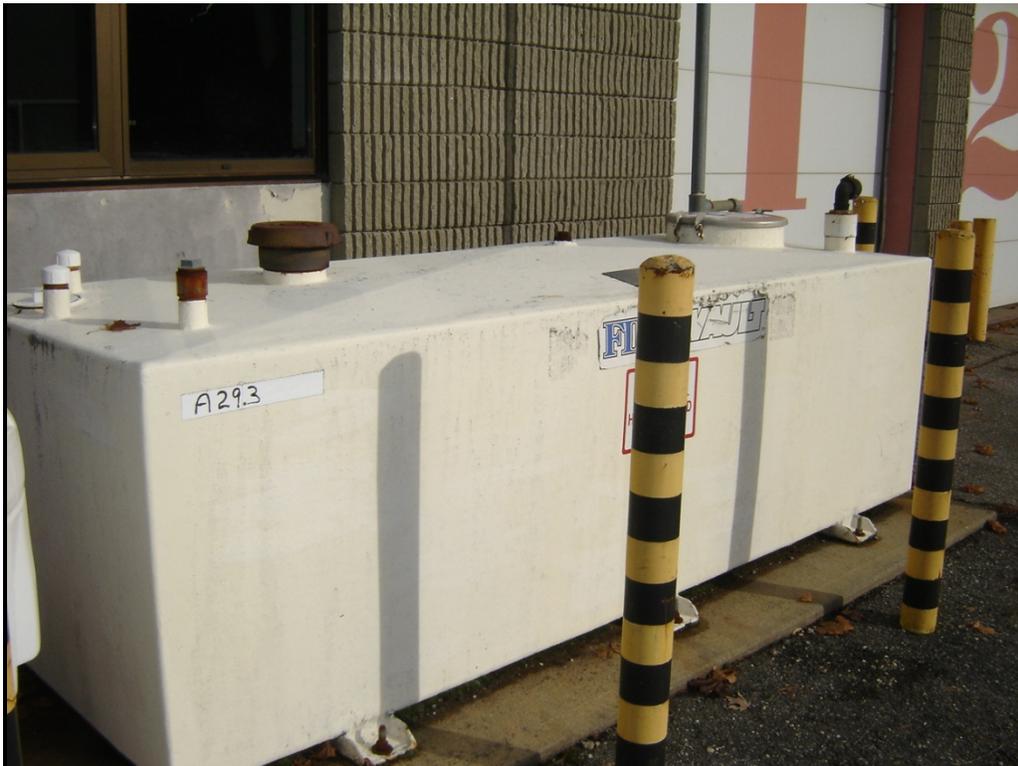
- A 500-gallon, concrete-vaulted AST (A29.3) was located south of the Building 29. The tank is labeled "used oil, aircraft fuel, hydraulic fluid, engine oil", as observed on March 9, 2011.

No. 5 Building 29 – Auto Hobby Shop, NAS Brunswick November 10, 2010
500-gallon concrete-vaulted waste oil tank located south of Building 29

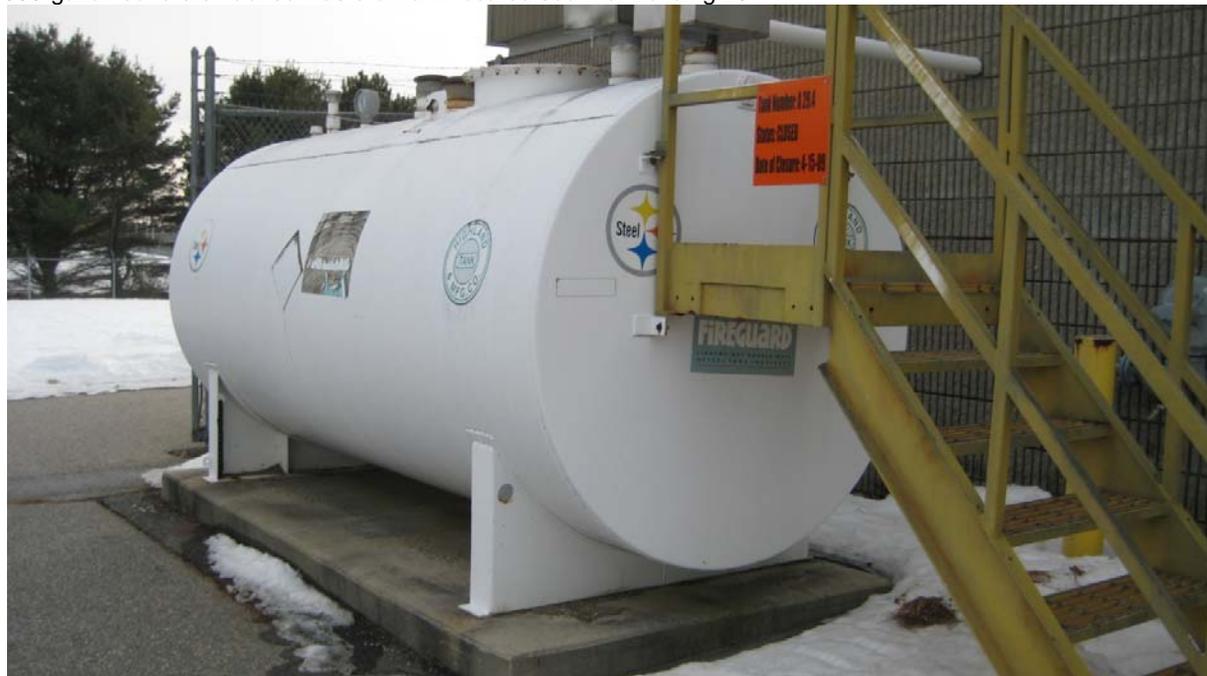
- A 2,000-gallon AST (A29.4) was installed on the eastern side of the building in 1999. This fuel oil tank is double-walled with double-walled piping and was closed in April 2009. The tank appeared to be in good condition and no evidence of a past leak from this AST was observed.

No. 6 Building 29 – Auto Hobby Shop, NAS Brunswick March 9, 2011
Closed AST (2,000gallon tank for No.1 heating oil), east of Building 29

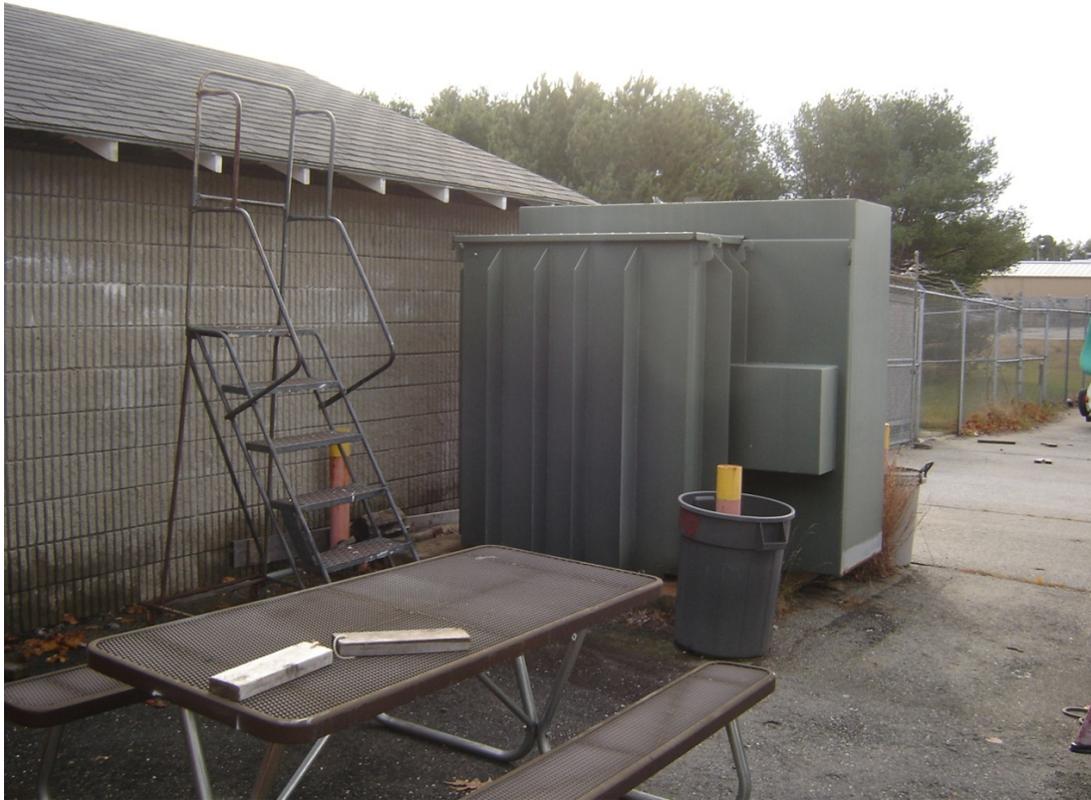
- No peeling and flaking paint was observed on the exterior or interior of the building.
- One non-polychlorinated-biphenyl (PCB) pad-mounted transformer was located south of Building 29.

No. 7 Building 29 – Auto Hobby Shop, NAS Brunswick
Northwest elevation of Building 29 transformer, located on the west side of abrasive blasting shed

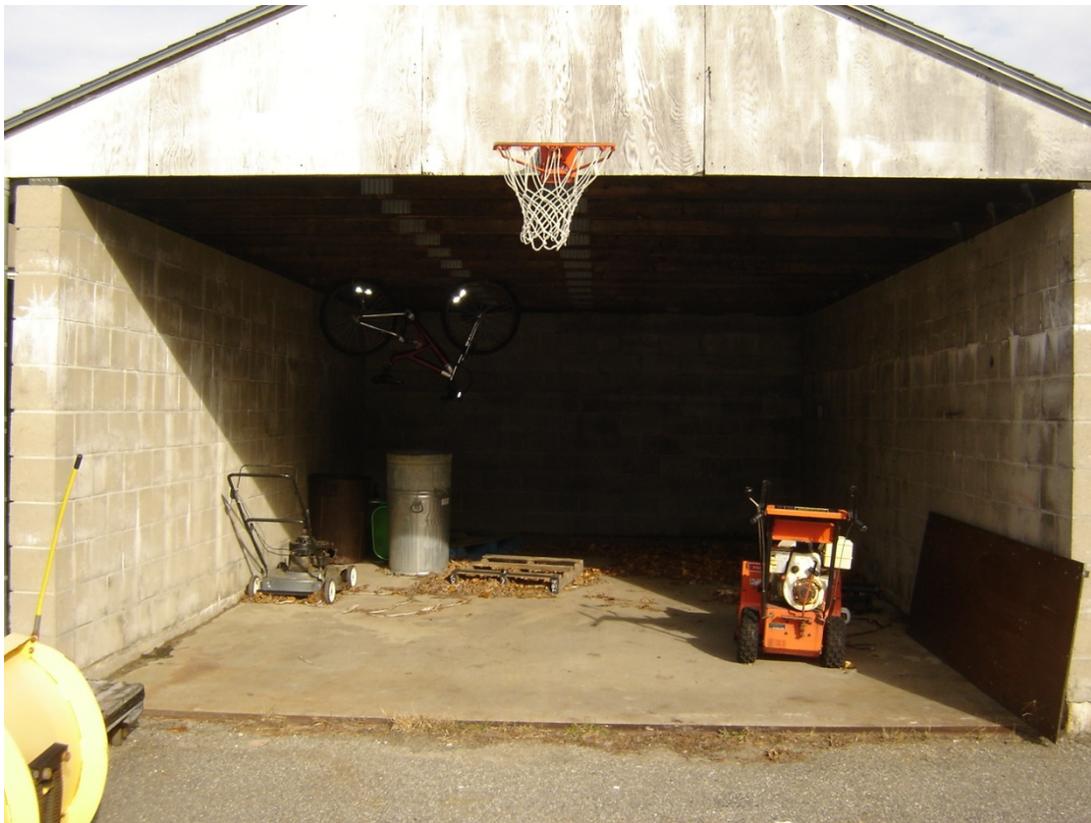
- A flammable locker (Structure X4) is located southwest of Building 29 and used to store gasoline cans. Debris and dirt were observed on the floor.
- The abrasive blasting shed was used to store chainsaws, ice augers, mowers, generators and other equipment. Staining was observed on the floor of this shed.

No. 8 Building 29 – Auto Hobby Shop, NAS Brunswick
Abrasive blasting shed, interior view from entrance

Floor cleaning was conducted on February 1, 2011 by TK&K in the abrasive blasting shed area, using the procedures described above. All cleaning wastewater was containerized using a wet-vacuum, placed in a 55-gallon drum, and transferred to the NAS Brunswick hazardous waste department for disposal.
