FINAL RESOURCE CONSERVATION AND RECOVERY ACT PARTIAL CLOSURE REPORT  
FOR BUILDING 55 WITH TRANSMITTAL LETTER NAS BRUNSWICK ME  
4/6/2011  
NAS BRUNSWICK

Subj: Final RCRA Partial Closure Report for Building 55

**RCRA PARTIAL CLOSURE REPORT**  
**for**  
**BUILDING 55 – BASE SECURITY BUILDING PARCEL**  
**NAVAL AIR STATION BRUNSWICK, MAINE**  
**USEPA IDENTIFICATION NUMBER ME8170022018**  
**MARCH 2011**

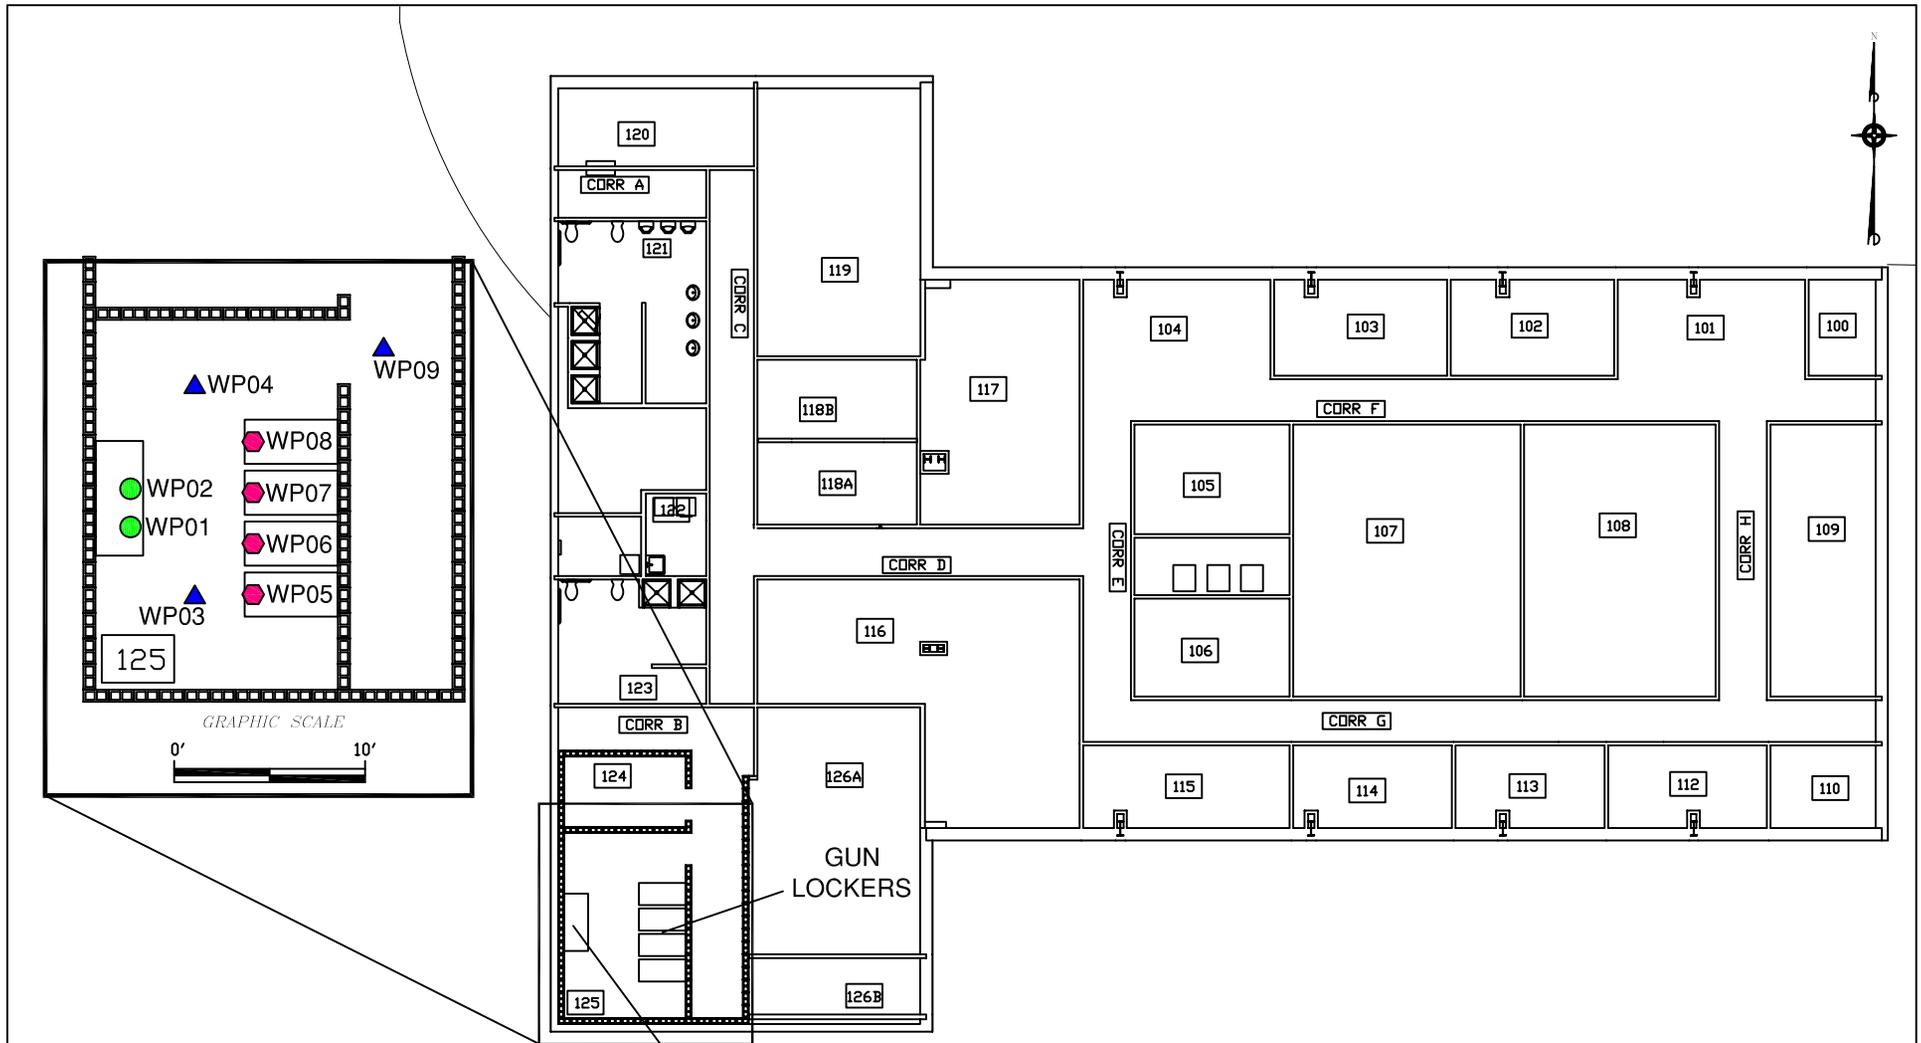
Building 55 Residue Investigation - On January 14, 2011, wipe samples for RCRA metals analysis were collected from nine locations in Building 55, including the work bench, floor, and gun lockers in Room 125, as well as the floor of the hallway at the entrance to Room 125, as shown on Figure 3. The samples were collected with cotton gauze saturated with dilute nitric acid (1:4 nitric acid to distilled water). A 10-centimeter (cm) by 10-cm sampling area was wiped with the cotton gauze while applying moderate pressure. All wipe samples were submitted for RCRA metals analysis by Tetra Tech's subcontracted laboratory, Katahdin Analytical Services of Scarborough, Maine (Katahdin). The resulting analytical data underwent limited data validation consisting of field duplicate evaluation, blank contamination evaluation, and completeness evaluation.

As shown in Table 1, lead exceeded the MEDEP criterion for walls (250  $\mu\text{g}/\text{ft}^2$ ) in the two samples and in the duplicate sample that were collected from the workbench. Lead also exceeded the MEDEP criterion for walls in one of the four samples collected in the gun locker. In all other wipe samples, including gun locker and floor samples, lead levels were below the MEDEP criteria. All levels of other detected metals were below the WTC screening values.

Based on the analytical results and discussions with NAS Brunswick personnel, it was determined that no cleaning is necessary for Building 55. NAS Brunswick personnel indicated that the four gun lockers, which are fully contained, will continue to be used in the same capacity and for the intended purpose of storing guns. Additionally, the work bench was removed for disposal and will be replaced with a new workbench that would be covered with plastic or other disposable material during weapons cleaning activities to prevent recontamination of the new bench.

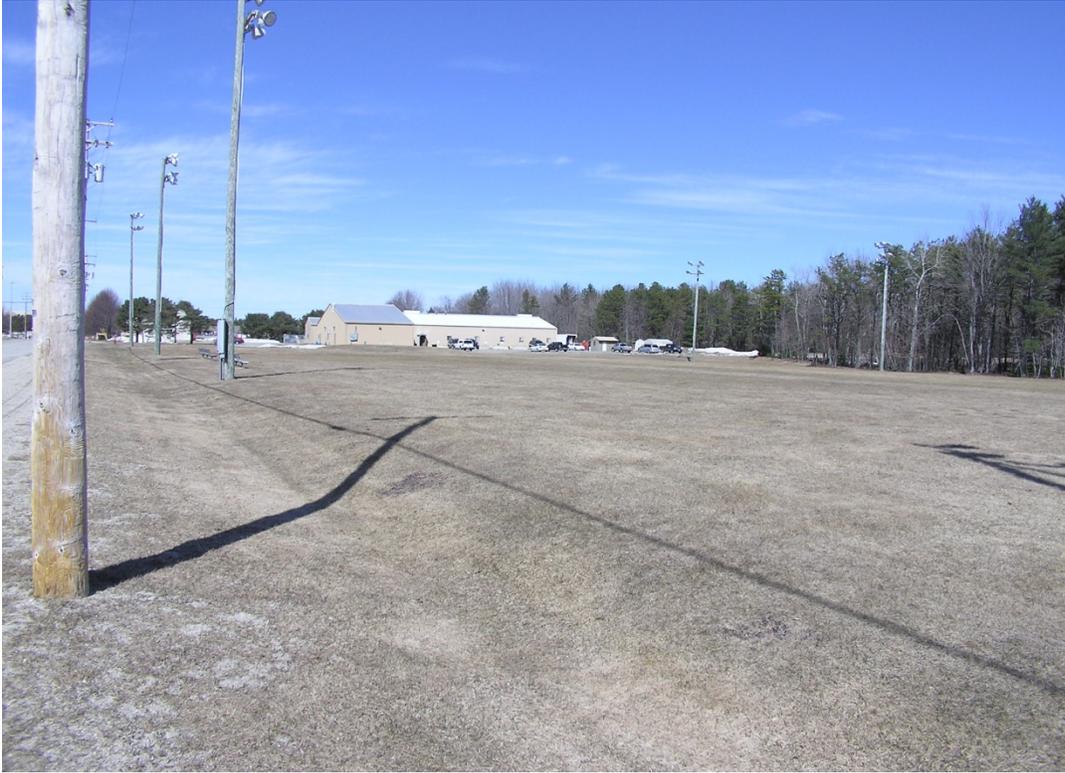
No.1 Building 55 – Base Security Building, NAS Brunswick March 29, 2011  
View of Building 55 parcel looking towards the northeast from SW corner of playing field and Orion Street

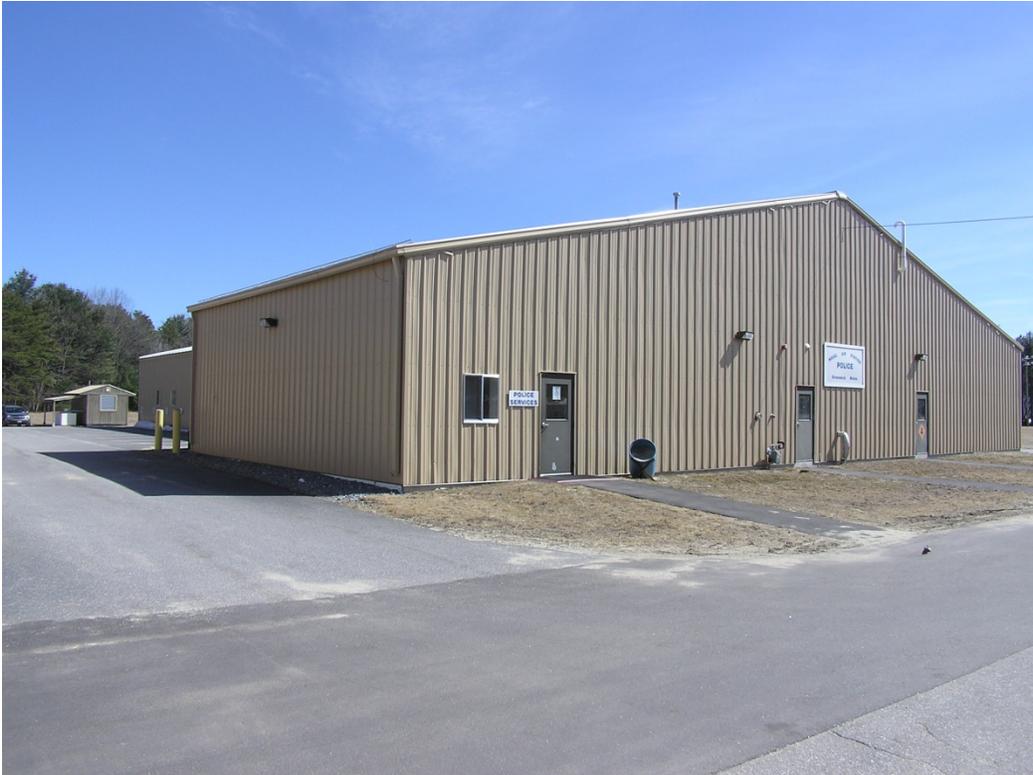
No.2 Building 55 – Base Security Building, NAS Brunswick March 29, 2011  
Northwest elevation; Building 551 (Security Generator) and trees in background

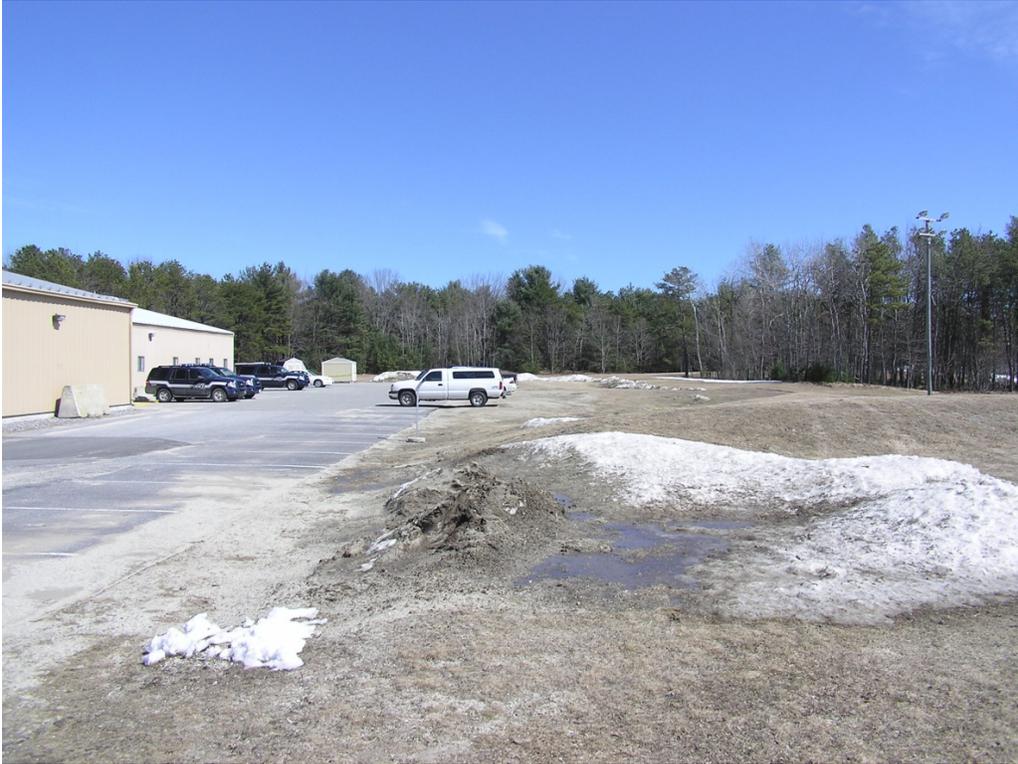
No. 3 Building 55 – Base Security Building, NAS Brunswick March 29, 2011  
Building 55 south paved parking area looking east towards former Machine Gun Bore Sight Range; Structure A6 and two evidence storage sheds on grassy area in background

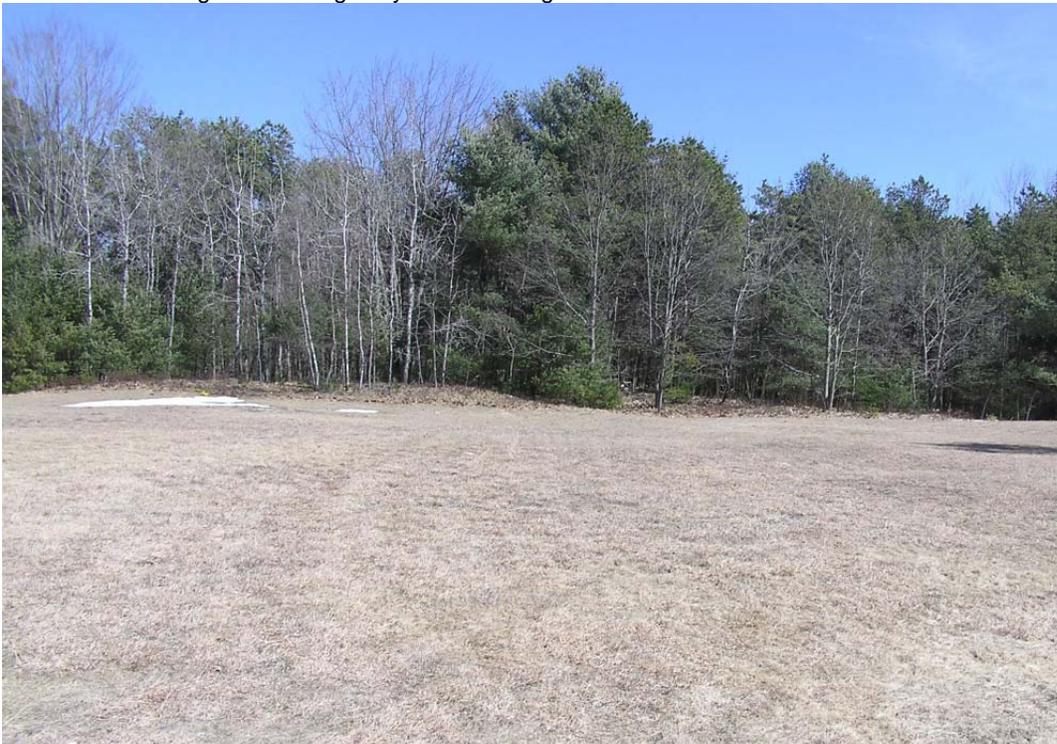
No. 4 Building 55 – Base Security Building, NAS Brunswick March 29, 2011  
Area southeast of Building 55 looking east towards former Machine Gun Bore Sight Range berm

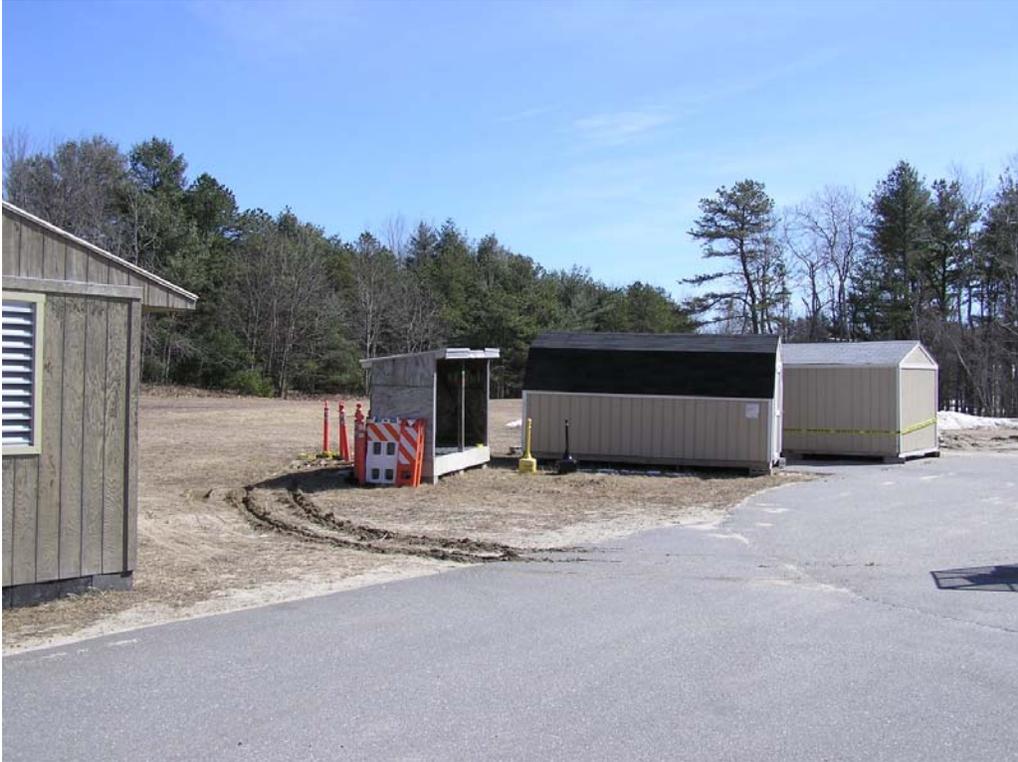
- Two wooden sheds, marked with yellow tape labeled "Crime Scene Do Not Cross", were also staged on the grassy area south of Structure A6 and were not opened for inspection. According to NAS Brunswick personnel, these sheds are being stored at this location temporarily and are evidence in an ongoing criminal investigation.

No. 5 Building 55 – Base Security Building, NAS Brunswick March 29, 2011  
East of Building 55 (left to right); Building 551 (Security Generator), Structure A6, and two unlabeled sheds (evidence)

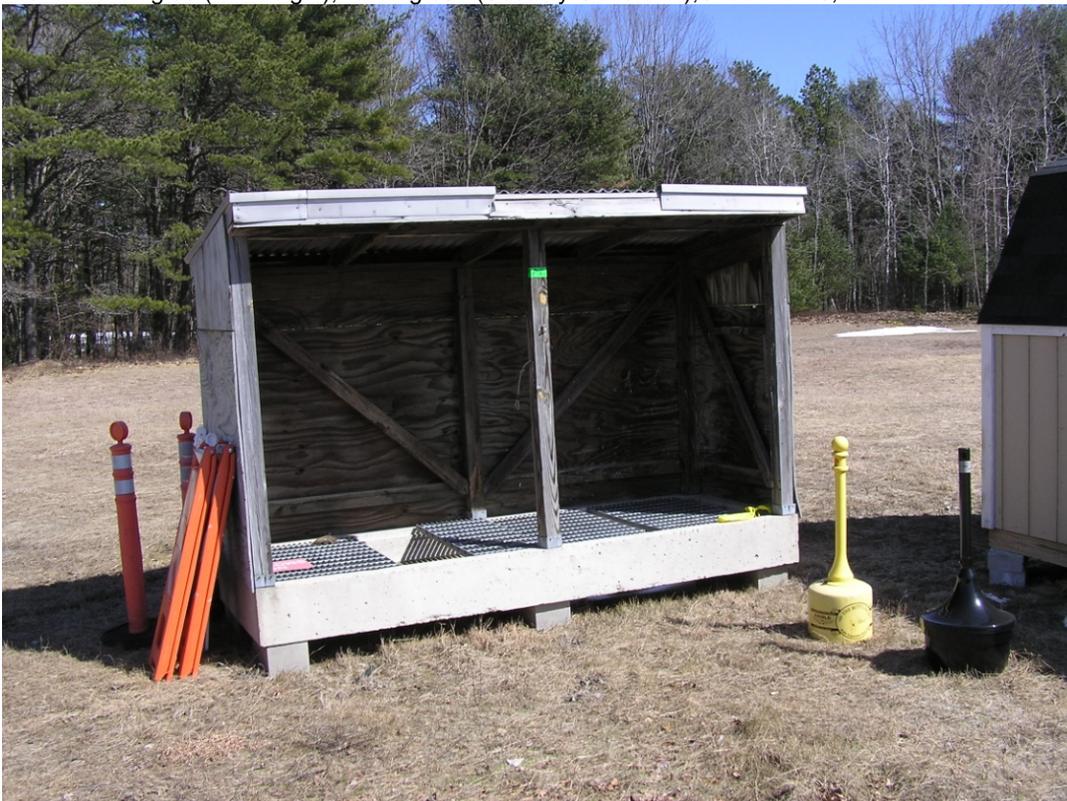
- No peeling or flaking paint was observed on the exterior or interior of the building.
- Structure A6 was staged on the grassy area near the eastern end of Building 55. This wooden shed with a concrete bottom is similar to other sheds formerly used on the base for temporary storage of hazardous material and waste. According to NAS Brunswick personnel, Structure A6 was only used as a smoking area; no hazardous material and waste items were being stored in the shed and the its bottom was visibly clean.

No. 6 Building 55 – Base Security Building, NAS Brunswick March 29, 2011  
Structure A6 (smoking area) on grassy area east of Building 55

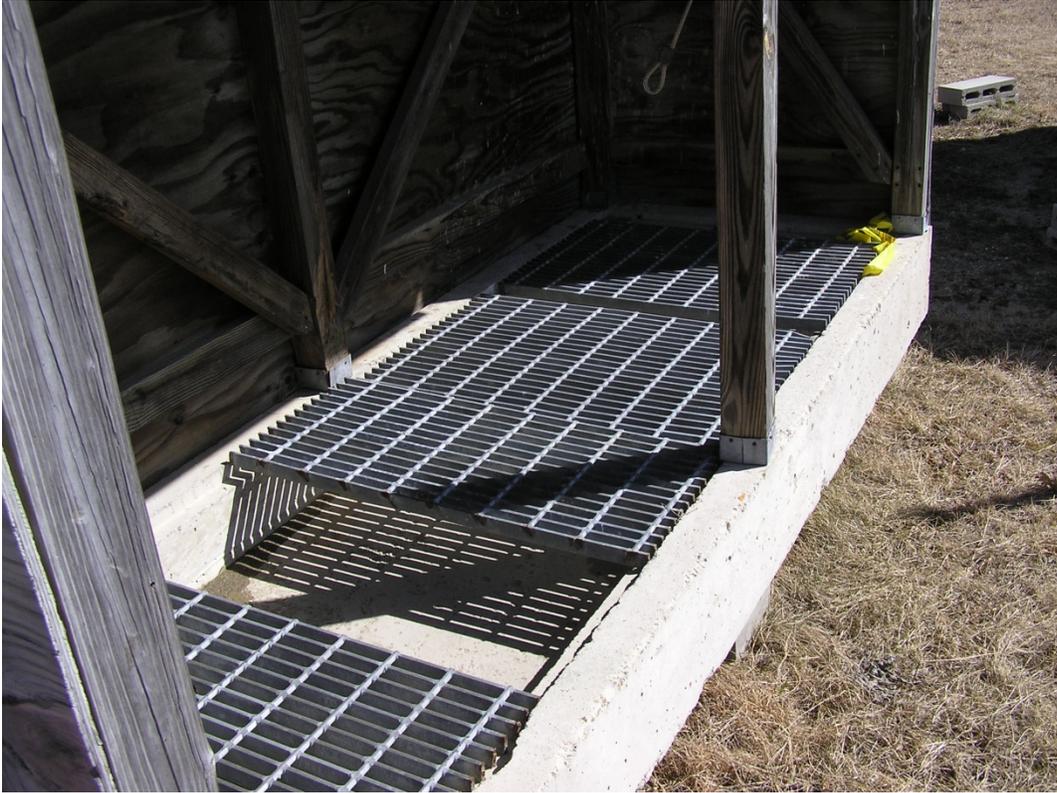
No.7 Building 55 – Base Security Building, NAS Brunswick March 29, 2011  
Interior of Structure A6

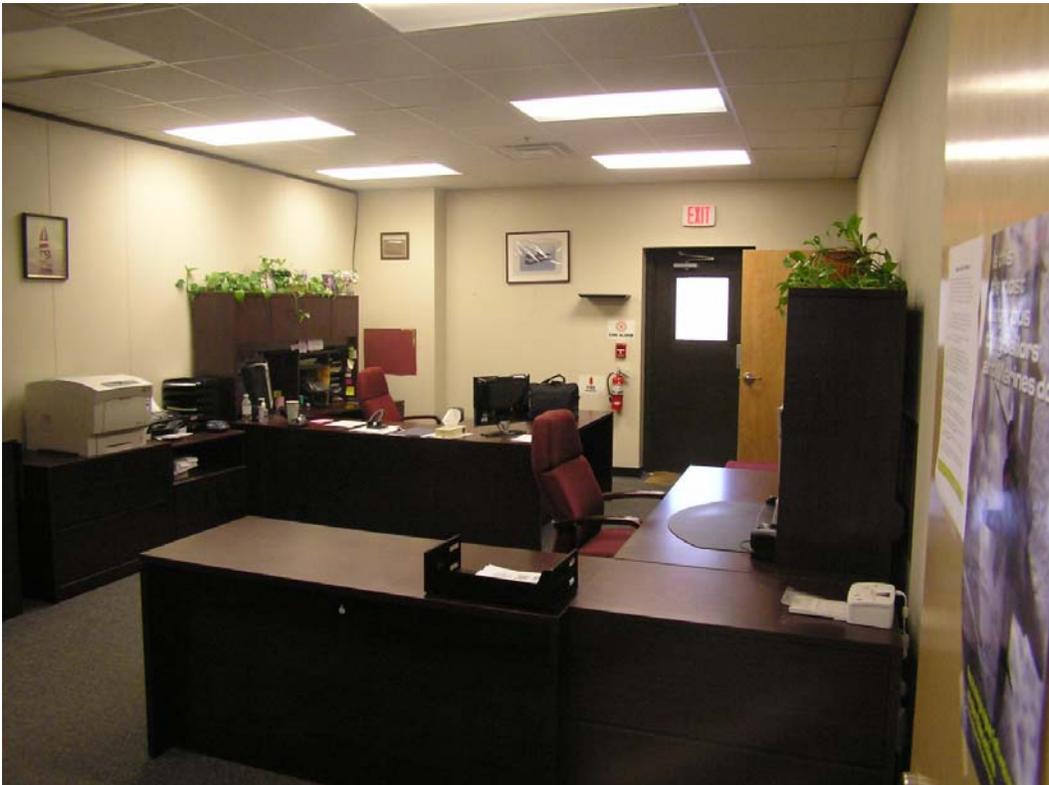
No. 8 Building 55 – Base Security Building, NAS Brunswick November 23, 2010  
Building 55 Interior; administrative office space (northwest end of building, exit to north side)

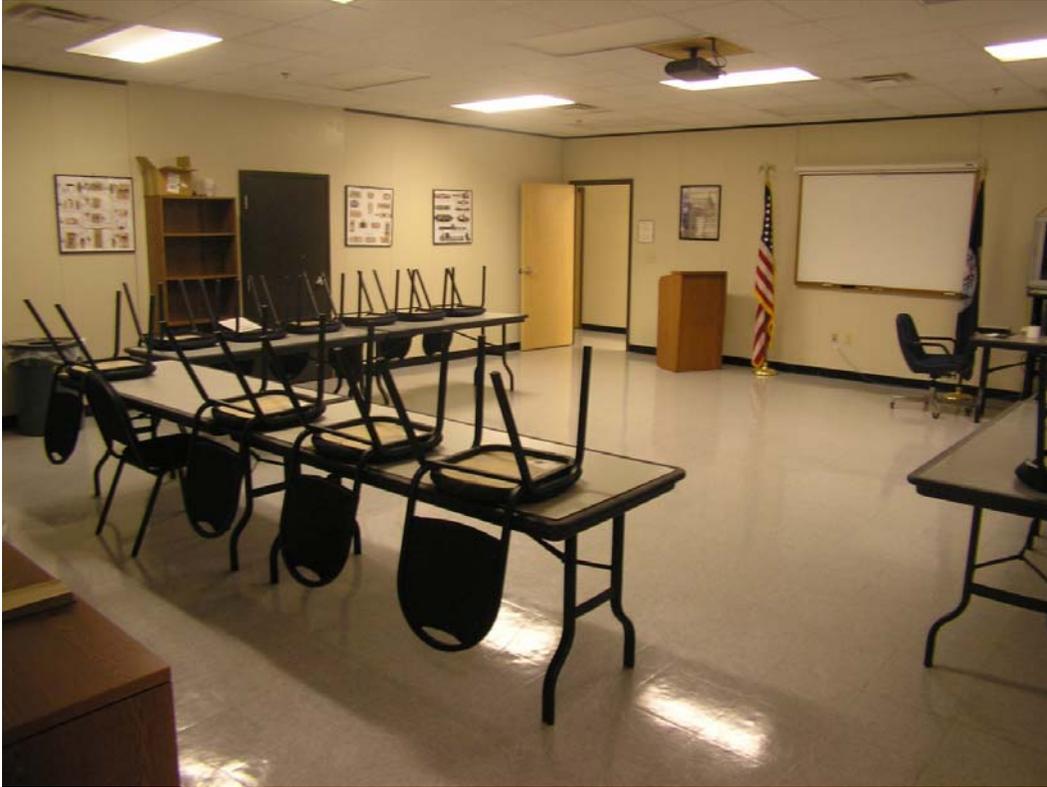
No. 9 Building 55 – Base Security Building, NAS Brunswick November 23, 2010  
Building 55 Interior; classroom (central area of building)

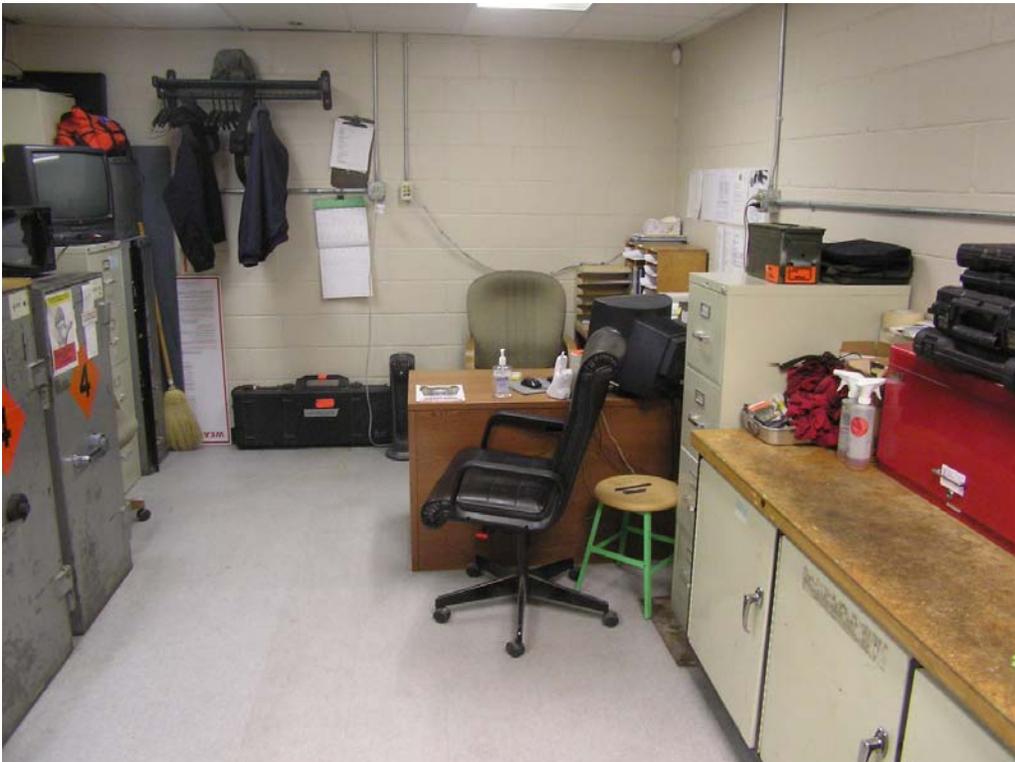
No. 10 Building 55 – Base Security Building, NAS Brunswick November 23, 2010  
Building 55 Room 125 (southwest corner of Building 55); gun cleaning area (workbench) and gun storage cabinets (opposite workbench) prior to workbench removal
