STATE OF MAINE
DEPARTMENT OF ENVIRONMENTAL PROTECTION

Re: Site 9, Monitoring Event 15, September 1999
Naval Air Station, Brunswick, Maine

The Maine Department of Environmental Protection (MEDEP or Department) has reviewed the report entitled Monitoring Event 15-September 1999; Site 9: Neptune Drive Disposal Site, dated November 1999, prepared by EA Engineering, Science and Technology. Based on that review the Department has the following comments and issues.

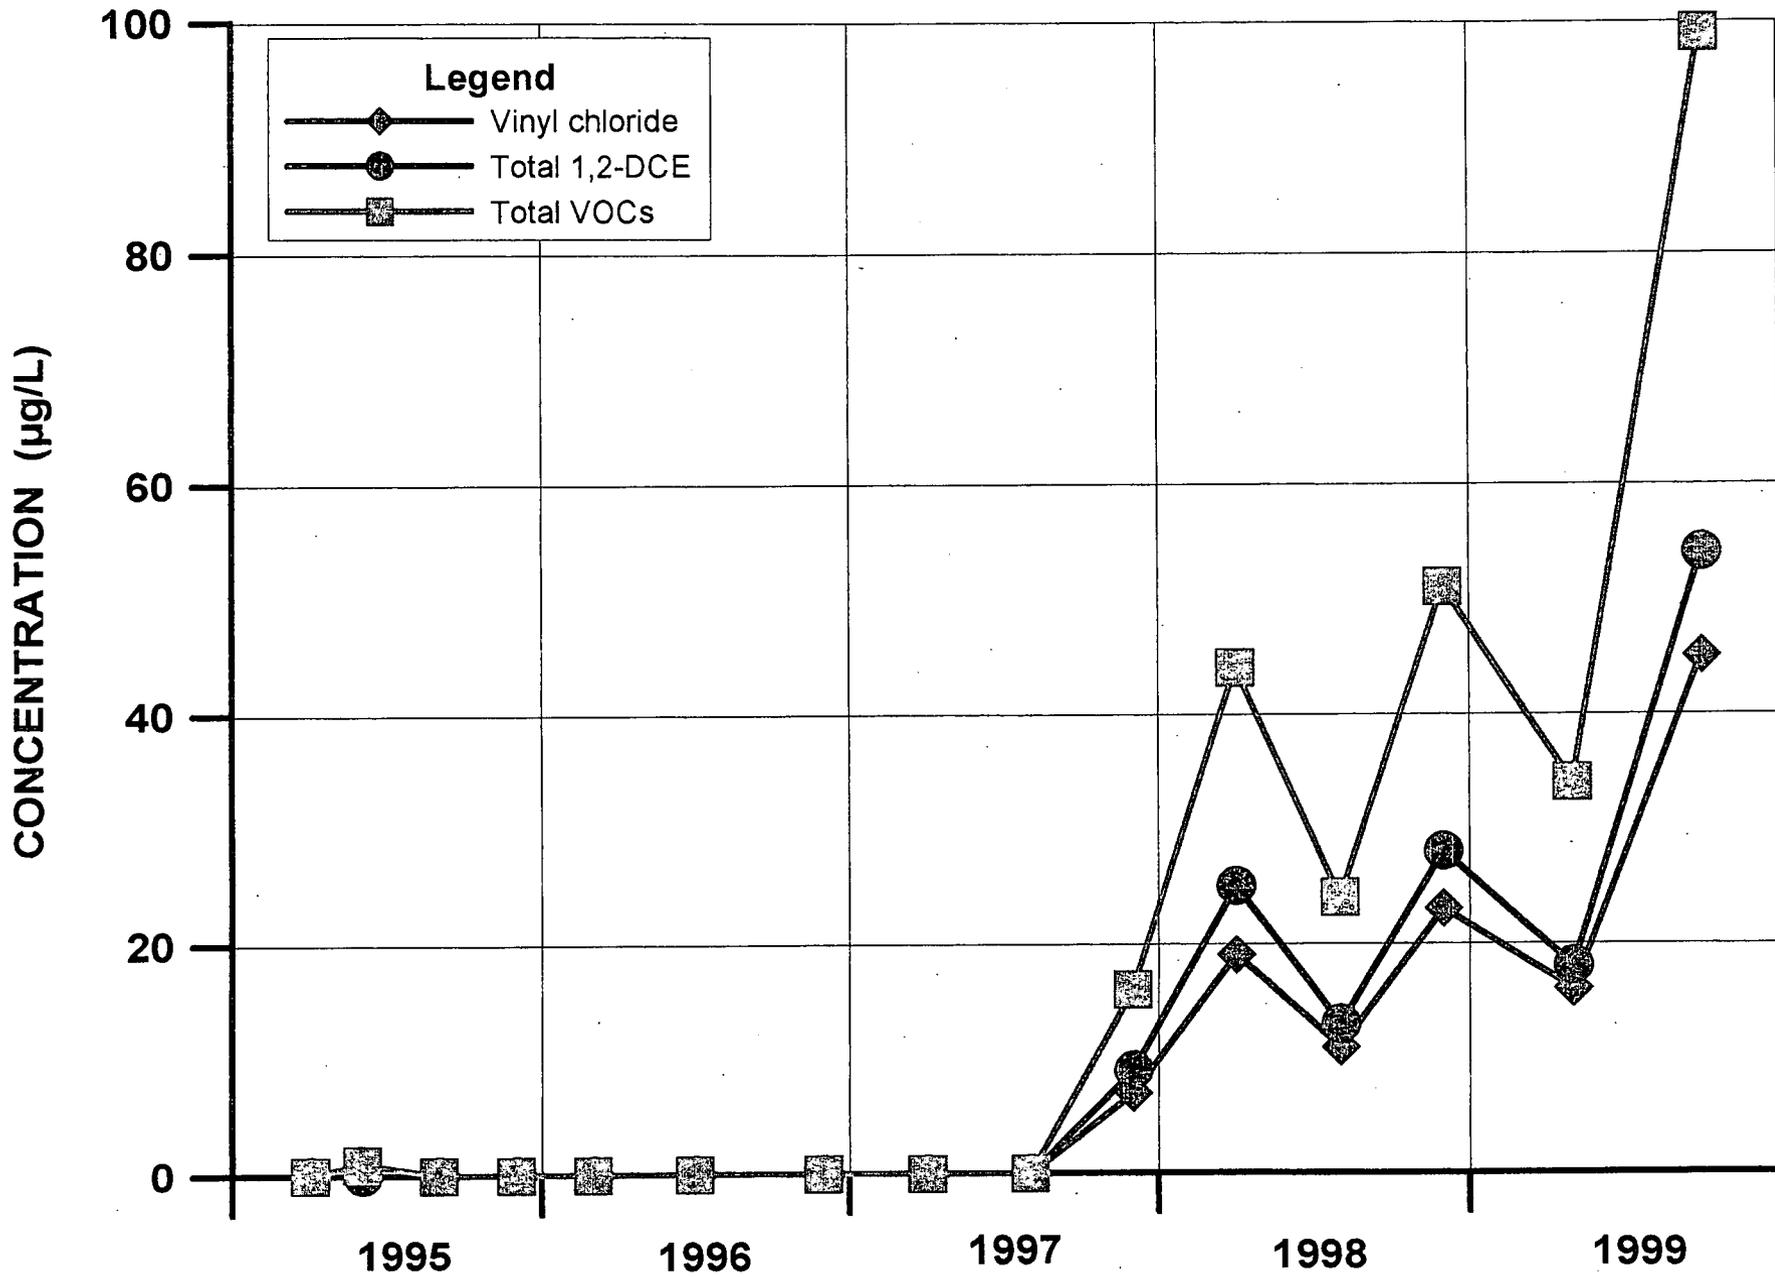
1. This event's VOC data illustrates the importance of comparing the current event concentrations with trends and historical data. The Department reviewed these new data in this fashion, and has attached a graph of concentrations versus time for MW-NASB-069. What the graph shows is that the rising trends for both vinyl chloride and total 1,2-dichloroethene have continued in dramatic fashion, with the September 1999 concentrations being more than double the previous highs (November 1998 event). The DCE concentration of the duplicate sample is nearly at the MCL and MEG of 70 µg/L. Most significantly, vinyl chloride is approximately 25 times greater than its MCL at this location and over 300 times its MEG.

The Department recognizes that MW-NASB-069 is not the typical monitoring well at Site 9 in that it draws groundwater from a deep elongated depression in the top of the underlying clay. The screens of other monitoring well at Site 9 are shallower, and most are located outside the clay trough. Because vinyl chloride and 1,2- DCE are

undoubtedly daughter products of PCE and/or TCE, which are sinkers in aquifers due to their specific gravity being significantly greater than water, it is not surprising that MW-NASB-069 is much more contaminated than other Site 9 wells.

The increasing trends of vinyl chloride and DCE, in combination with very low dissolved oxygen and relatively high manganese, suggests that natural biodegradation of parent compounds is occurring and apparently has accelerated. A postulated reason for this accelerated breakdown is that the chemical side-effects (e.g., anaerobic state) of fuel contaminant remediation at the NEX (immediately upgradient) have migrated downgradient in the shallow system, and have promoted increased reductive dehalogenation of chlorinated compounds trapped in the uppermost clay layer as a residual from old solvent releases.

In light of the above trend, the Department has growing concerns that contaminant levels may eventually increase in the Site 9 pond sediments, and possibly in pond water. The point at which the Department will need more subsurface contaminant information in order to continue to support the Natural Attenuation with Monitoring remedy may be fast approaching. Therefore, the Navy should seriously consider making plans to install several new monitoring wells to better define and track this apparent top-of-clay VOC plume, and assume that last year's concentration trend will not soon reverse. MEDEP is ready to assist the Navy in such an endeavor. This should be a topic of discussion at the next technical meeting.
