**FINDINGS FROM POST-FIELD WORK MAGNETOMETER SURVEY
MERRICONEAG EXTENSION DEBRIS SITE, SITE 15
SWAMPY ROAD DEBRIS SITE, SITE 16
NAVAL AIR STATION BRUNSWICK, MAINE
29 February 2000**

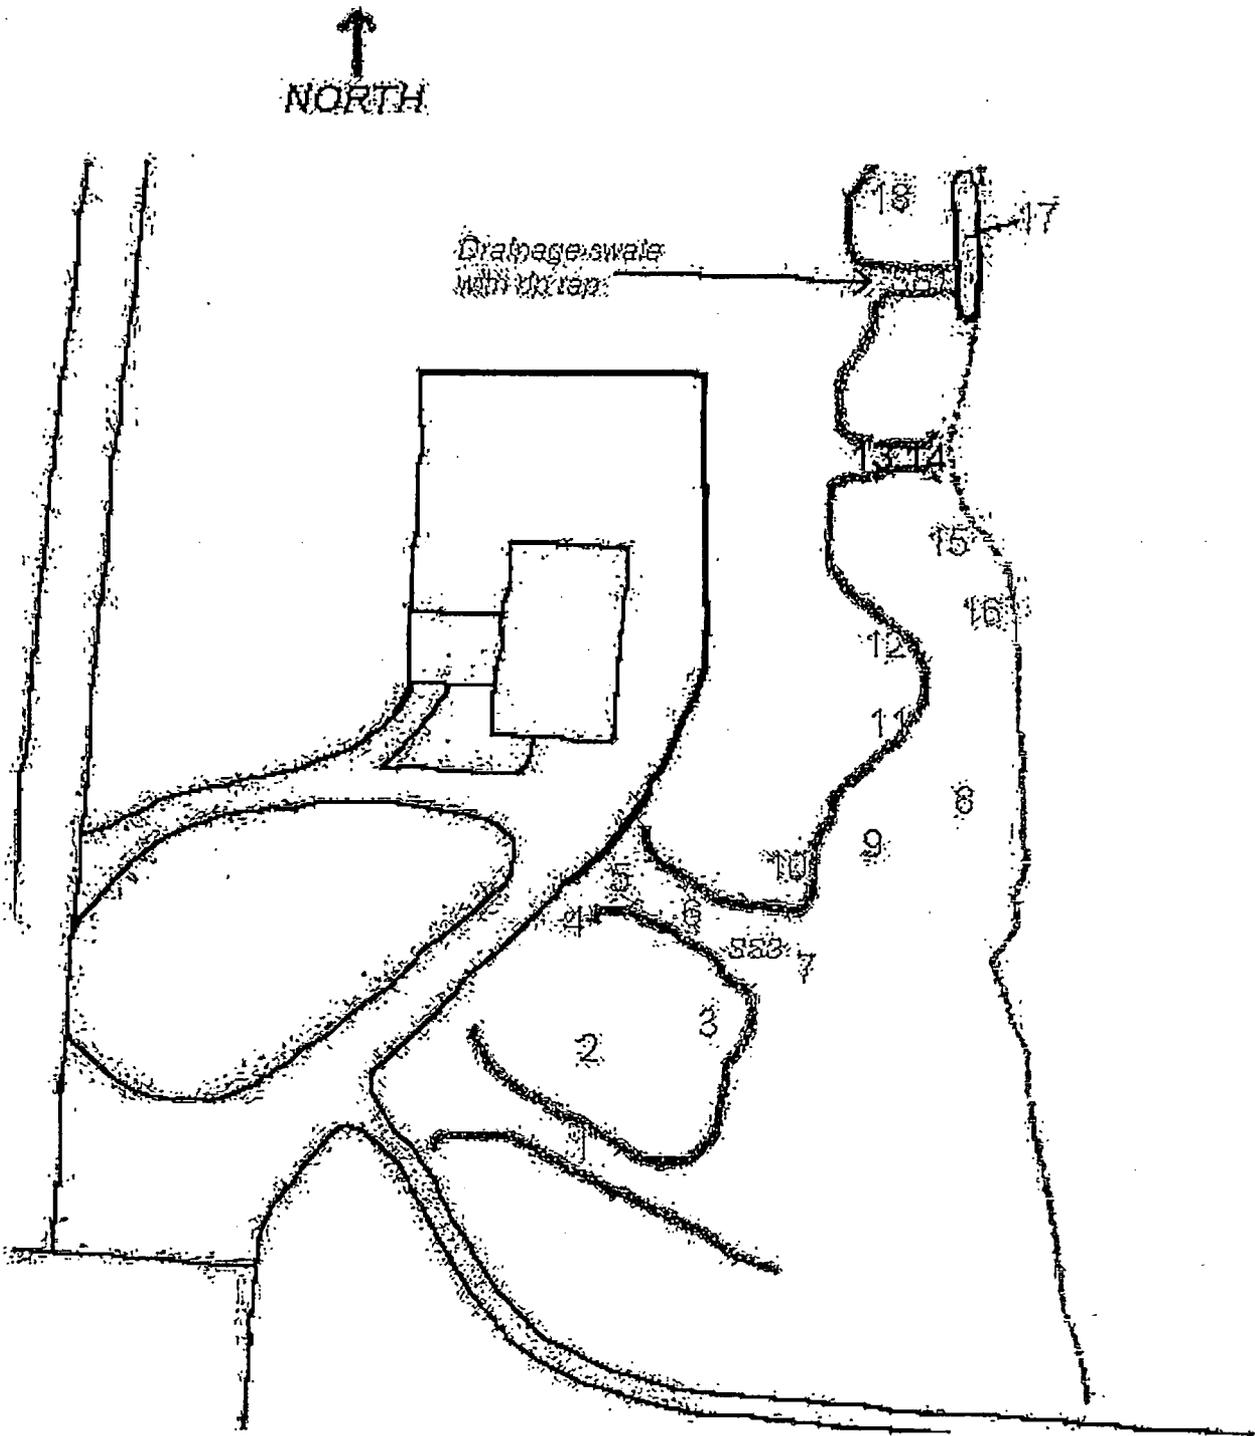
Figure 2 - Sketch of Anomaly Locations

D. Inventory of Items Discovered (refer to sketch at Figure 2 for locations)

1. 5 gallon gas can (empty), 2½ gallon milk pail (empty), 1# coffee can, red fence post, gym locker door, soup can, fence wire, 3 metal wire fence posts with wire pieces attached

2. Telephone pole guy wire anchor
3. 1 gallon paint can (empty)
4. Perforated steel planking, approximately 1' deep
5. Perforated steel planking, approximately 2' deep

6. Large metal object (1' deep) with control rod device mounted on top indicating "low/med/high" adjustments. Looks like a tractor-towed grass mower deck attachment. Soup cans, bottles, light bulbs, bricks, and other domestic trash items about 2 meters downgradient from mower deck.

7. Steel fence post, about 6' long
8. 1 gallon paint can (empty)
9. Wood fence post with 3" diameter cast iron piping extended through it
10. Large flat rock causing strong metallic readings on the instrument. I exposed a 4' x 2' section with the shovel and struck it several times to verify it as either rock or concrete.

11. Metal fence post or steel pipe approximately 1½' deep
12. Heavily rusted pieces of a flattened metal drum (empty)
13. Rotary blade grass cutter and wheel assembly

14. 4 quart metal motor oil can (empty) labeled "Oilzum motor oils and lubricants," glass bottles, rusted cans, and other domestic trash debris items approximately 2 meters upgradient from an older orange pin flag marked "SS2"

15. 2½' metal pipe, threaded end, approximately 1½" diameter
16. Steel pail-mounted mop ringer without the pail

17. Many larger metal debris items (all heavily rusted); pieces of three 5-gallon motor oil(?) cans; a child's metal toy wagon body; an old round 5 gallon gas can; many old glass bottles, rusted soup-sized cans, and domestic trash items.

18. Old soup-sized cans, old glass bottles, and domestic trash items

a. Based on agreement in our team's teleconference call on 9 Feb 00, recommend removal of subsurface debris found at Site 16 and magnetometer resurvey of the specific spots where subsurface debris was removed in order to confirm that no additional debris remains buried beneath those areas.

b. Also agreed in the 9 Feb 00 call, recommend a visual survey of the southern section of stream bank at Site 16. All visible debris items found on this "south" section will be identified and the approximate locations of such items graphically recorded. If any area of the site contains six or more surficial debris items within a 50' x 50' square area, then descriptions and locations of all items will be documented and the items removed for disposal. That area will then be surveyed with a magnetometer for subsurface debris items. If any subsurface anomalies are detected, additional debris items will be unearthed, recorded, and removed. The spot will then be resurveyed with the magnetometer for confirmation.
