**POST-FIELD WORK MAGNETOMETER SURVEY
AND DEBRIS REMOVAL ACTION
SWAMPY ROAD DEBRIS SITE, SITE 16
24 JANUARY 2001**

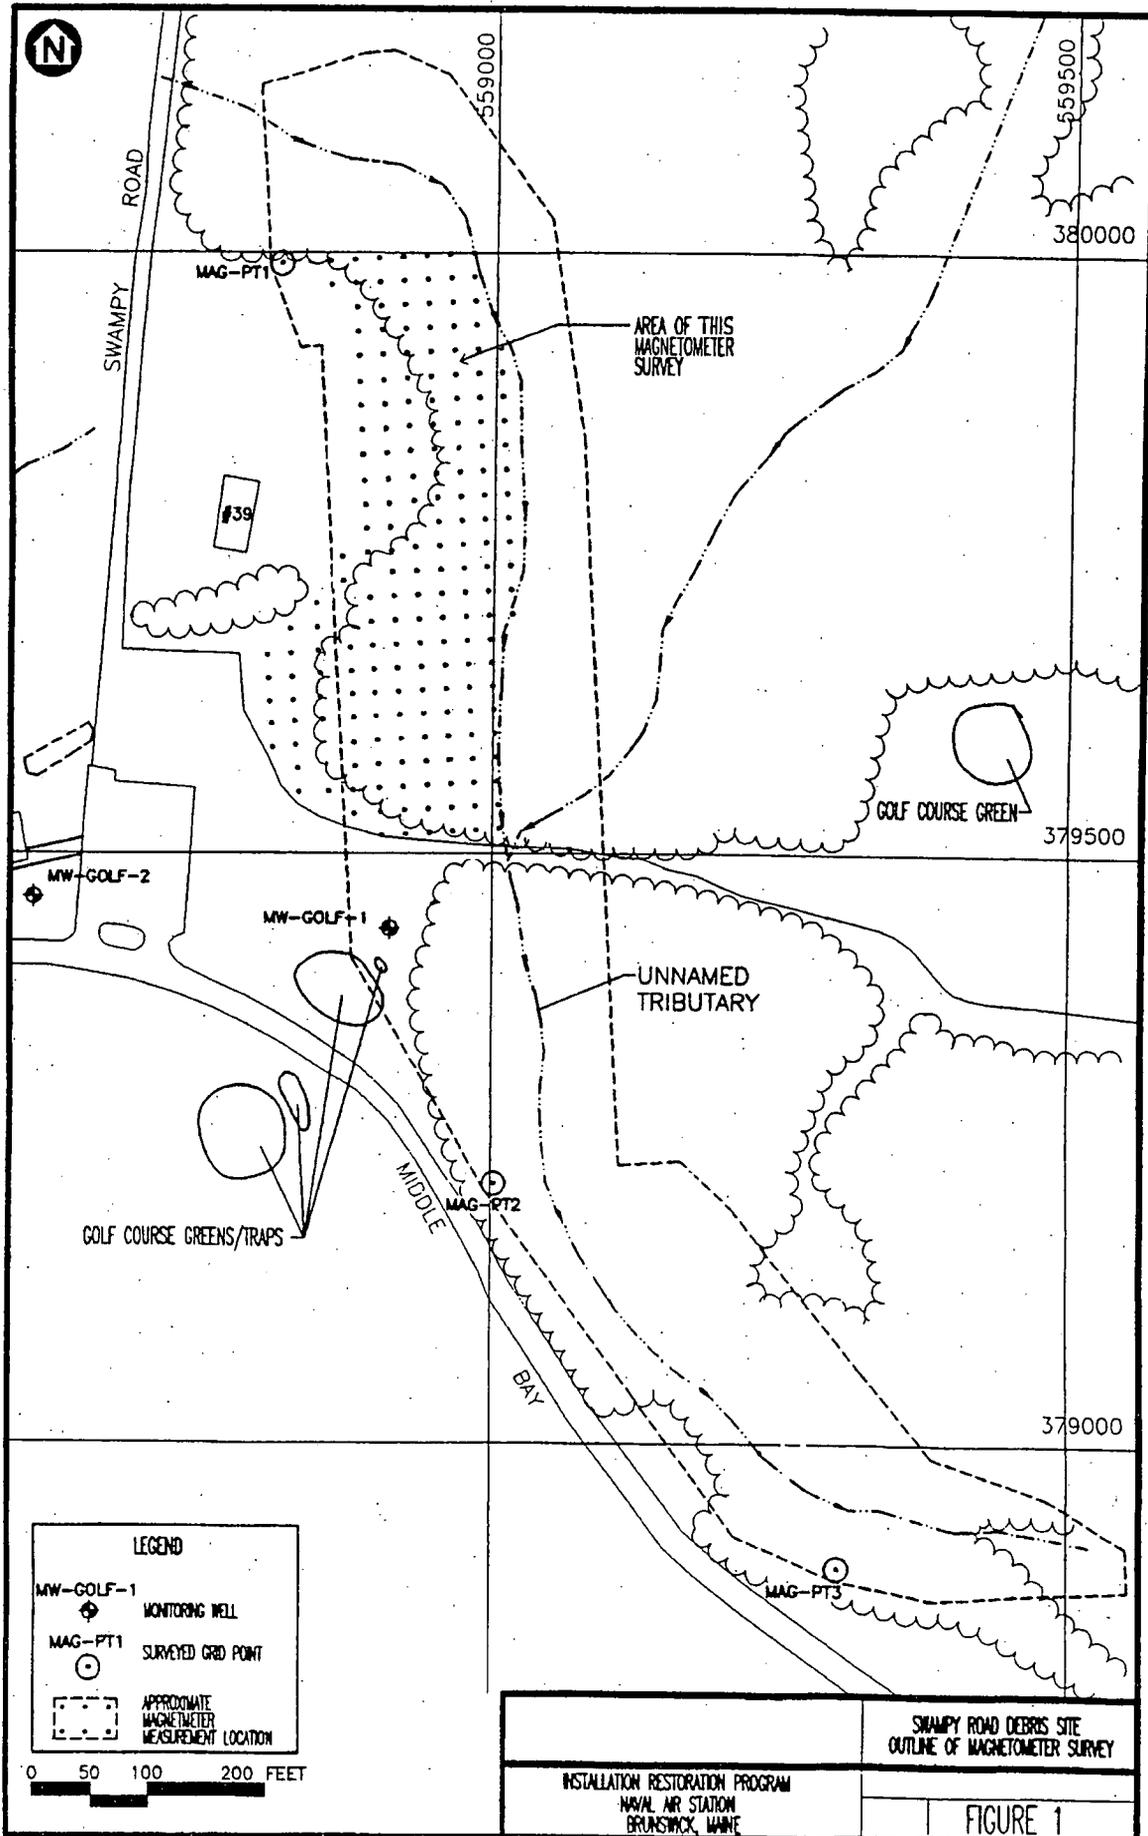
a. Northern Section of Site 16. Most items identified in the northern section of Site 16 (area north of the golf path, see Figure 1) were removed and disposed in the scrap metal containers of Supply Department's recycling area on 10 May 00. The large subsurface item that was previously identified as a "large metal object...like a tractor towed grass mower deck attachment" (Item D6 of previous report) was fully excavated and found to be an older type of kerosene heater unit filled with soil and contained no evidence of fuel residuals. No petroleum odors or visibly stained soils were detected around or beneath the heater unit when it was excavated and removed. The soils at the bottom of this excavation were surveyed with the magnetometer. Additional smaller metal debris items of a domestic nature were found, uncovered, and subsequently disposed. These items included several manufactured metal pieces suspected to be related to suspension components of a horse-drawn wagon, a Model A type of automobile horn, and some rusted food cans. With concurrence from Mr. Fusco, the following household and construction debris items were left in place in the northern section of Site 16:

- Perforated steel planking (Items D4 & D5 of previous report)
- Partially buried block of concrete with reinforcing steel (Item D10 of previous report)
- Large metal tub with an evergreen tree growing through middle of it (part of Item D17 of previous report)
- Several standing steel fence posts
- Partially buried steel sheep fencing attached to the fence posts

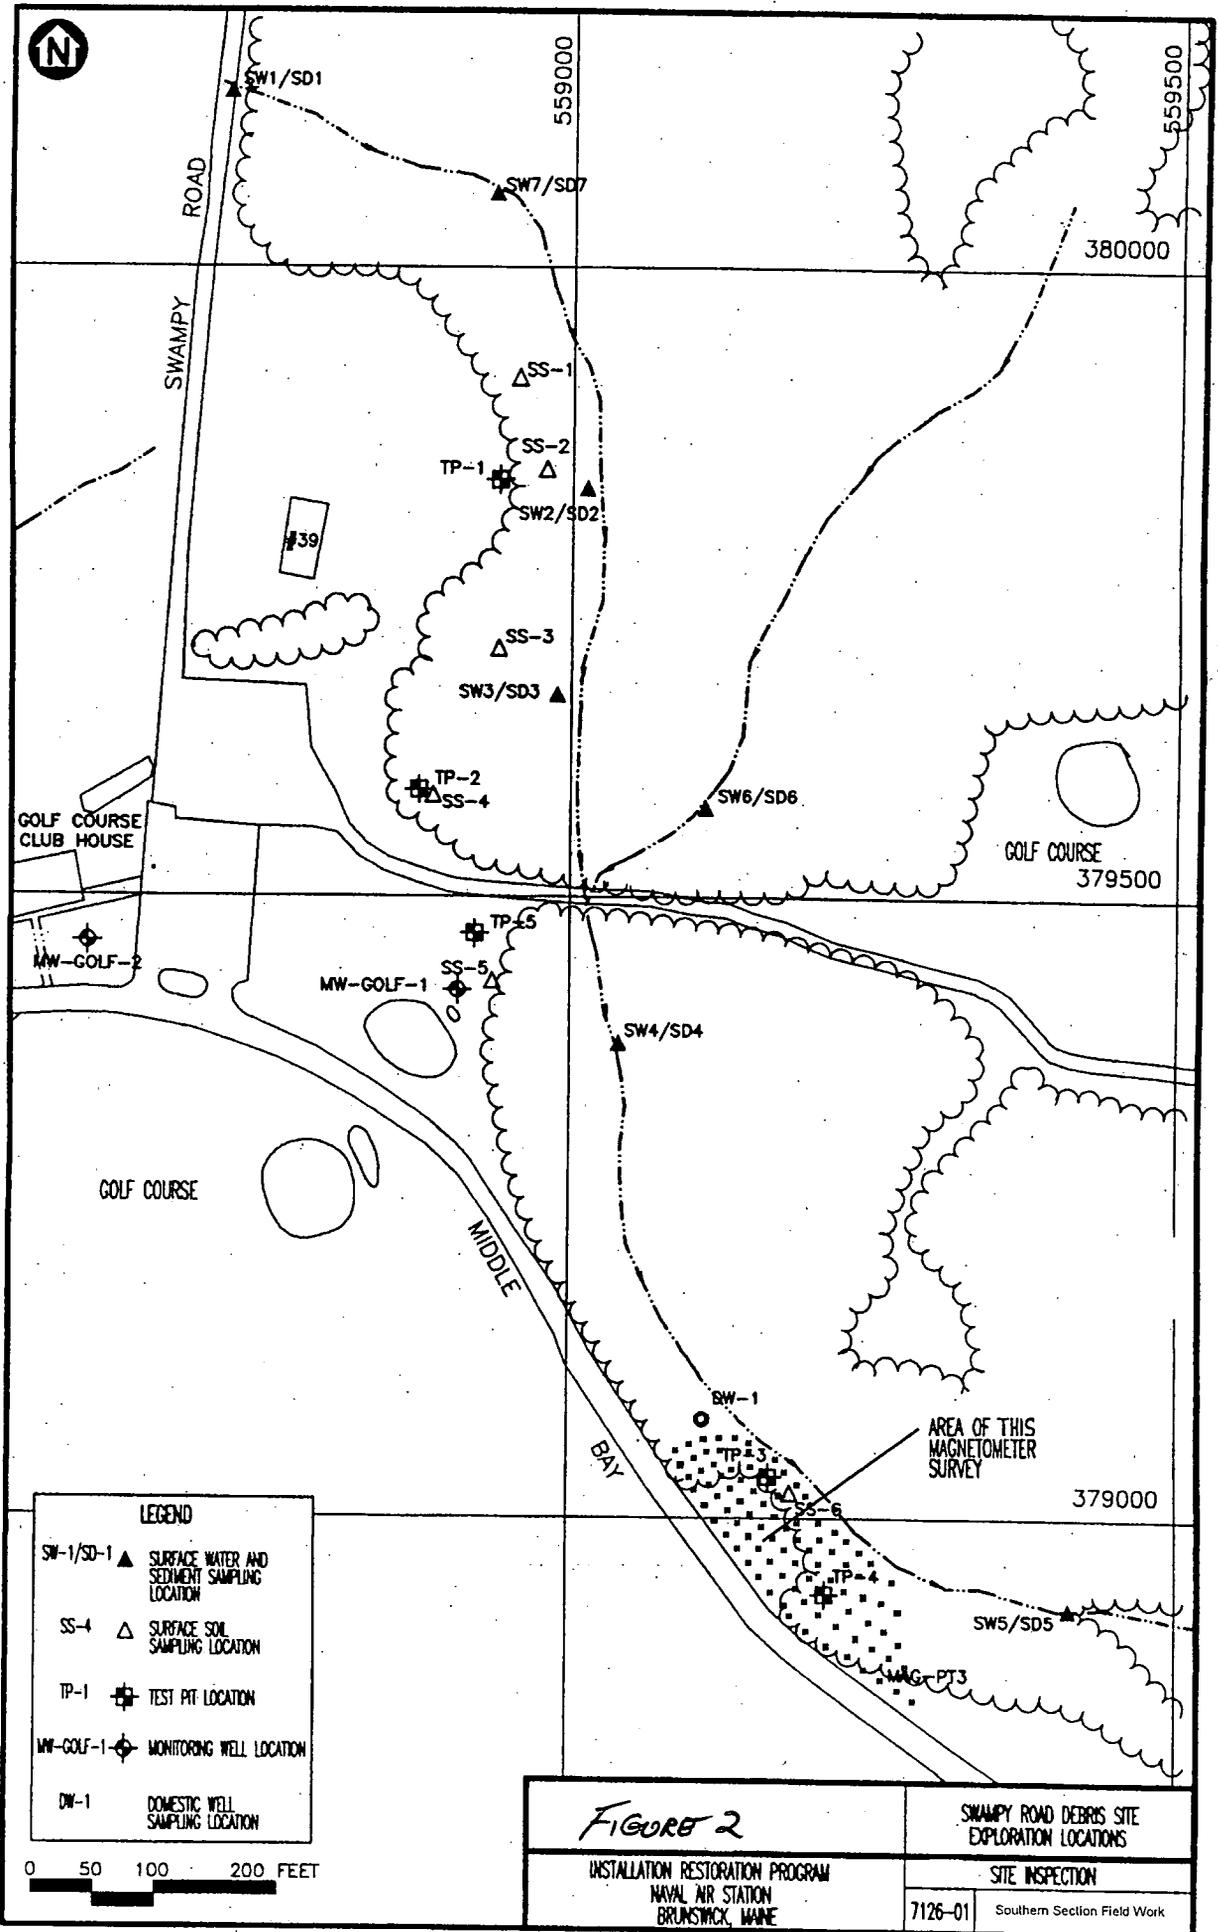
FIGURE 2 INSTALLATION RESTORATION PROGRAM NAVAL AIR STATION BRUNSWICK, MAINE	SWAMPY ROAD DEBRIS SITE EXPLORATION LOCATIONS
	SITE INSPECTION 7126-01 Southern Section Field Work

b. Southern Section of Site 16. Most metal debris items found in the southern section of Site 16 (area south of the golf path, see Figure 2) were removed and disposed in the scrap metal containers of Supply Department's recycling area on 11 and 15 May 2000. The length of stream floodplain and west stream bank (between stream and road) was visually inspected twice from the golf cart path to the irrigation pond, then a more focused inspection was performed at the outcropping area due to the number of debris items found. Surficial metal debris items were removed first. Most debris items recovered from the southern section were crumpled pieces of sheet metal roofing and piping or fence posts. After almost all visible items were removed, the outcropping area was then surveyed with the magnetometer. The subsurface metal anomalies detected with the magnetometer were then revealed with a hand shovel to identify them. If debris items were small enough, they were excavated and disposed. If anomalies would require heavy equipment to remove (such as concrete chunks with steel reinforcing, large fence posts, culverts, or piping), the items were identified, assessed for environmental potential, re-covered with soil, and left in place. Based on this method of detection and identification, there is a possibility for additional items to exist beneath the subsurface metallic items left in place. With concurrence from Mr. Fusco, the following debris items were left in place in the southern section of Site 16:

- Buried and partially buried chunks of concrete with reinforcing steel
- Steel fence posts, piping, and wire conduit

- Corrugated steel drainage conduit
- Large piece of metal box constructed of thick sheet metal with row of rivets at corner
