REMEDIAL INVESTIGATION PHOTOGRAPH ALBUM

**OPERABLE UNIT NO. 8 (SITE 16)
OPERABLE UNIT NO. 11 (SITES 7 AND 80)
OPERABLE UNIT NO. 12 (SITE 3)**

**MARINE CORPS BASE, CAMP LEJEUNE
NORTH CAROLINA**

MARCH 27, 1995

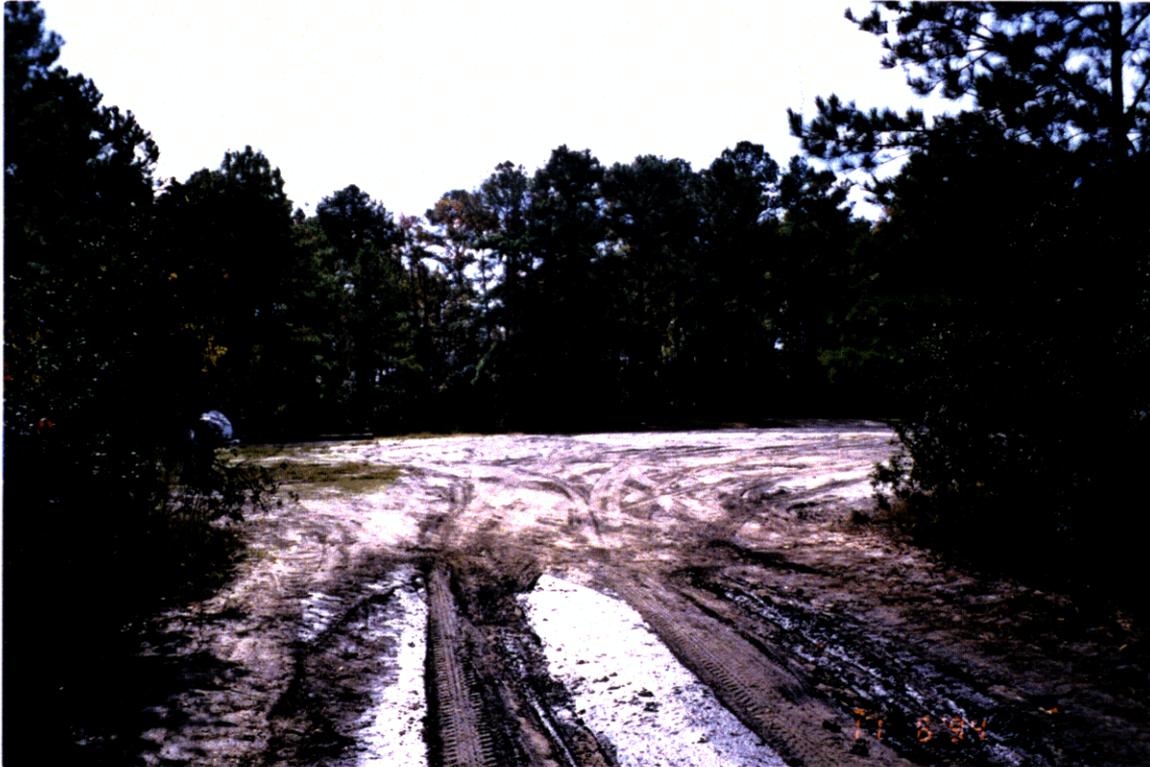
OU8-Site16: End of Access Road (looking southeast) coming off Wilson Road at Site 16 opening up into Former Burn Dump.

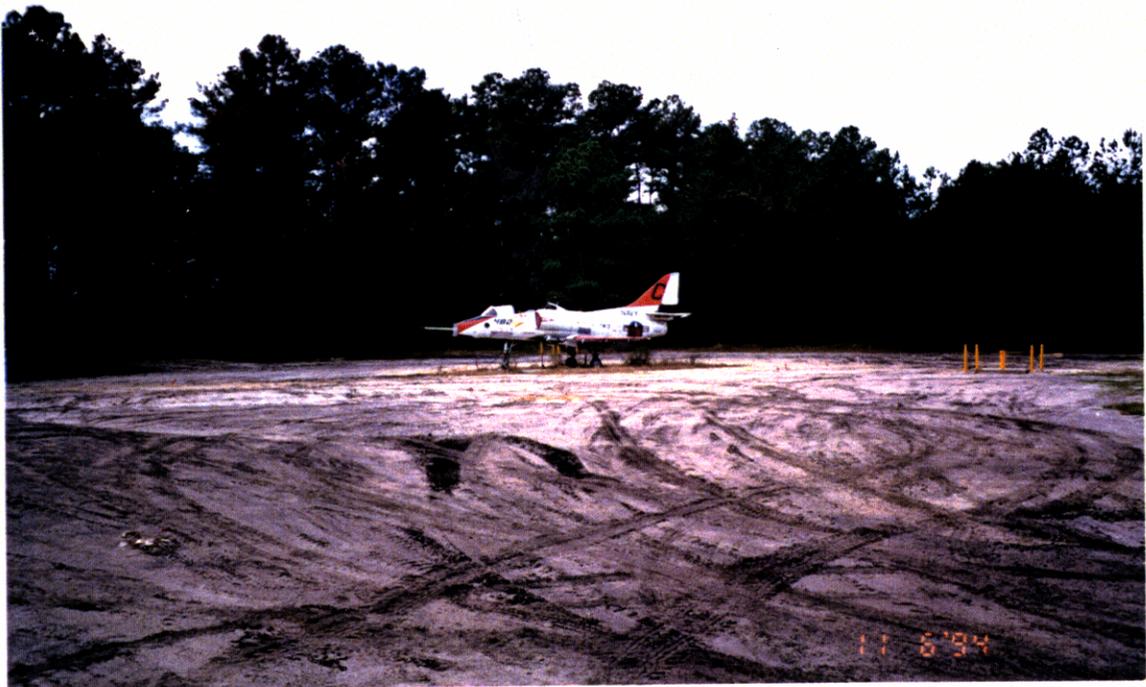
OU8-Site16: Site 16 looking south, across Former Burn Dump. Monitoring well 16-MW05 is to the right side of the photo. A training plane for fueling sits in the center of Burn Dump.

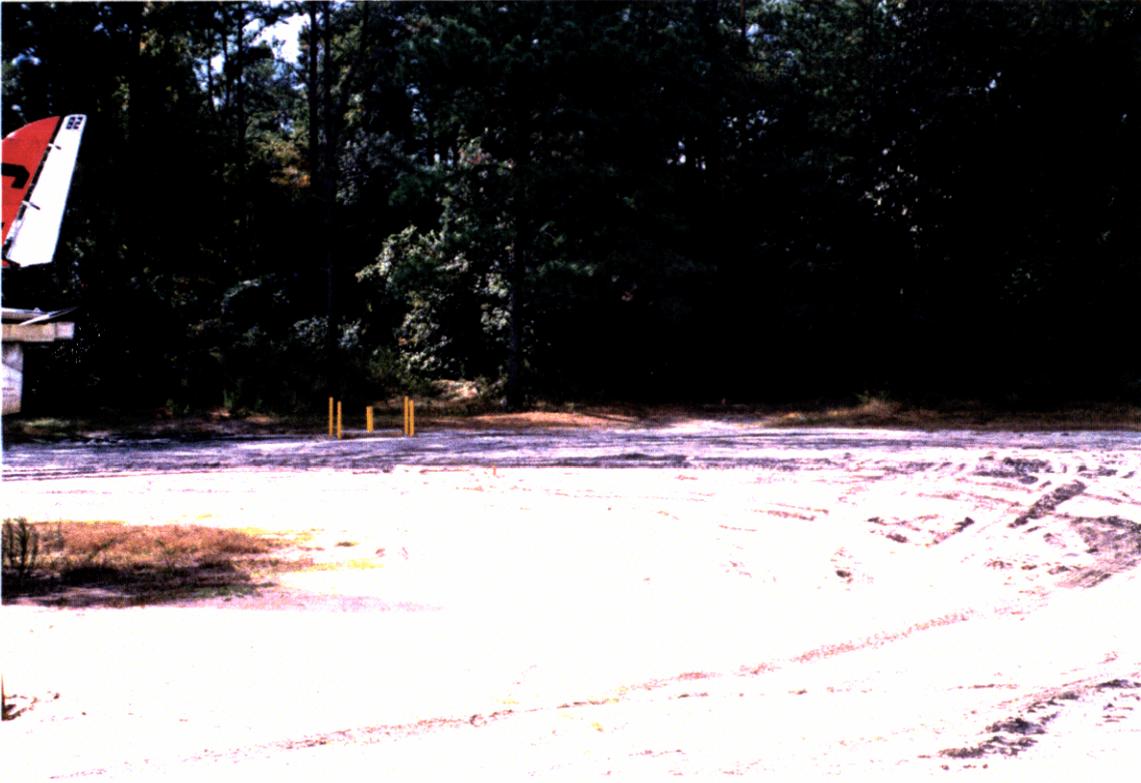
OU8-Site16: Photograph taken from monitoring well 16-MW05 looking south towards monitoring well 16-MW06. Test boring 16-BD-SB14 is shown in front of monitoring well 16-MW06 and test boring 16-BD-SB20 is shown to the right back at tree line.

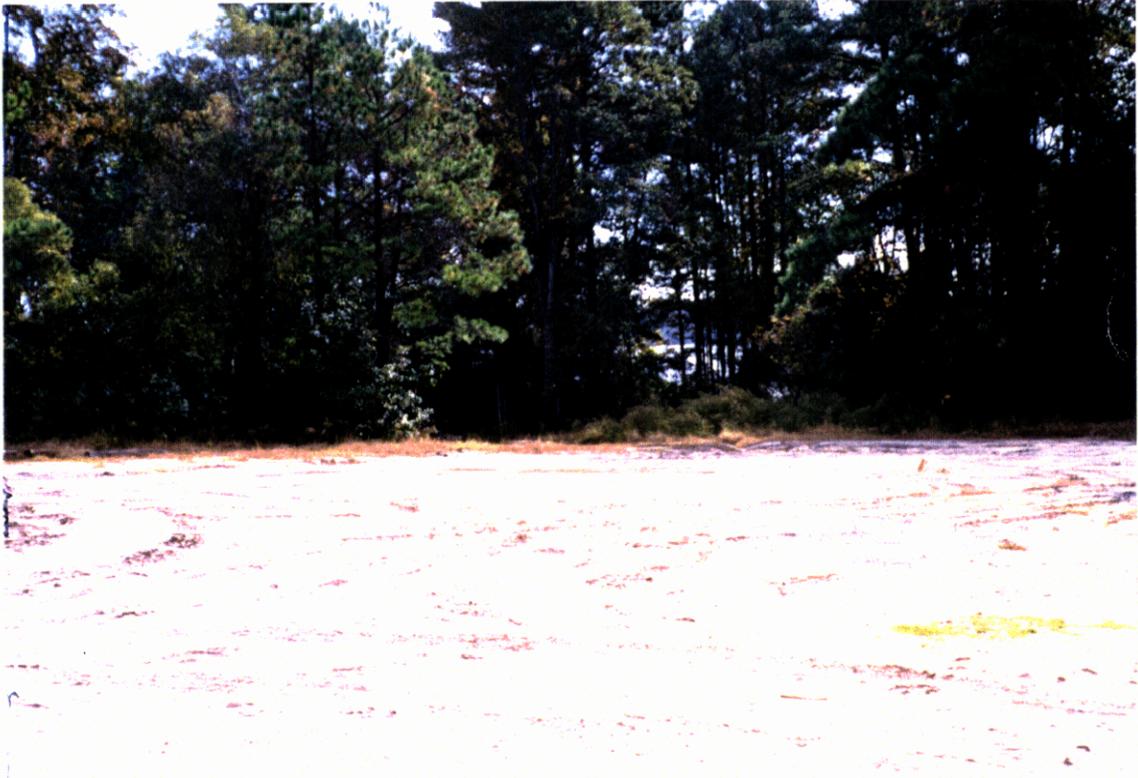
OU8-Site16: Photograph taken from monitoring well 16-MW05 looking east/southeast at the open area leading down towards Northeast Creek.

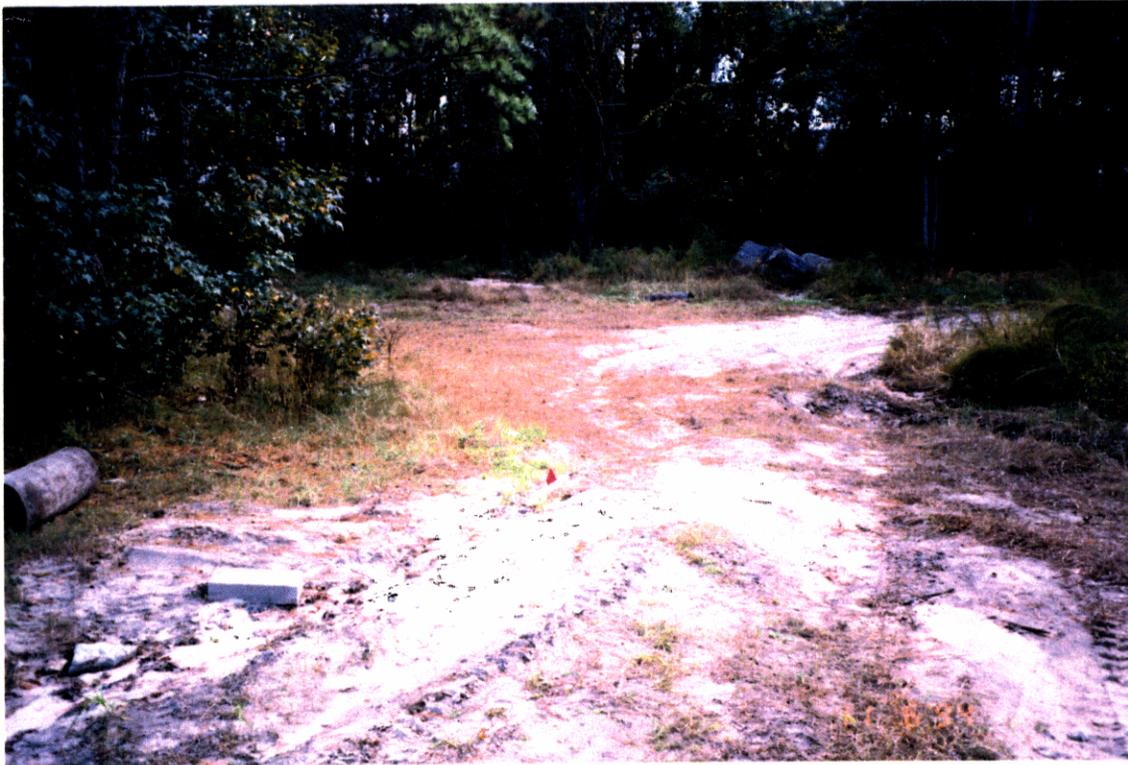
OU8-Site16: View looking east across the surface drainage area. Hand auger location 16-SDA-SB01 is in the foreground and 16-SDA-SB02 is in the background. The cleared area depicts a sewer right-of-way that crosses (from northeast to southwest) the drainage area.

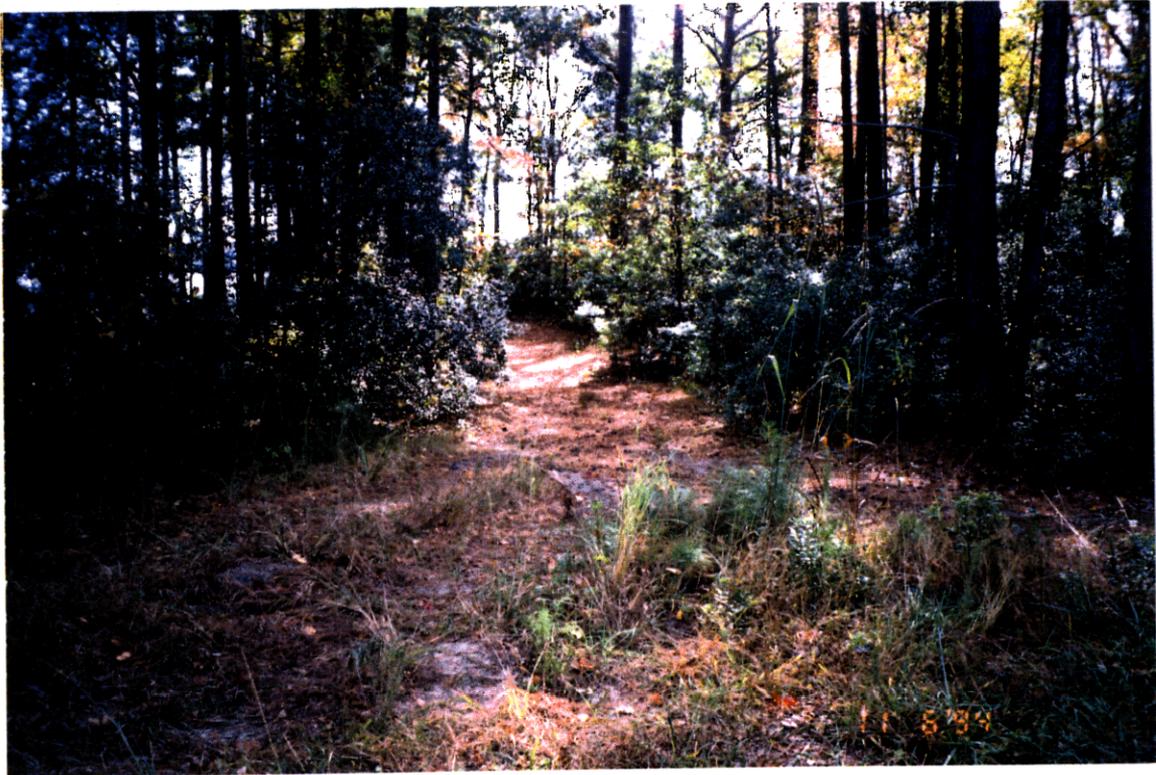
OU8-Site16: View is looking south/southeast along access road towards Northeast Creek. Hand auger location 16-SDA-SB03 is in the foreground. This access leads to monitoring well location 16-MW03.

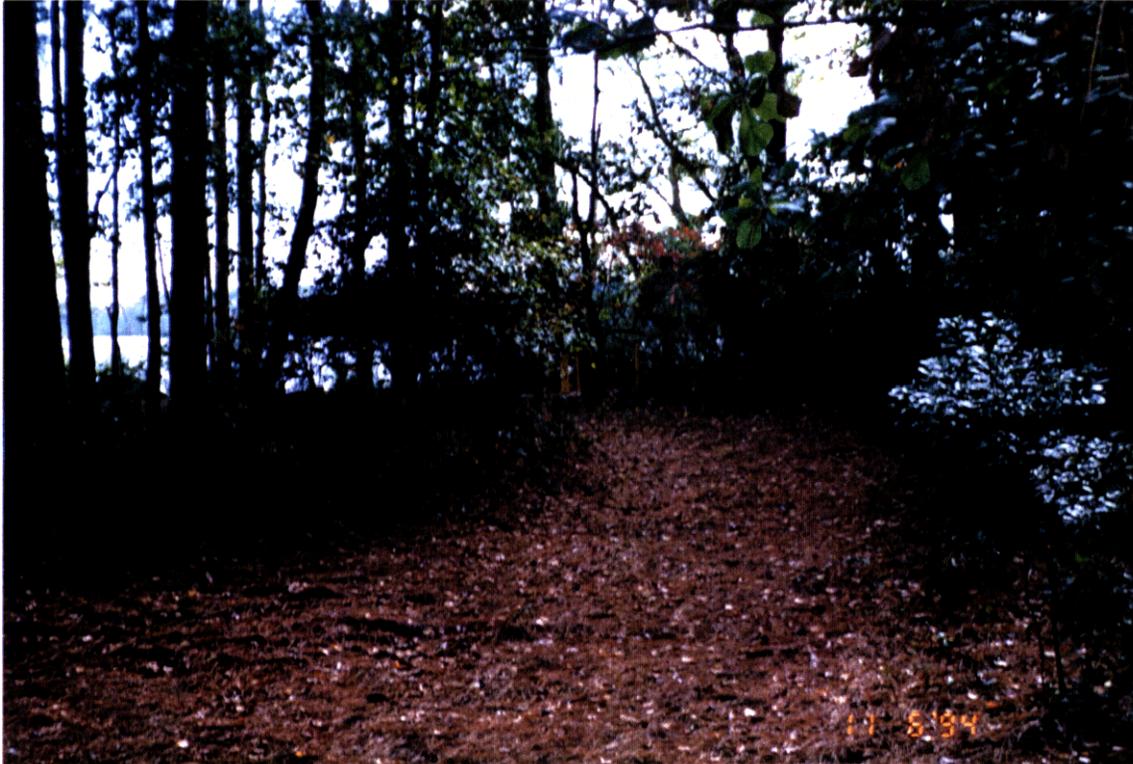
OU8-Site16: Photograph taken on access road looking southeast at monitoring well 16-MW03. Northeast Creek is in the background.

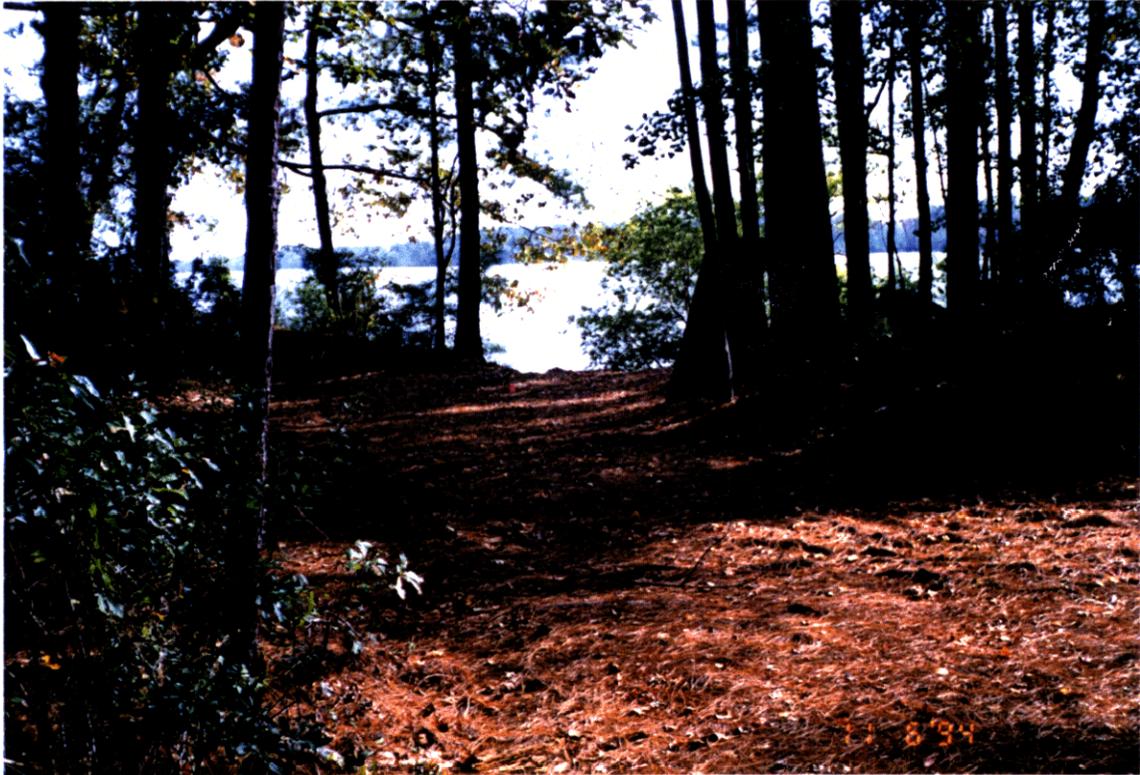
OU8-Site16: Looking east/southeast along access road to Northeast Creek. Hand auger location 16-SDA-SB04 is marked by red flag in the center of photograph. Monitoring well 16-MW03 is to the back right of photograph.

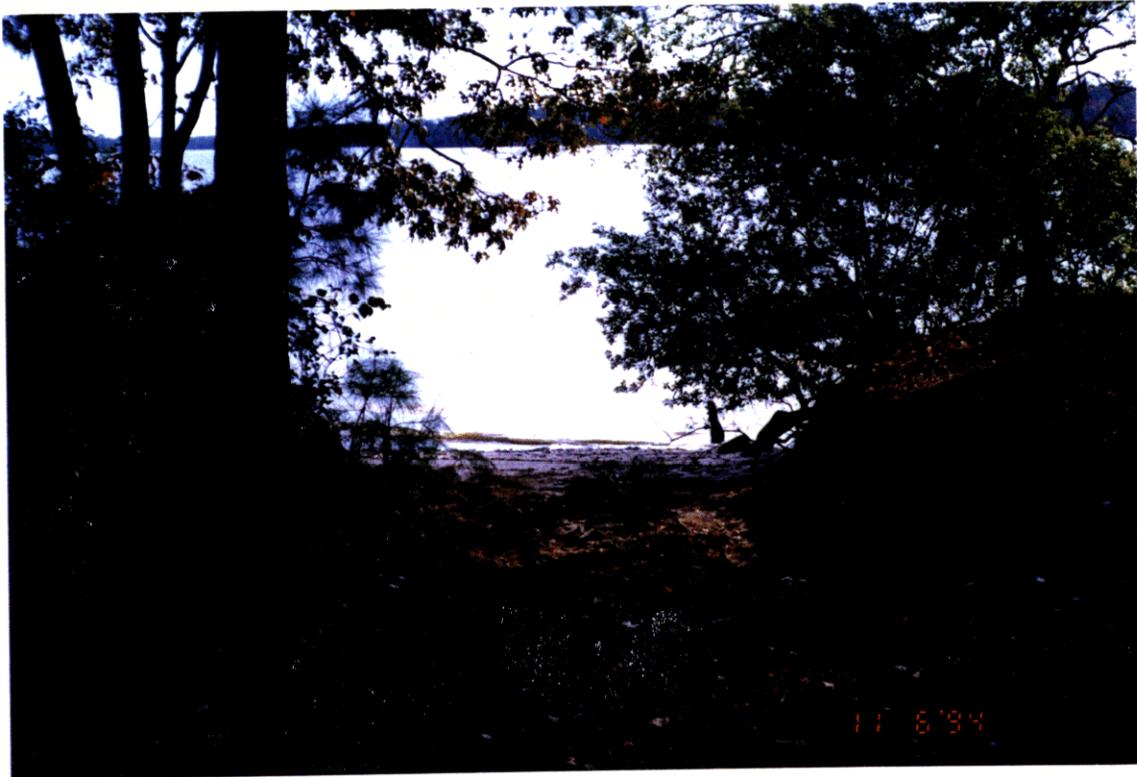
OU8-Site16: Photograph taken from hand auger location 16-SDA-SB04 looking east/southeast along access ramp to Northeast Creek. This is a probable location for a staff gauge. Monitoring well 16-MW03 is to the right of the photograph.

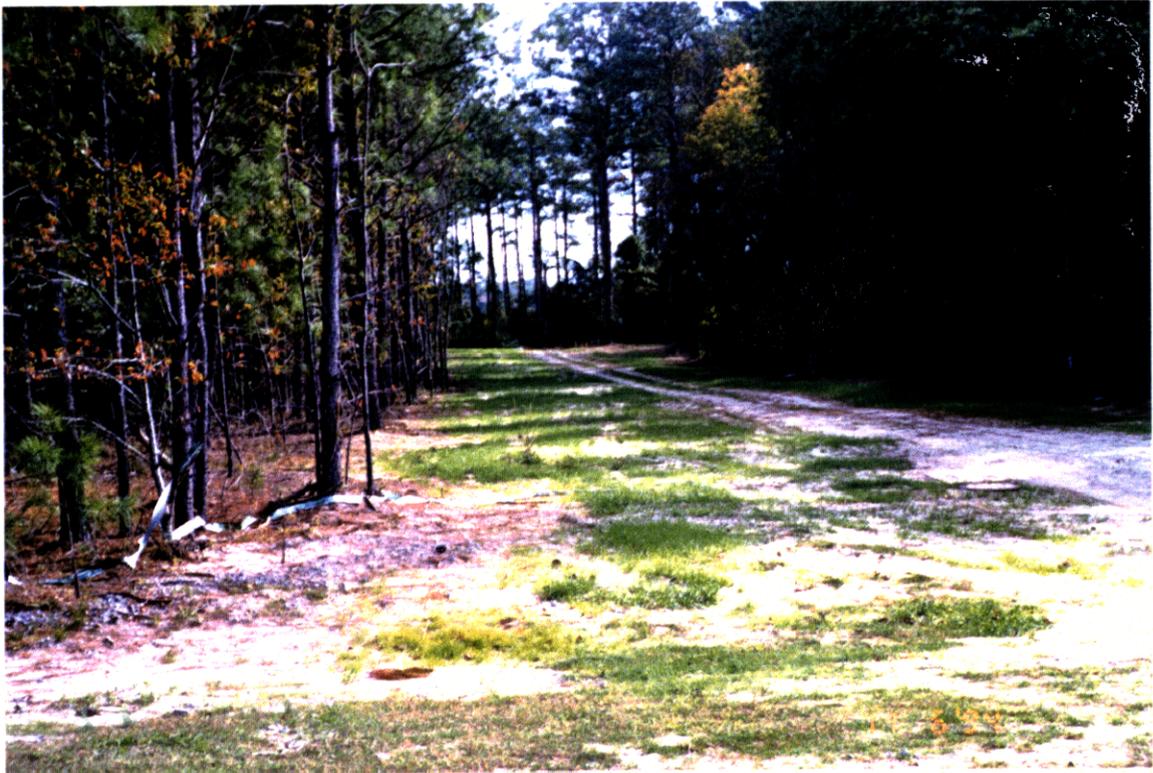
OU8-Site16: View is from Harding Road looking east/southeast along the sewer right-of-way. Monitoring well 16-MW04 can be seen in the distance near the center of the picture. The cleared area of the Former Burn Dump is located thru woods on the left side of sewer right-of-way.

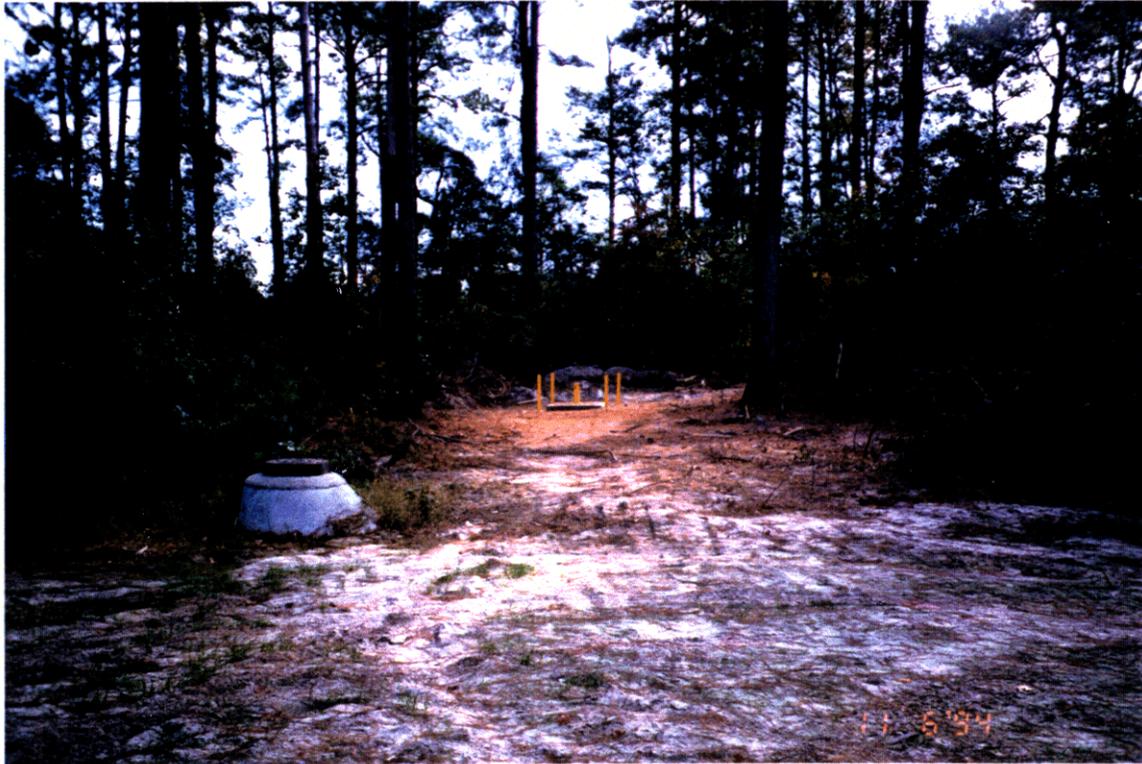
OU8-Site16: Monitoring well 16-MW04, looking east/southeast, with a sewer manhole in the foreground. This location is the intersection point of the two sewer right-of-ways.

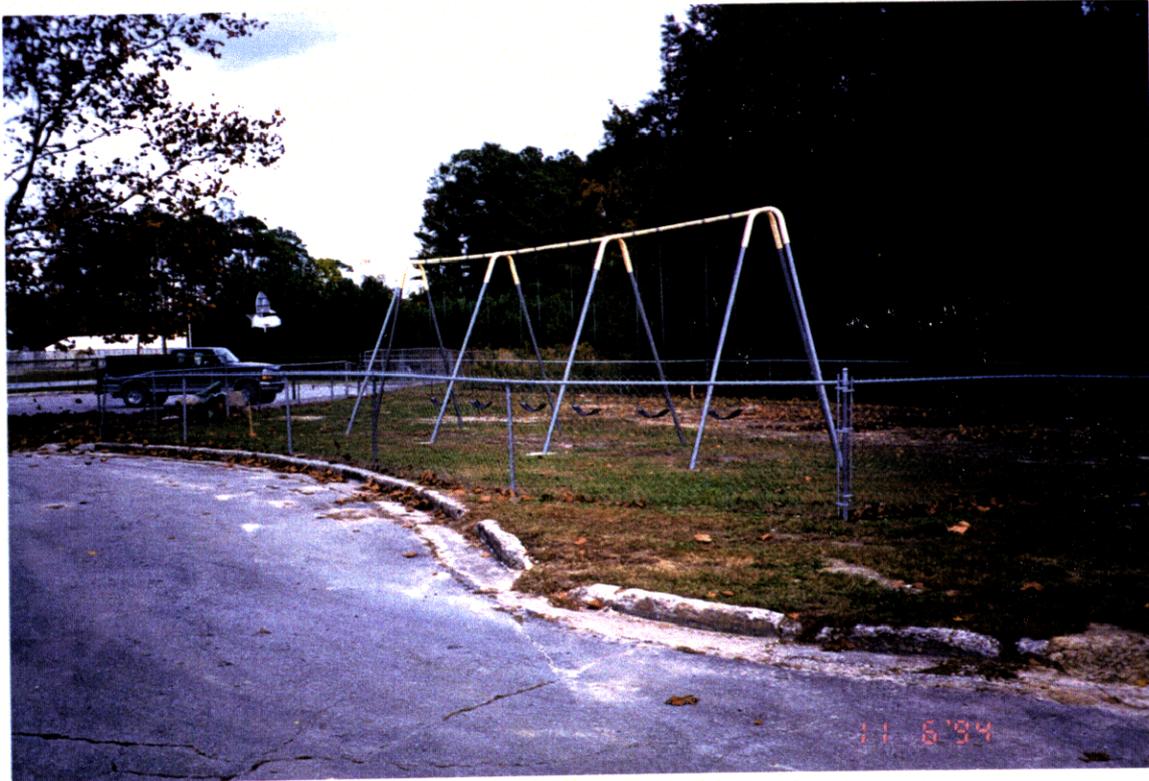
OU11-Site7: Photograph was taken from the rear of the Community Center looking east towards playground. Soil borings 7-CC-SB01 and 7-CC-SB02 are in the playground area. "East" area of concern is to the right of the photograph.

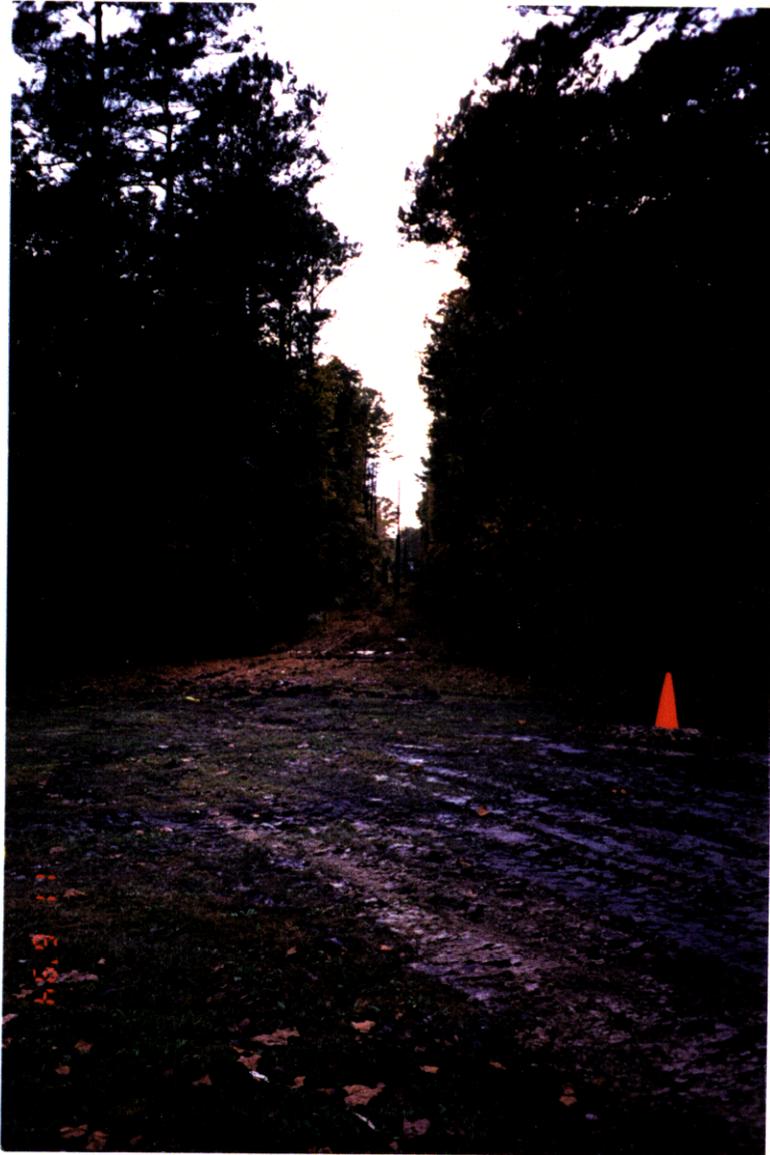
OU11-Site7: Photograph taken from Tarawa Boulevard looking west/southwest along electric service line right-of-way to sewage treatment plant. Test boring 7-NA-SB03 is in the foreground.

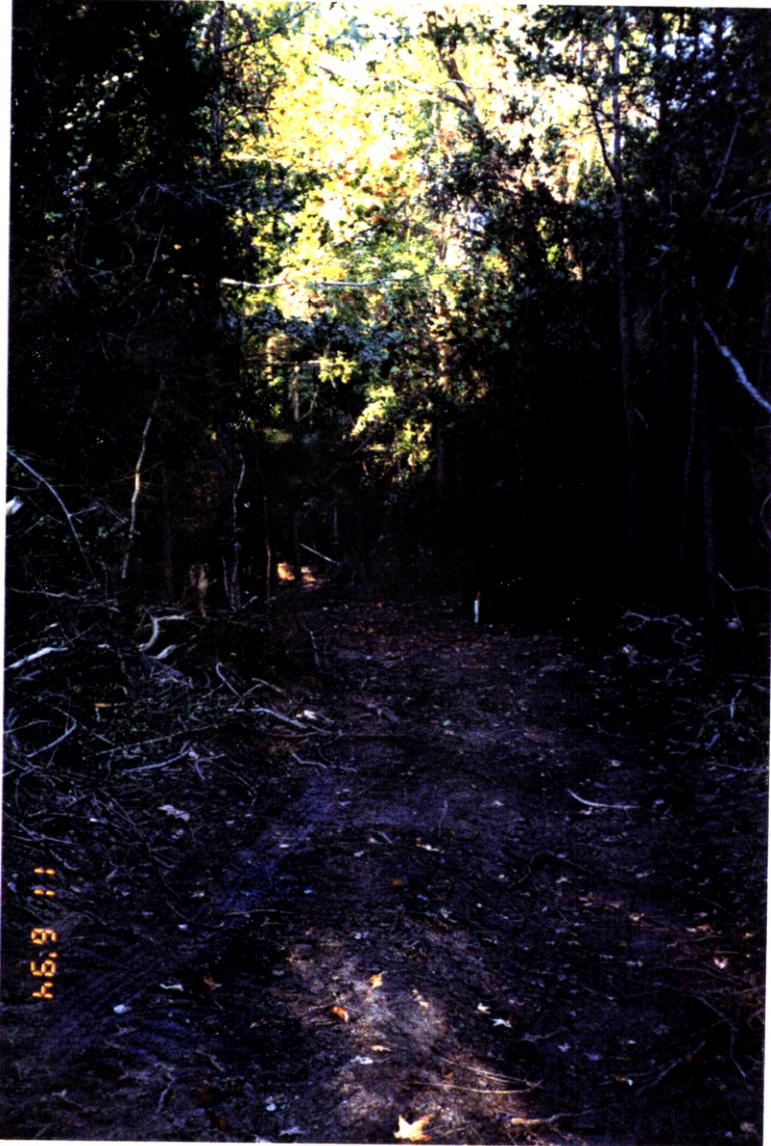
OU11-Site7: View is from cleared access road in southwest area looking east/northeast toward temporary well 7-TW02. Hand auger 7-SWA-SB04 is approximately 15 feet on the left side of the cleared access road.

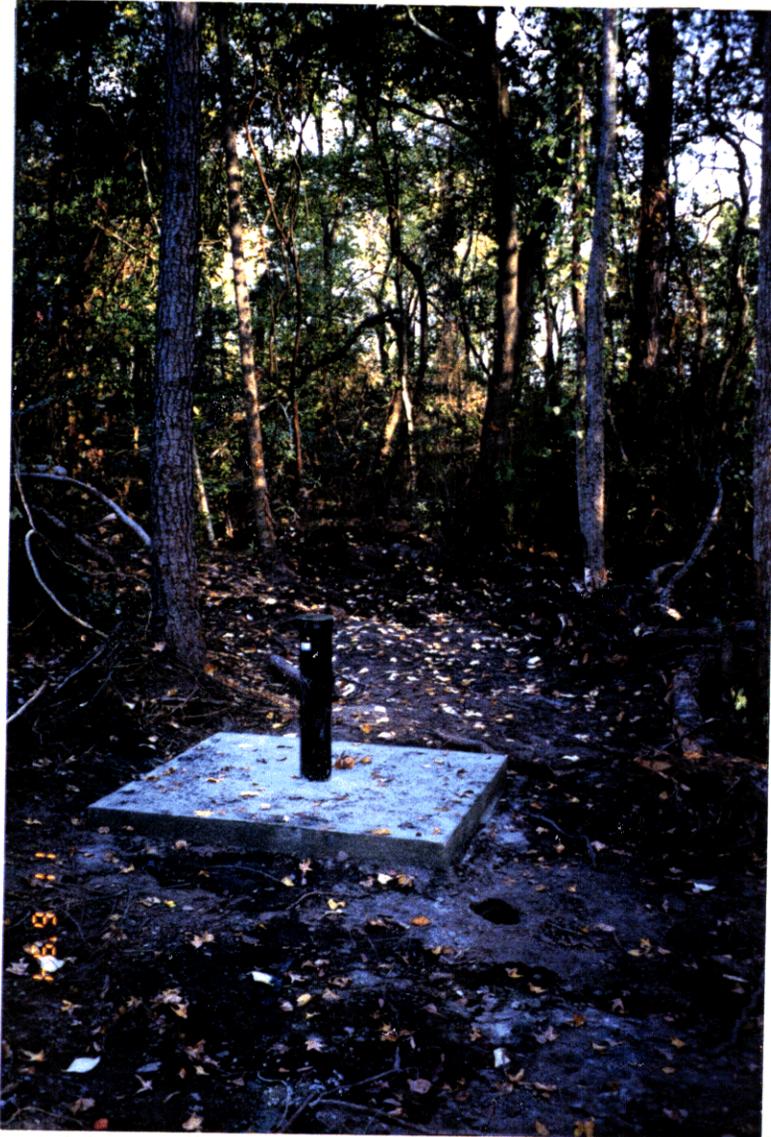
OU11-Site7: Close-up of monitoring well 7-MW05 showing the soft area behind well where a backhoe was stuck. This area is at the northern boundary of swamp.

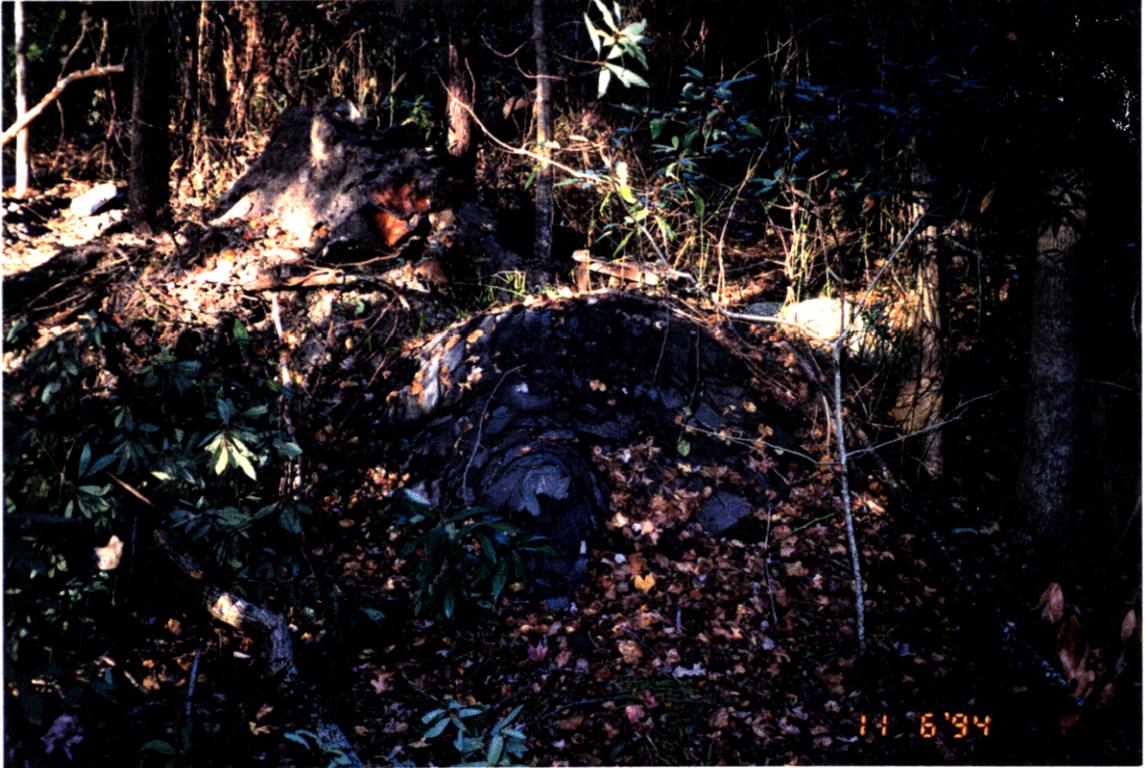
OU11-Site7: Photograph shows a large pile of asphalt roofing shingles near the cleared access road in the southwest area. This is near monitoring well 7-MW05.

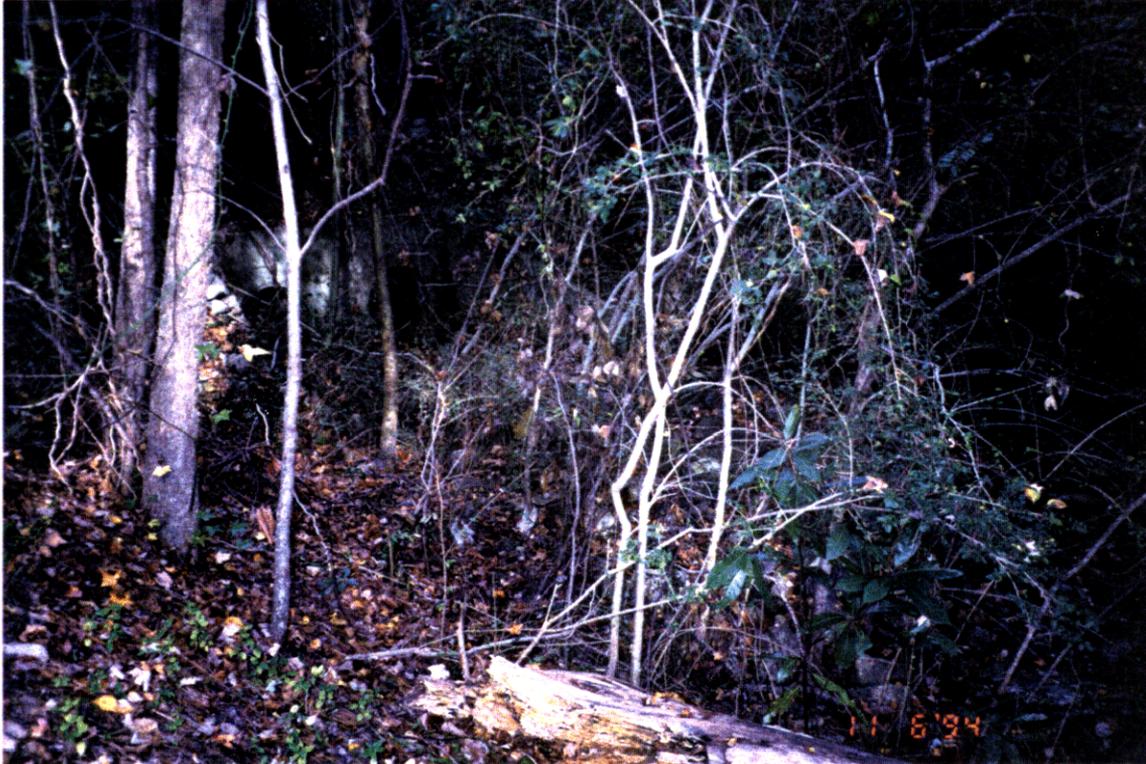
OU11-Site7: Photograph shows culvert from storm drains. This is the start the Eastern Tributary in the “east” area of concern.

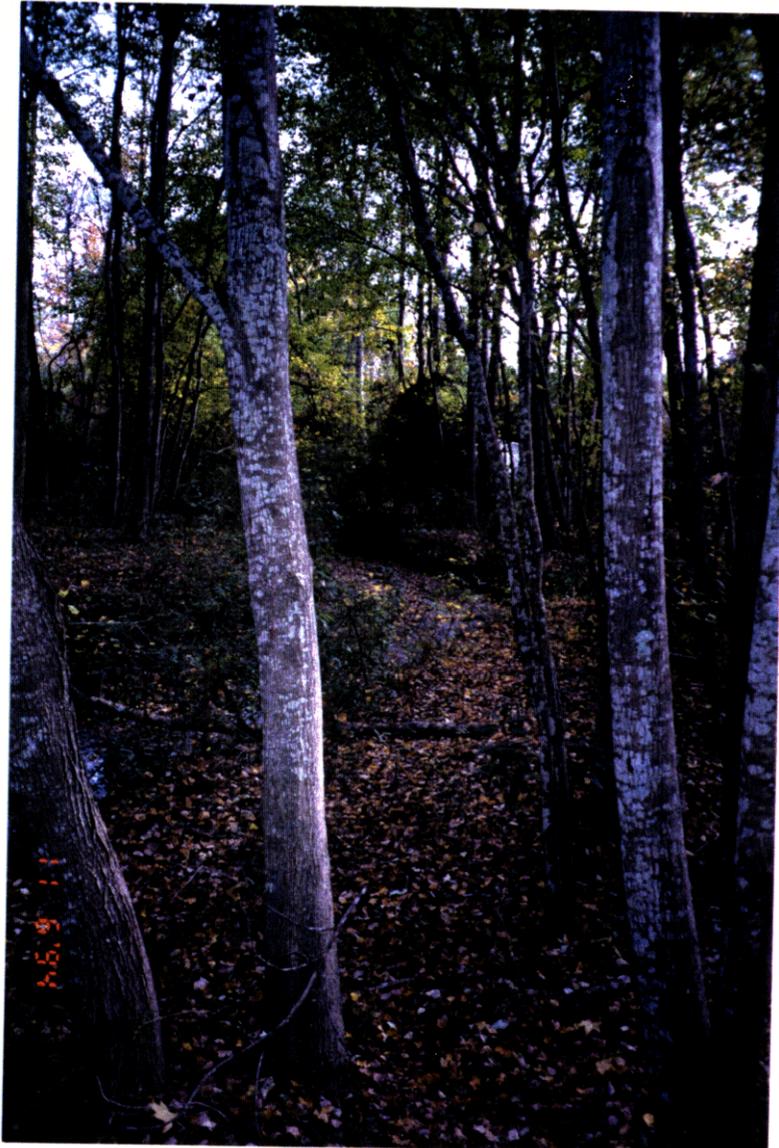
OU11-Site7: This view is looking south along the Eastern Tributary course. A drainage ditch is coming in from the right hand side into the Eastern Tributary at the center of photograph. Monitoring well 7-MW01 is located towards the south on the west side of the Tributary.

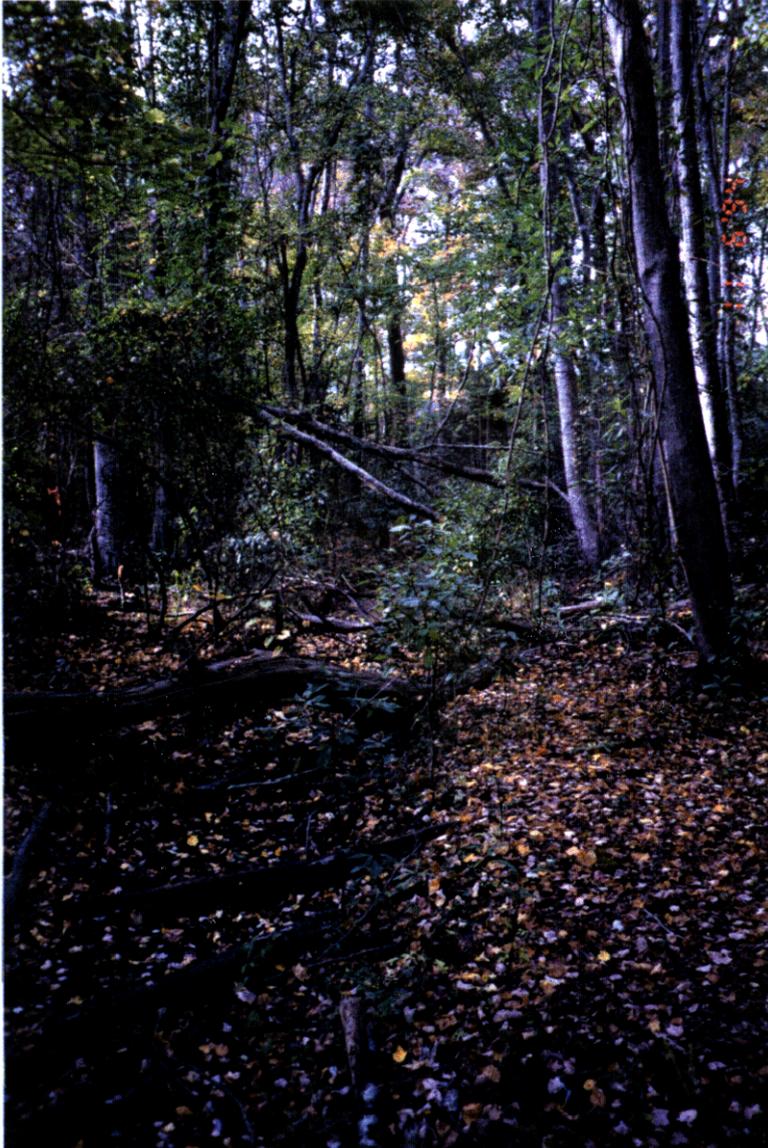
OU11-Site7: View is looking northwest in the upstream direction of the drainage ditch in the “east” area. Photograph was taken approximately 25-30 feet from the confluence with the Eastern Tributary. Soil boring 7-EA-SB06 is on the left side of the photograph.

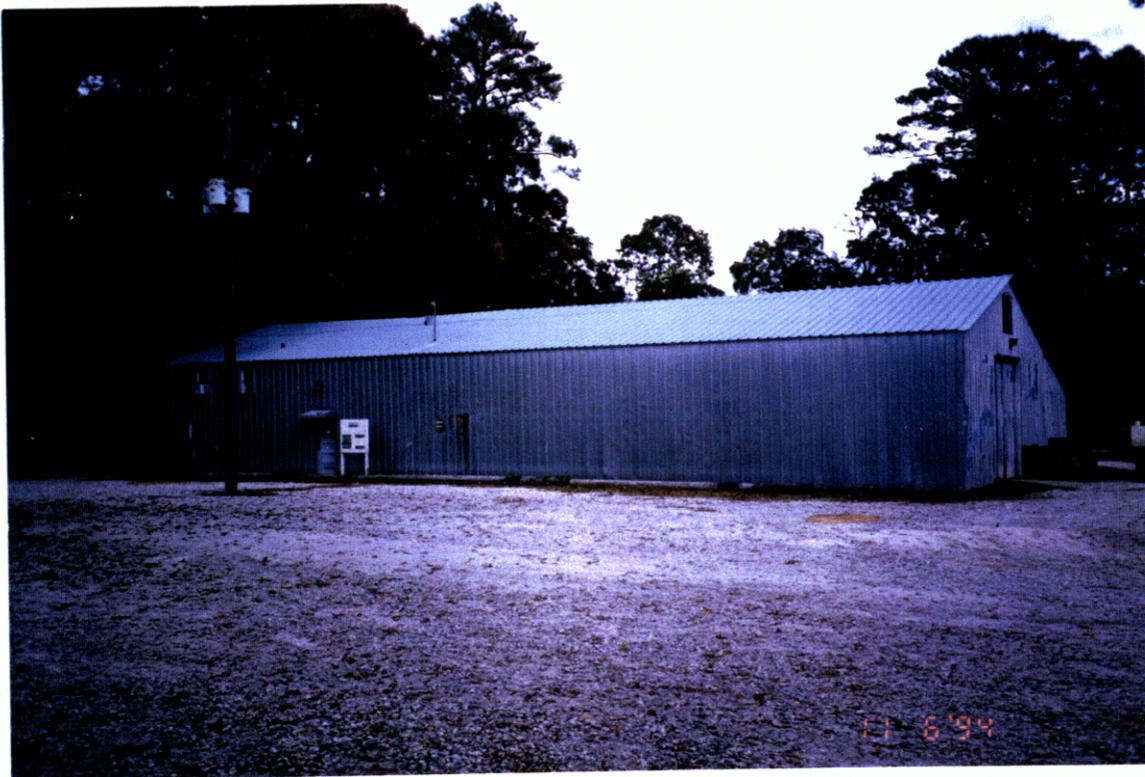
OU11-Site80: View is from the fuel dispensing area looking northeast towards Building 1916. Test borings 80-MA-SB01 and 80-MA-SB03 are visible.

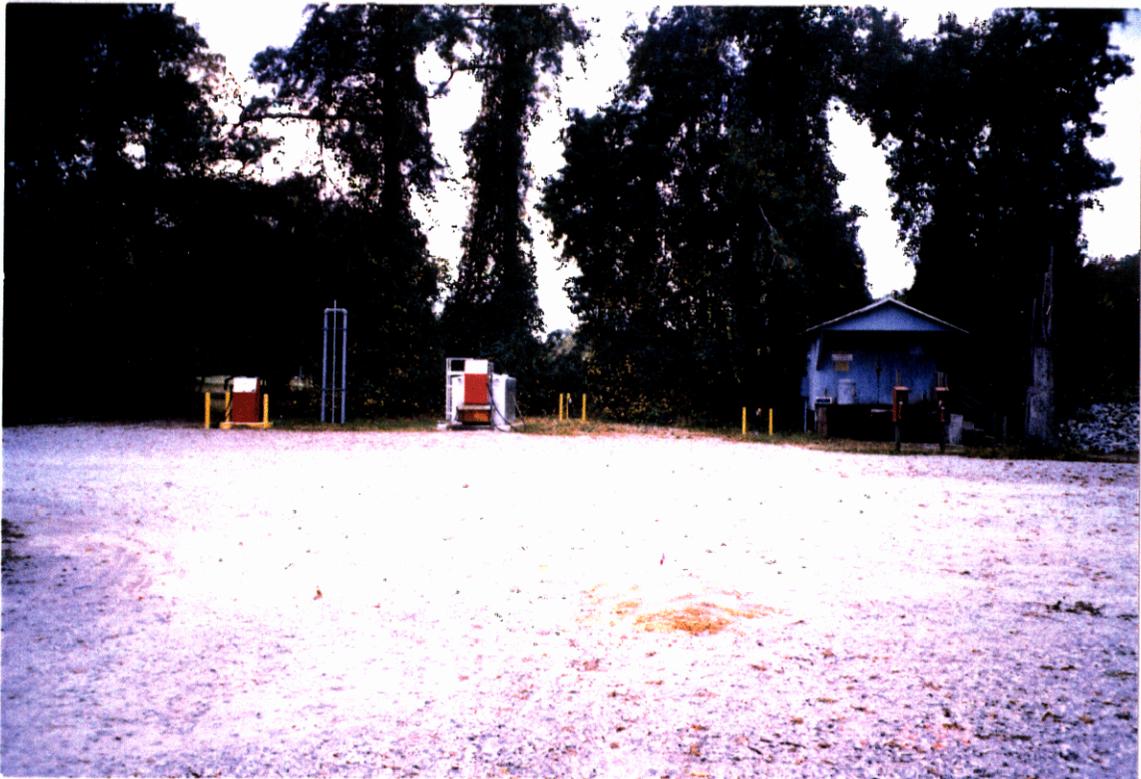
OU11-Site80: Photograph taken from the southeast corner the Maintenance Building 1916 looking west/southwest towards the fuel-dispensing area. Two groundwater monitoring wells (UST site) are shown.

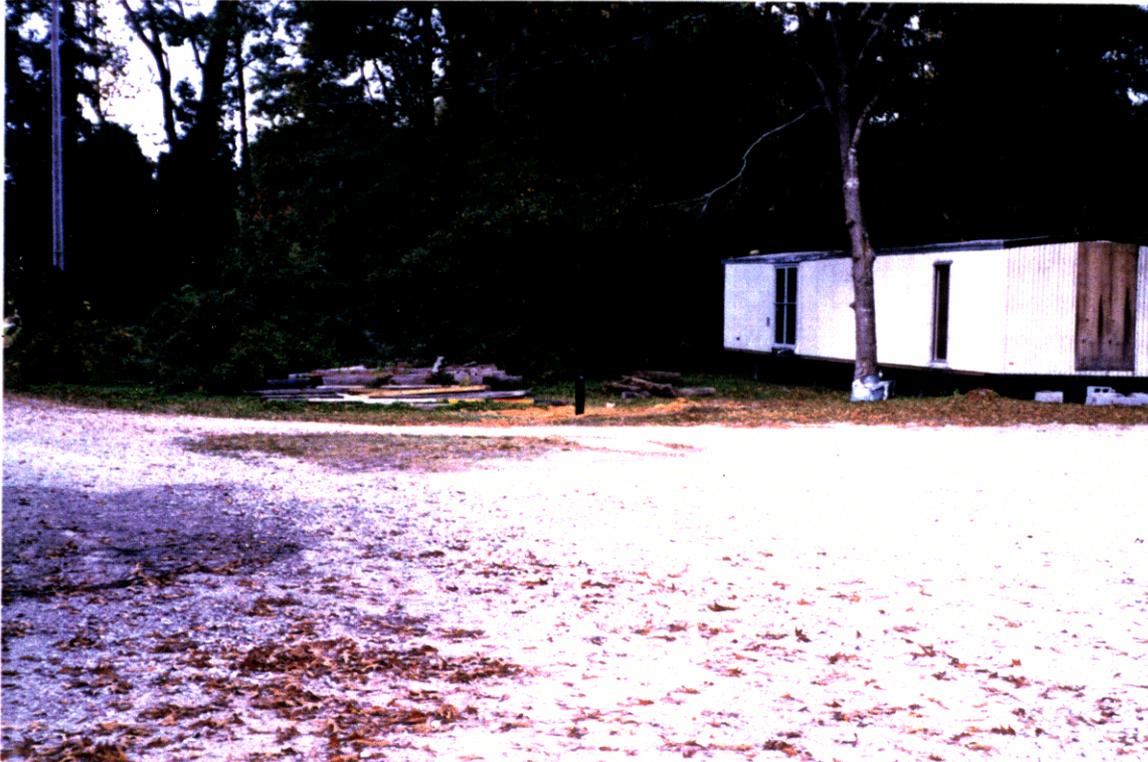
OU11-Site80: Photograph taken from Access Road looking north/northwest to maintenance area and monitoring well 80-MW04. This well is located off of the northwest corner of Building 1916, also this well is located in the septic tank area.

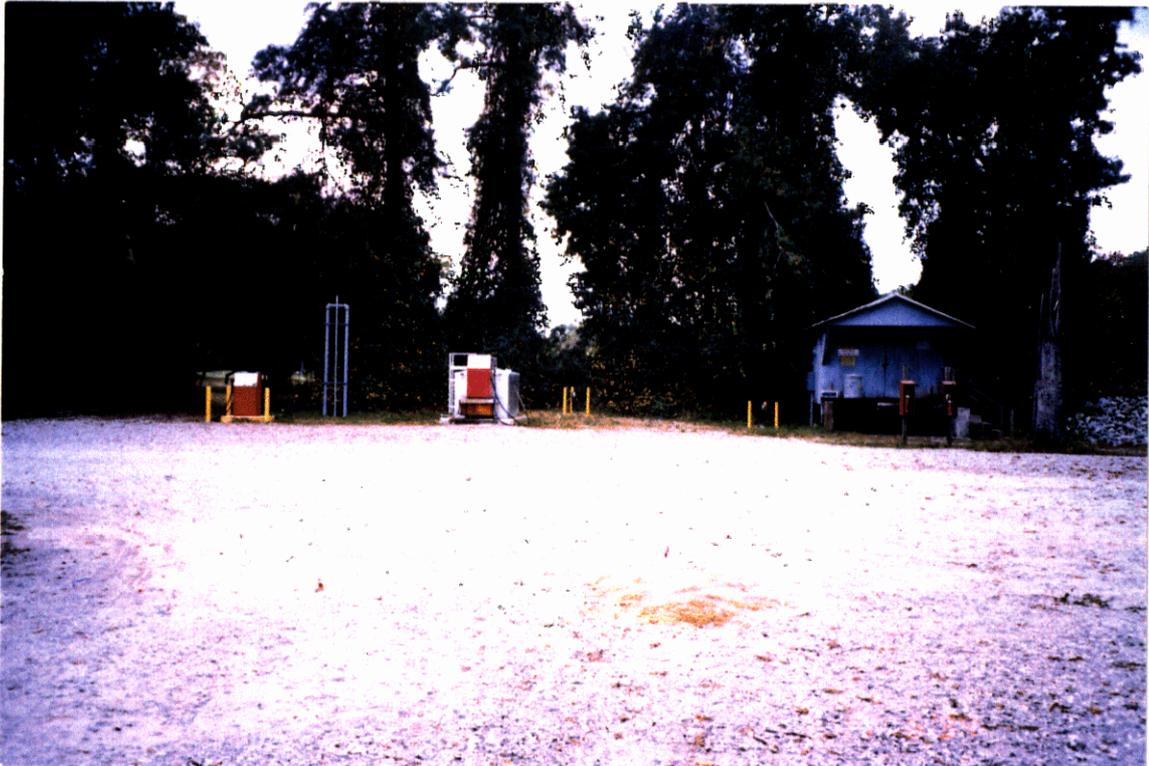
OU11-Site80: Photograph taken from the southeast corner the Maintenance Building 1916 looking west/southwest towards the fuel-dispensing area. Two groundwater monitoring wells (UST site) are shown.

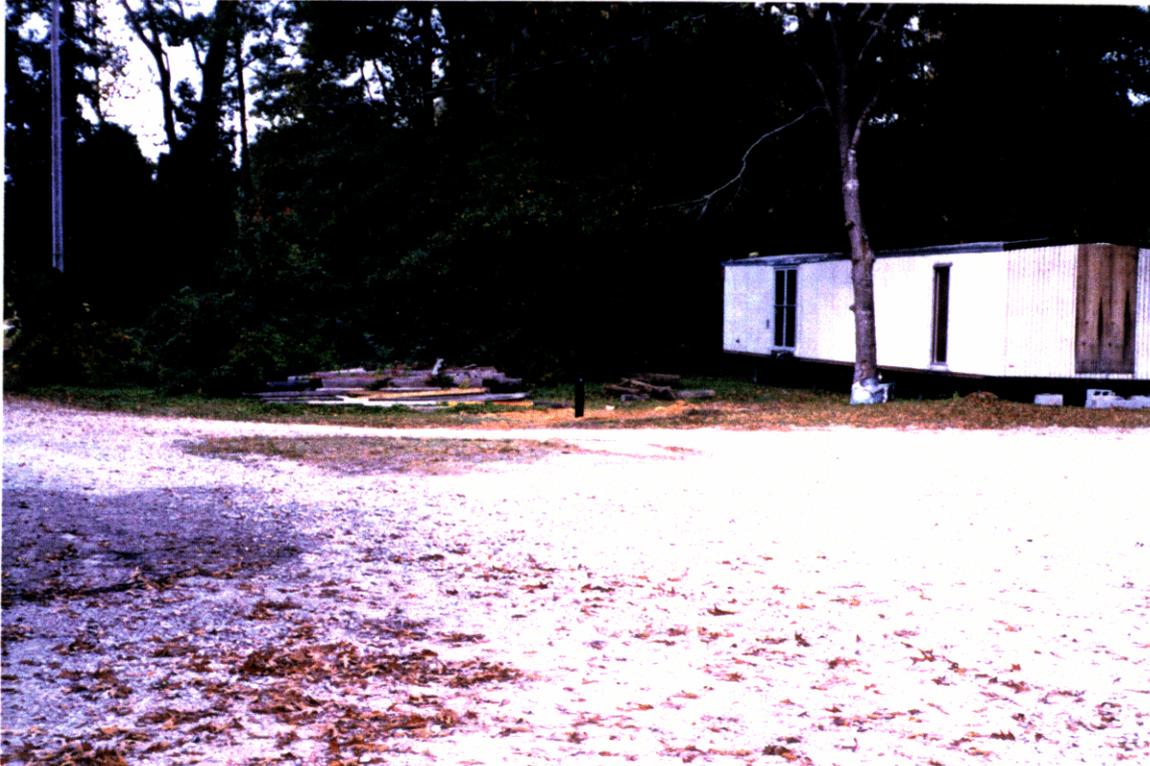
OU11-Site80: Photograph taken from Access Road looking north/northwest to maintenance area and monitoring well 80-MW04. This well is located off of the northwest corner of Building 1916, also this well is located in the septic tank area.
