REMEDIAL INVESTIGATION PHOTOGRAPH ALBUM

**OPERABLE UNIT NO. 8 (SITE 16)
OPERABLE UNIT NO. 11 (SITES 7 AND 80)
OPERABLE UNIT NO. 12 (SITE 3)**

**MARINE CORPS BASE, CAMP LEJEUNE
NORTH CAROLINA**

MARCH 27, 1995

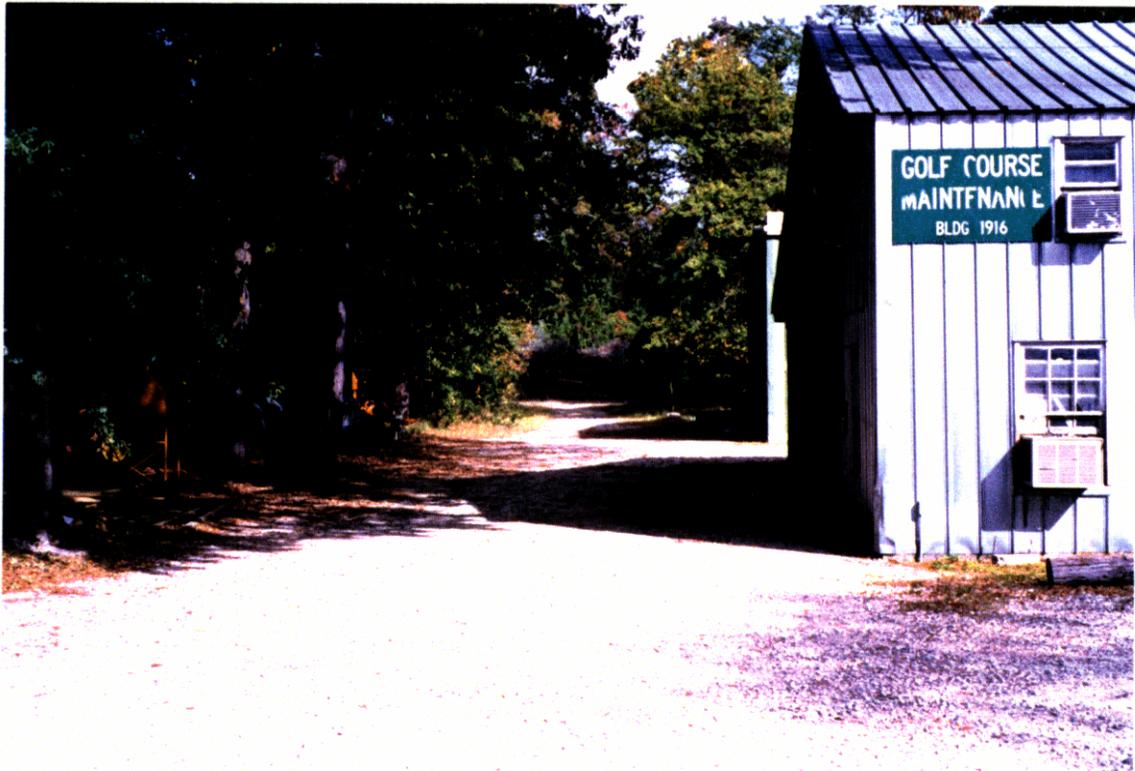
OU11-Site80: View is looking east/northeast along Access Road leading back to the open area. Maintenance Buildings 1916 and 600 are on the right hand side.

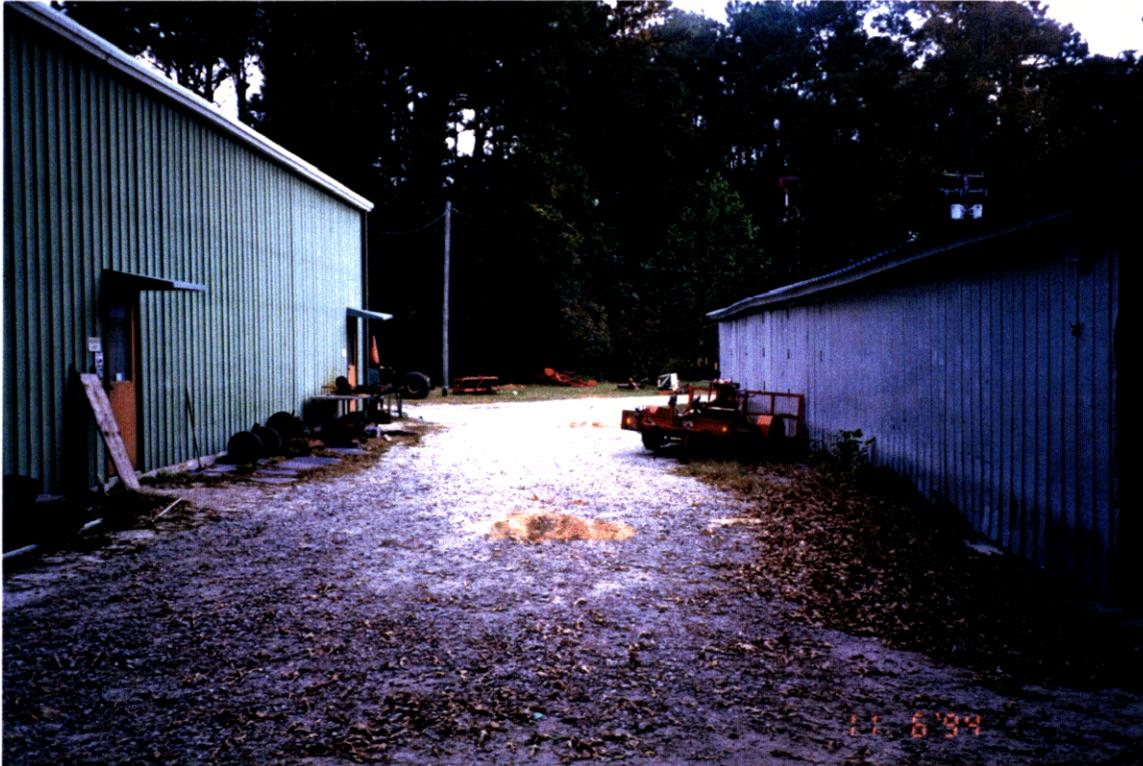
OU11-Site80: View is looking south/southeast between Maintenance Buildings 1916 (on right) and 600. Test borings 80-MA-SB02 and 80-MA-SB04 are between the buildings.

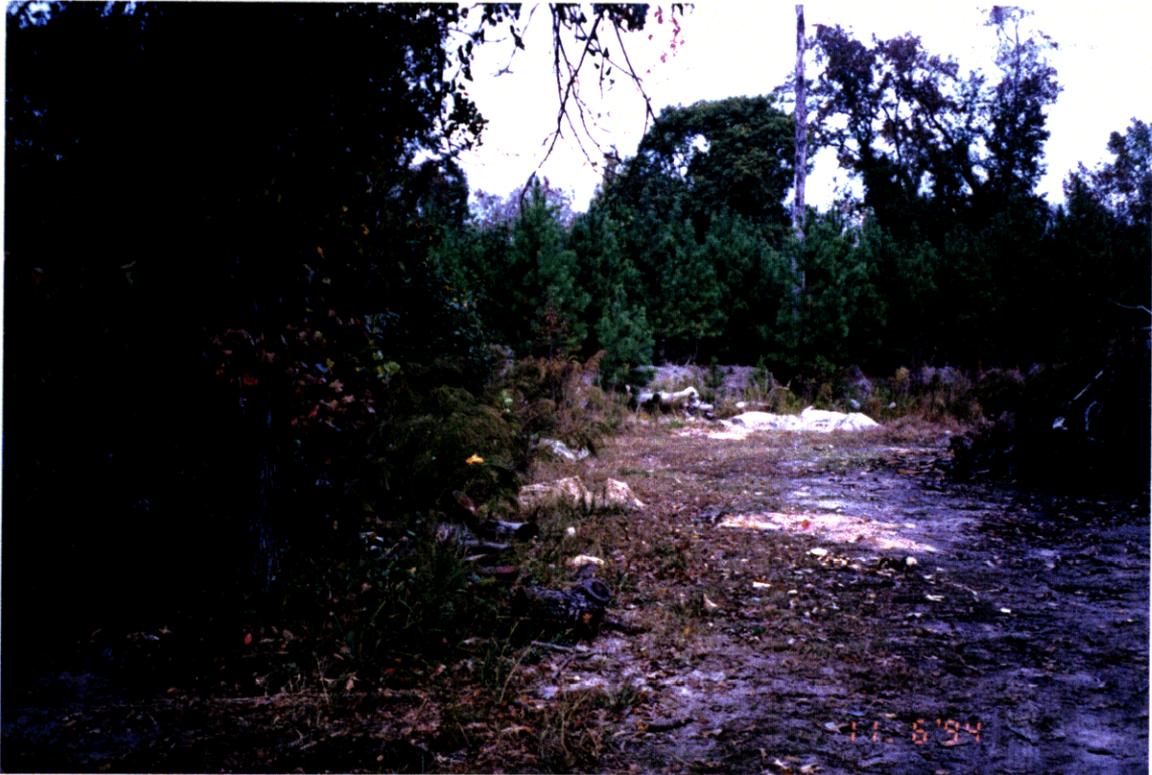
OU11-Site80: The next three photographs are a panorama view of the open area with debris pile. A low soil mound approximately 5-6 feet high can be seen in the background with young pine tree growth. Test borings 80-OA-SB01 and 80-OA-SB02 are located to the left side of the open area. The orange flagging visible in front of the soil mound indicates access to hand auger locations performed on top of the mound.

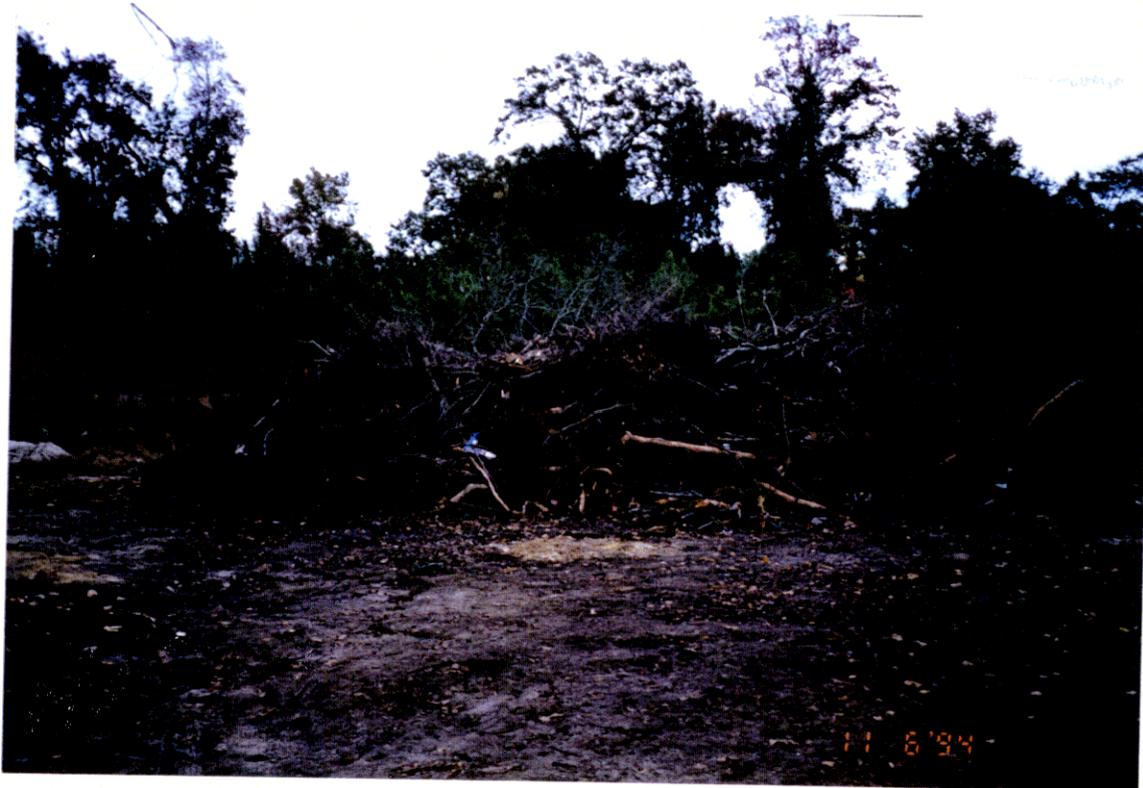
OU11-Site80: This photograph is the middle of the panorama view showing the debris pile. Test boring 80-OA-SB03 is located directly in front of the debris pile.

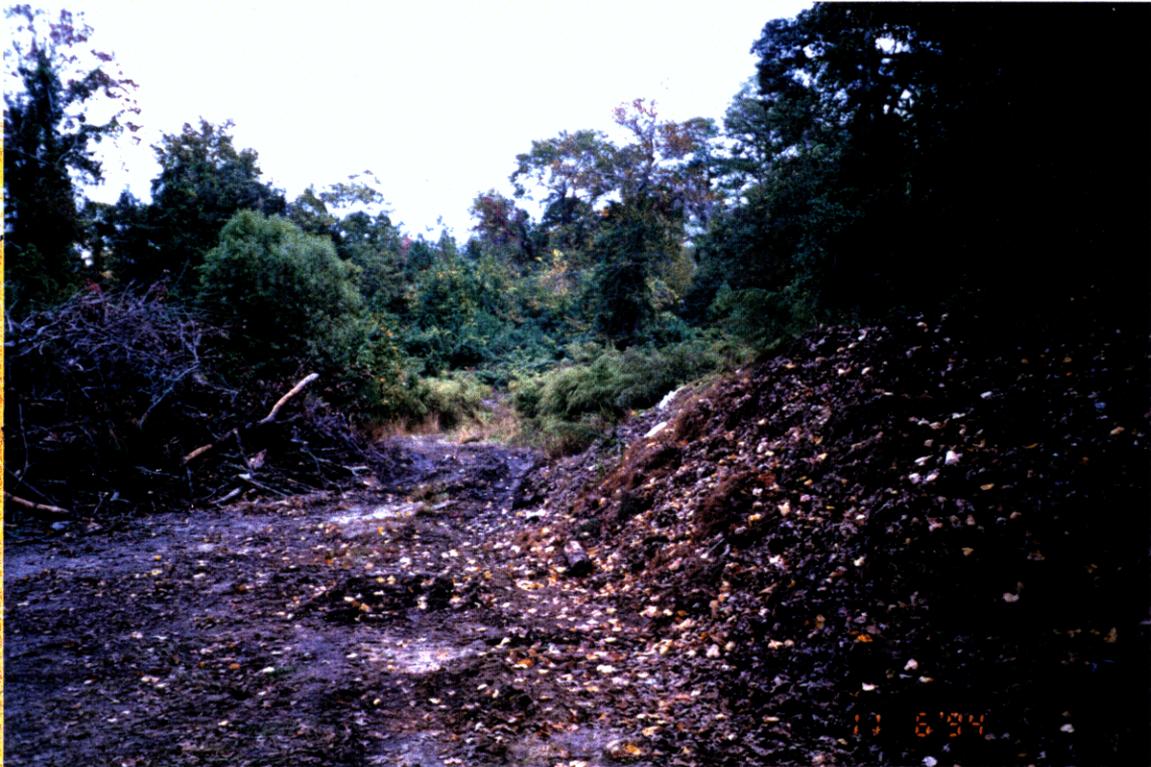
OU11-Site80: Photograph shows the right side of the debris pile. Test boring 80-OA-SB05 is located in the foreground and to the right of the debris pile.

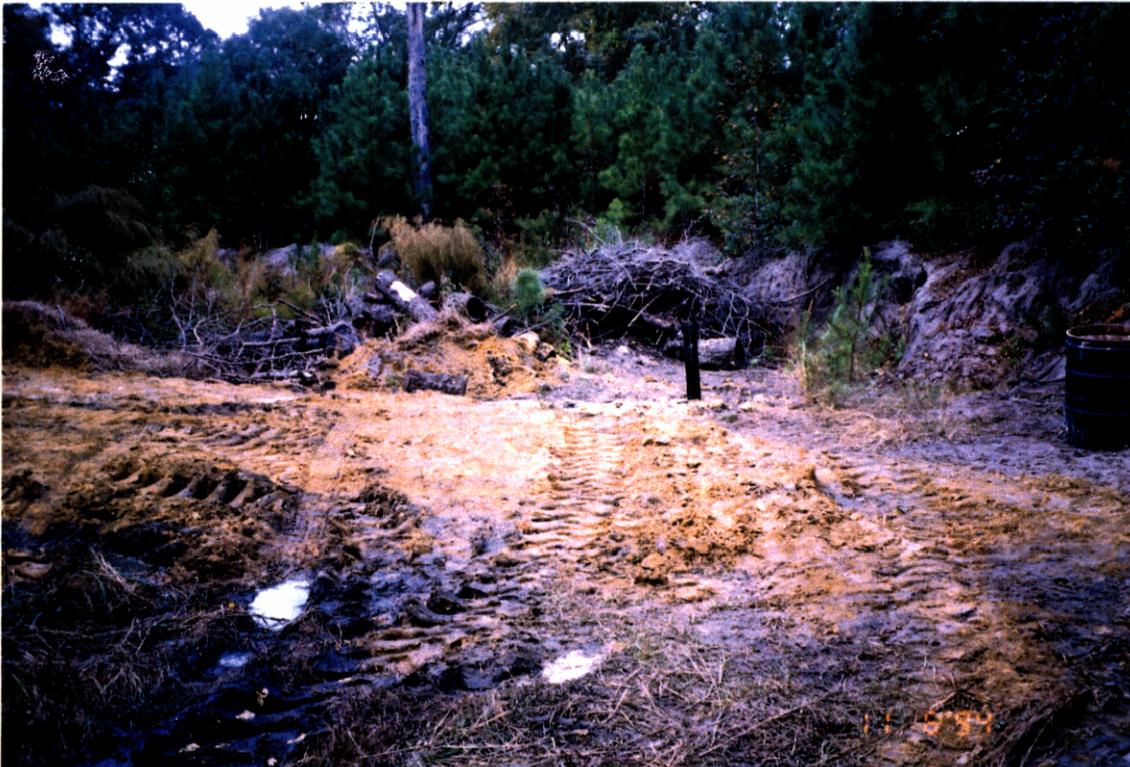
OU11-Site80: Photograph taken from the rear of the right side of the debris pile looking north towards monitoring well 80-MW06. Test boring 80-OA-SB04 was drilled in the cleared area to the left of 80-MW06.

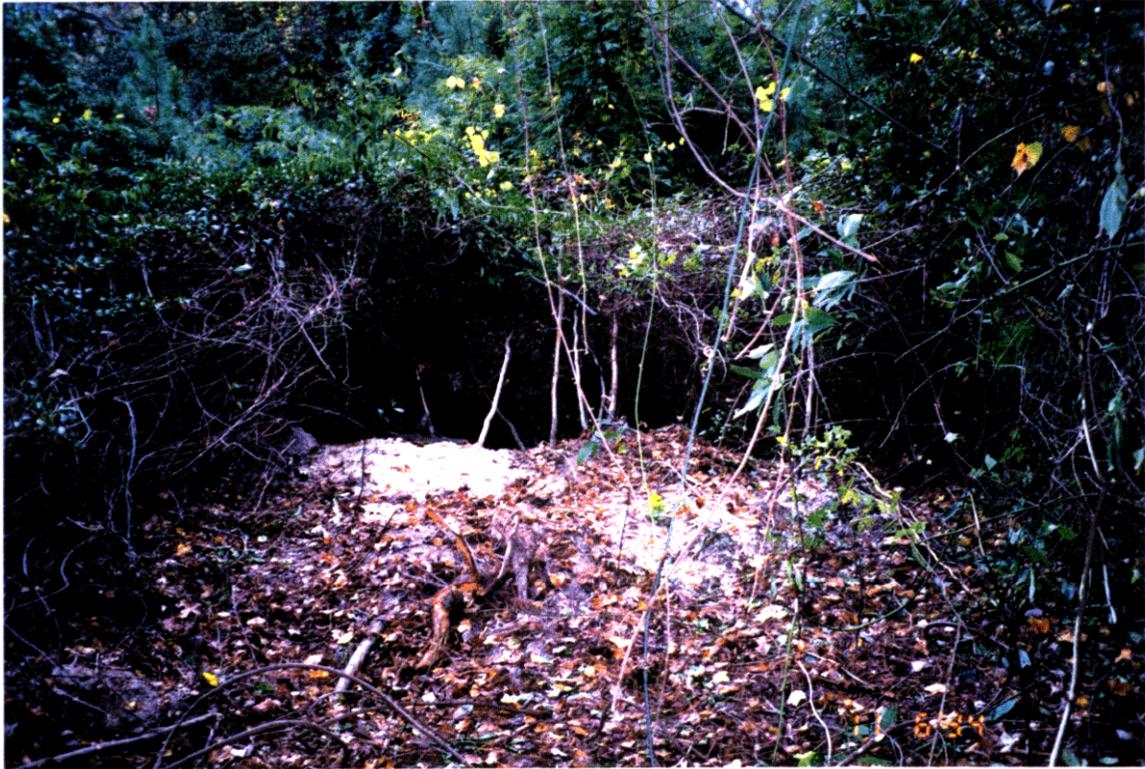
OU11-Site80: Photograph taken from 80-BB-SB01 looking east/southeast. A ditch, approximately 6 feet deep, is 12-15 feet away.

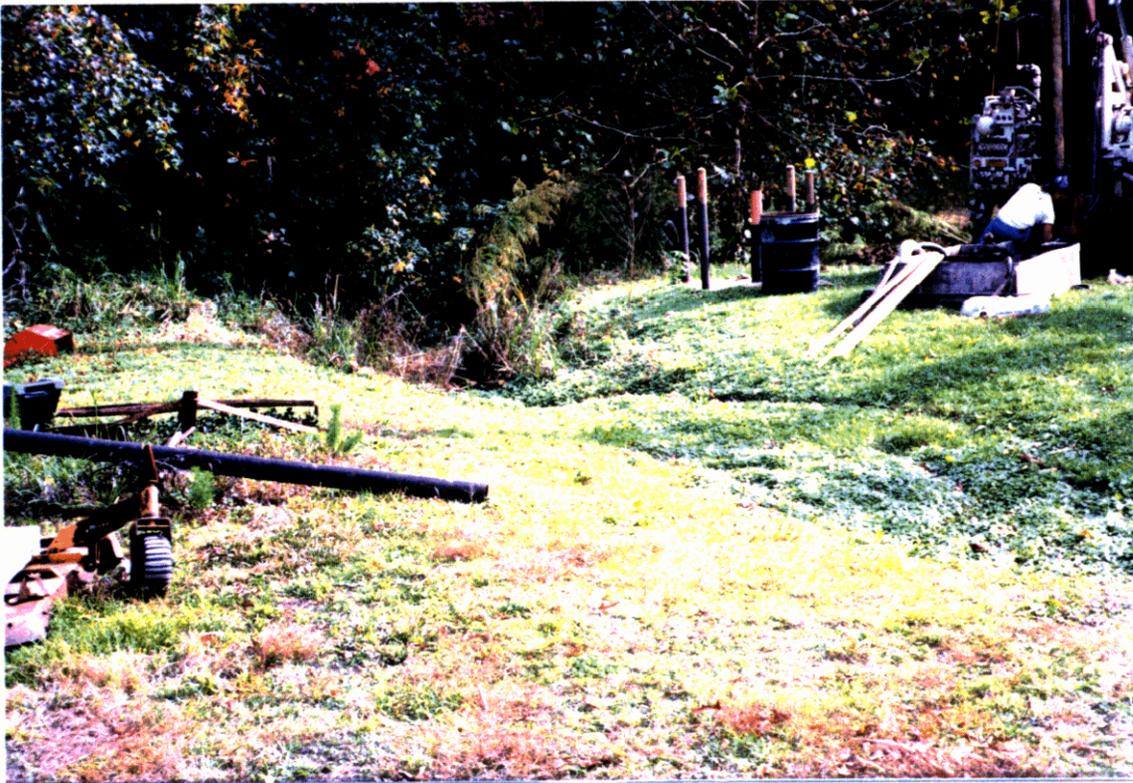
OU11-Site80: Photograph taken from south side of Building 1916 looking south/southeast. A shallow drainage channel leads into the drainage ditch. Monitoring well 80-MW03 can be seen to the right side of the drainage ditch. A drilling rig is set up on intermediate well 80-MW03IW.

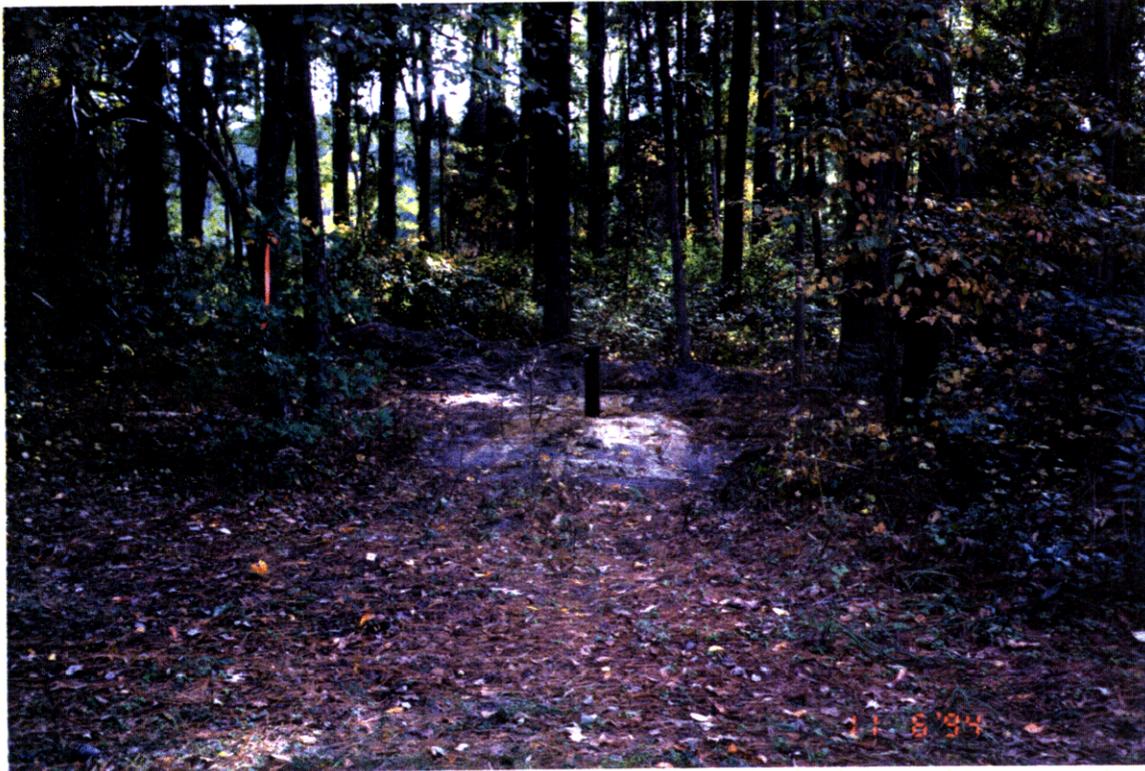
OU11-Site80: View is taken from electrical right-of-way looking south/southwest. Monitoring well 80-MW07 “background well” is in the center of the photograph.

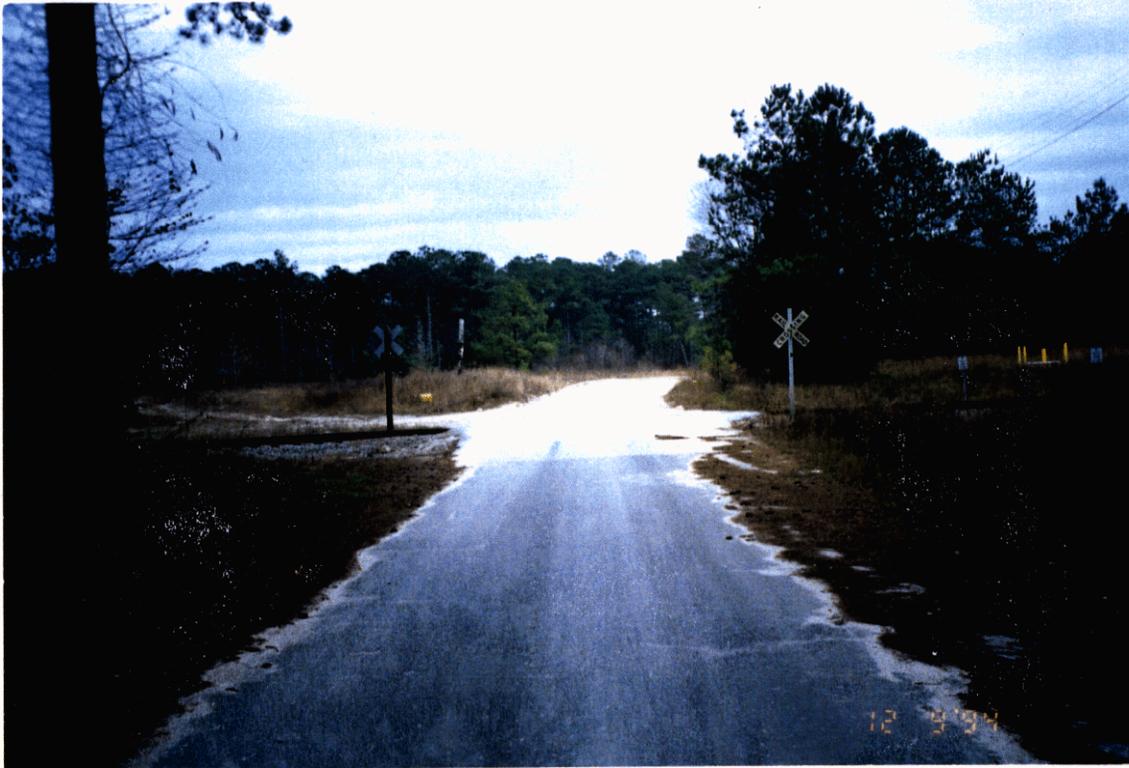
OU12-Site3: Photograph taken from Access Road off Holcomb Boulevard before railroad tracks, looking east. Monitoring well 3-MW04 is visible on the right.

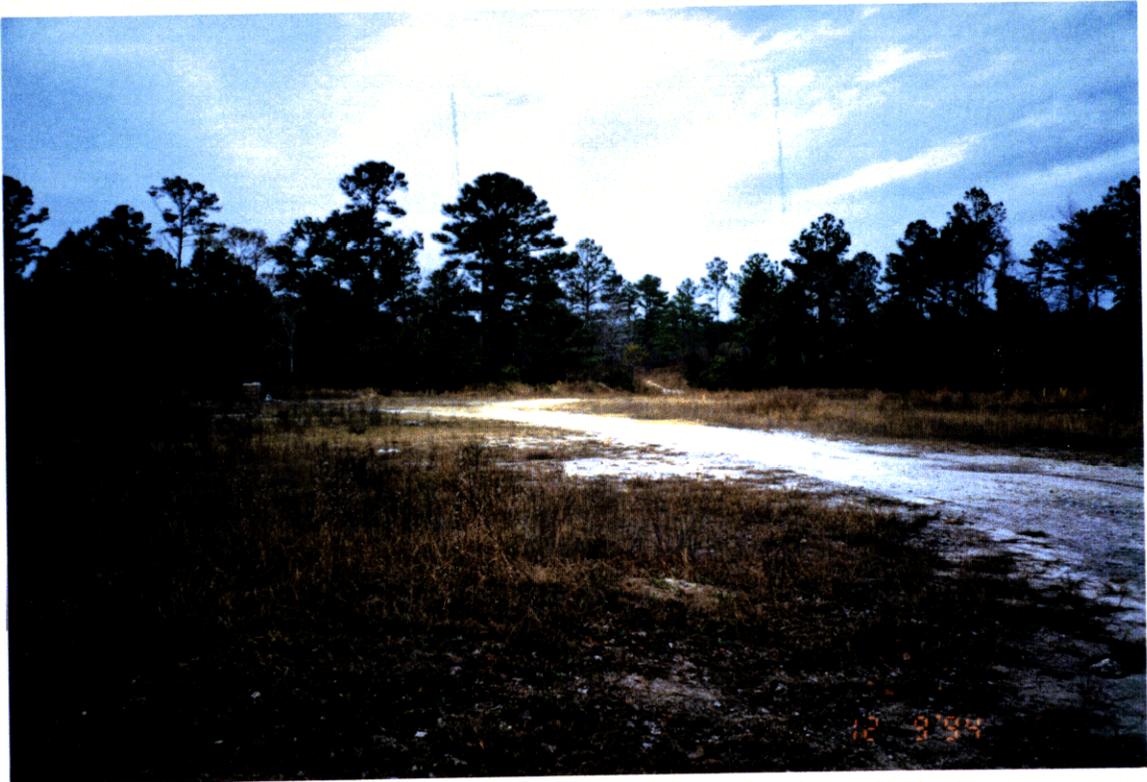
OU12-Site3: Site 3 from Access Road, looking at north area. Monitoring well 3-MW03 is visible in the rear and to the right of the photograph.

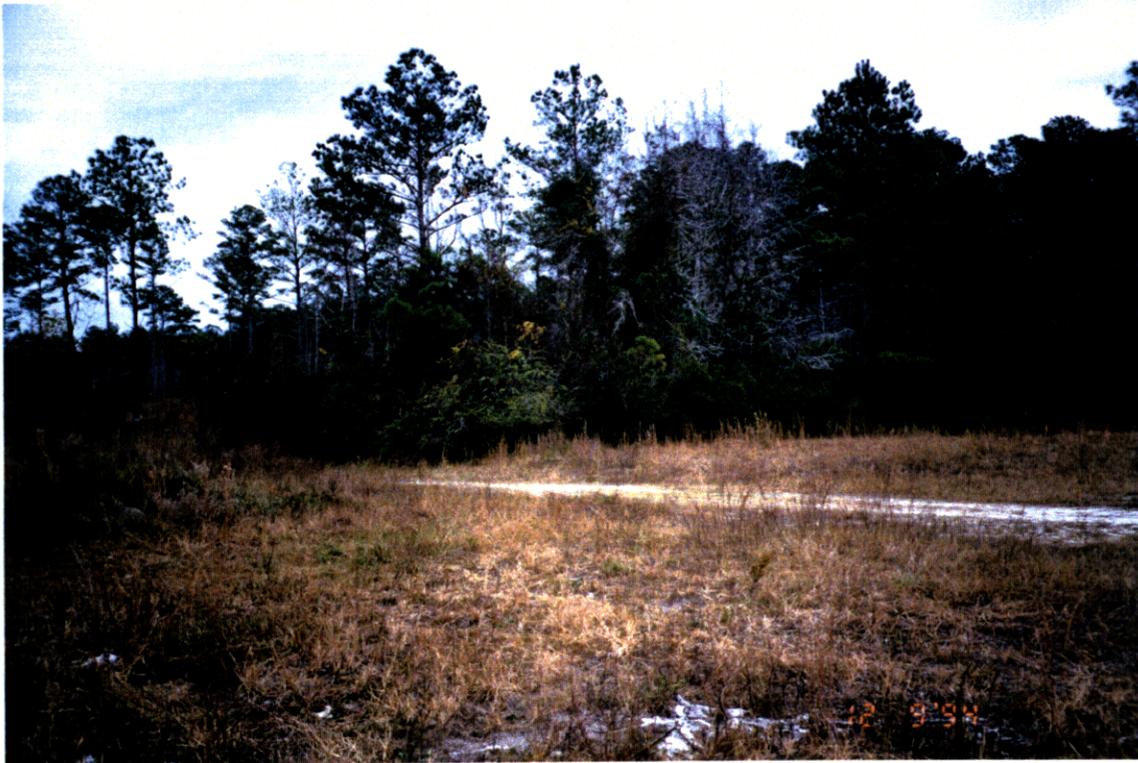
OU12-Site3: View of trees at the north boundary of Site 3.

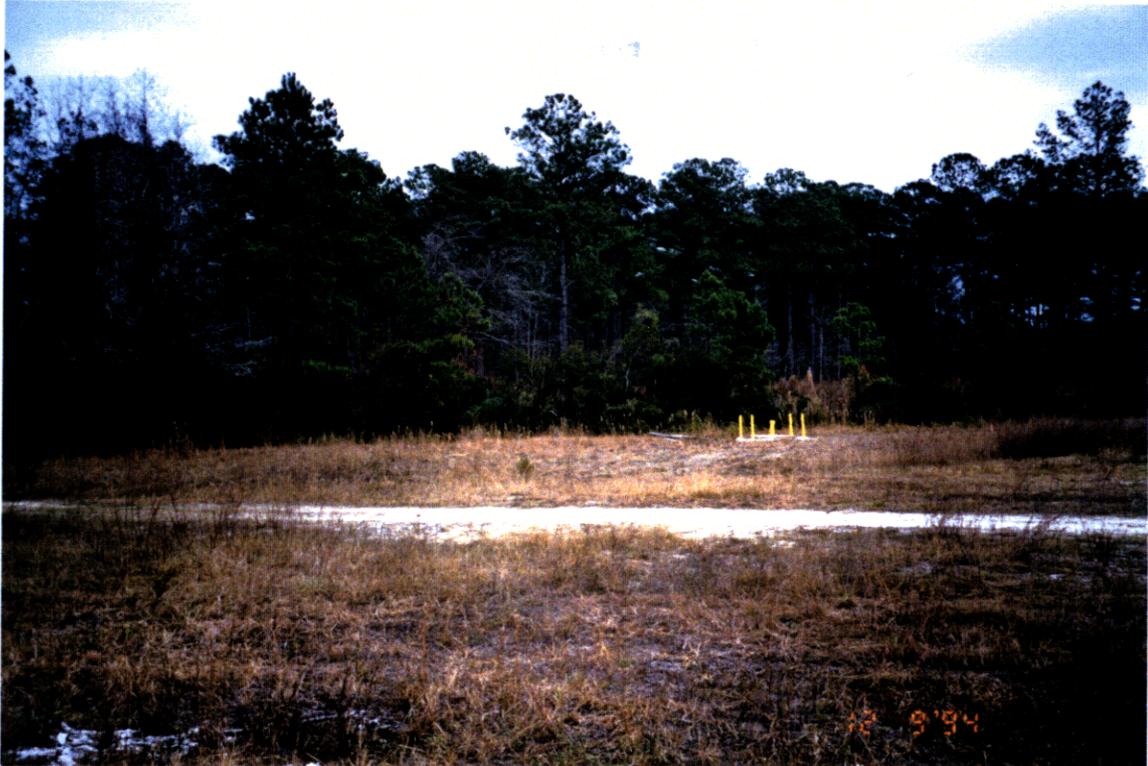
OU12-Site3: Photograph of trees at the north/northeast boundary of Site 3 with monitoring well 3-MW08 visible.

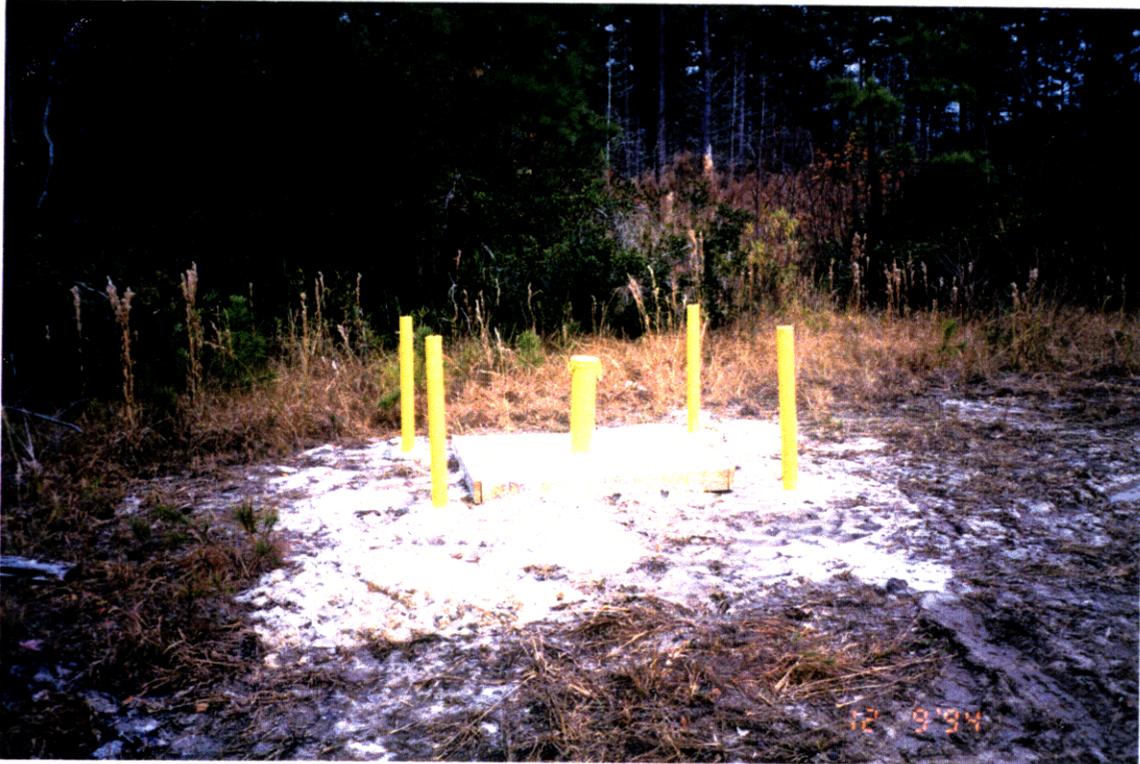
OU12-Site3: Monitoring well 3-MW08, north area.

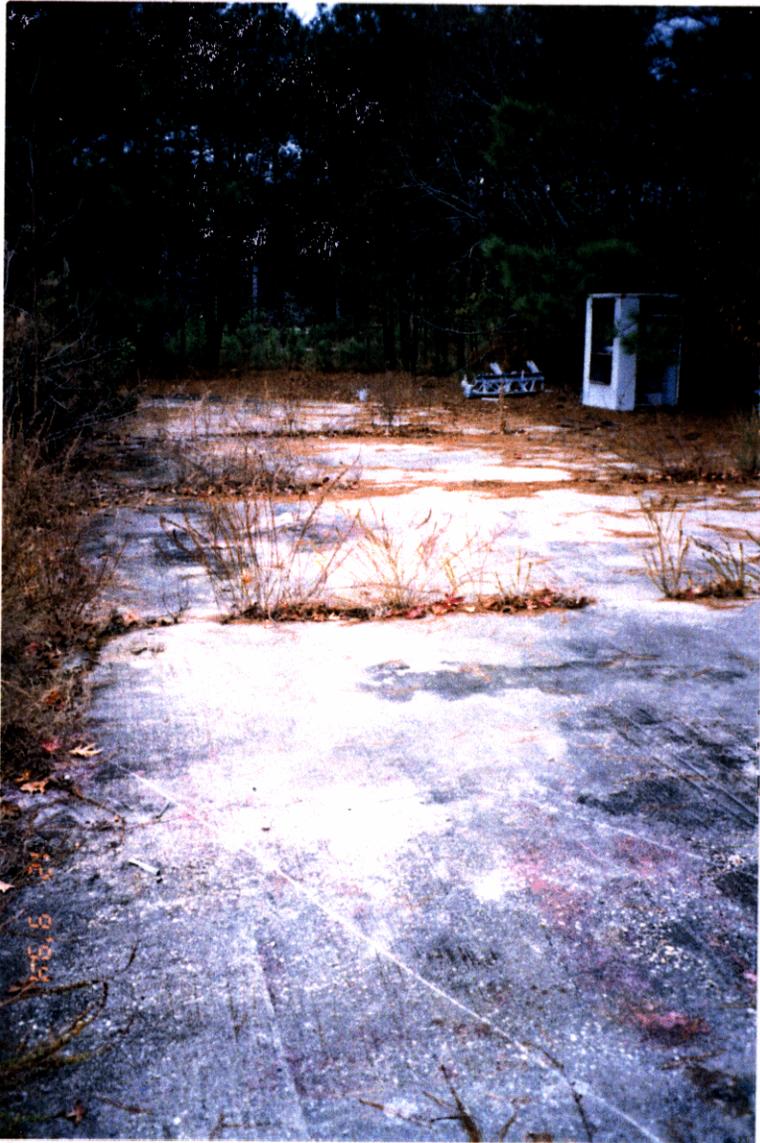
OU12-Site3: Photograph of the concrete pad in the north area of Site 3.

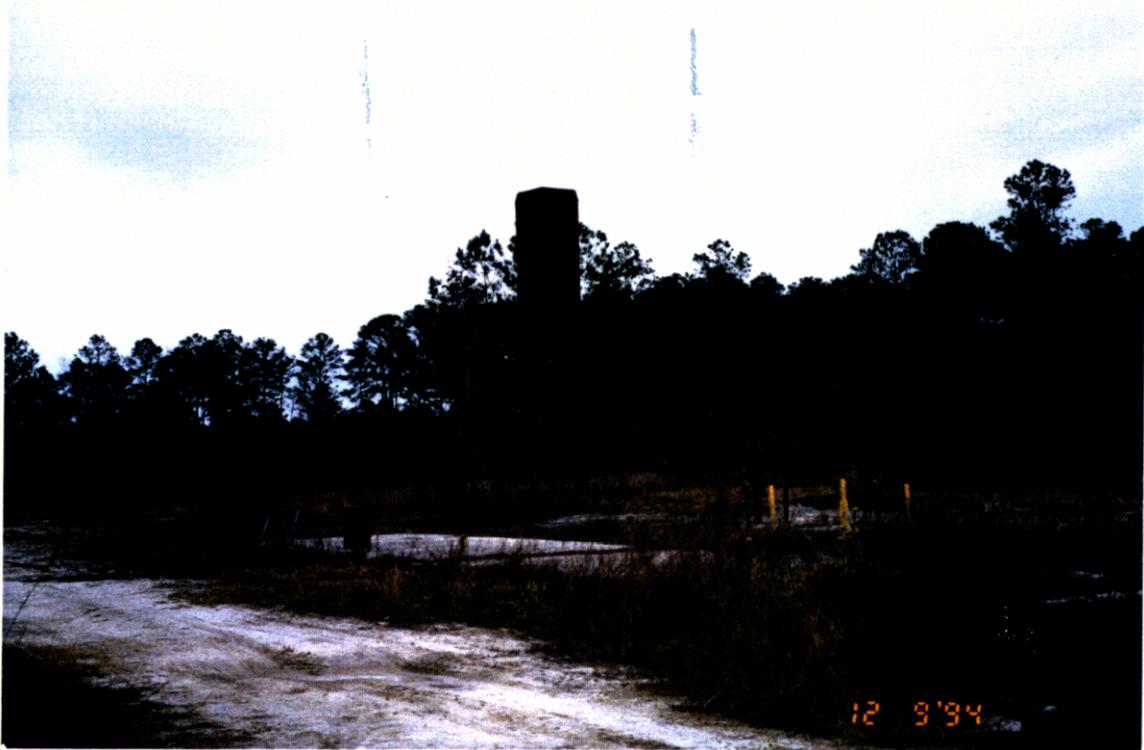
OU12-Site3: Photograph looking northeast toward monitoring well location 3-MW02, chimney and concrete pad with rails within former treatment area.

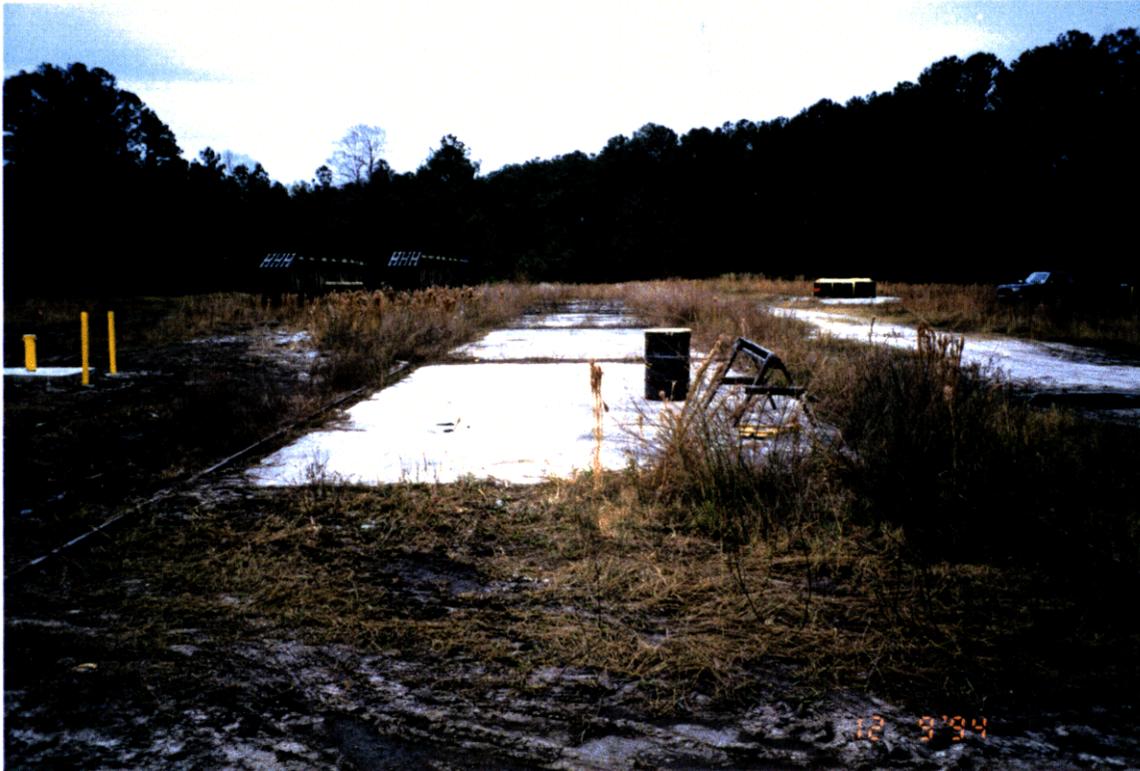
OU12-Site3: Photograph taken in the southern area of Site 3 looking south along concrete pad with rails within former treatment area. Monitoring well 3-MW02IW is on the left side of the photograph.

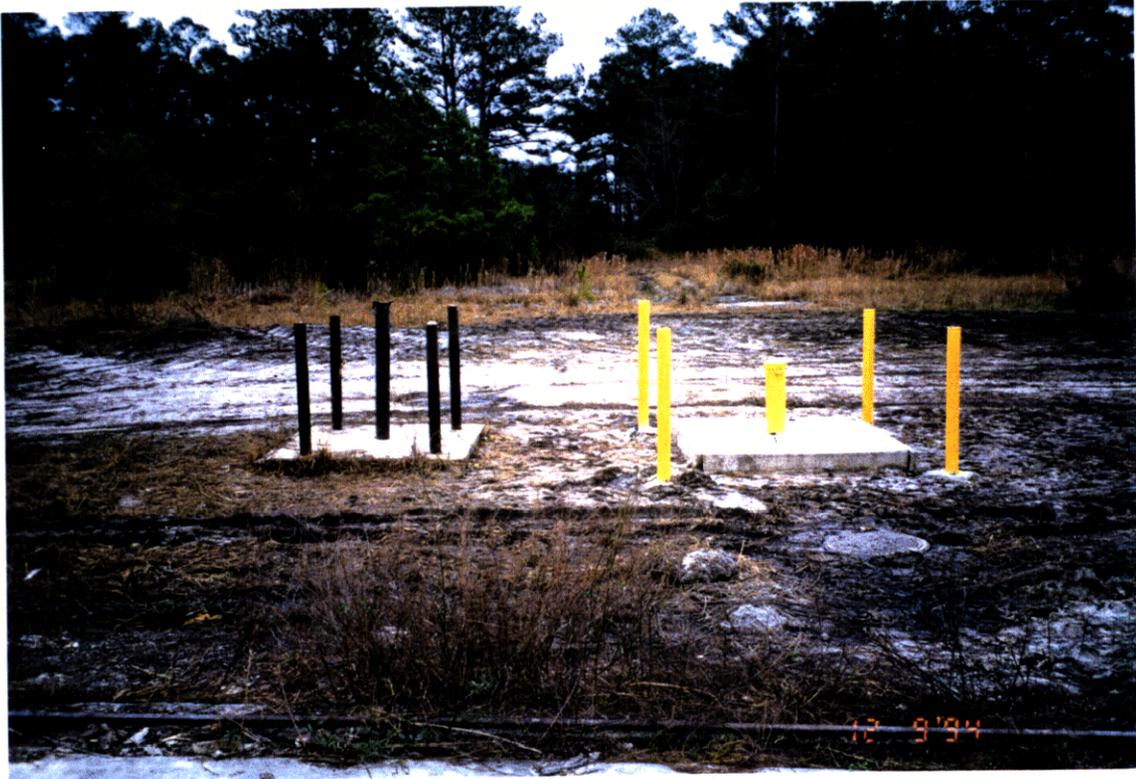
OU12-Site3: View (looking east) of monitoring wells 3-MW02 (on left) and 3-MW02IW (on right). Wells are located east of north/south running concrete pad in treatment area.

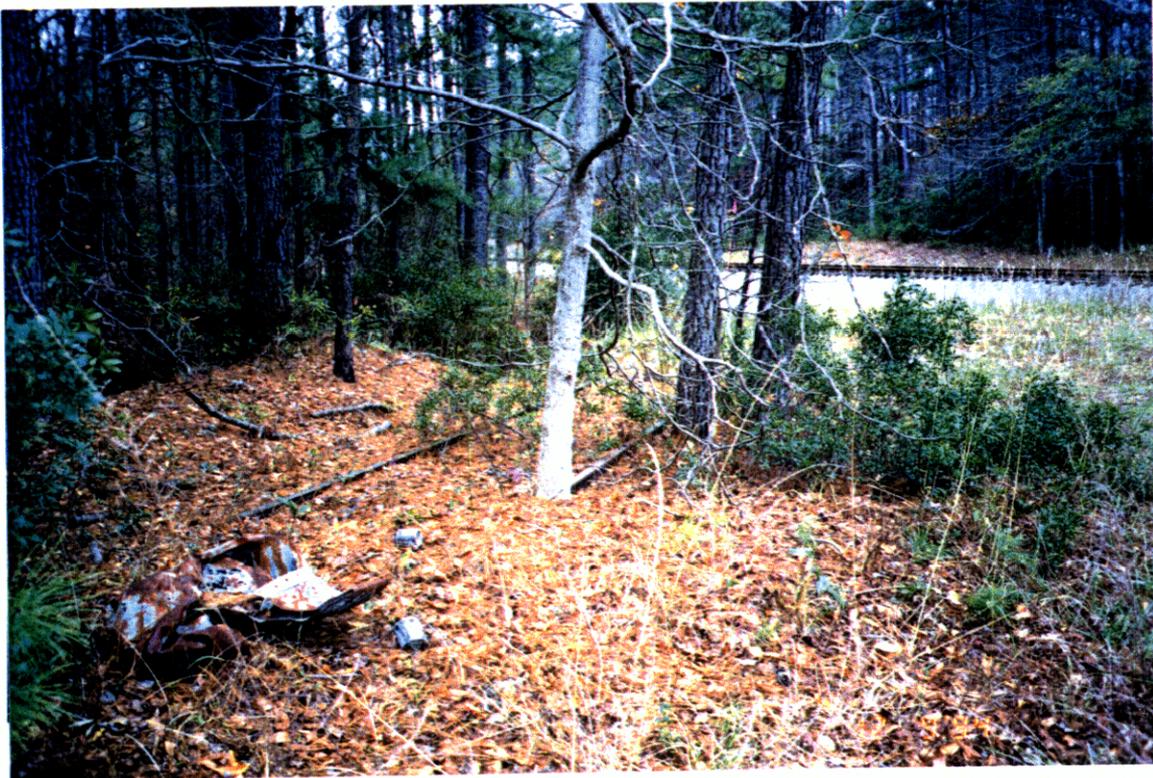
OU12-Site3: Photograph shows evidence of old rail spur at southern tip of south area. Existing base railroad is seen in background.

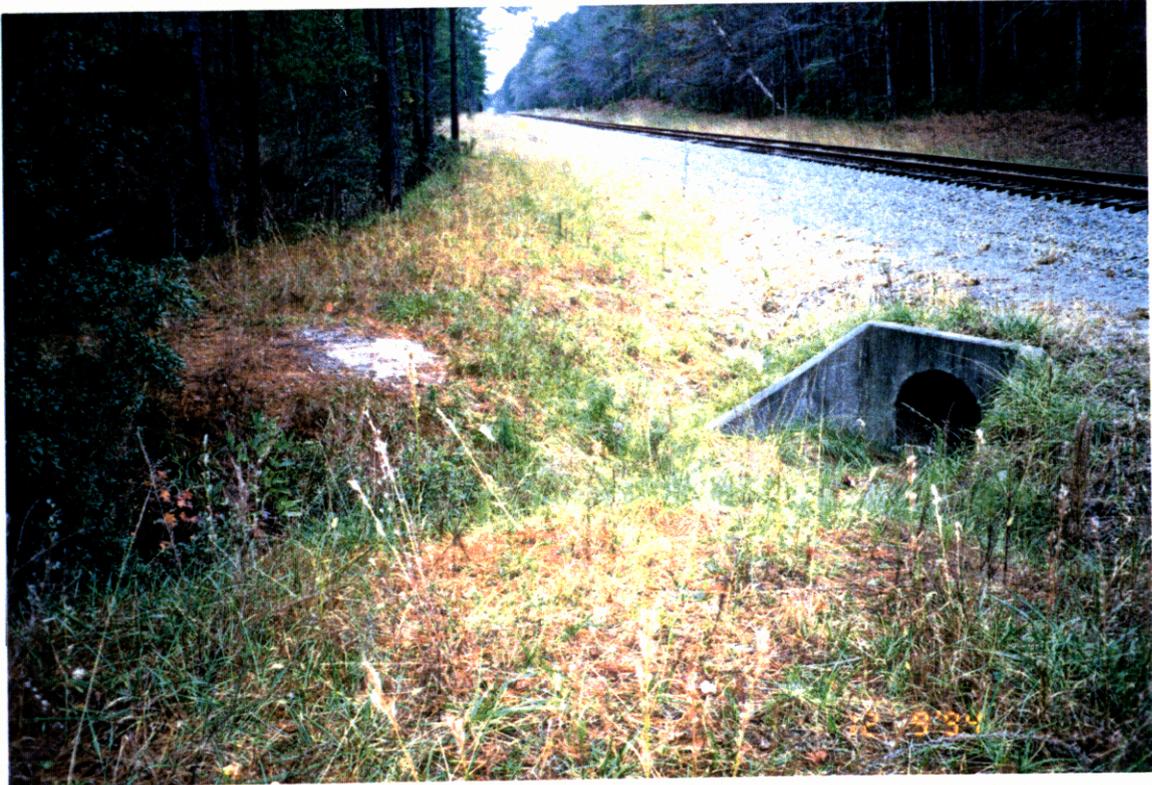
OU12-Site3: Drainage ditch at south end of southern area. Base railroad is seen on the right side of the photograph.

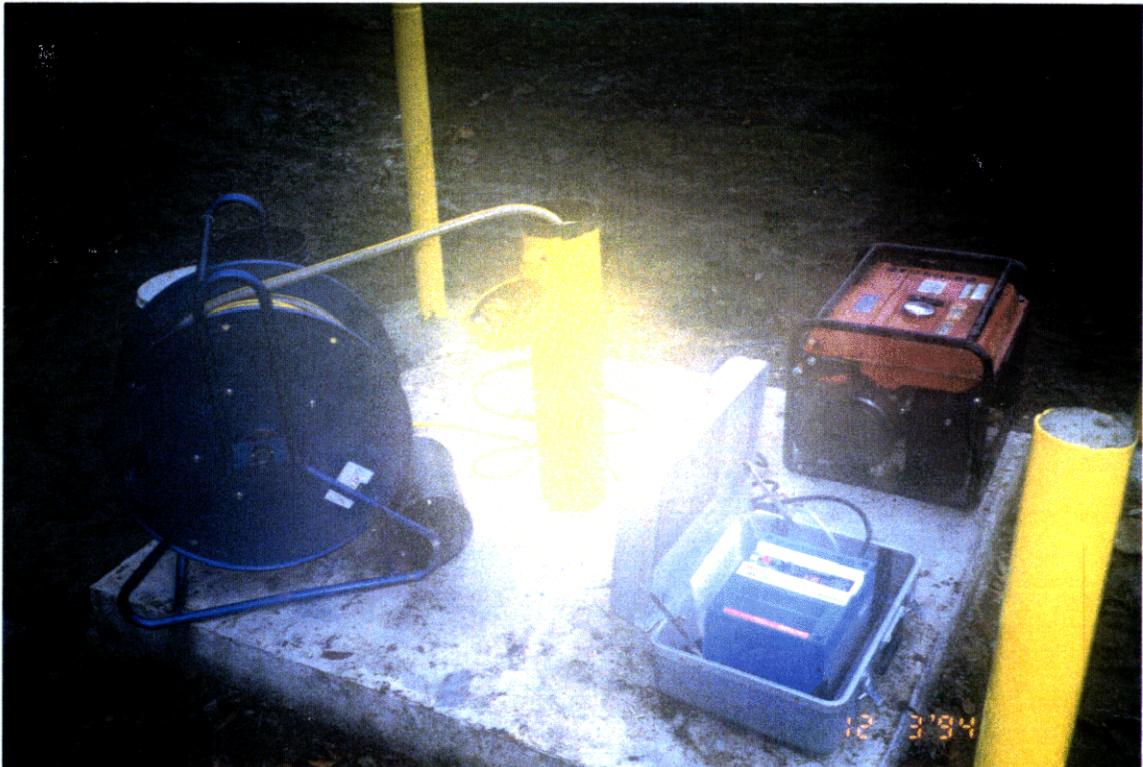
GWSAMPLING: Close up photograph of a low-flow purging and sampling set up (well 80-MW03IW).

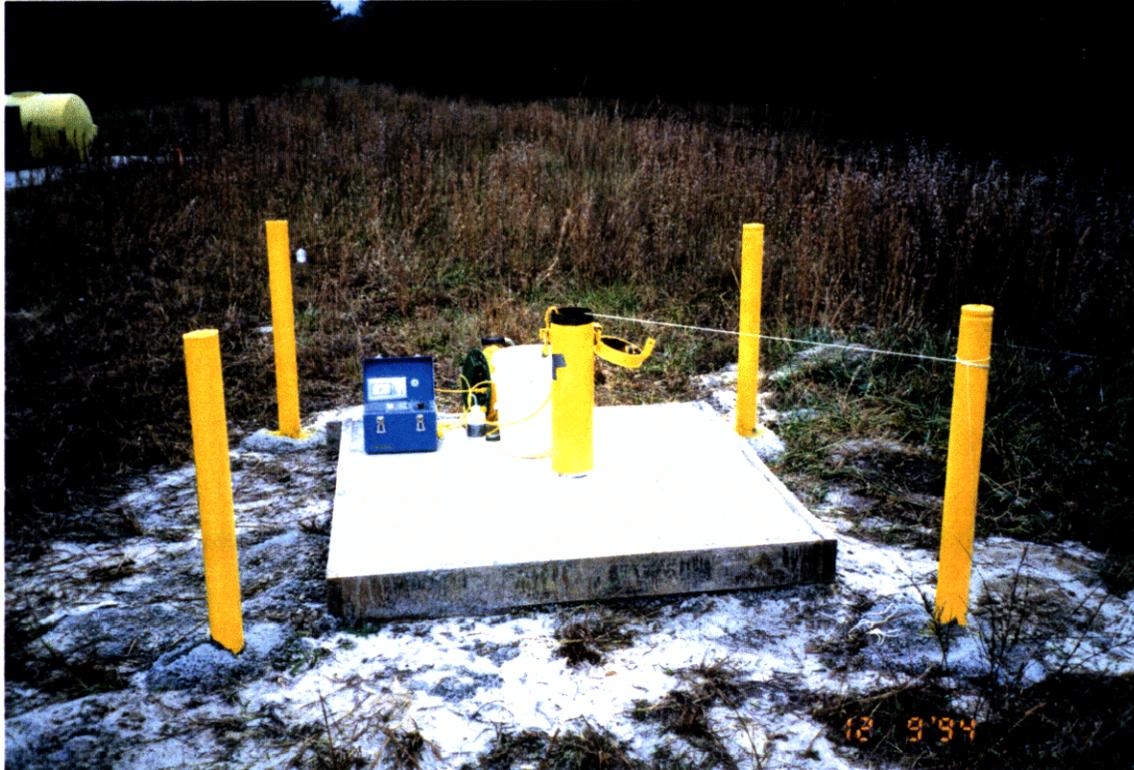
GWSAMPLING: Monitoring well 3-MW05 with data logger/transducer/slugs installed for a slug test.

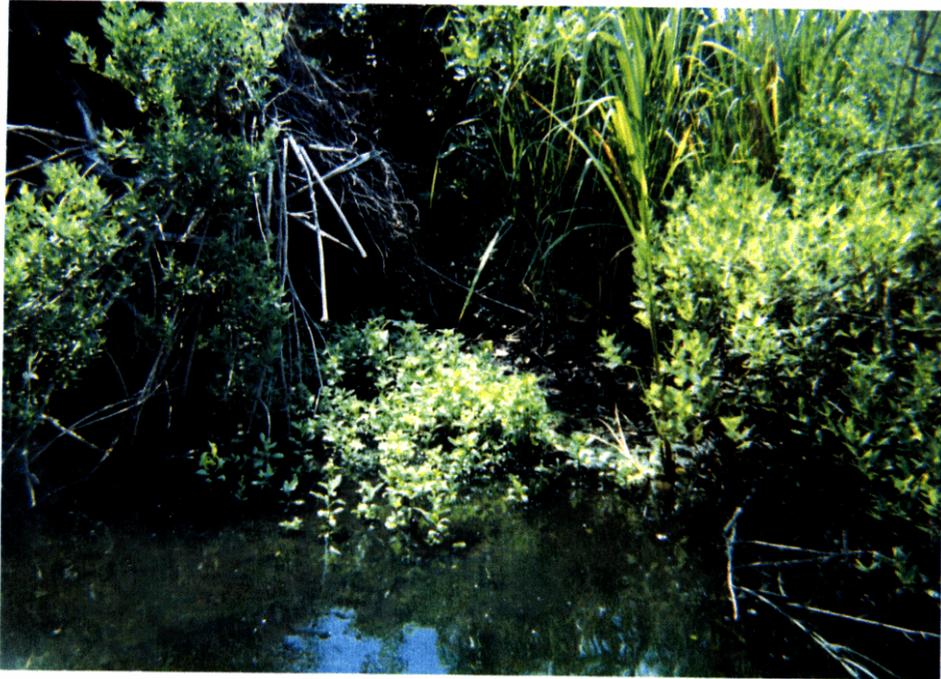
SWSEDINVEST: Photograph is of sampling station 7-ET-SW/SD02 looking east.

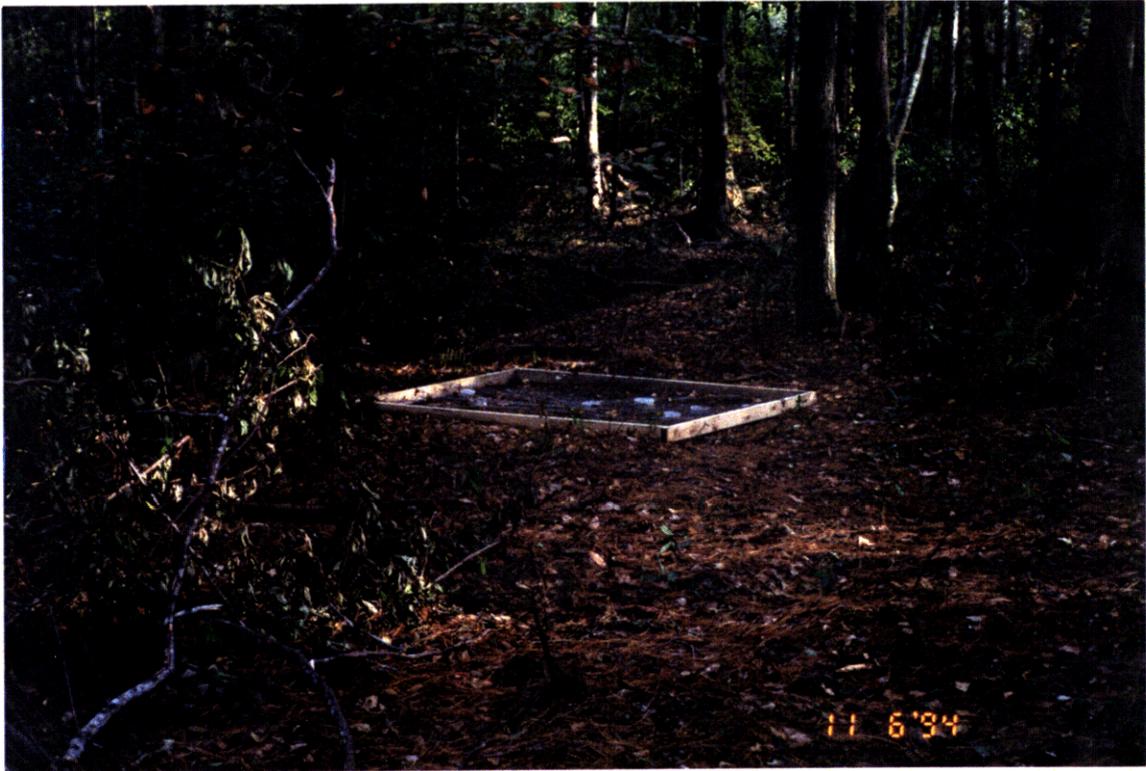
AQUATICECOL: The view is looking south/southeast towards earthworm station 5-8 (in “north” area). The Western Tributary runs behind the worm cells.

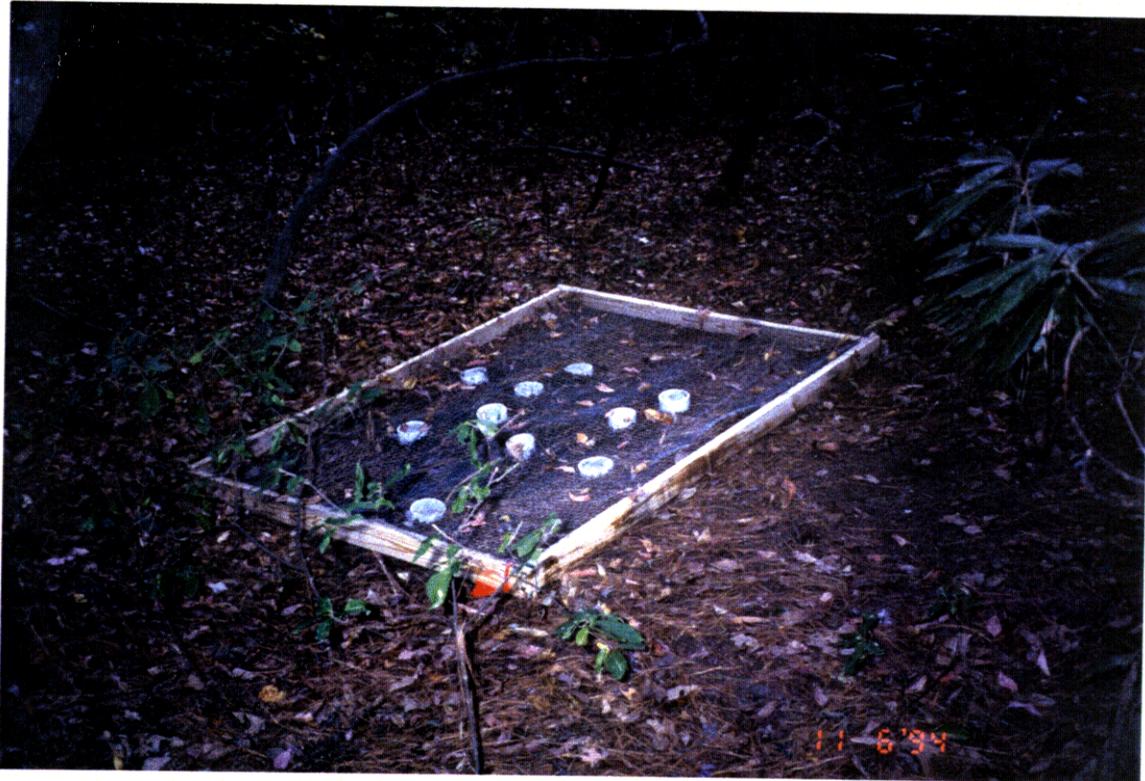
AQUATICECOL: Photograph was taken looking southwest towards earthworm stations 1-4 (in "east" area).
