REMEDIAL INVESTIGATION PHOTOGRAPH ALBUM

**OPERABLE UNIT NO. 8 (SITE 16)
OPERABLE UNIT NO. 11 (SITES 7 AND 80)
OPERABLE UNIT NO. 12 (SITE 3)**

**MARINE CORPS BASE, CAMP LEJEUNE
NORTH CAROLINA**

MARCH 27, 1995

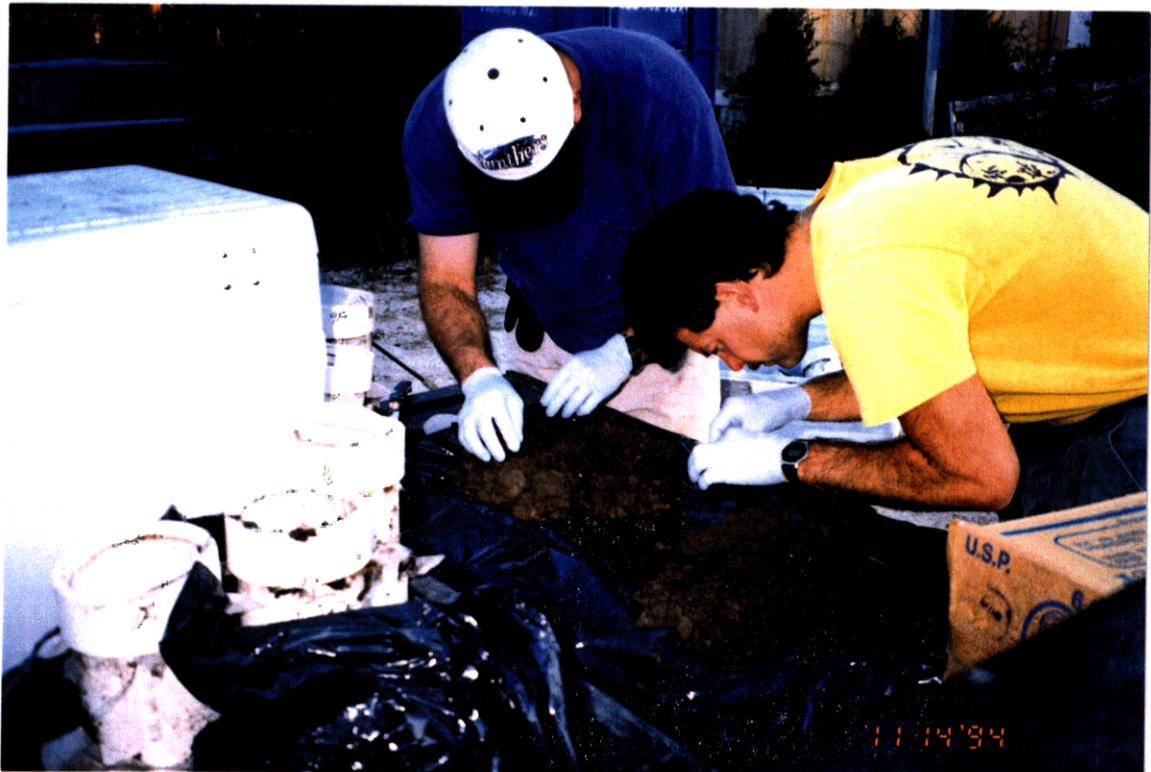
AQUATICECOL: Baker personnel sifting through worm cells 9A and 9B.

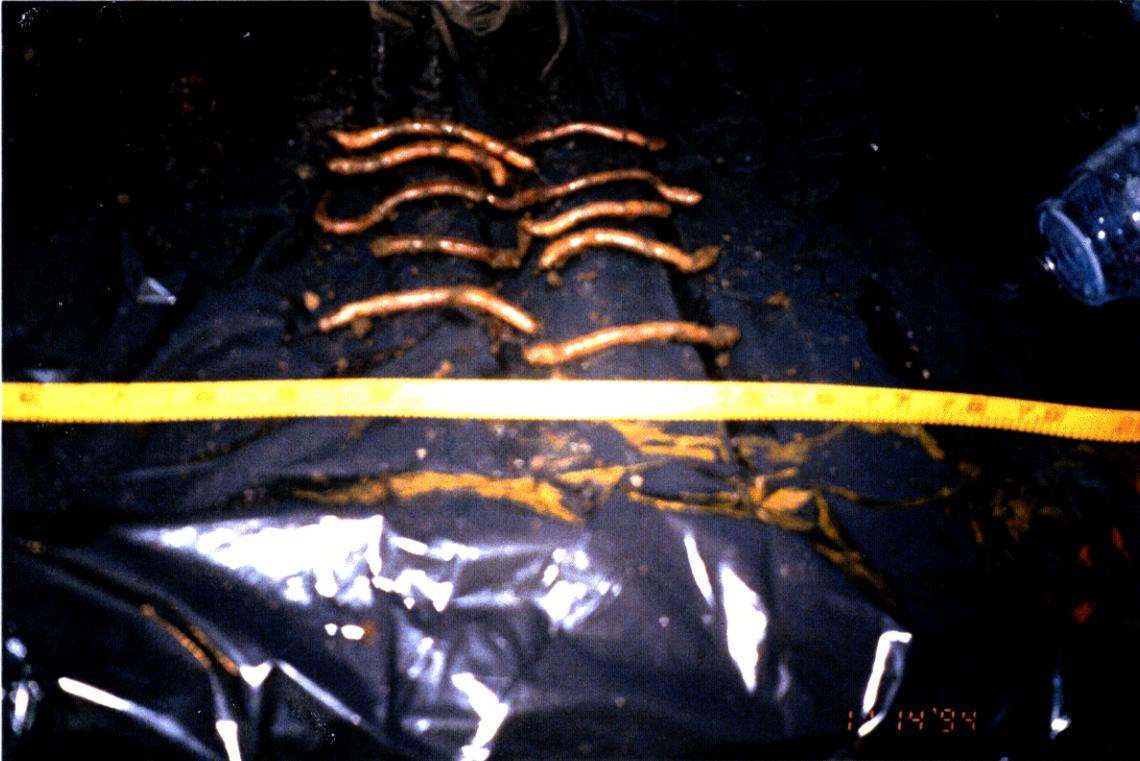
AQUATICECOL: Ten worms from worm cell 6A with a scale in front.

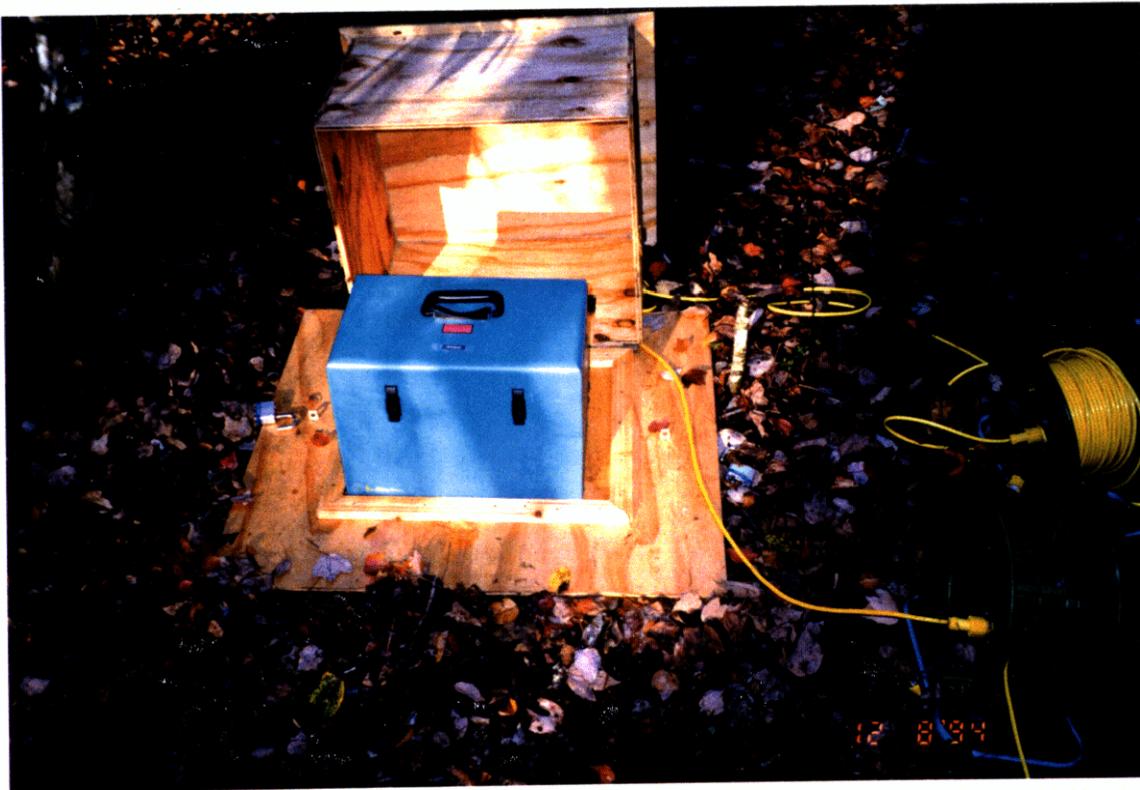
TIDALSTUDY: Photograph taken at low tide on the west bank of the Western Tributary showing data logger box and reels.

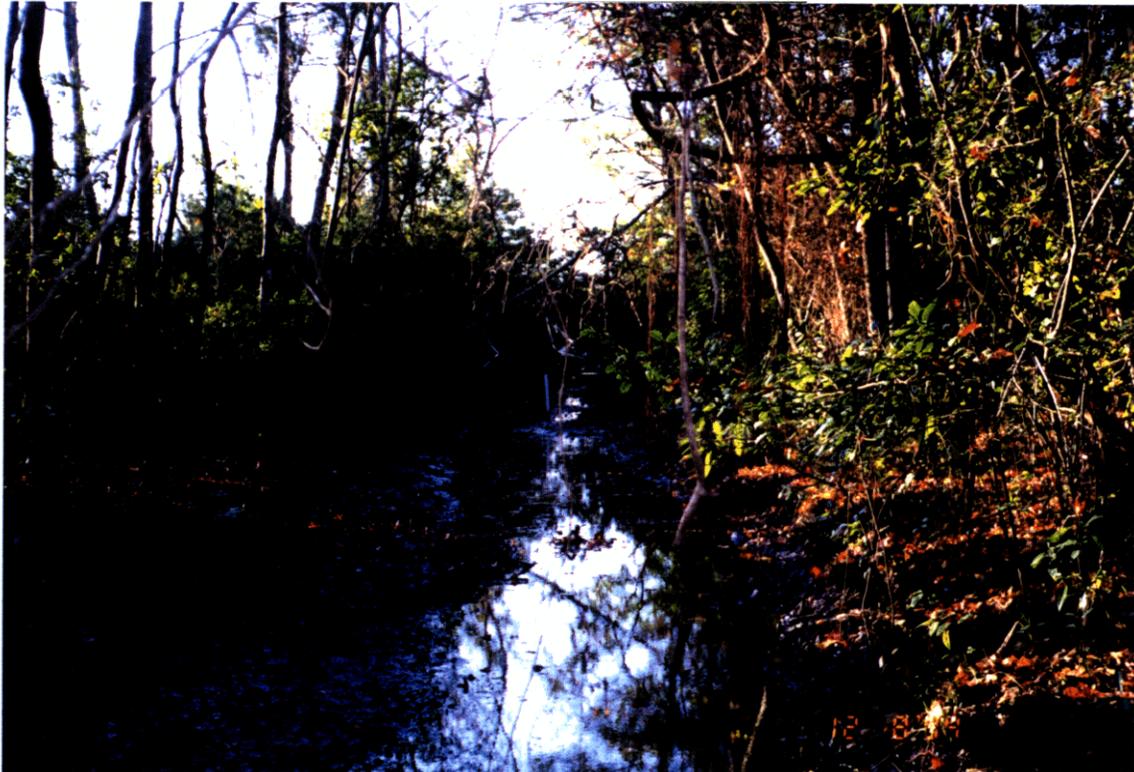
TIDALSTUDY: The Western Tributary looking downstream at a staff gauge from equipment location on the bank.

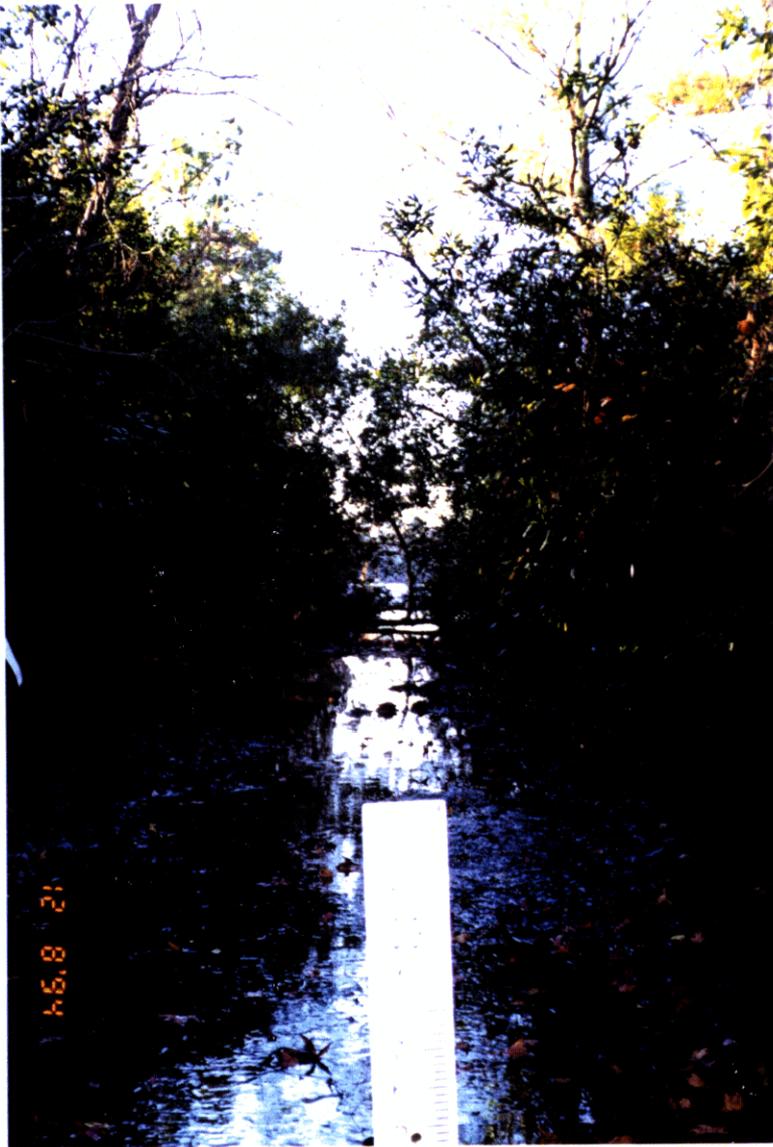
TIDALSTUDY: Photograph shows the Western Tributary at low tide from staff gauge location. View is looking downstream towards Northeast Creek.

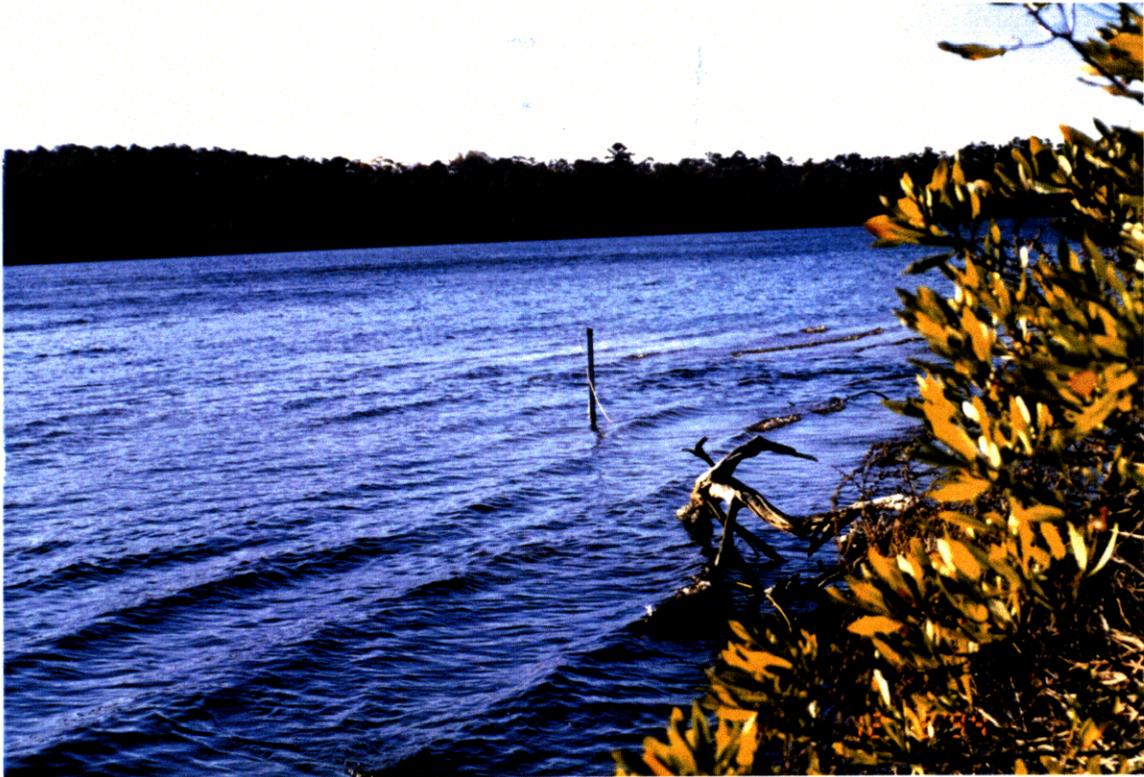
TIDALSTUDY: Photograph shows a staff gauge in Northeast Creek near the Western Tributary approximately 50 feet offshore at (0.25) reading during low tide.

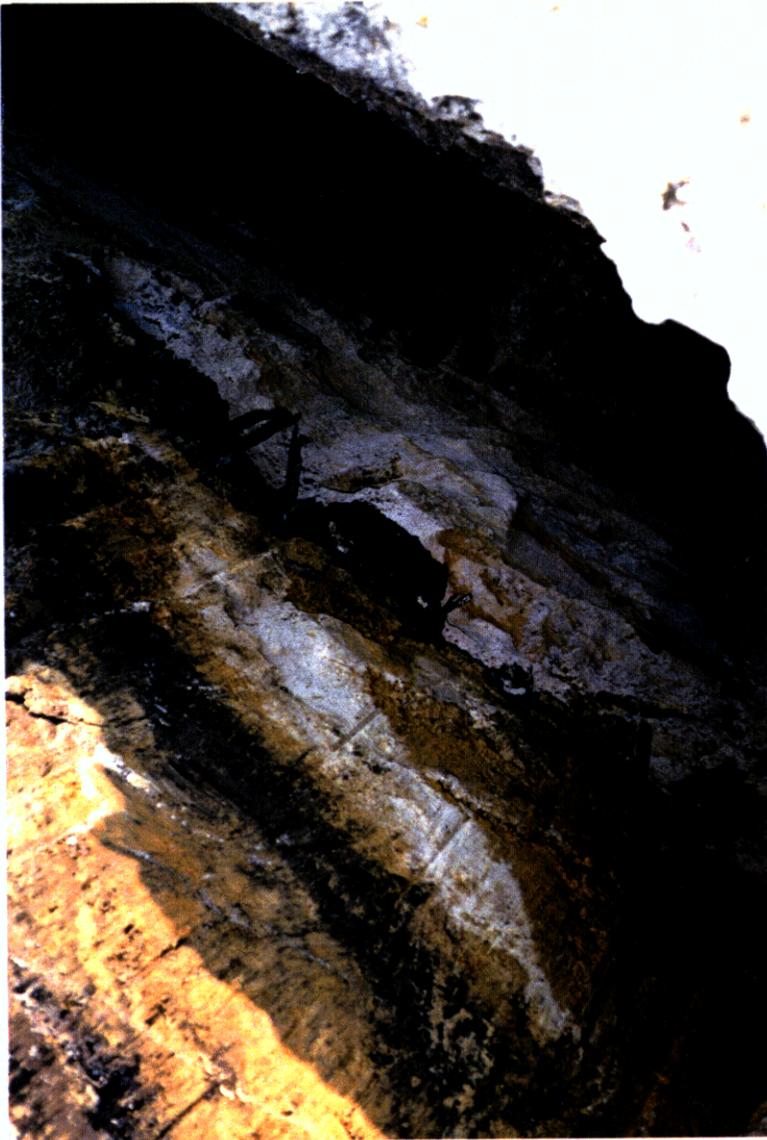
TESTPIT: Photograph shows the east wall of test pit 16-BD-TP03 (southeast area of Former Burn Dump) at the north end of the trench. Metal strips with nails, roofing shingles, and rotting wood are at the top of the trench.

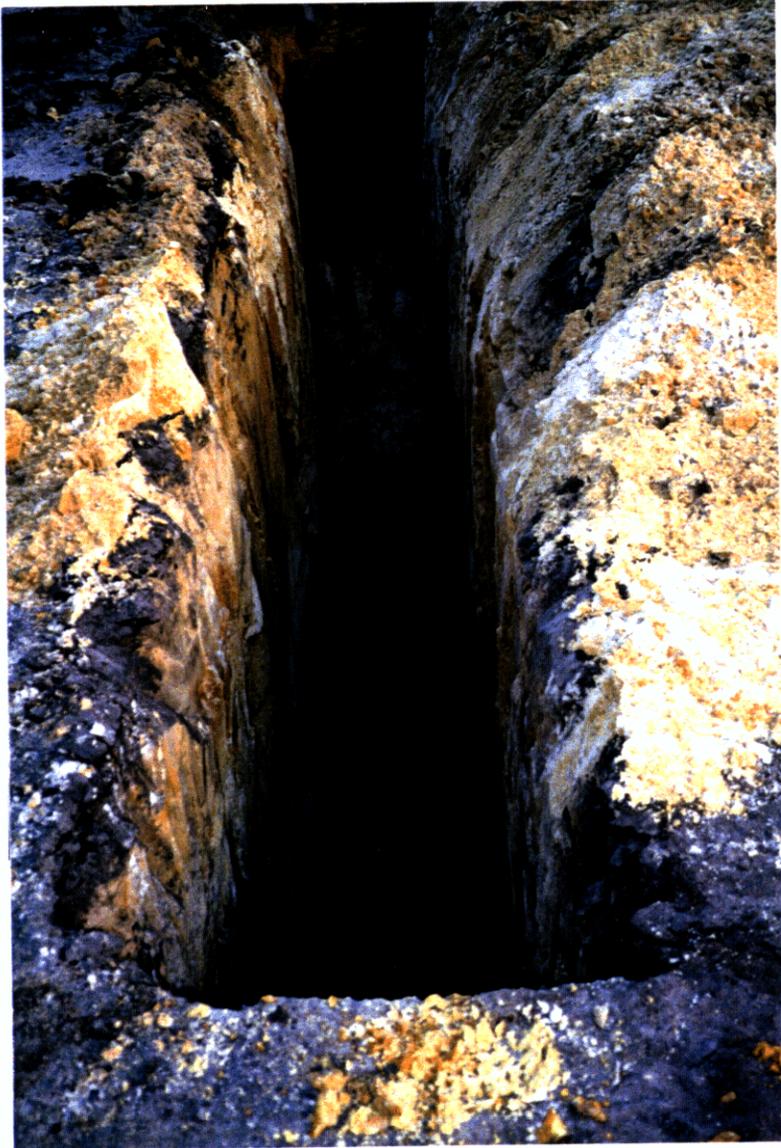
TESTPIT: Test pit 16-BD-TP04 (northeast area of former burn dump) looking south/southeast.

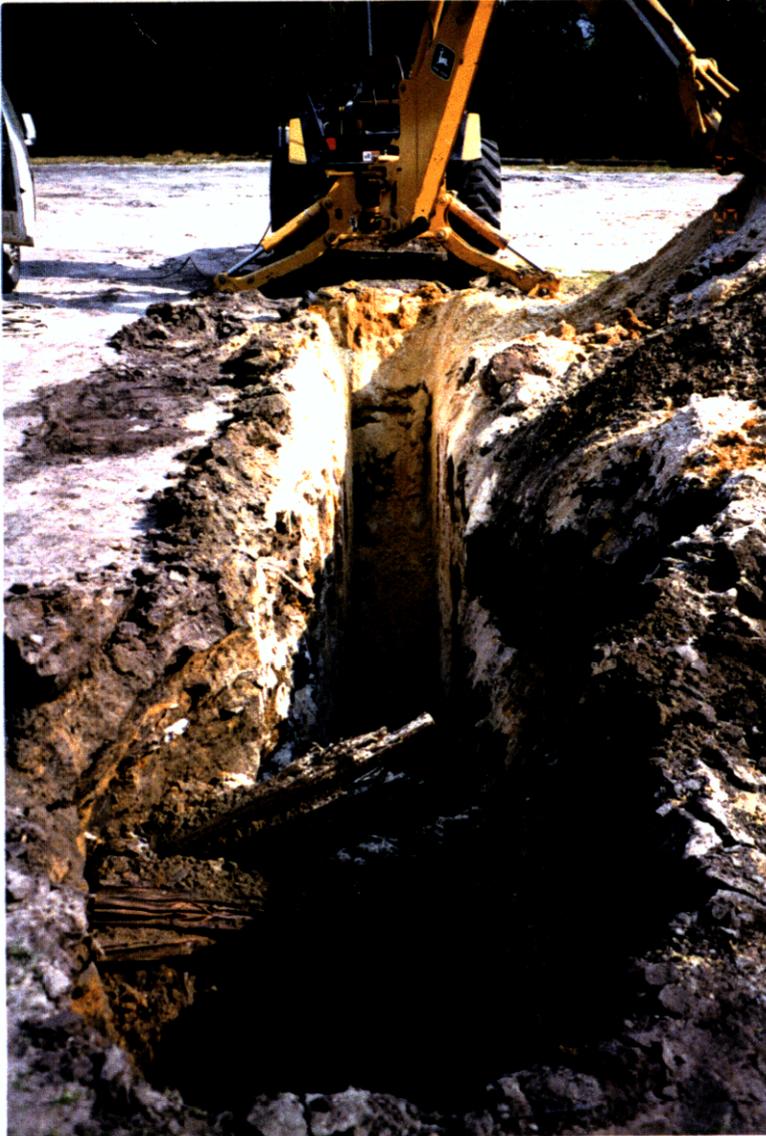
TESTPIT: Test pit 16-BD-TP01 located in the north area of Site 16. Visible inside of pit are treated poles. Equipment is John Deere J310D backhoe.

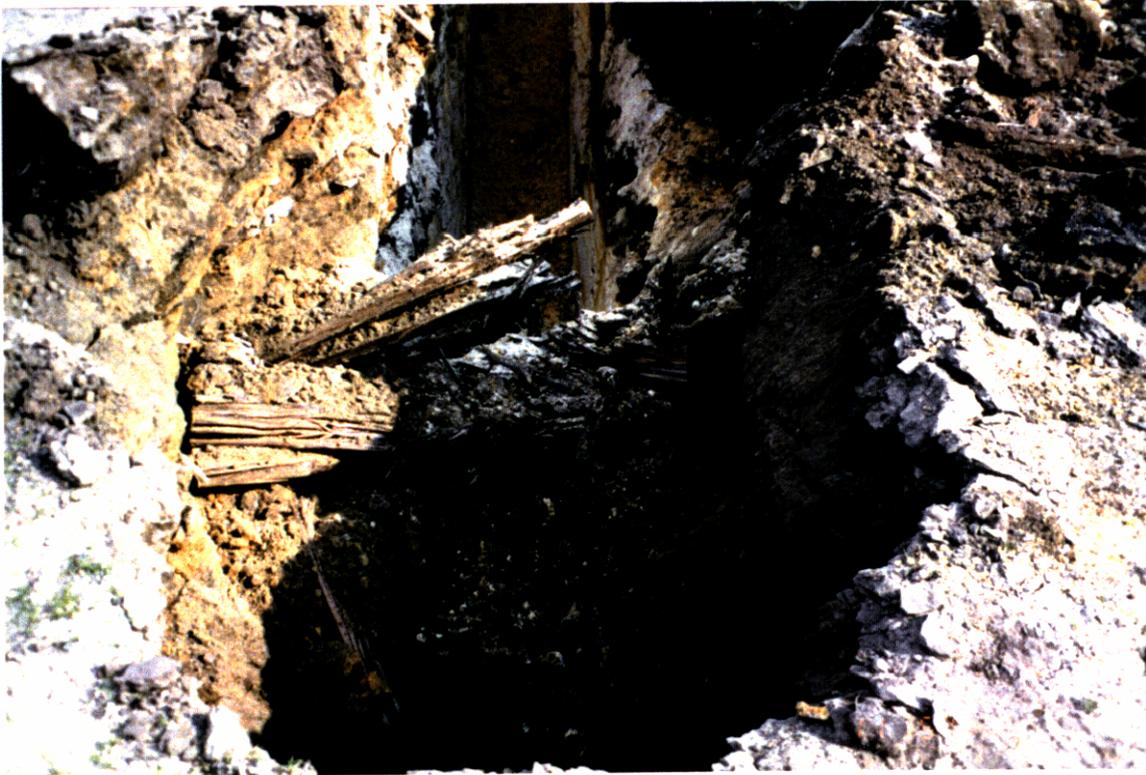
TESTPIT: Test pit 16-BD-TP01 showing treated poles.

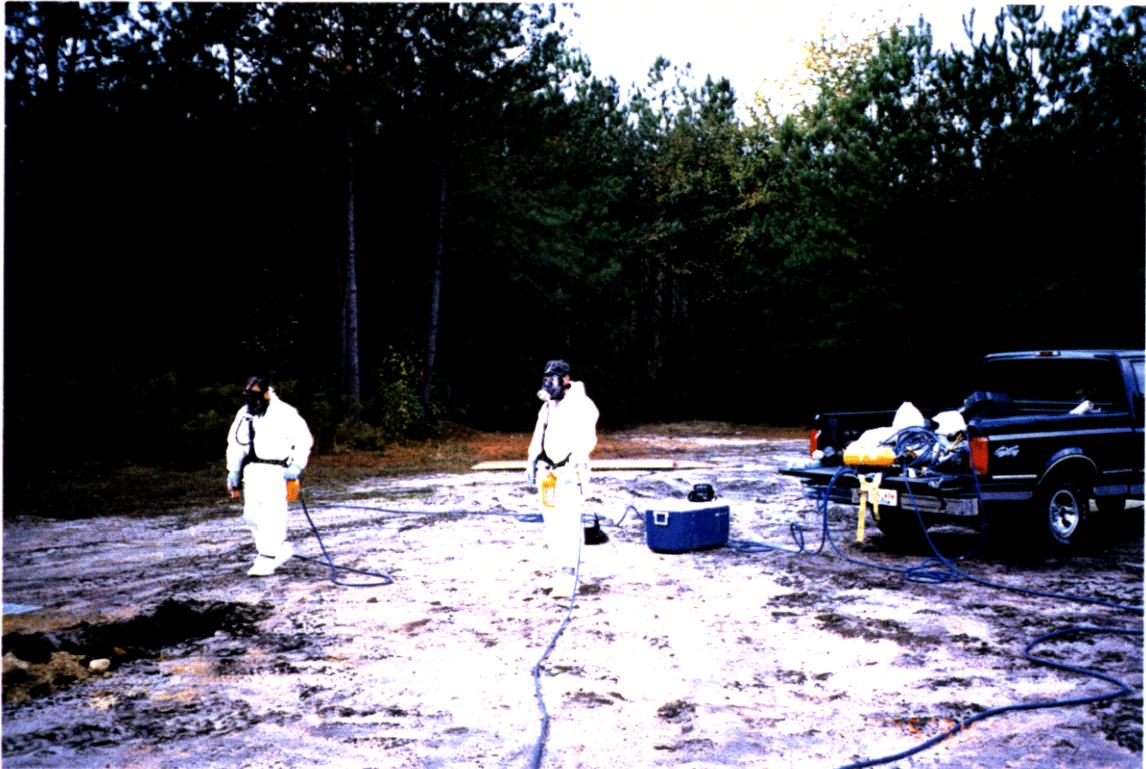
TESTPIT: Baker personnel in Level "B" safety gear at test pit 16-BD-TP02 located in southwest area of former burn dump.

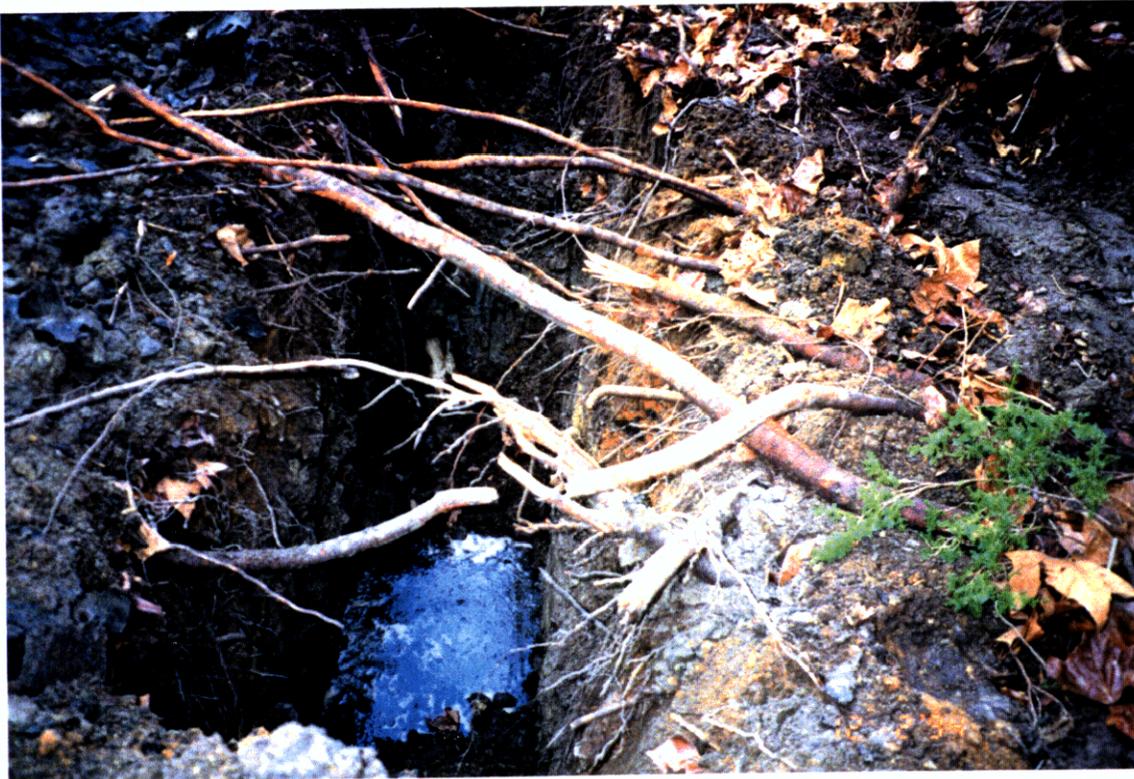
TESTPIT: Photograph of test pit 7-SWA-TP02 looking north. Water is visible on the bottom of the pit.

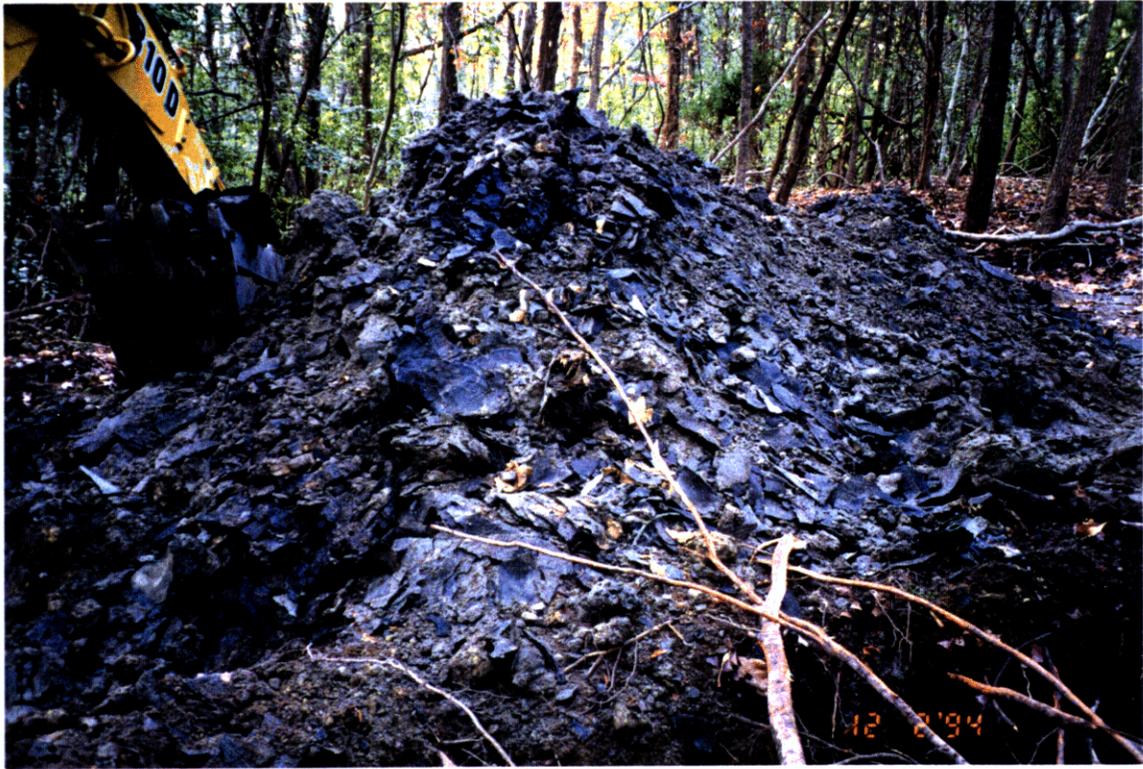
TESTPIT: View of spoil pile from test pit 7-SWA-TP02 looking east. Large quantity of roofing shingles is visible.

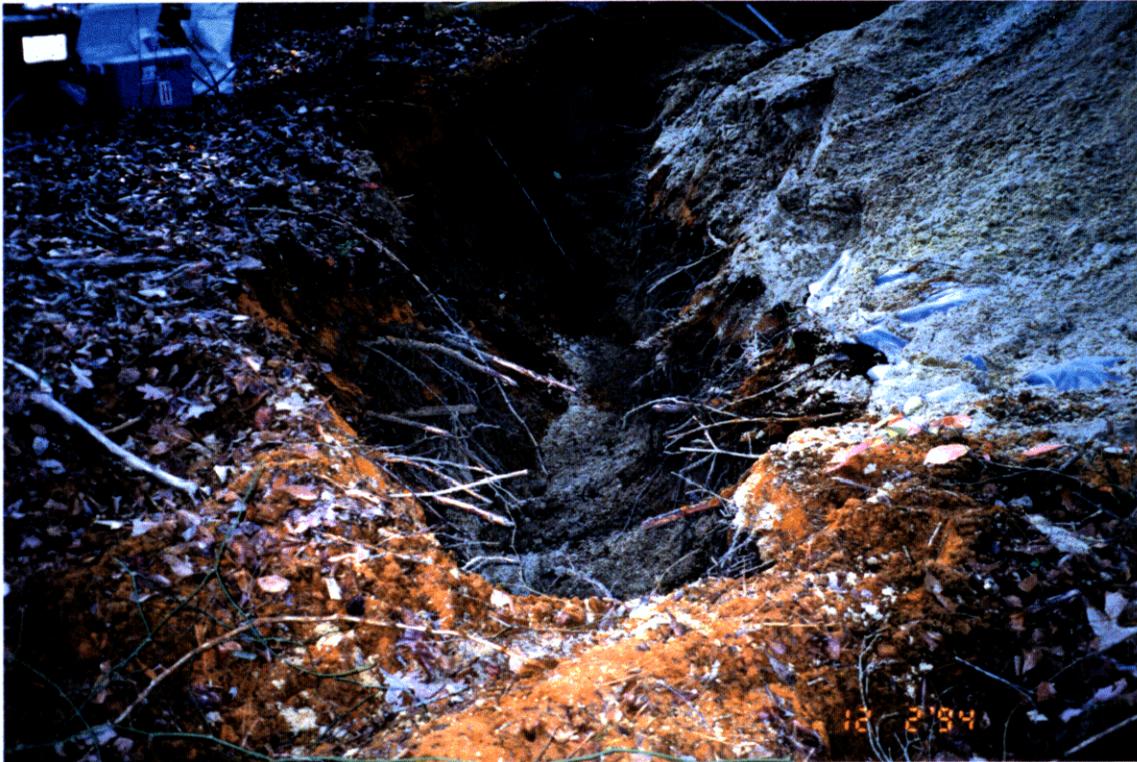
TESTPIT: View of test pit 7-SWA-TP05 looking west.

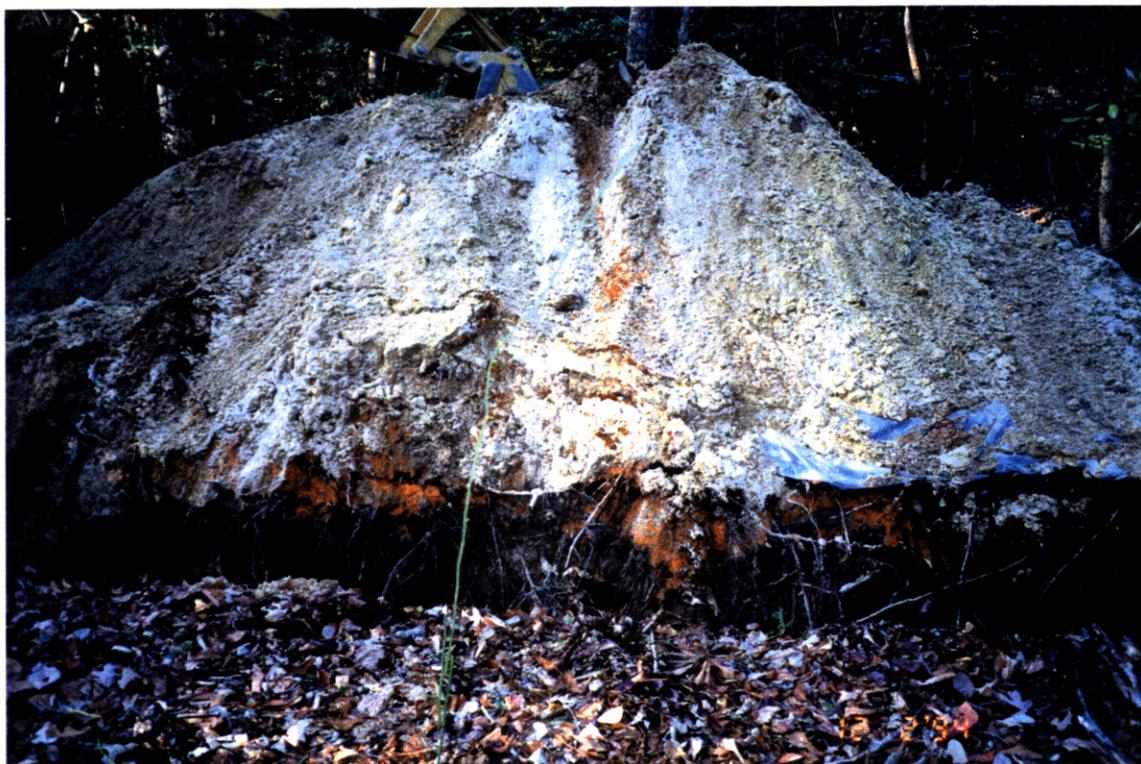
TESTPIT: Photograph looking south across test pit 7-SWA-TP05 with spoil pile in the rear.

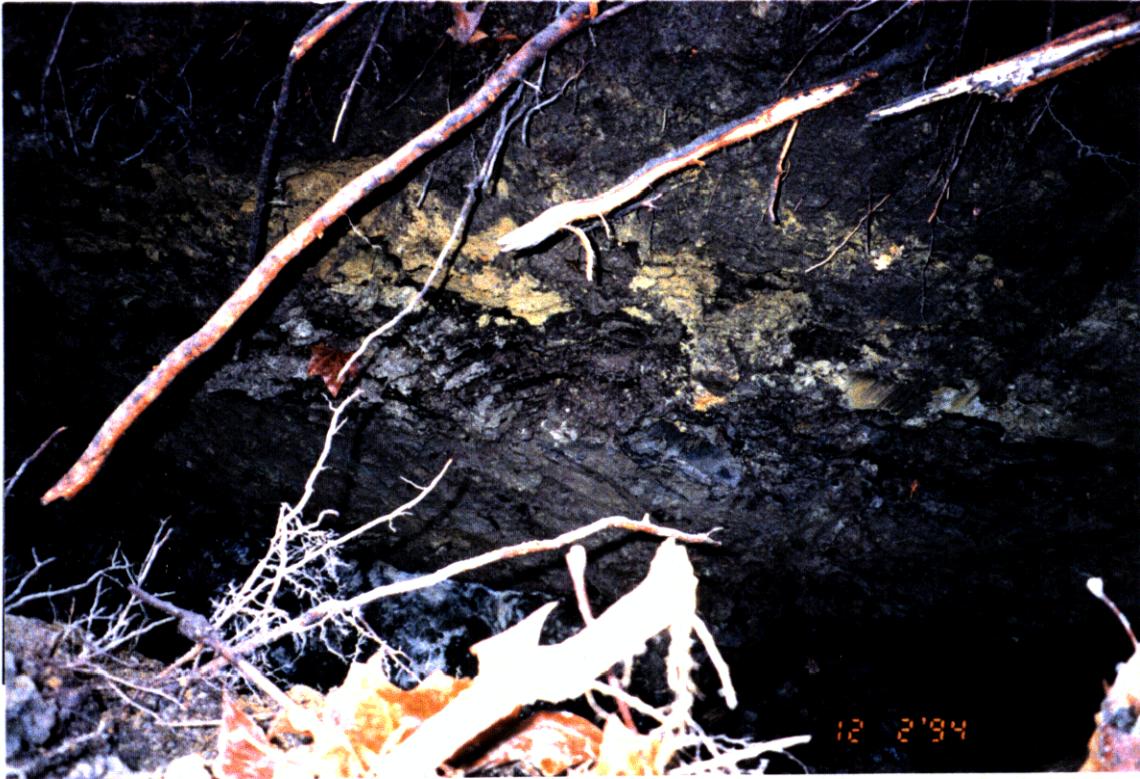
TESTPIT: View of southern end of test pit 7-SWA-TP02 looking into the eastern edge of pit. Roofing shingles in sidewall are at a depth of 4.5 feet.
