**Department of the Navy  
Installation Restoration Program  
Field Investigation Photograph Album  
Sites 6, 9, 48, and 69**

**SITES 6, 9, 48, AND 69  
MARINE CORPS BASE CAMP LEJEUNE  
NORTH CAROLINA**

**CONTRACT TASK ORDER 0133**

**JANUARY 15, 1993**

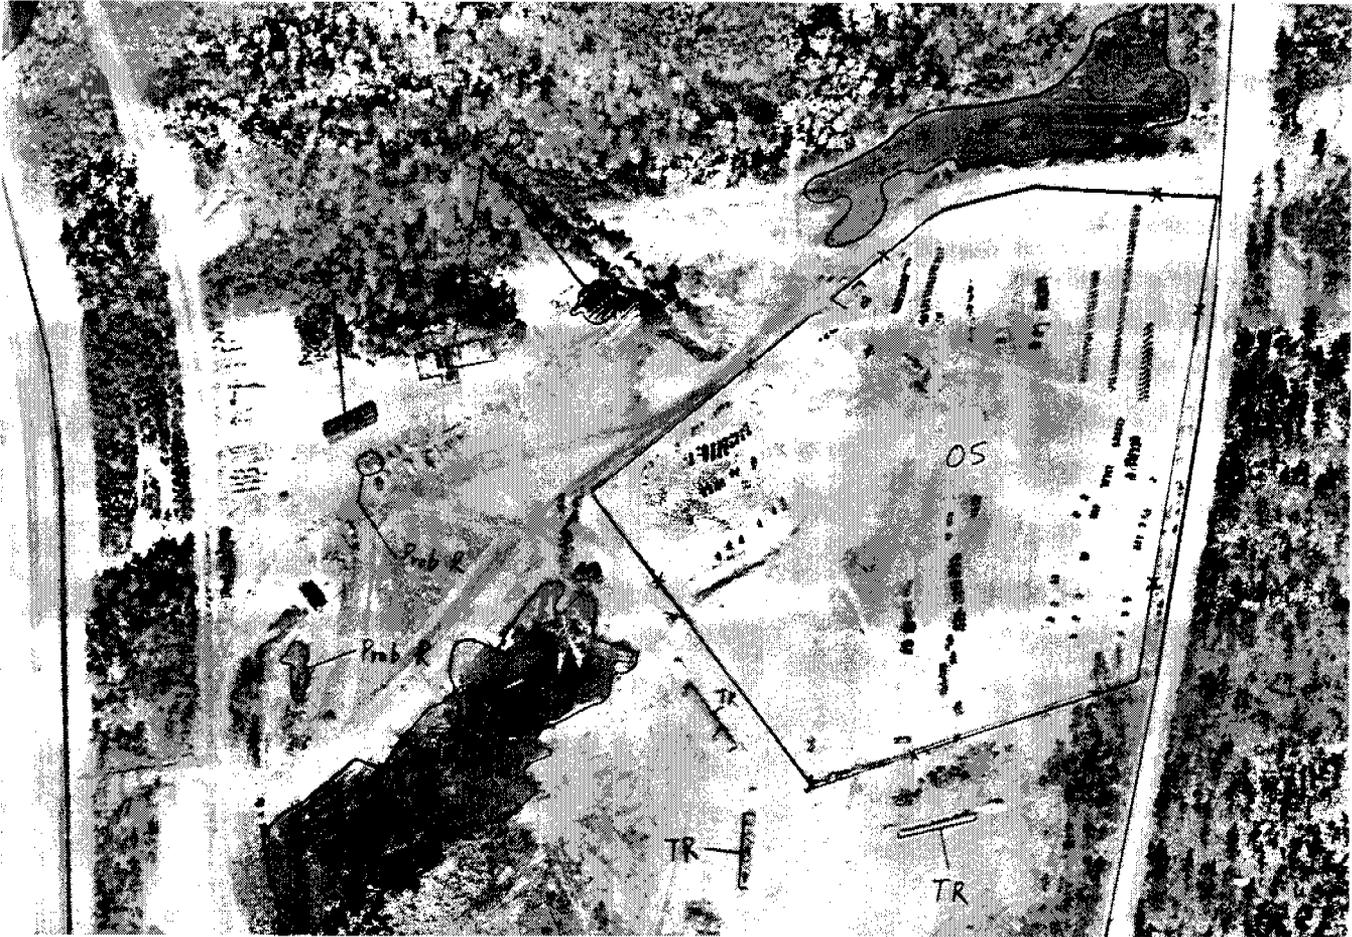
### Aerial Photograph 2-1

Annotated aerial photograph, dated 29 November 1960, depicting Lot 203 indicates trenching (TR) and probable refuse (Prob R) disposal activity within and surrounding the open storage (OS) area. Disturbed soil and ground scars are evident throughout the cleared areas.

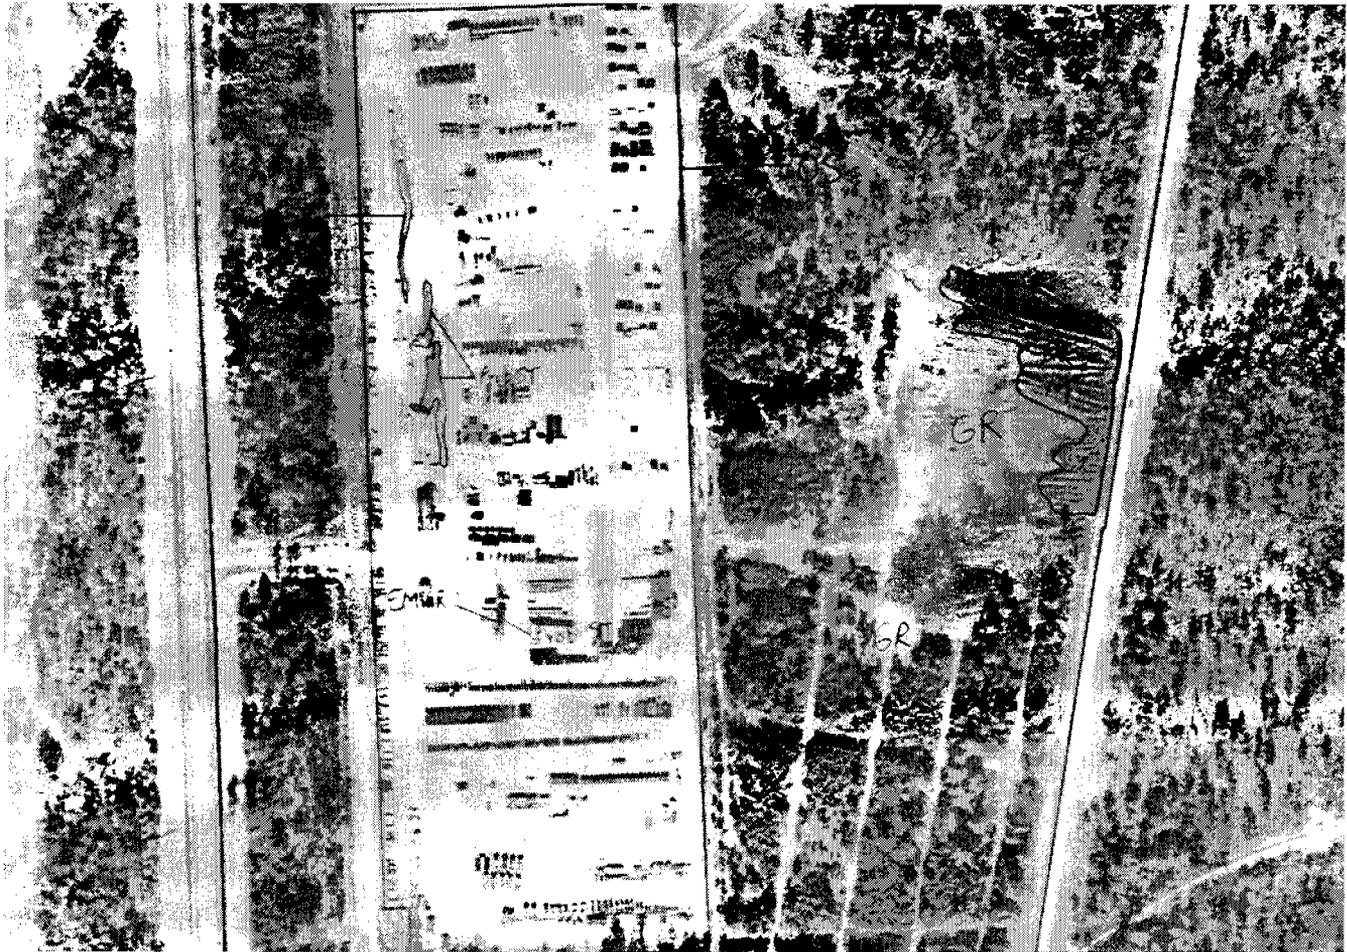
### **Aerial Photograph 2-2**

Annotated aerial photograph depicts Lot 201 and surrounding wooded areas as of 29 November 1960. Probable staining (Prob ST) has been noted around the equipment maintenance/wash rack (EMWR) and in other areas within Lot 201.

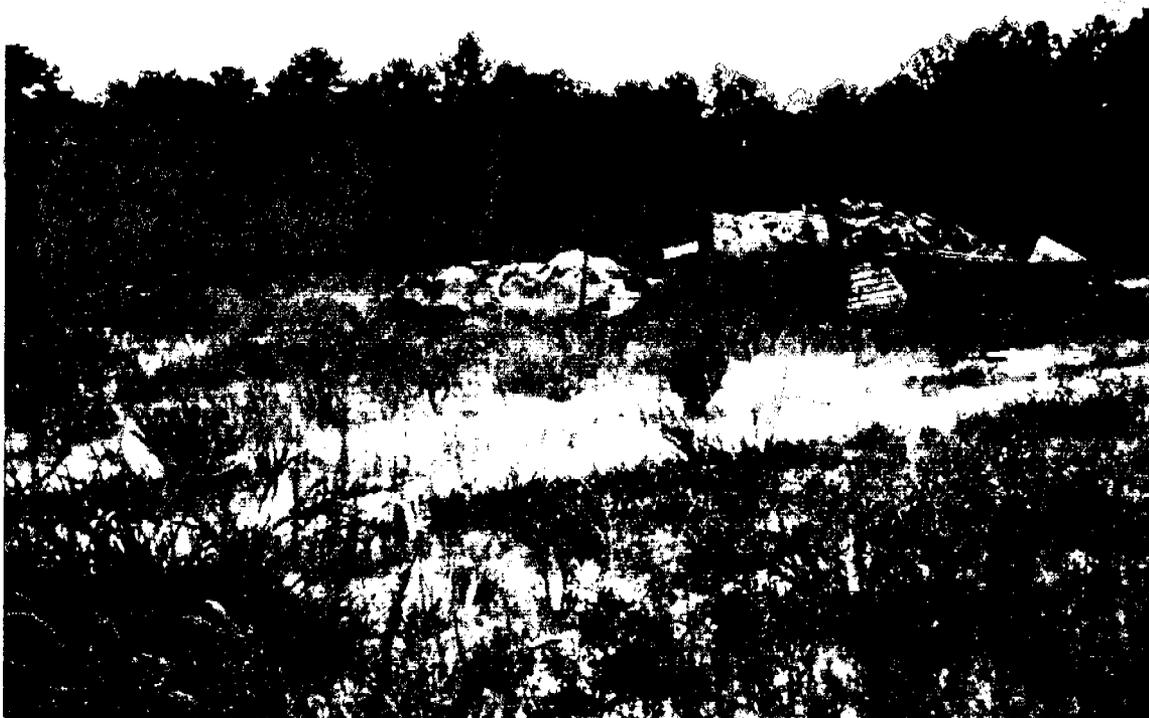
**Photograph 2-3**

View looking north from within Lot 203, toward the wooded area. Empty 1000-gallon tank is pictured adjacent to several 55-gallon drums.

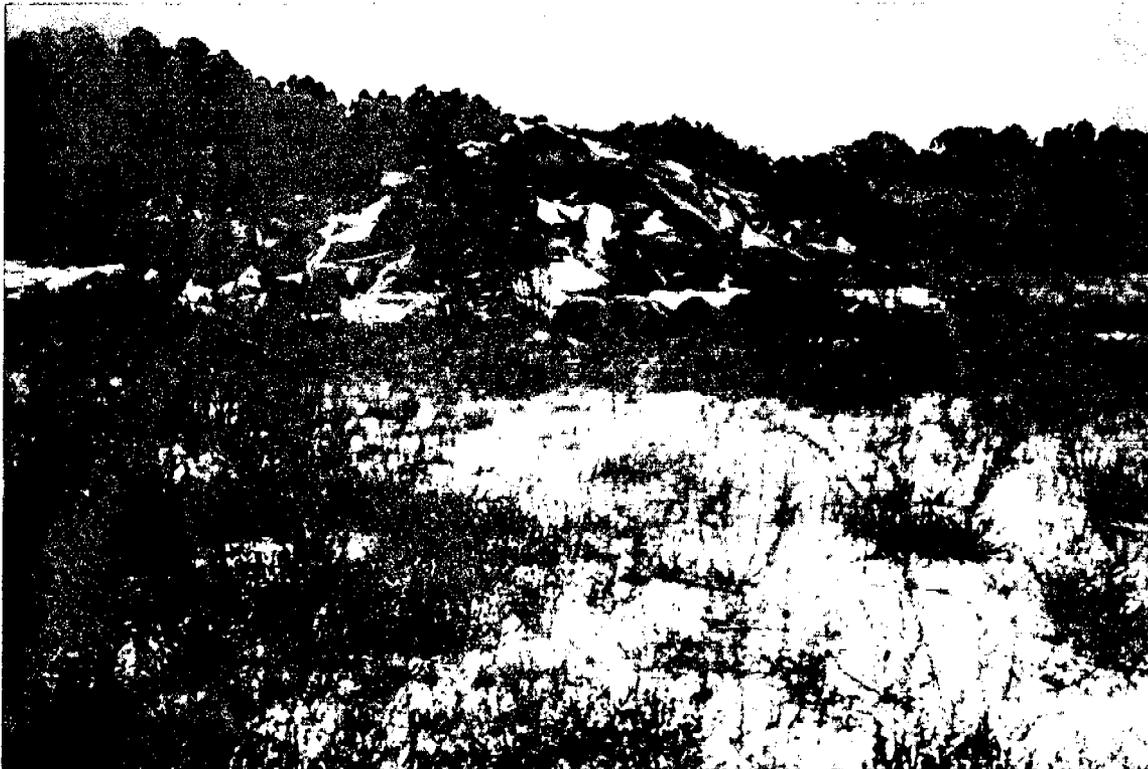
**Photograph 2-4**

Photograph shows mounded rubber rafts located within Lot 203. Shredded vehicle tires and other miscellaneous rubber wastes are mounded in the background.

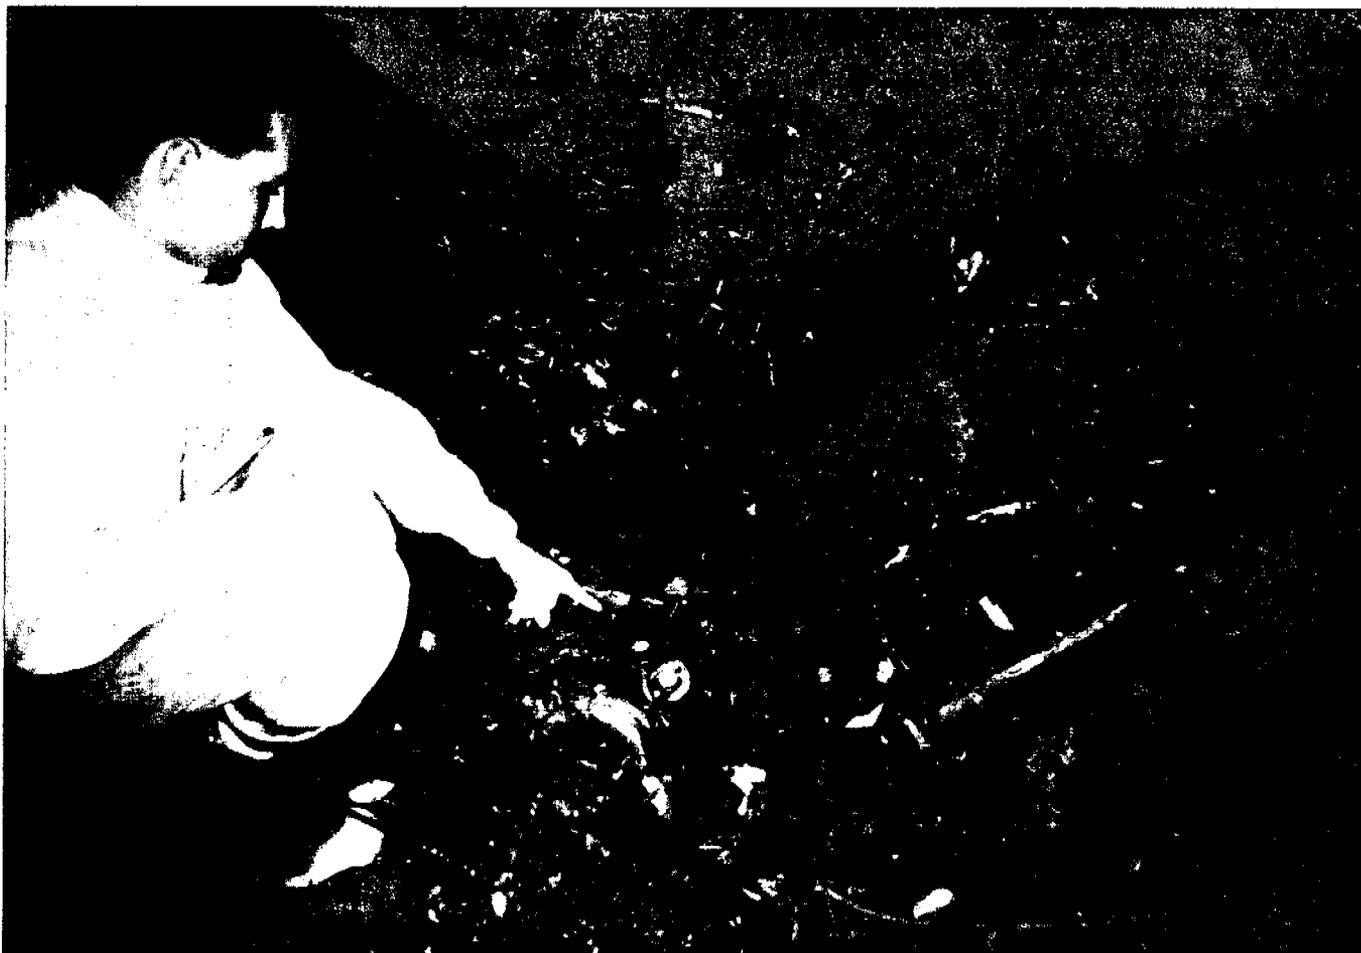
**Photograph 2-10**

Baker personnel pointing at one of several partially buried battery packs found within the ravine area.

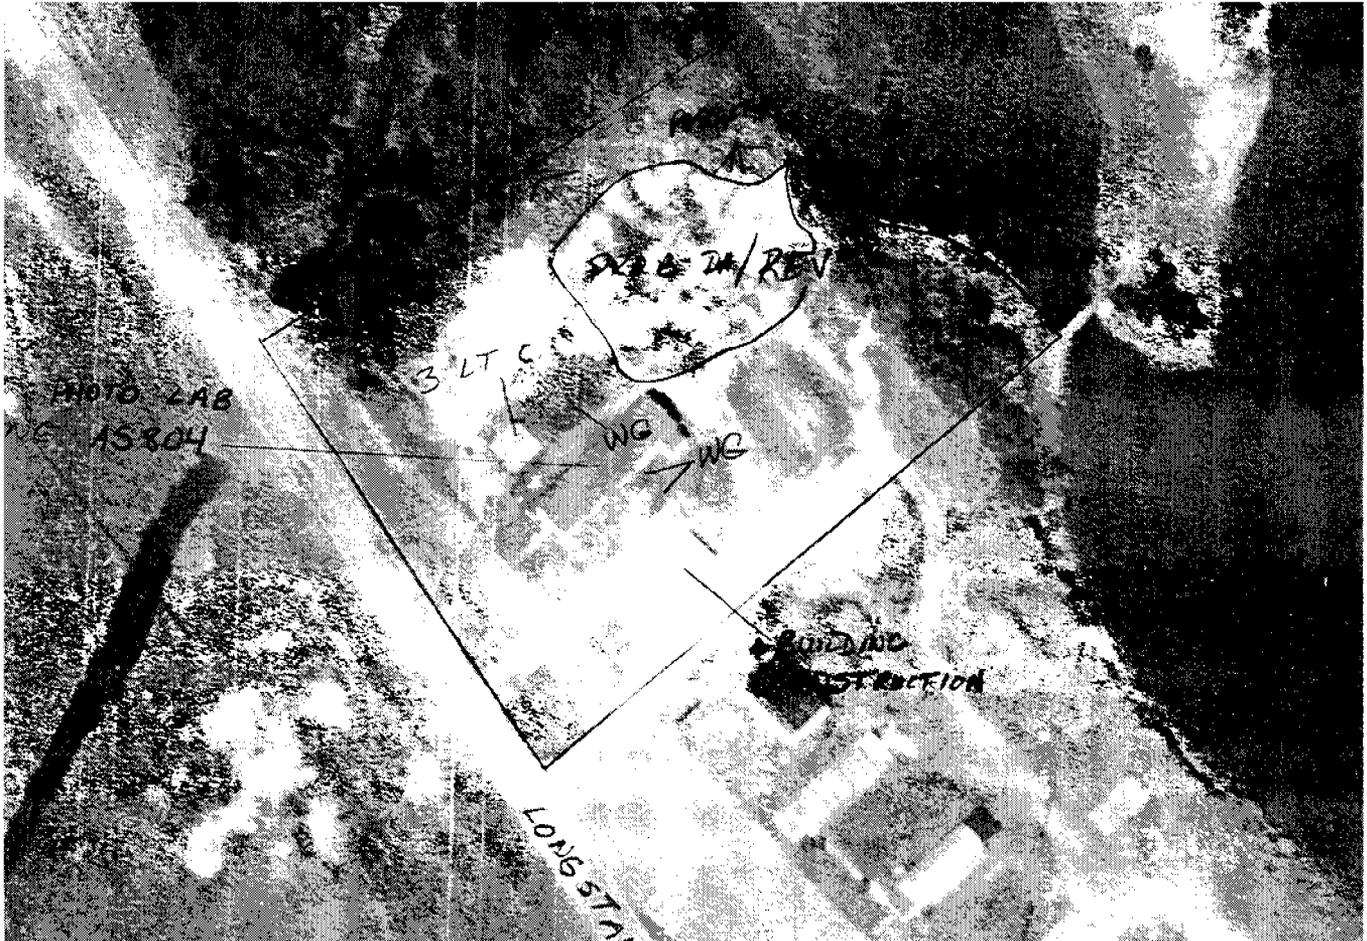
### Aerial Photograph 2-4

Annotated aerial photograph depicts Site 48 as of 4 October 1970. The probable mercury disposal area (Prob DA), northeast of Building AS804, appears to have been graded over and revegetated (REV).

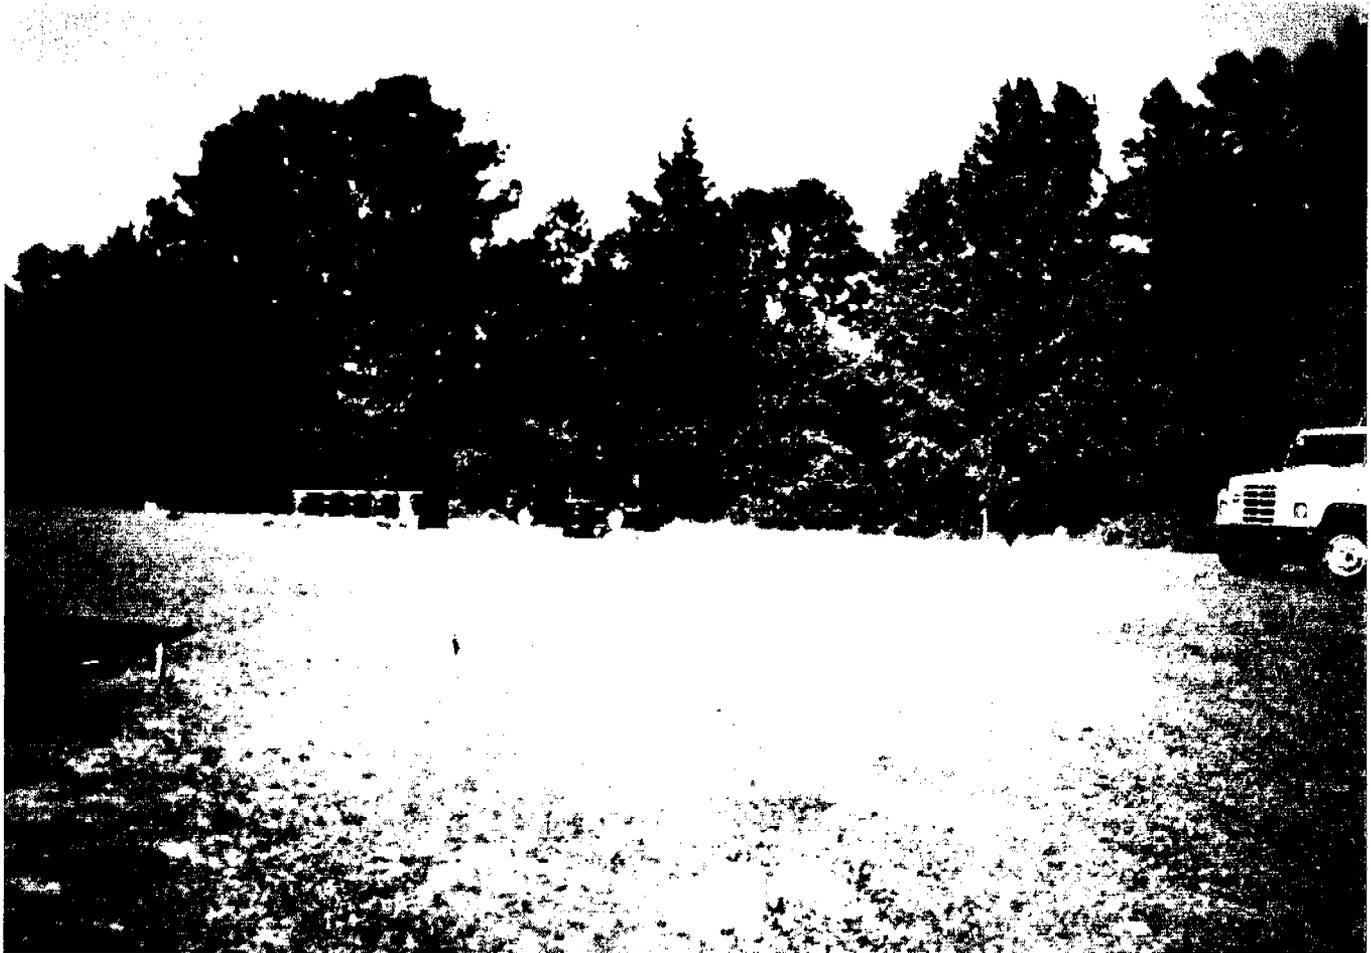
**Photograph 2-16**

View looking northwest toward shallow well number 48GW1, across eastern portion of Site 48. Suspected mercury dump is pictured immediately in the foreground.

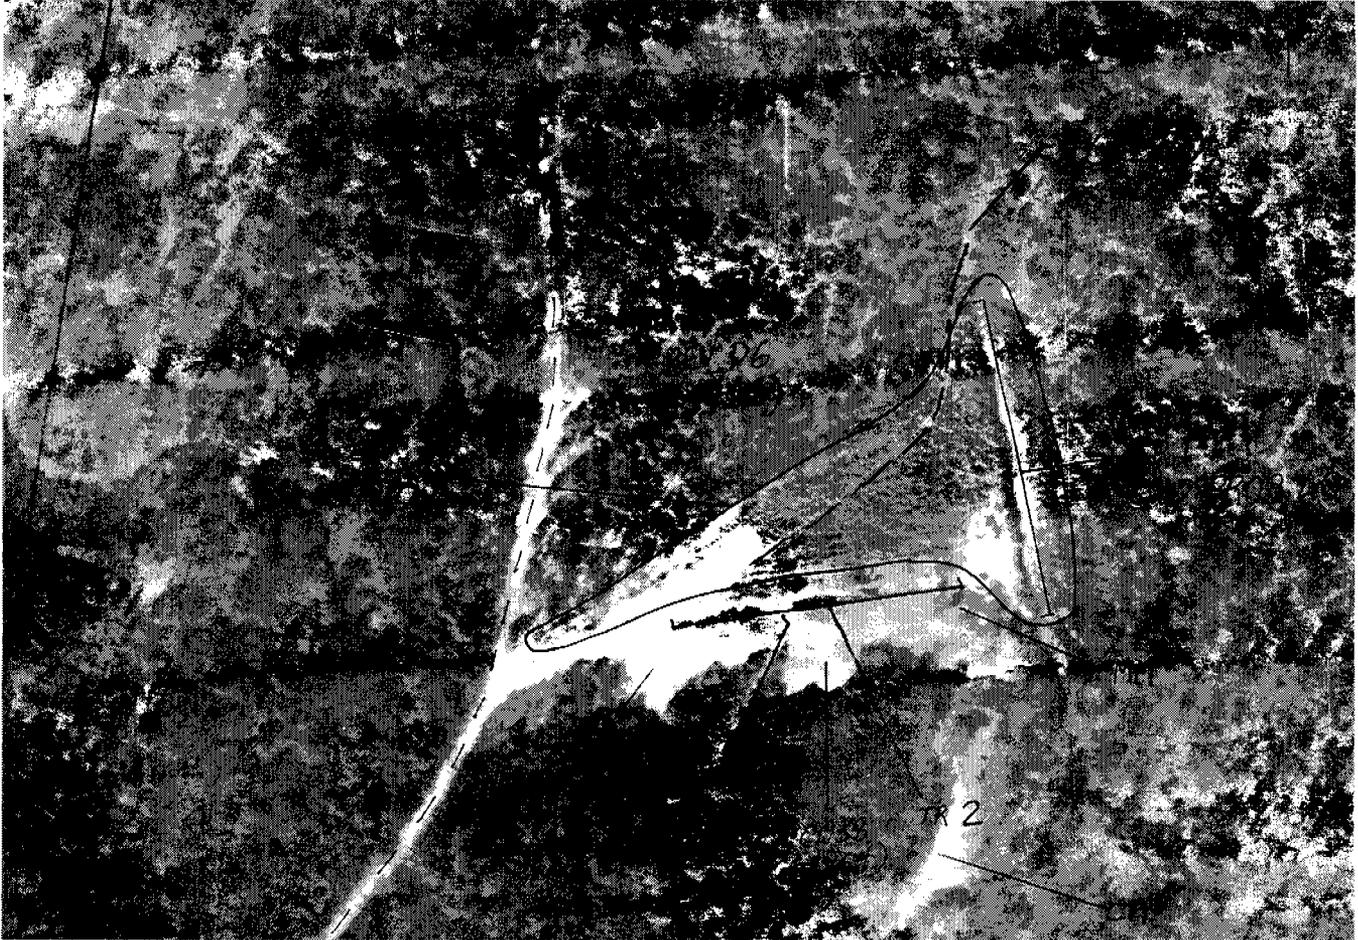
**Aerial Photograph 2-5**

Annotated aerial photograph depicts Site 69 as of 10 February 1964. Past trenching (TR) activity is visible despite continued revegetation.
