FINAL PHASE
IMPLEMENTATION REPORT
FOR SMALL-ARMS RANGE D-30 REMEDIATION PROJECT
AT MARINE CORPS BASE (MCB) CAMP LEJEUNE, NORTH CAROLINA

Contract DAAL03-91-C-0034
Scientific Services Program Task Number 96-198
Delivery Order 1960

July 25, 1997

Battelle
505 King Avenue
Columbus, Ohio 43201-2693

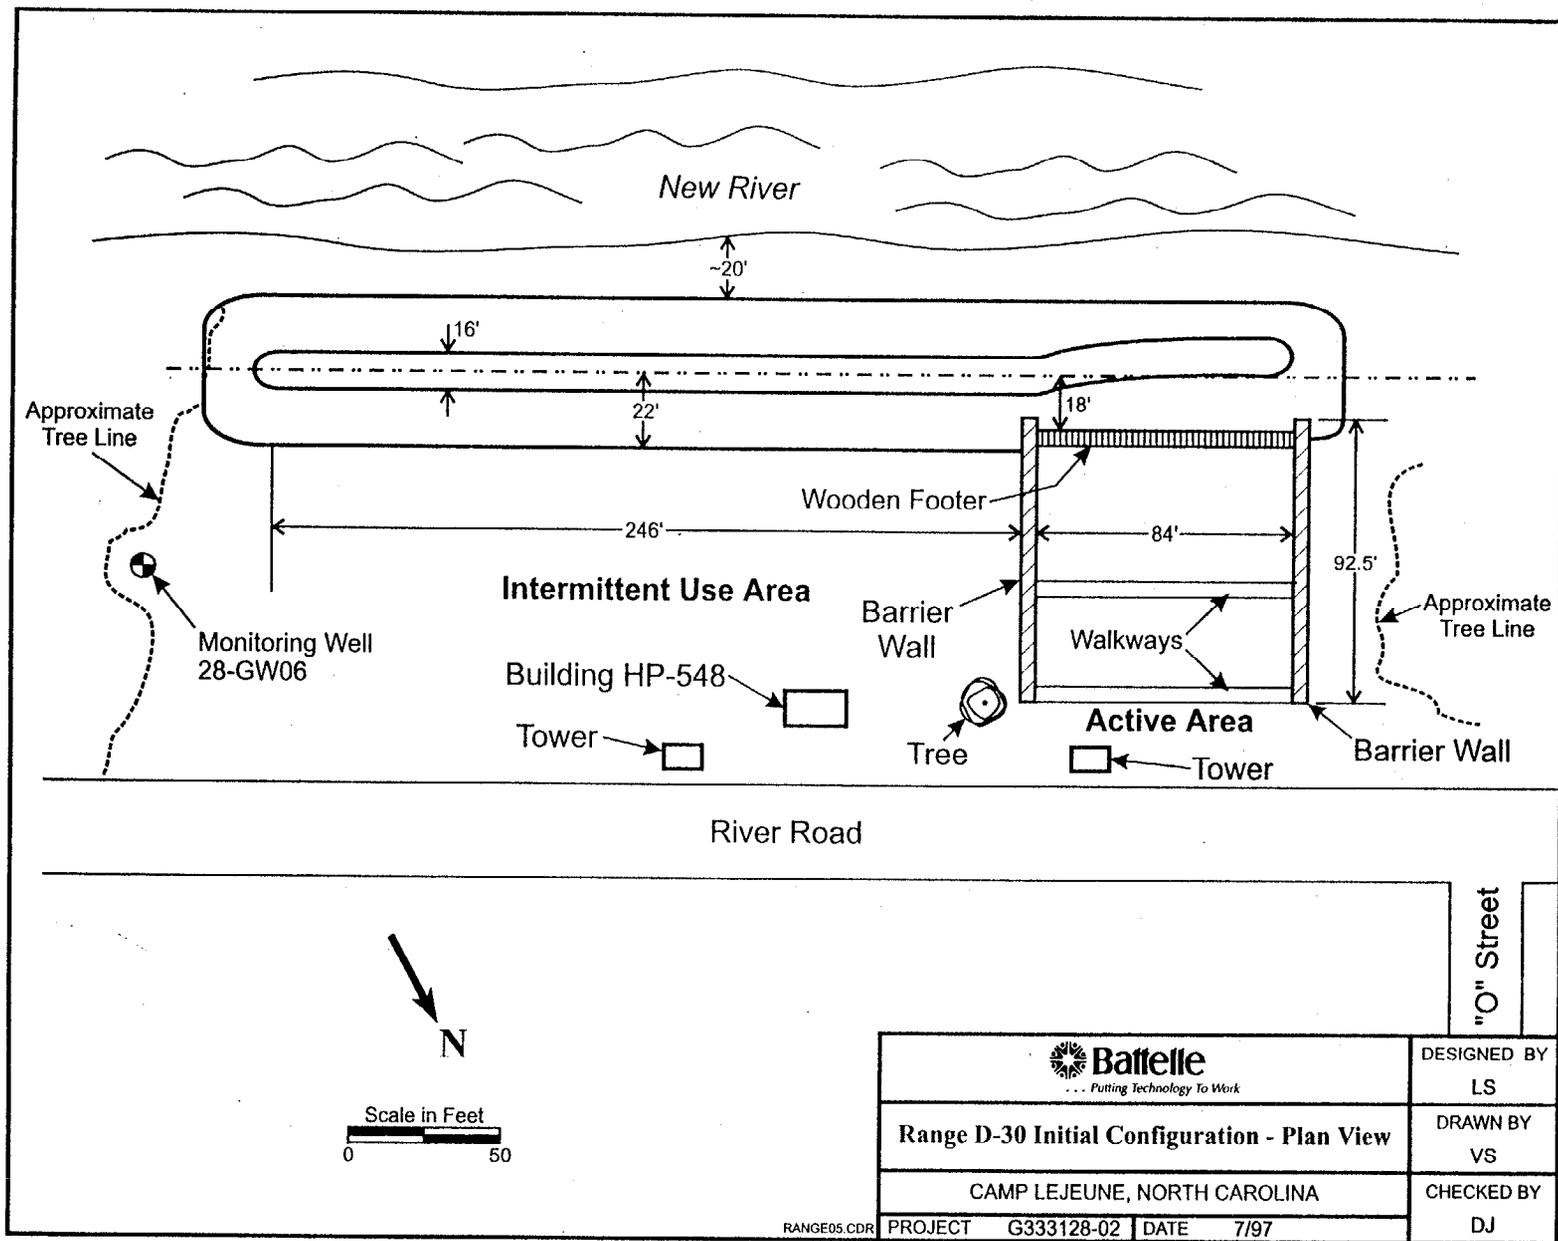
Figure 1-2. Range D-30 Initial Configuration — Plan View

The portion of the range located to the right when facing the river is about 84 ft long and is actively used for pistol training and qualification. A longer portion of the range, located to the left when facing the river, is used intermittently. There is an earth-filled wooden barricade on the right end of the actively used portion and a second earth-filled wooden barricade between the active and intermittent use portions of the range.

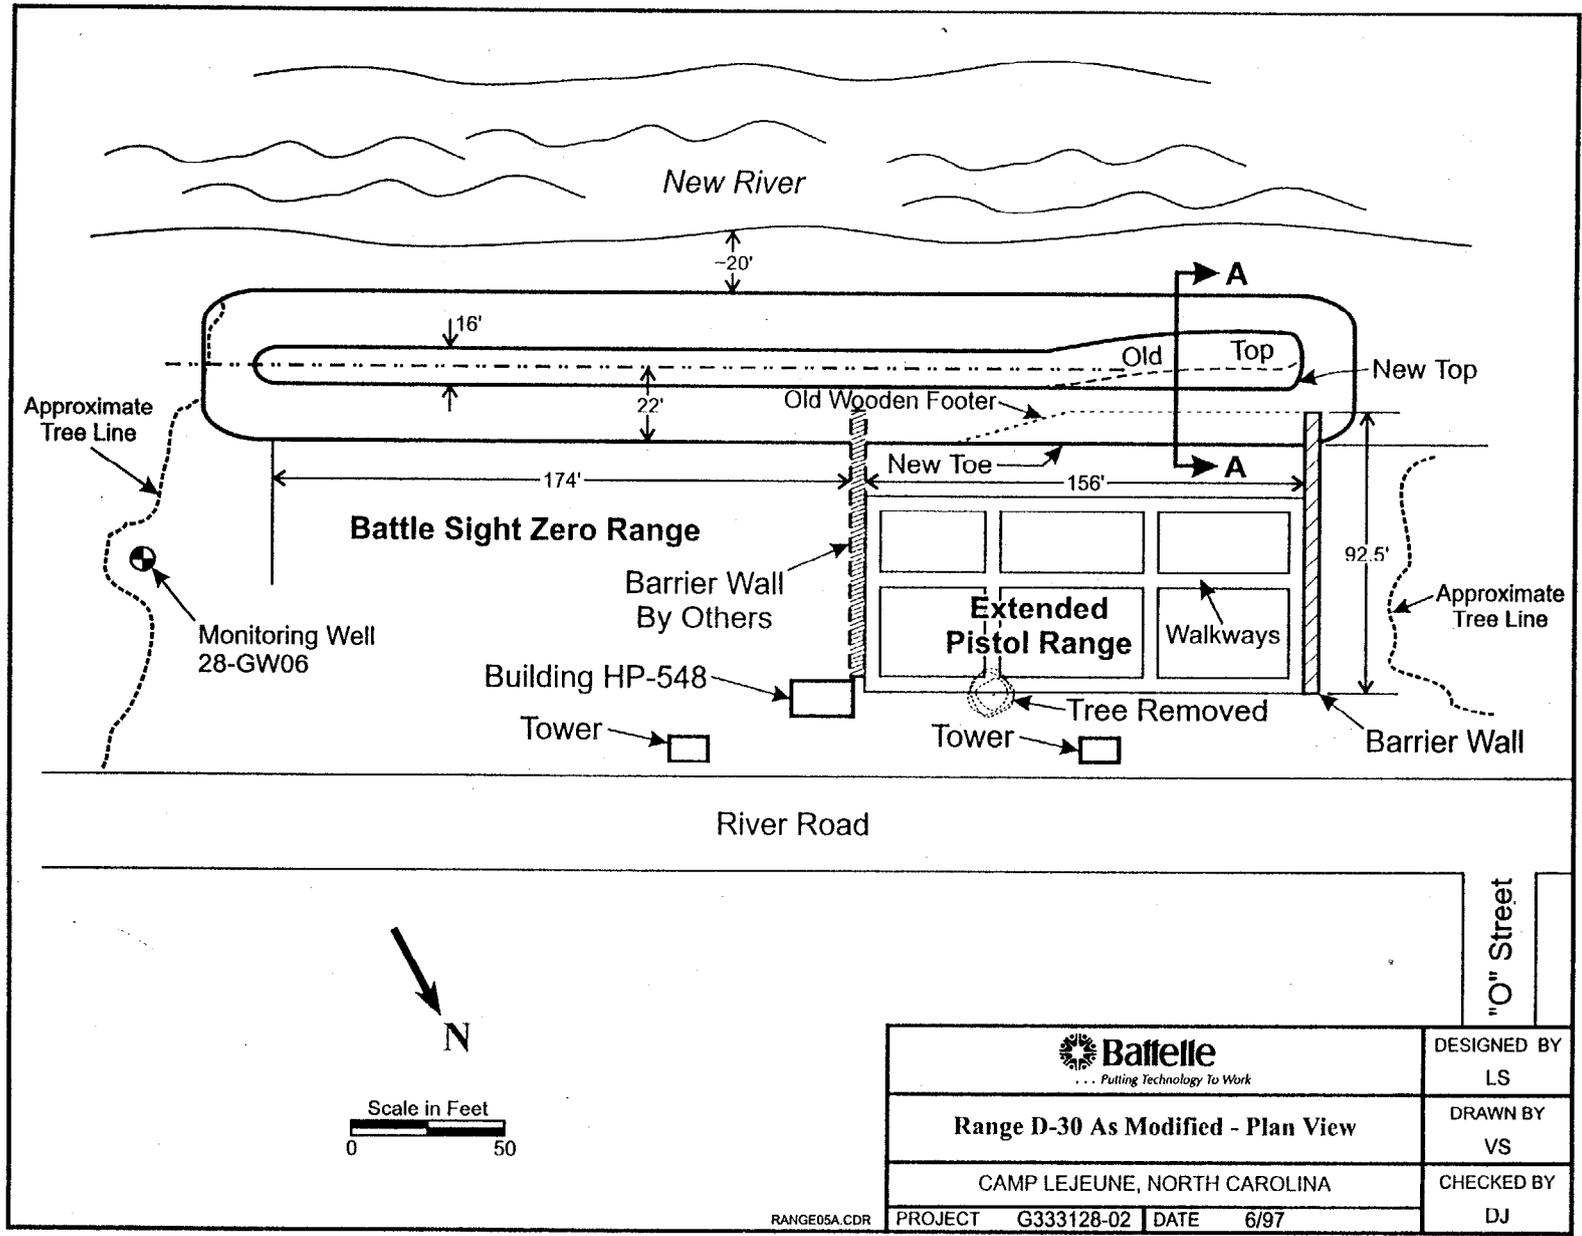
Figure 1-3. Range D-30 as Modified — Plan View

The front of the active area berm was several feet further from the firing line than the front of the intermittent use berm. The front of active area berm needed to be aligned with the front of the intermittent use berm to allow the planned extension of the active use area. The alignment required the addition of about 160 yd³ of soil to advance the front of the active area berm into alignment with the intermittent use area berm, as well as construction of a new drainage path at the toe of the berm, removal of the existing concrete walkways that marked firing line locations, and placement of 843 ft of gravel walkways to mark new firing line locations. MCB Camp Lejeune supplied two trucks and operators to move the soil from the borrow pit to Range D-30. Base personnel removed a tree that interfered with the range extension.

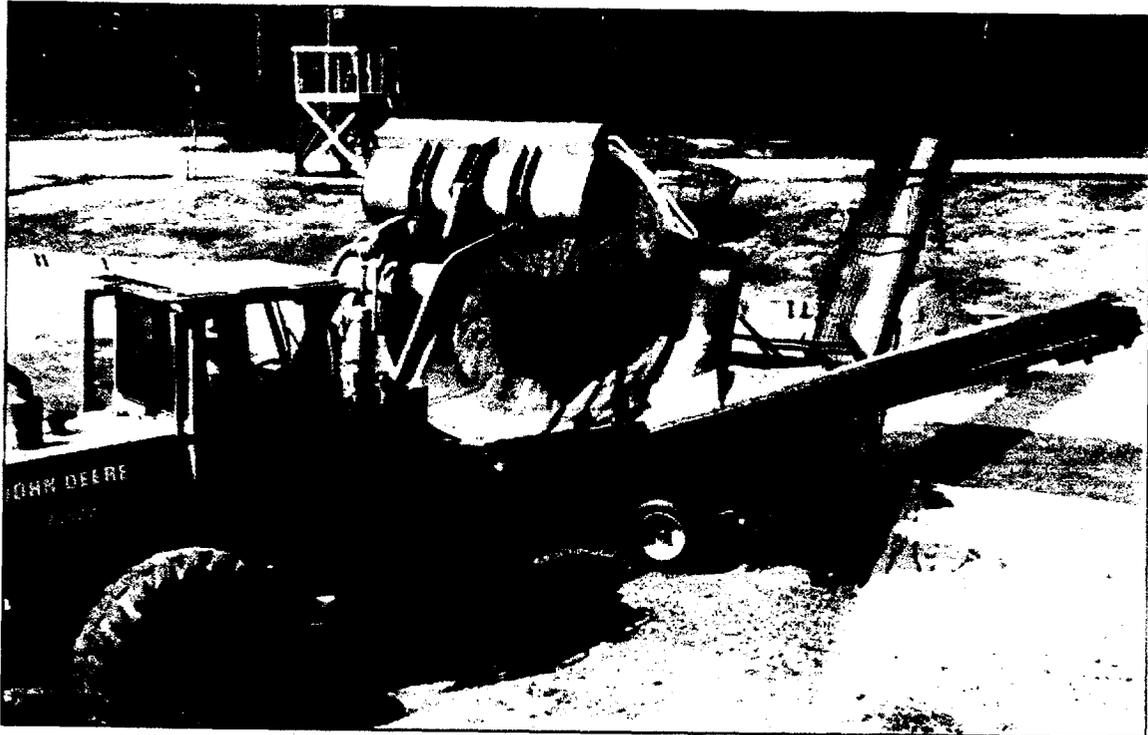
Photo 3. Rotating Screening Plant Operation

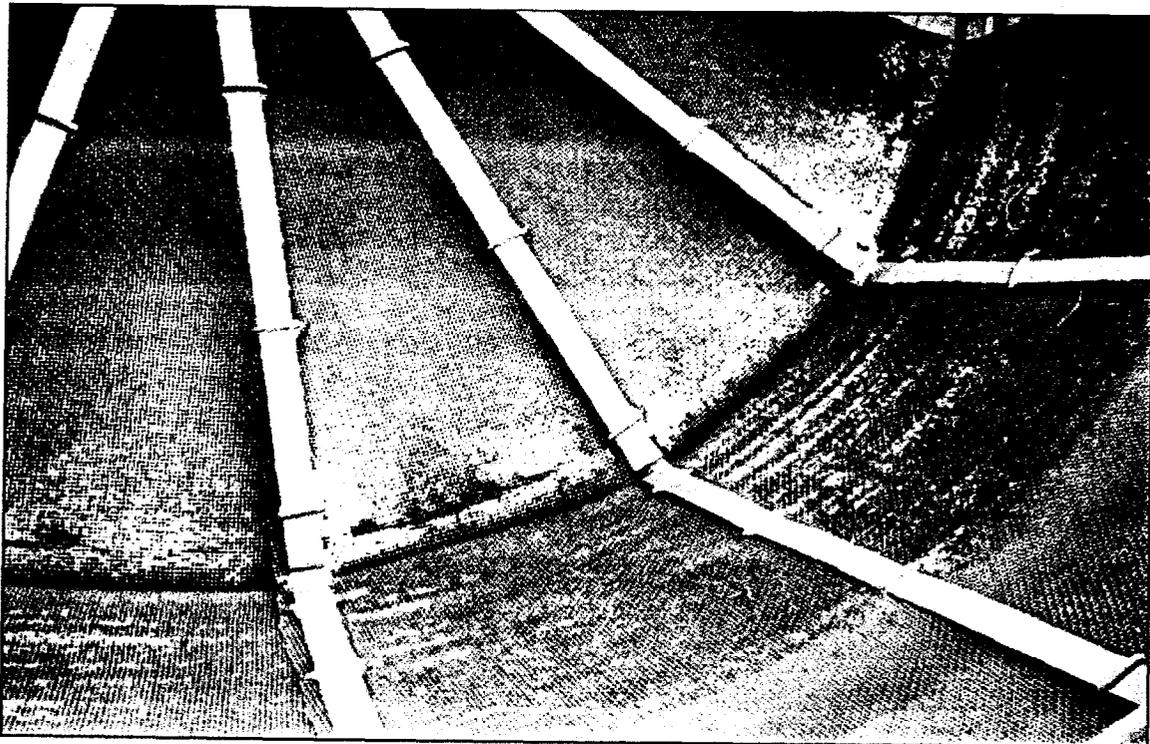
The soil proved to be more cohesive than expected, causing the #5 mesh screen to plug frequently. The active area soil, which contained the highest proportion of bullets and bullet fragments, was screened using the #5 mesh. The intermittent use area soil was screened through a more open mesh (3/8-in. mesh screen) which did not plug with the moist, cohesive soil. The larger screen opening retained lead fragments because of the inclined orientation of the screen and the tendency for the soil to partially fill the openings.

Photo 4. Screen Showing Soil Accumulation in Openings

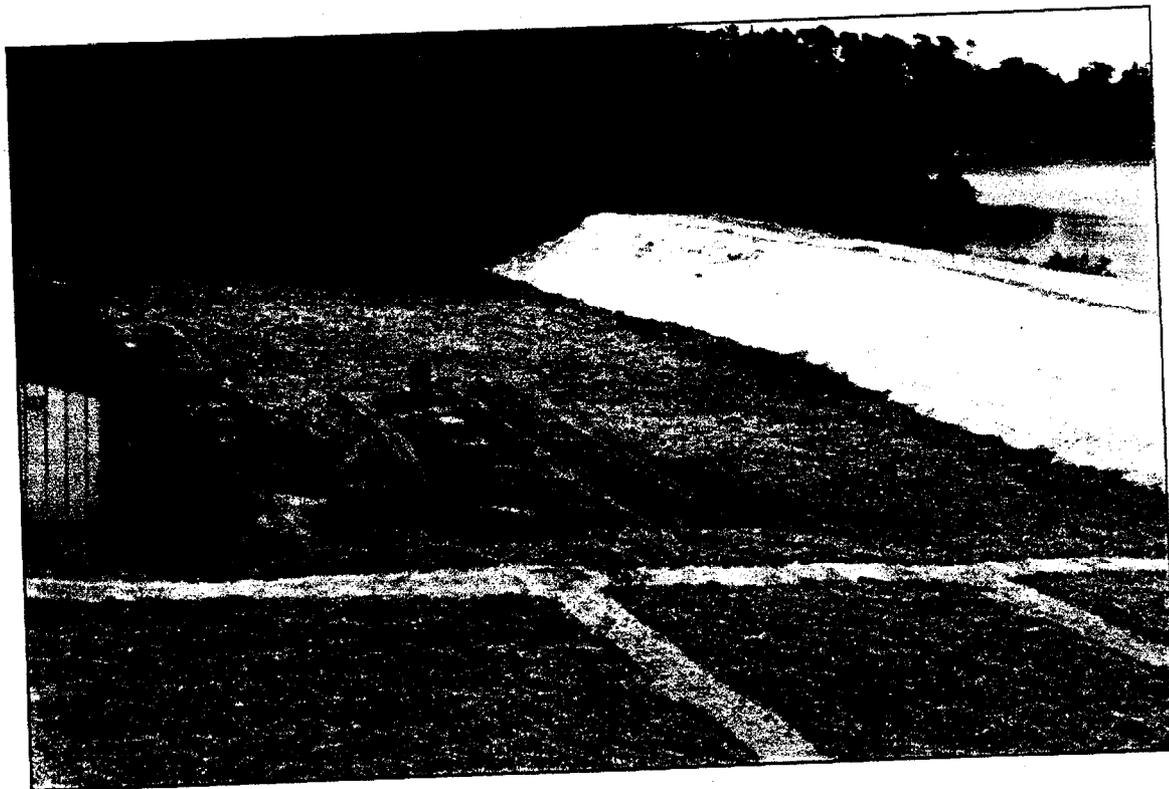
Photo 12. Site Restoration
