**PHOTO LOG
FOR OPERABLE UNIT NO. 10
(SITE 35)**

CAMP GEIGER AREA FUEL FARM

**MARINE CORPS BASE
CAMP LEJEUNE, NORTH CAROLINA**

JULY 29, 1994

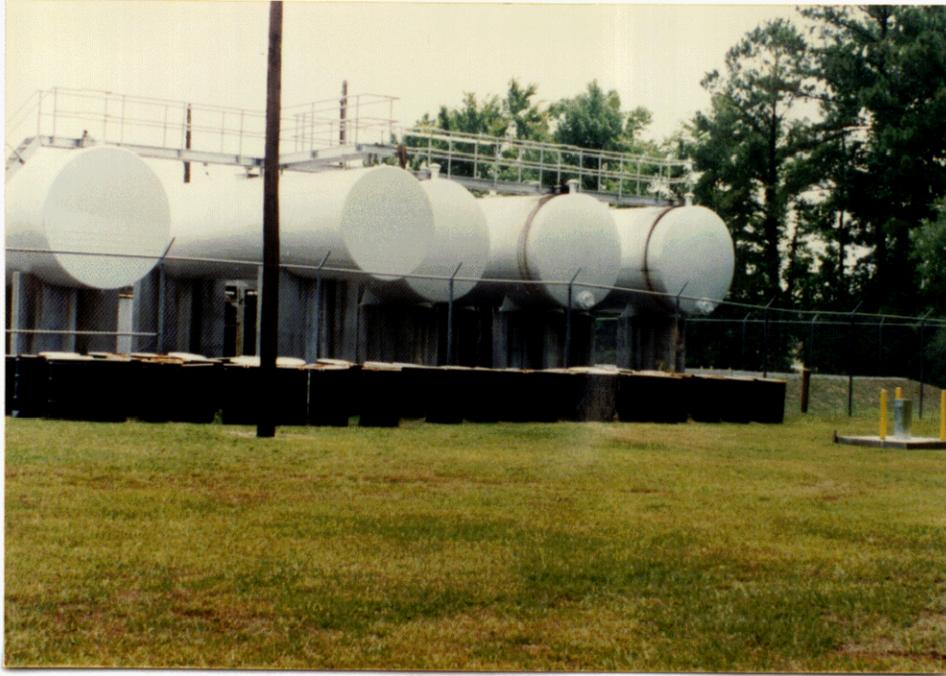
OU10.SITE 35.1994.1

View of aboveground storage tanks (ASTs) located at the Camp Geiger Fuel Farm, looking southwest. The drums stored soil and fluids from a previous investigation and, although they remained on site at the time of the site visit, had been removed prior to the Remedial Investigation.

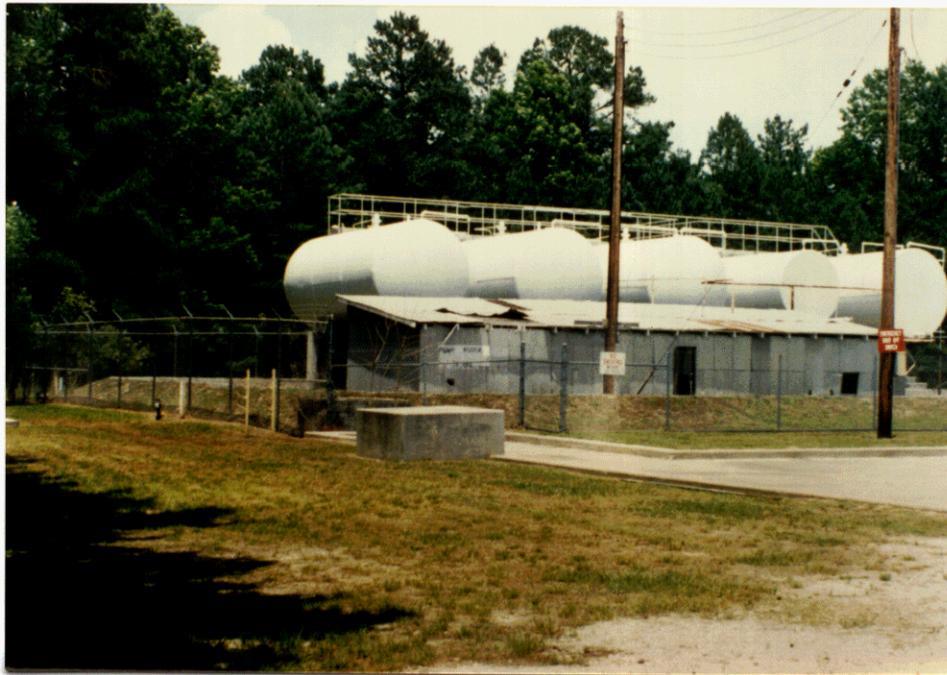
OU10.SITE 35.1994.2

A view of the ASTs and associated pump house located at the Camp Geiger Fuel Farm; looking northeast.

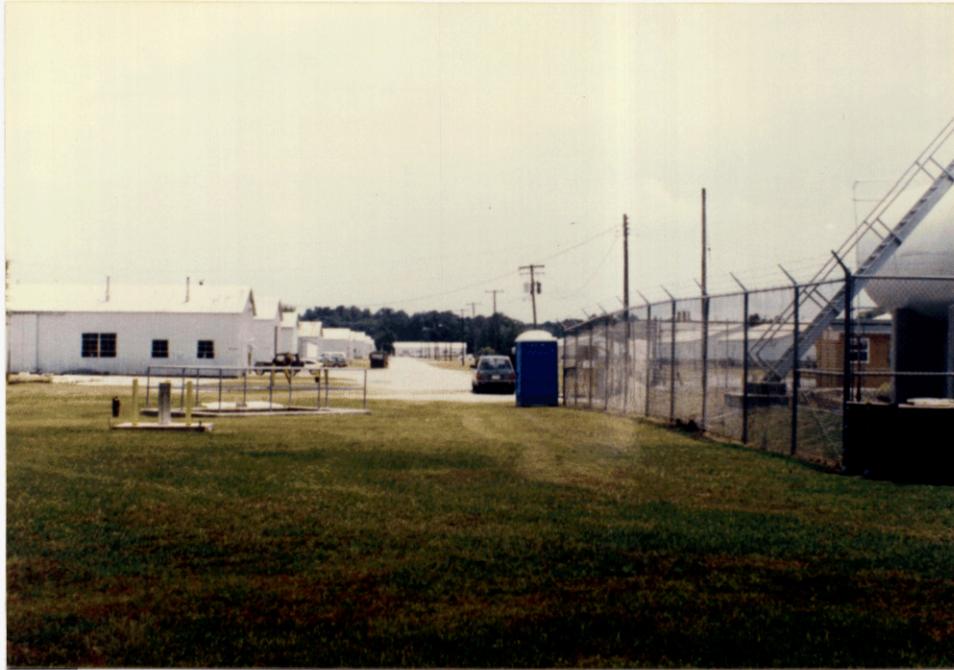
OU10.SITE 35.1994.3

A view down G Street from the Camp Geiger Fuel Farm, looking south. Note the row of warehouses on the east side of G Street. The first warehouse was formerly a vehicle maintenance facility and still utilizes a 500-gallon waste oil tank located near the double doors on the north side of the warehouse. Surface soil sample 35-SS03-00 was collected near the waste oil tank.

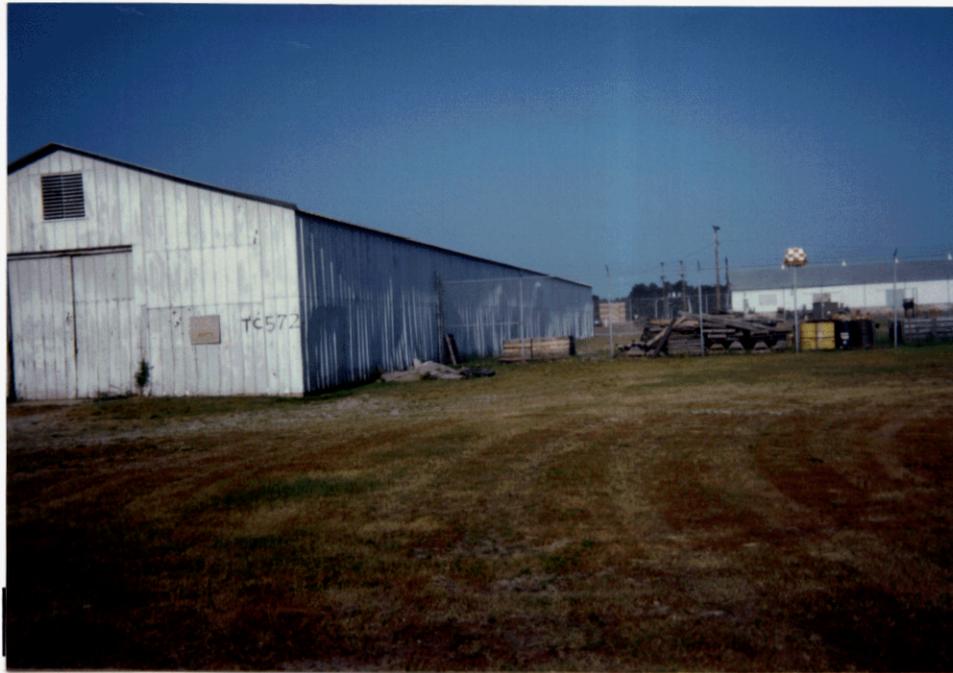
OU10.SITE 35.1994.4

View of Warehouse TC 572 located along G Street, looking southwest. This photo is the first in a series of three that illustrate the type of materials sorted in the fenced area between Warehouses TC572 and TC470.

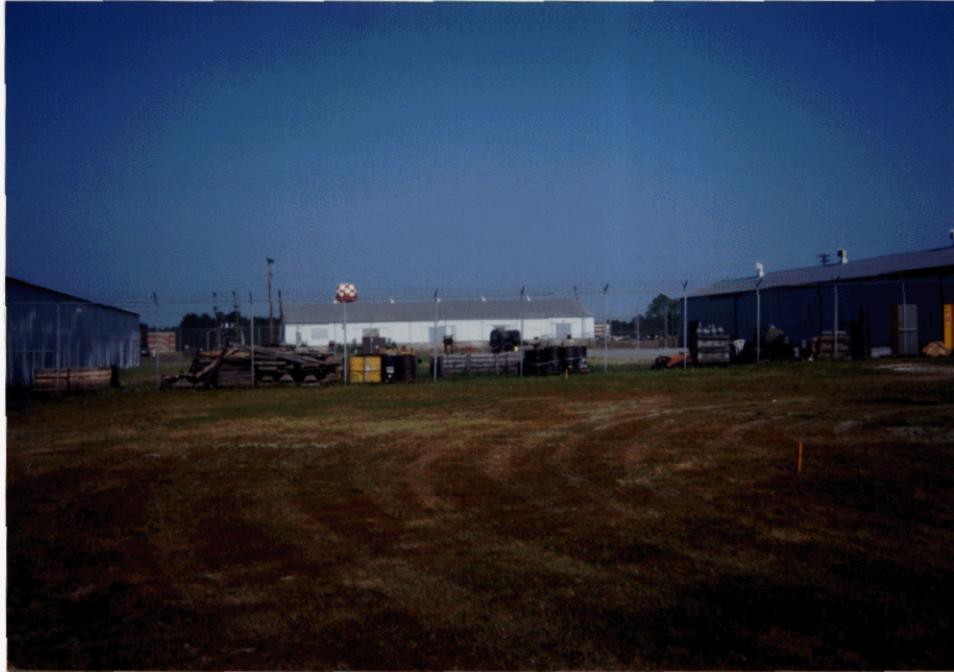
OU10.SITE 35.1994.5

A view of fenced area between Warehouses TC572 and TC470, looking west. This is the second photo in the Series of three.

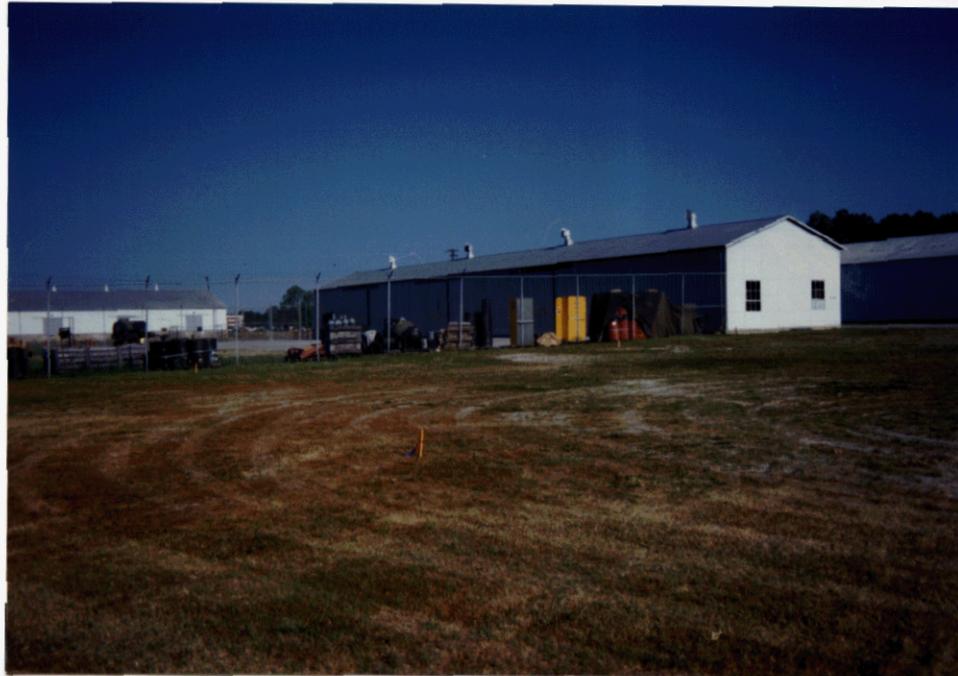
OU10.SITE 35.1994.6

A view of Warehouse TC470 located along G Street, looking northwest. This photo is the third of three. The survey stake in the foreground marks soil gas sample location.

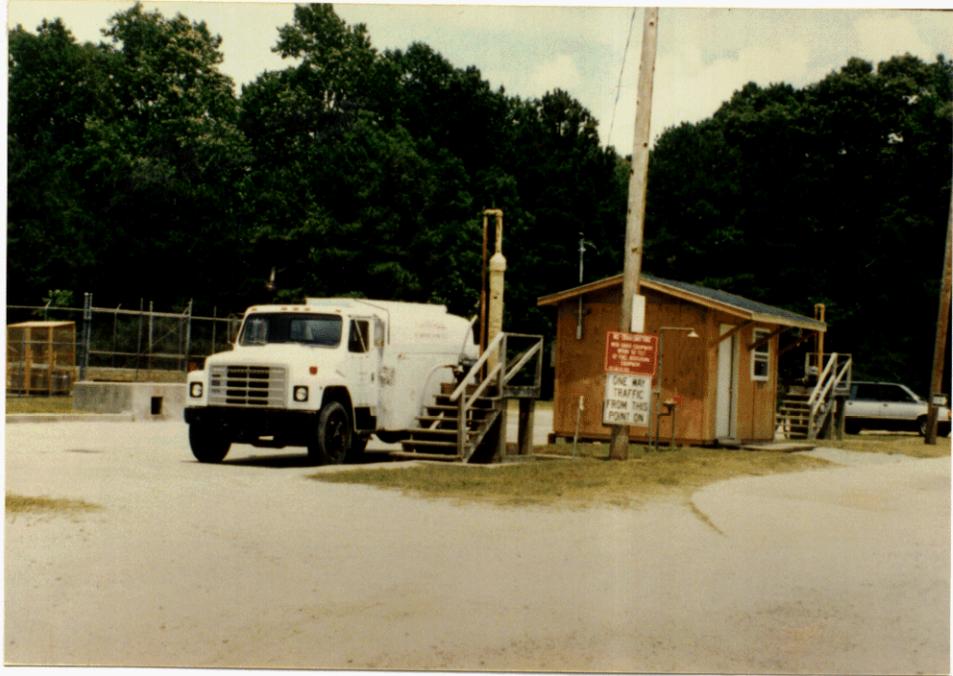
OU10.SITE 35.1994.7 A view of the fuel loading area and building TC36A located at the Camp Geiger Fuel Farm; looking northeast.

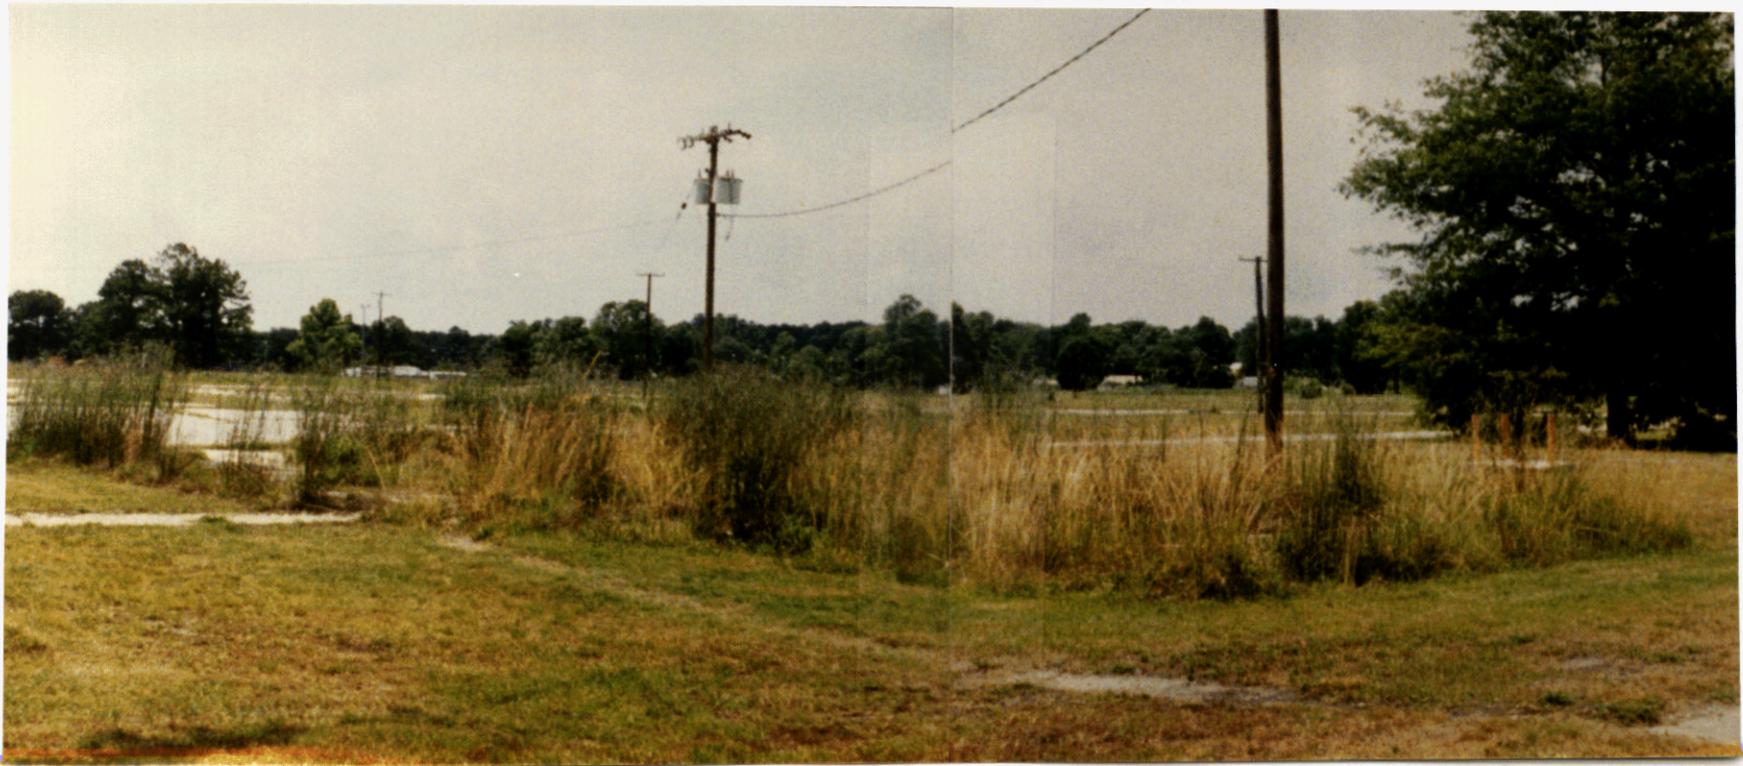
OU10.SITE 35.1994.8

A view of the location of the former Mess Hall Heating Plant, looking northwest. A Number 6 fuel oil underground storage tank (UST) was formerly located north of the heating plant and is the suspected source of hydrocarbon contamination in the area.

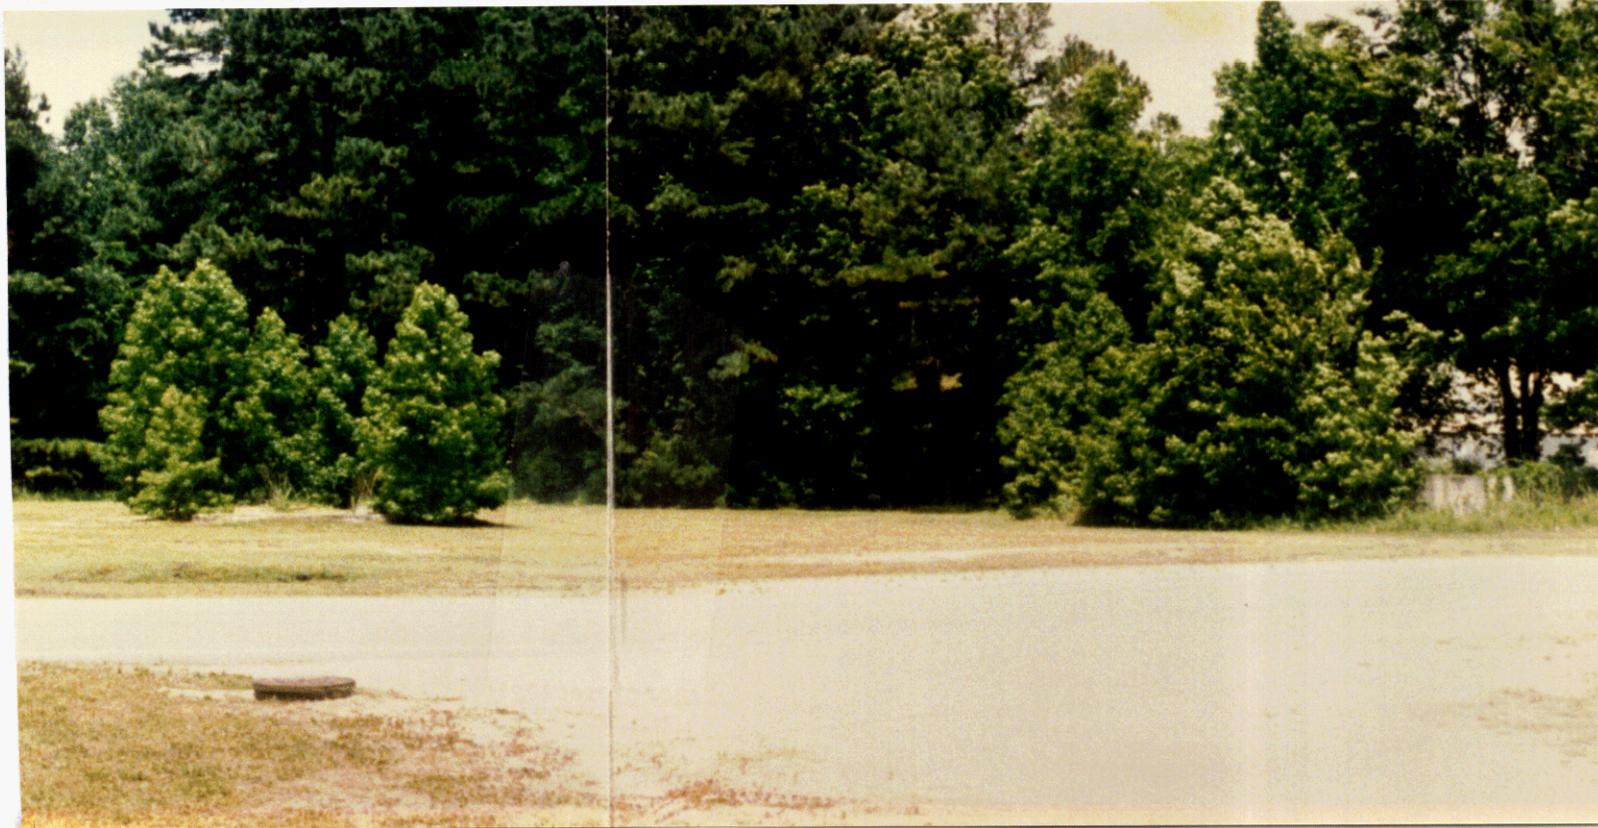
OU10.SITE 35.1994.9

The northeast corner of the intersection of Fourth and F Streets where a service station and an icehouse formerly existed; looking north. The foundation on the right of the photograph is the former icehouse location and the concrete slab near the trees in the center of the photograph is the former location of the service station.

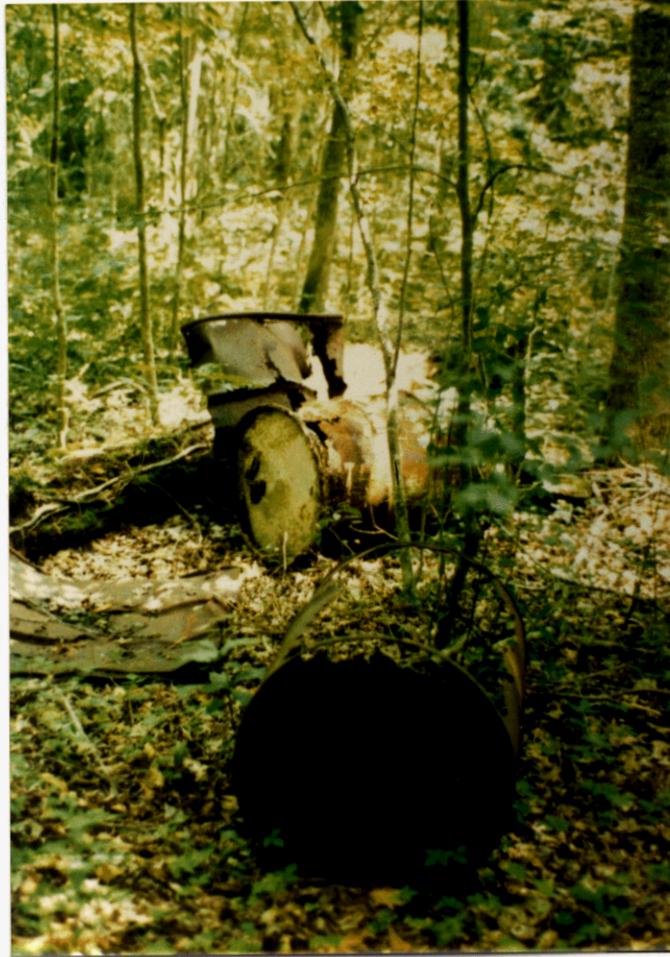
OU10.SITE 35.1994.10

Remnants of drums and related debris observed northeast of manmade ponds during site visit; looking north.

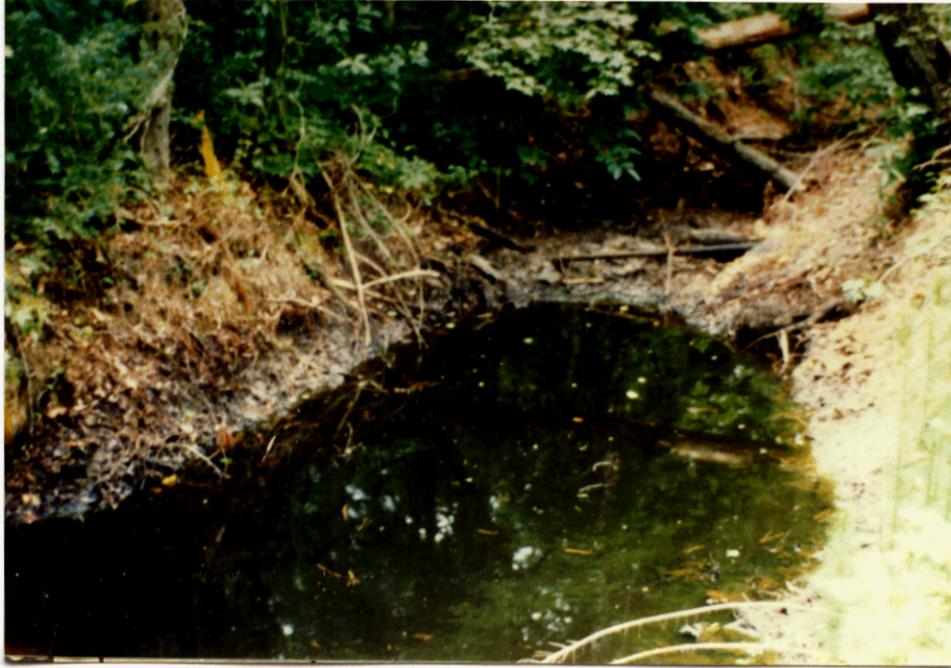
OU10.SITE 35.1994.11

A view of a small ditch which drains to a manmade pond; looking southwest. The pond was reportedly excavated to capture the fuel believed to have originated from a surface release of product (Law, 1992).

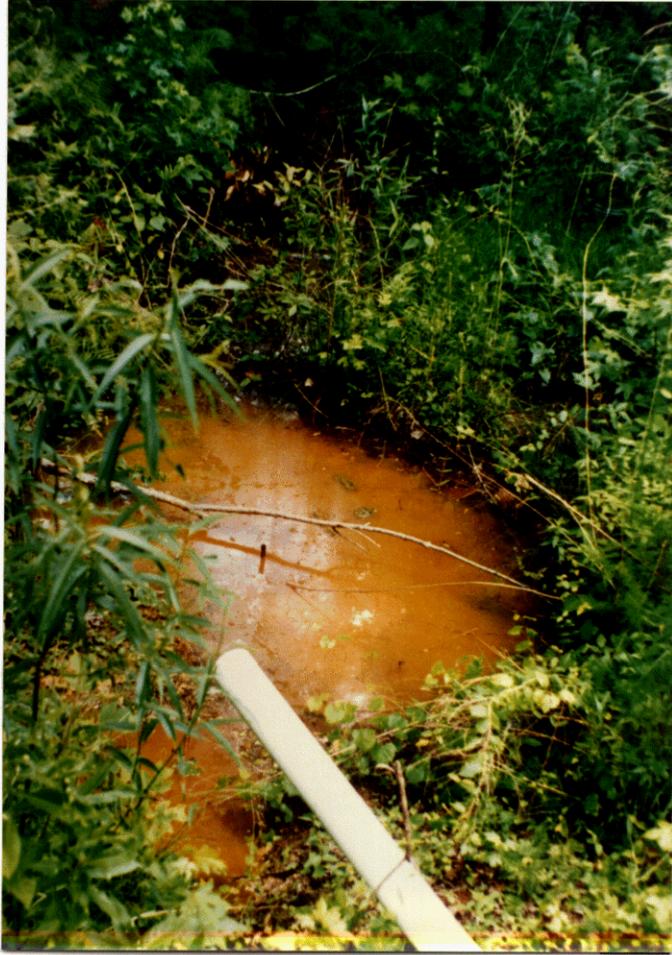
OU10.SITE 35.1994.12 A view of an orange-stained pond and a white PVC pipe located downgradient of the manmade pond visible in Photograph OU10.SITE35.1994.11, looking east. The PVC serves as an unregulated outlet that originates at the manmade pond and discharges into the orange-stained pond. This smaller pond discharges to a small ditch which eventually conveys flow to Brinson Creek.

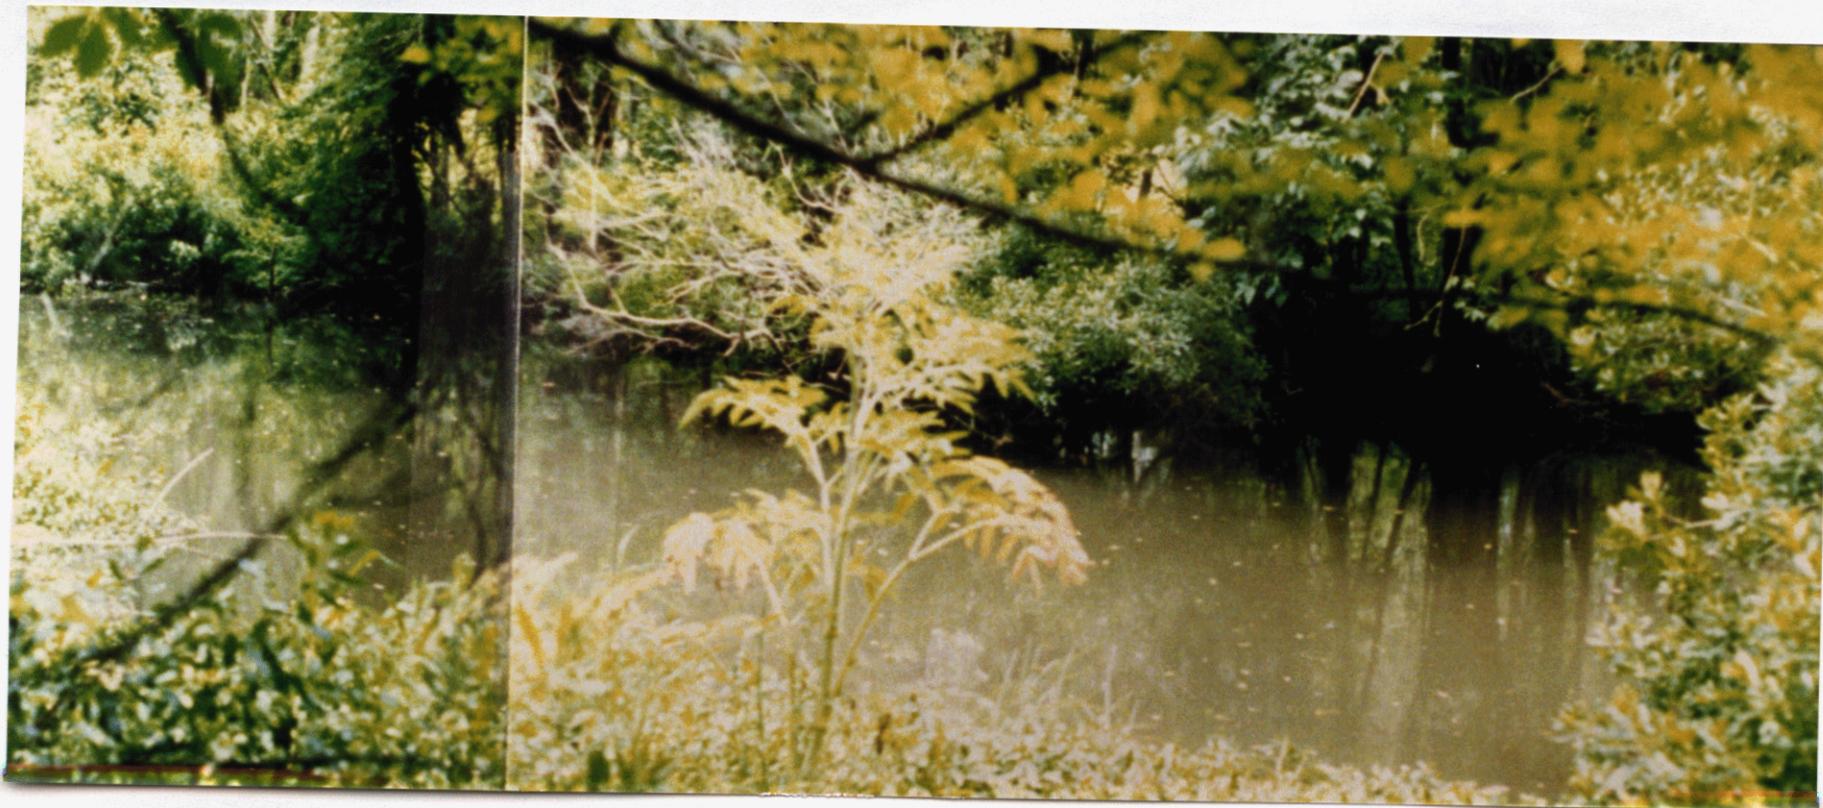
OU10.SITE 35.1994.13

A view of Brinson Creek, looking east, as seen from the confluence of the unnamed discharge channels located north of the Fuel Farm.

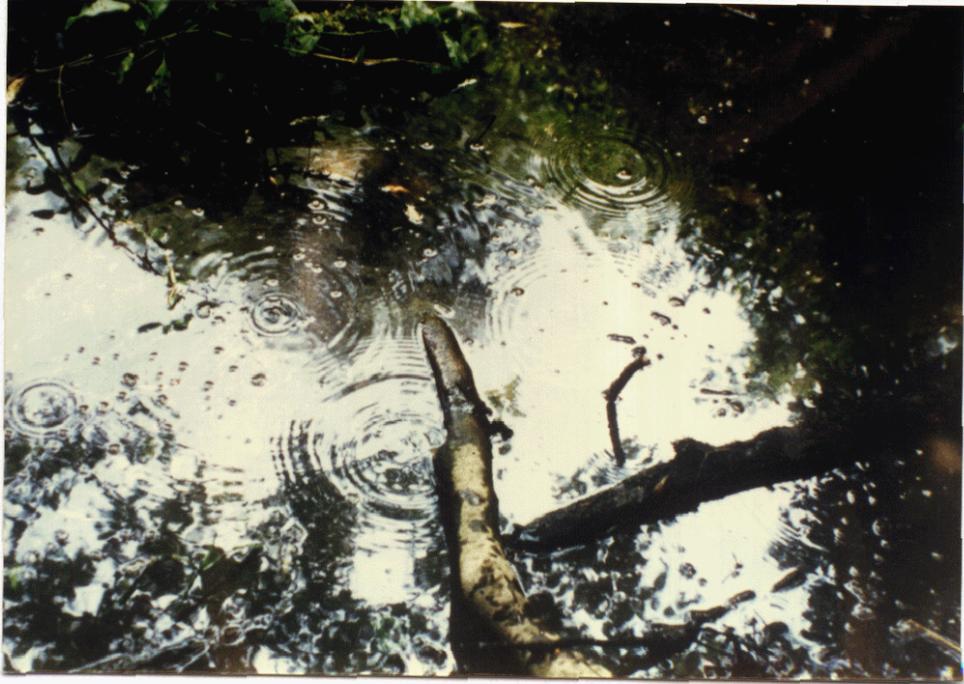
OU10.SITE 35.1994.14 A view of a sheen observed on Brinson Creek at the Confluence of the unnamed discharge channels and Brinson Creek looking east. The sheen developed when the sediments along the bank of Brinson Creek were disturbed. This is a typical phenomena along the creek's southwestern bank.

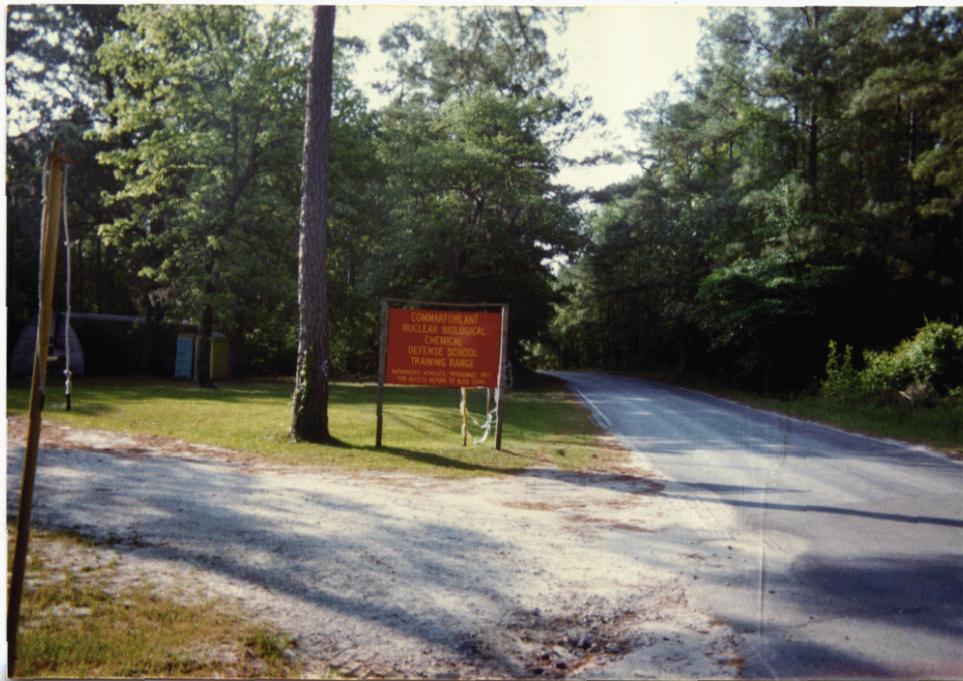
OU10.SITE 35.1994.15 A view of sign marking the entrance to the "Commarforlant Nuclear Biological Chemical Defense School Training Range," looking southeast. The training range is adjacent to the eastern edge of the site.

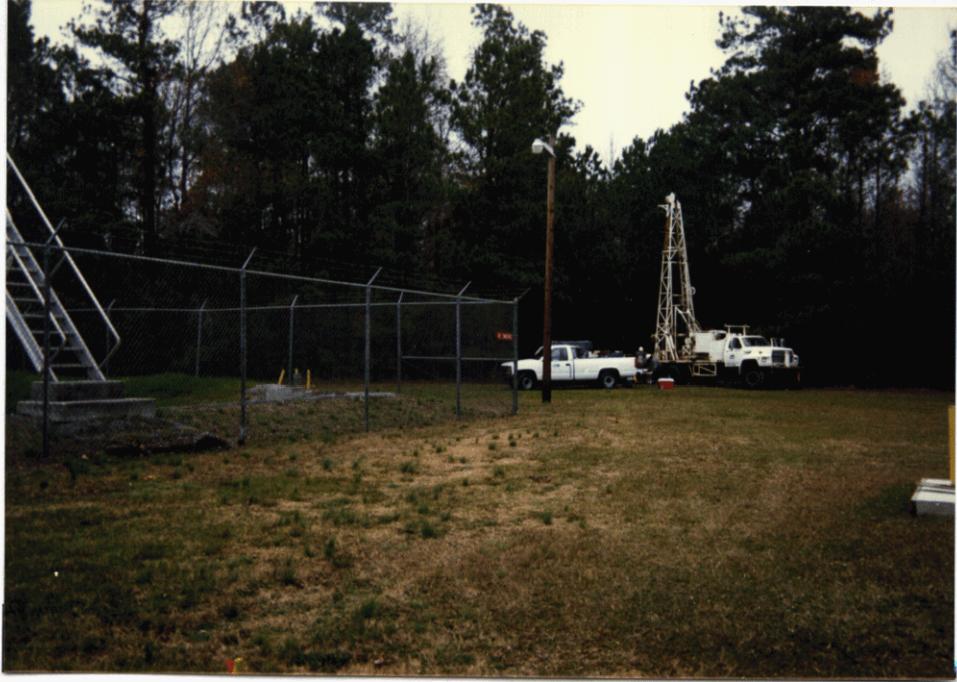
OU10.SITE 35.1994.16 View drilling subcontractor advancing soil boring SB-33 during Interim Remedial Action; looking north.

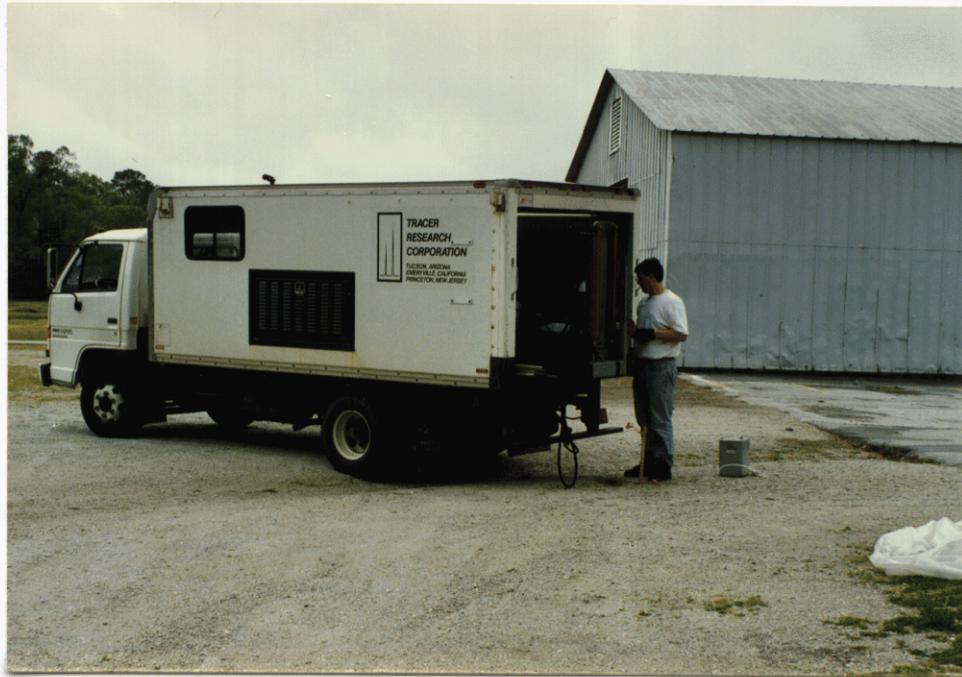
OU10.SITE 35.1994.17

View of Baker's subcontractor collecting soil gas sample 35-SGS-42 located near the southeastern corner of building TC474; looking south.

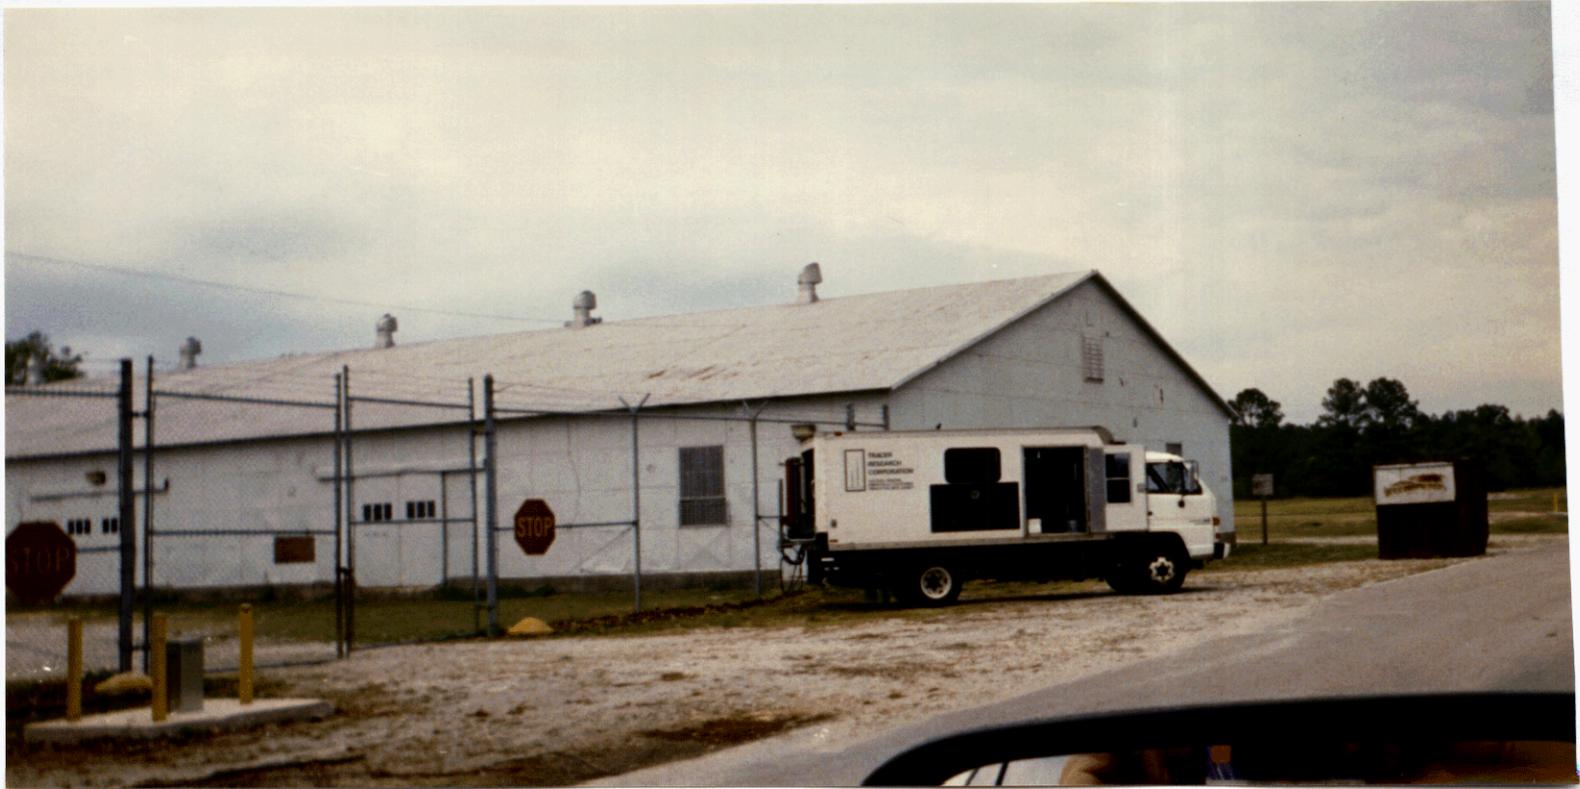
OU10.SITE 35.1994.18

View of Baker and subcontractor collecting soil gas sample 35-SG-12 located near eastern side of buildings TC341 and TC342; looking northwest.

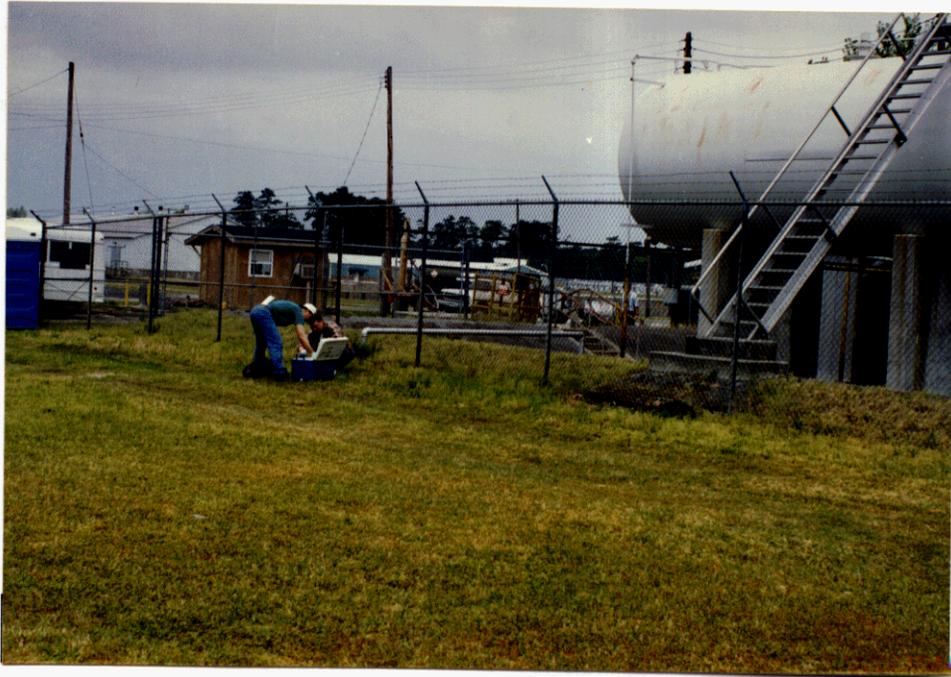
OU10.SITE 35.1994.19 View of Baker personnel preparing to collect surface soil sample 35-SS11-00; looking southwest.

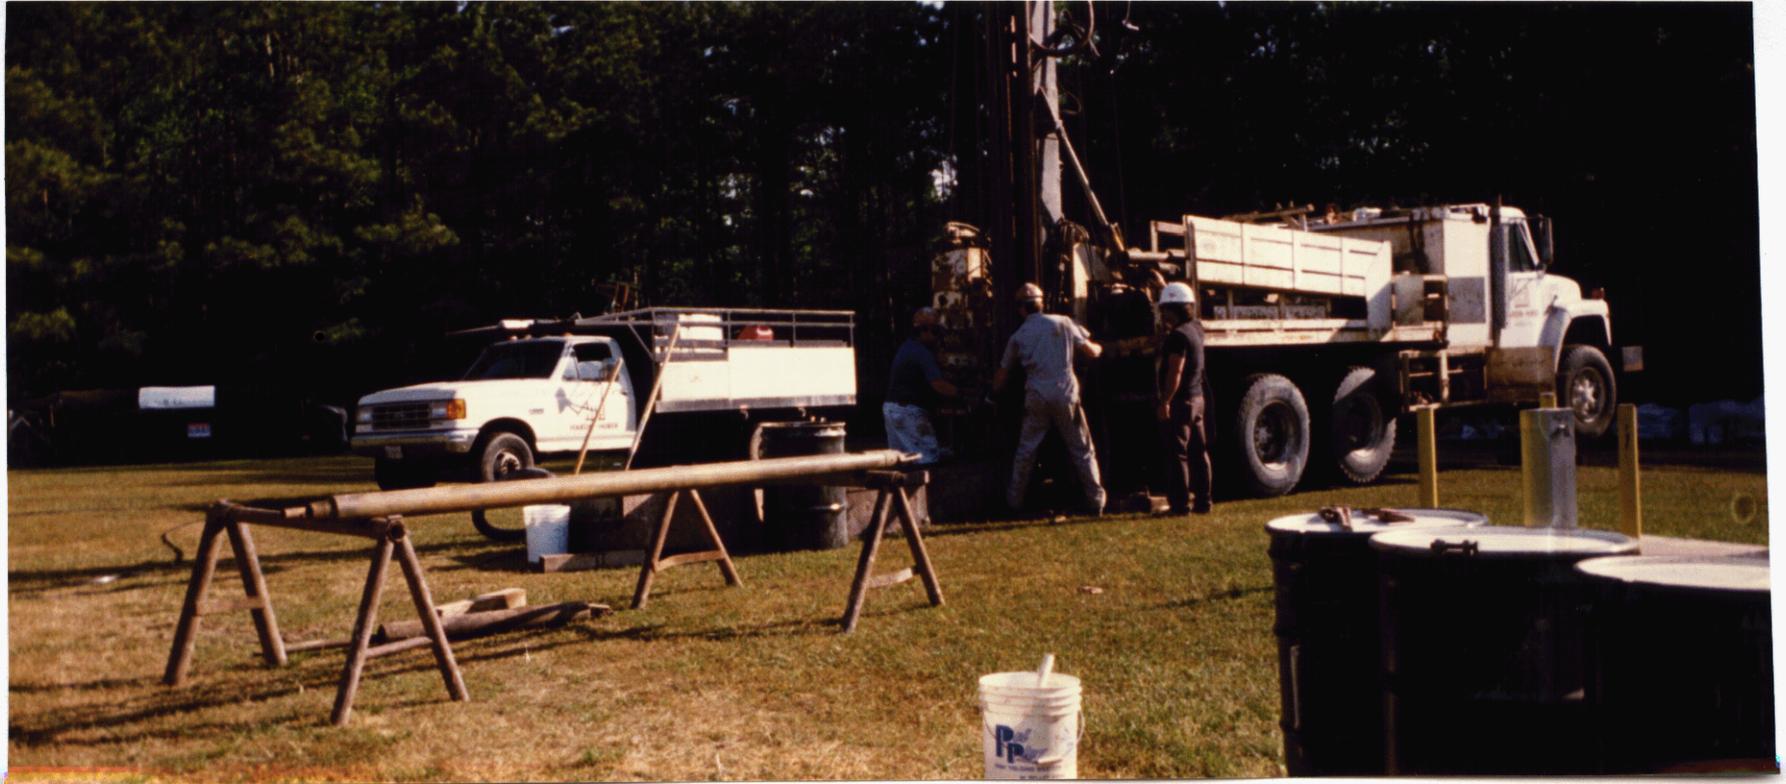
OU10.SITE 35.1994.20

View of Baker's drilling subcontractor advancing Type III monitoring well 35-GWD-2 (using fluid rotary techniques) during the Remedial Investigation; looking northeast.

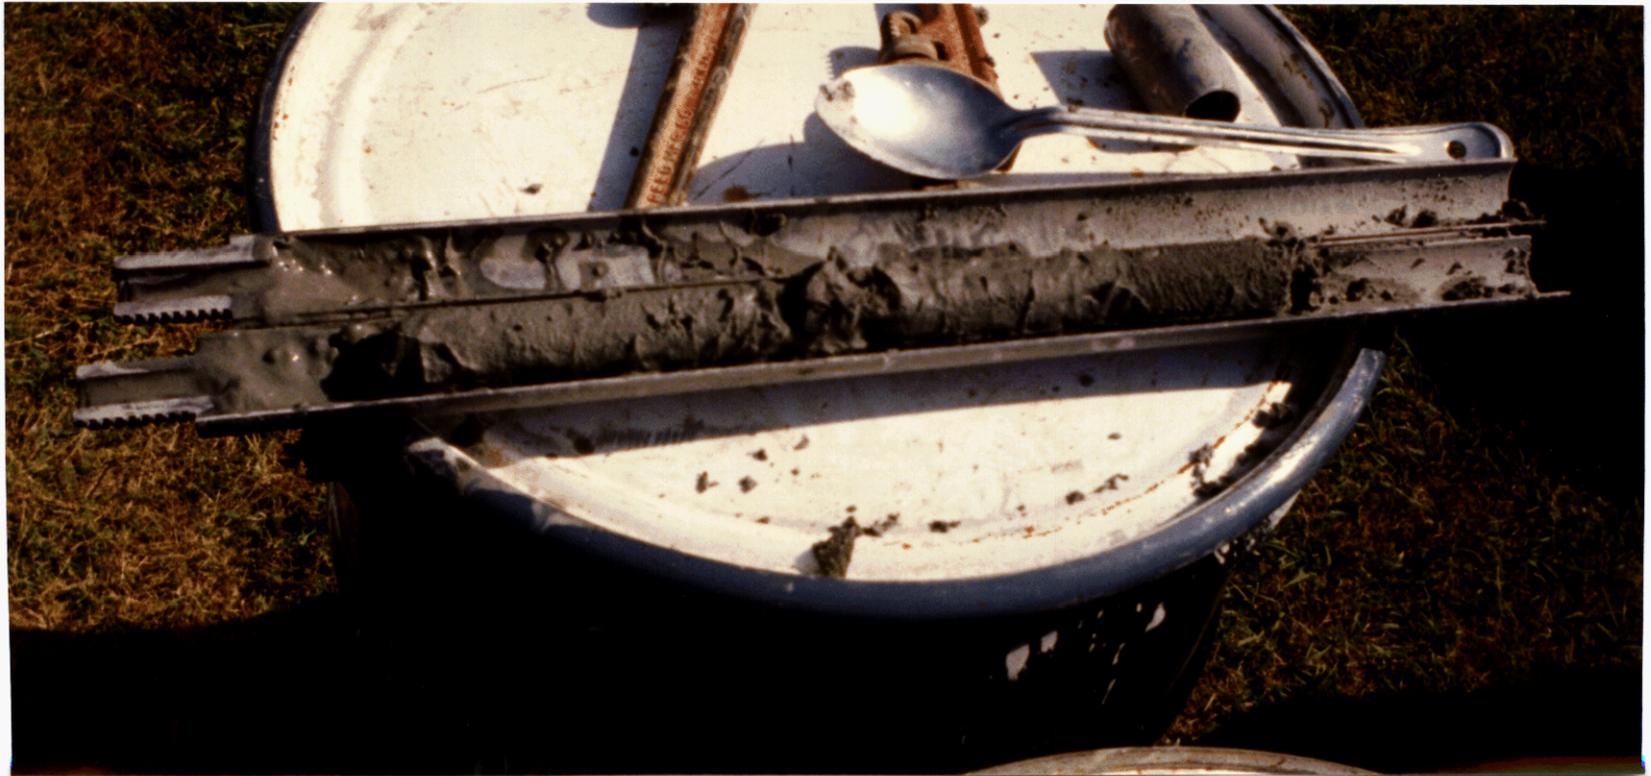
OU10.SITE 35.1994.21 View of semi-confining soil unit separating the surficial aquifer from the Castle Hayne Aquifer. It is generally described as a greenish grey, fine-grained, sand with some silt and trace amounts of shells. The soil type was generally encountered at 35 to 45 feet. This particular sample was obtained from 35GWD02 at a depth of 46 to 48 feet.

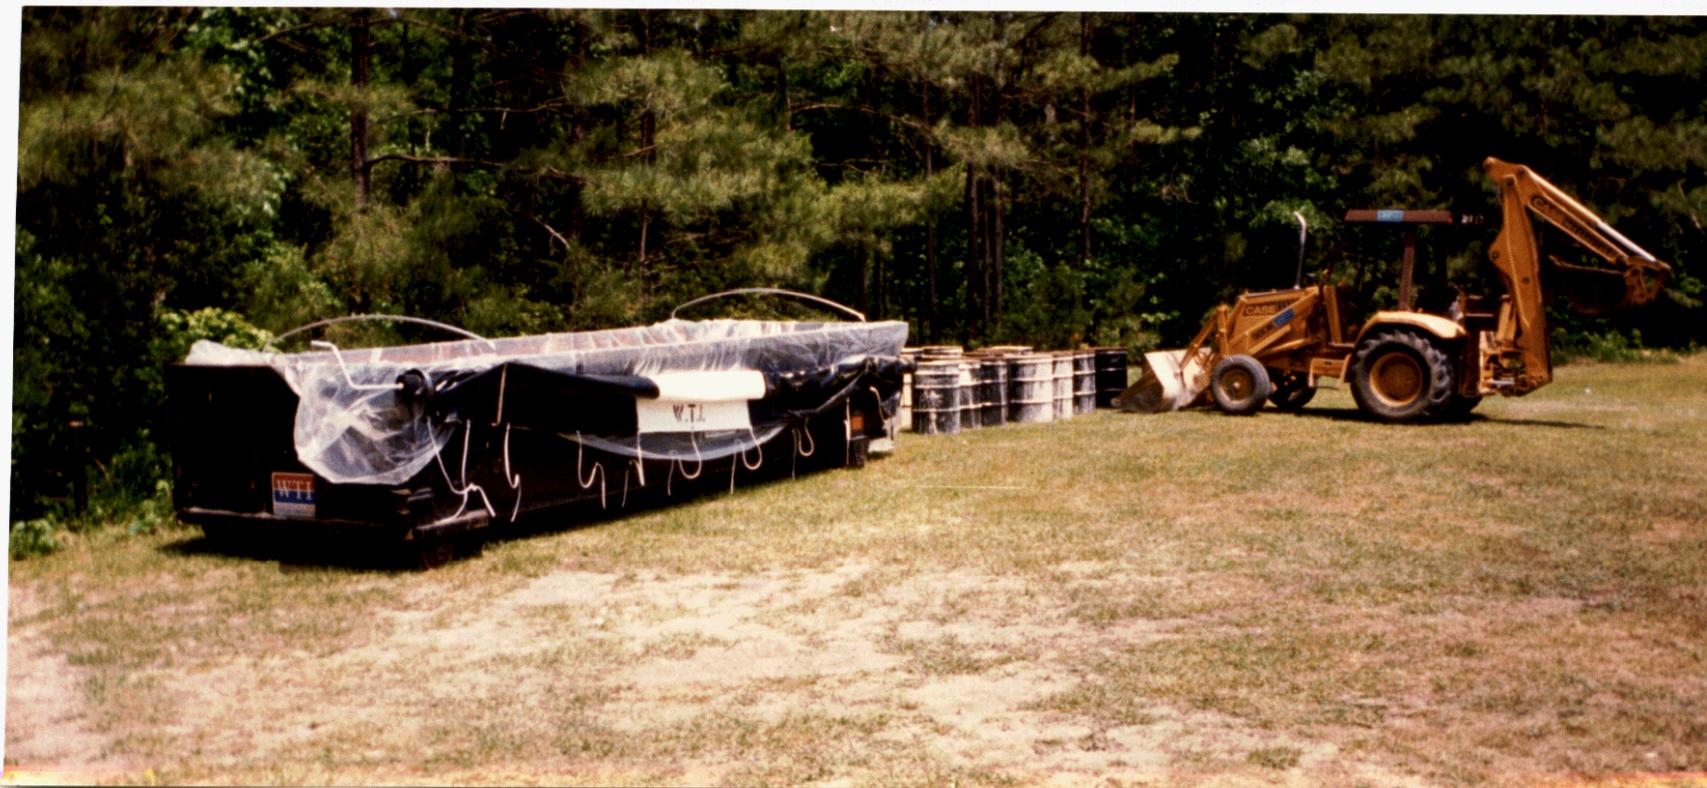
OU10.SITE 35.1994.22

View, looking northwest, of soil IDW management area located adjacent to the Fuel Farm. Soils were temporarily staged in drums and later transferred into a lined roll-off box pending analysis.

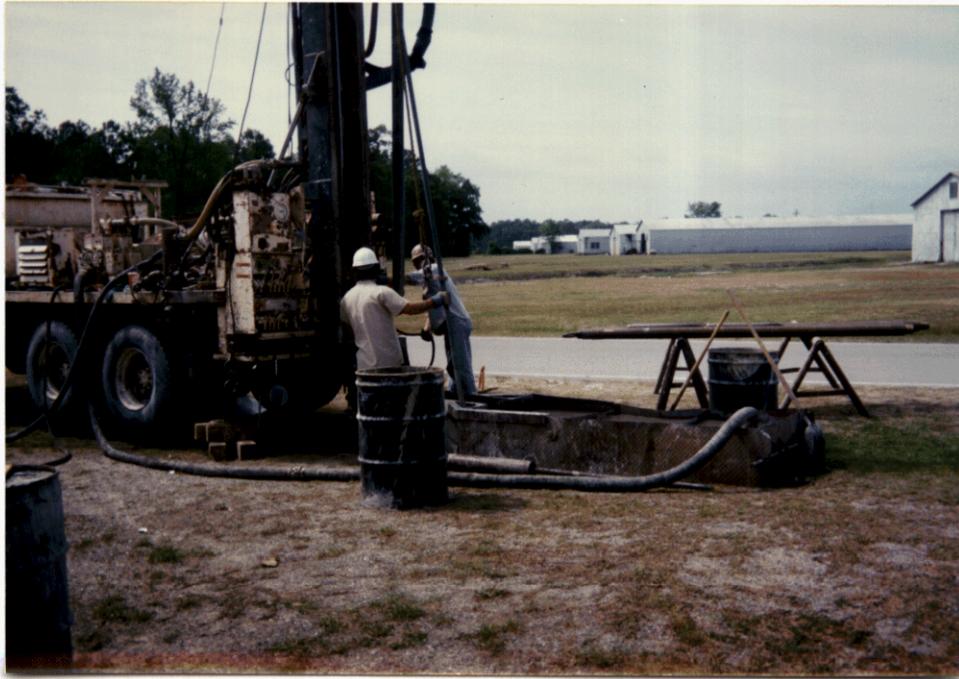
OU10.SITE 35.1994.23

Baker's drilling subcontractor advancing monitoring well/boring 35-MW35B; looking south.
