## Initial Investigation Completed

The initial investigation (Site Inspection) of Former Bomb Target 2 (BT-2) has been completed. The Site Inspection Report is being developed now and will be available to the public in early 2010, after it has been reviewed by the North Carolina Department of Environment and Natural Resources (NCDENR).

**This fact sheet provides an update on the investigation of munitions at Former Bomb Target 2 (BT-2) in Bogue Sound, where Marine Corps Air Station Cherry Point conducted training in the 1940s–1950s.**

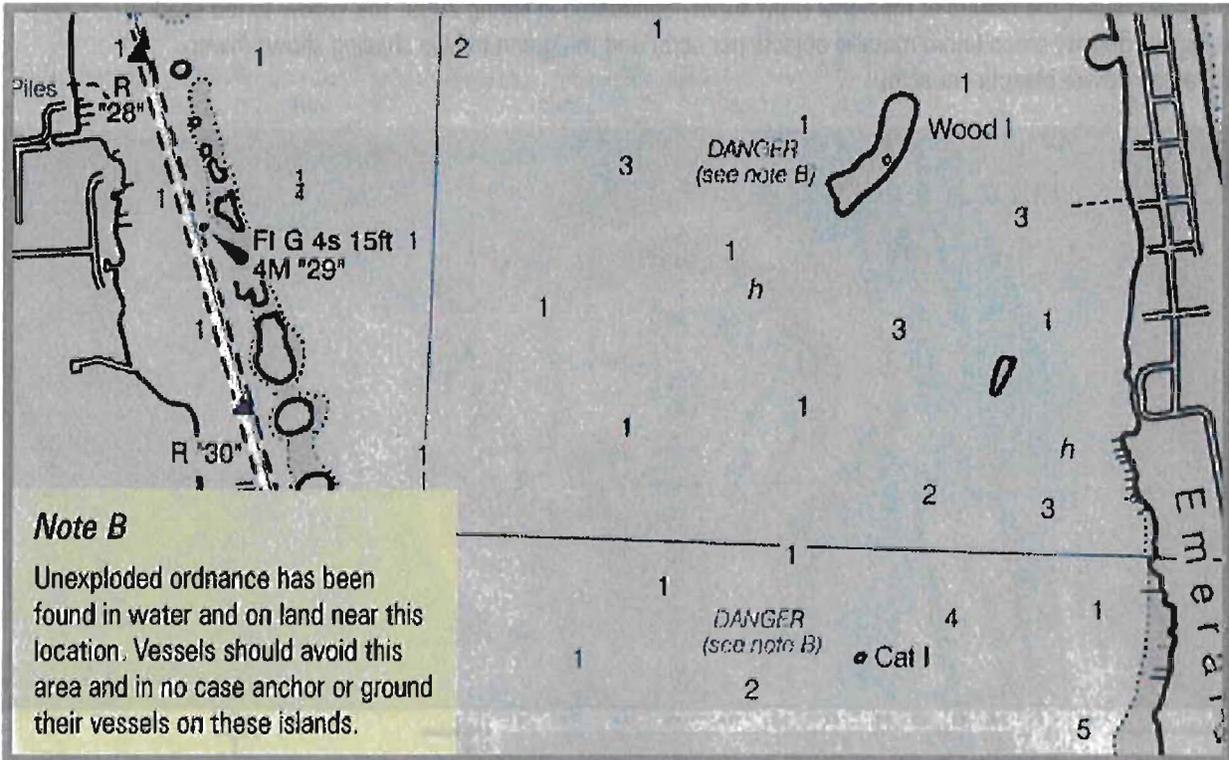
Figure 2 – Nautical chart 11541 around Wood Island

Wood Island is posted with danger signs. The official nautical chart (see Figure 2) for this area clearly states “Unexploded ordnance has been found in water and on land near this location. Vessels should avoid this area and in no case anchor or ground their vessels on these islands.”

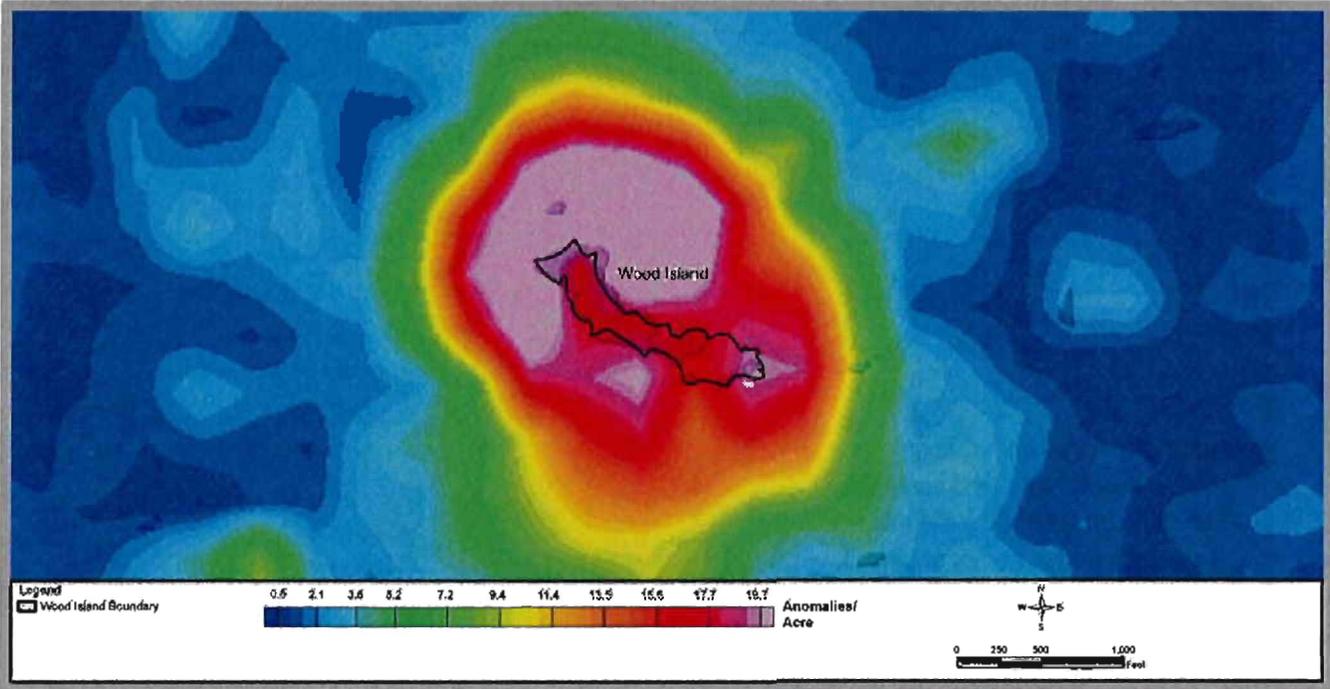
Figure 3 – Aerial DGM results near BT-2

The survey identified approximately 10,400 magnetic anomalies. There are several clusters of concentrated anomalies near Wood Island. The rest are irregularly distributed throughout the 10-square-mile (6,600-acre) investigation area (Figures 3 and 4).

The highest concentration of metallic objects is clustered within approximately 650 feet of Wood Island. This mass of closely-spaced magnetic anomalies is similar to the expected results for an aerial bombing target.

Therefore, the Site Inspection Report concludes that the large cluster of metallic objects on and surrounding the island would be associated with the former military training conducted at BT-2.

The old munitions visible on the surface of Wood Island and the high concentration of magnetic anomalies in the waters around the island show that further munitions investigation is needed.

After a Site Inspection, the next phase in a munitions investigation is to determine the nature (types and physical condition) and extent (affected areas, including depths) of the magnetic anomalies that are likely to be munitions and explosives of concern.

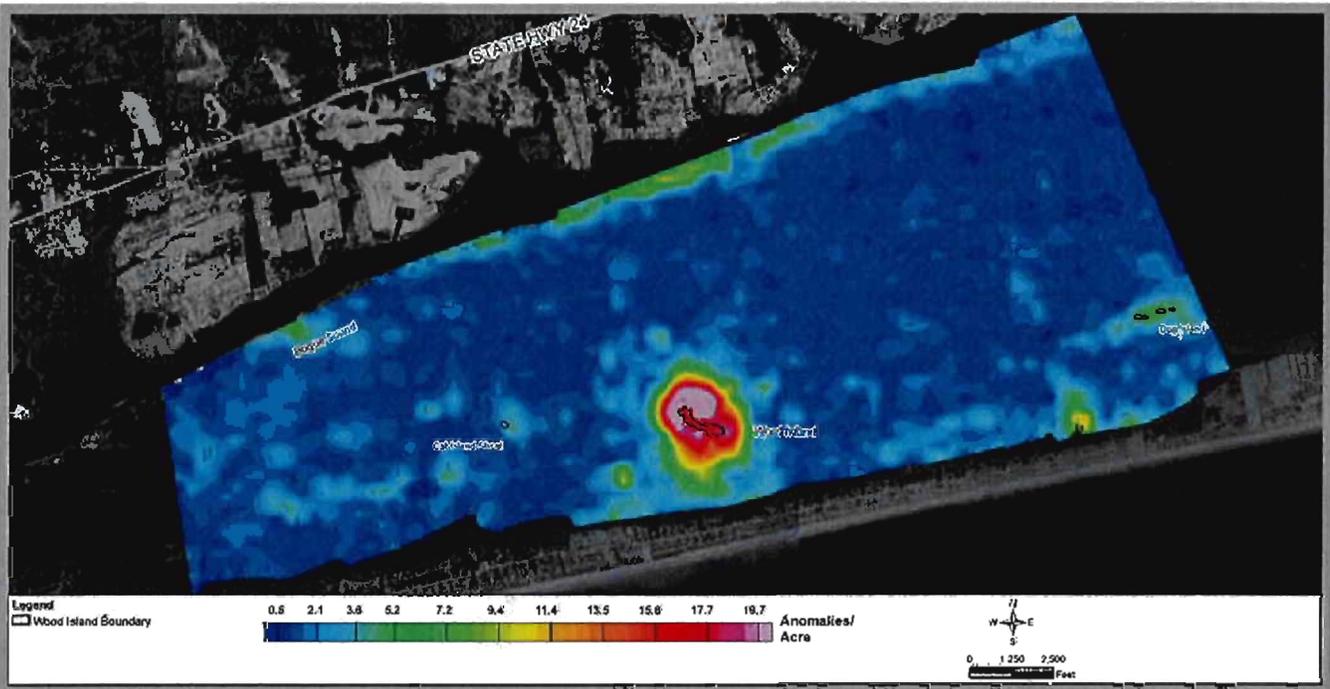
Figure 4 – Aerial DGM results in the investigation area

Three much smaller clusters of metallic objects were found in the investigation area, further away from Wood Island in Bogue Sound (Figure 4).

- One cluster is located approximately 2,500 feet southwest of Wood Island.
- The second cluster is located about 2.5 miles east of BT-2, directly off the northern shoreline between 1st and 2nd Streets in Emerald Isle, near some docks and piers that extend into Bogue Sound.
- The third cluster is located near Dog Island, about 3,000 feet north of the shoreline near the Emerald Isle/Indian Beach town boundary.

Except for these small clusters, the density of metallic objects decreases as you move from Wood Island toward Emerald Isle (see Figure 4).
