**Operable Unit 3  
Site Evaluation Report  
Naval Industrial Reserve  
Ordnance Plant  
Fridley, Minnesota**

September 1995

**SITE EVALUATION REPORT  
FOR  
OPERABLE UNIT 3  
NAVAL INDUSTRIAL RESERVE ORDNANCE PLANT  
FRIDLEY, MINNESOTA**

**COMPREHENSIVE LONG-TERM  
ENVIRONMENTAL ACTION-NAVY (CLEAN) CONTRACT**

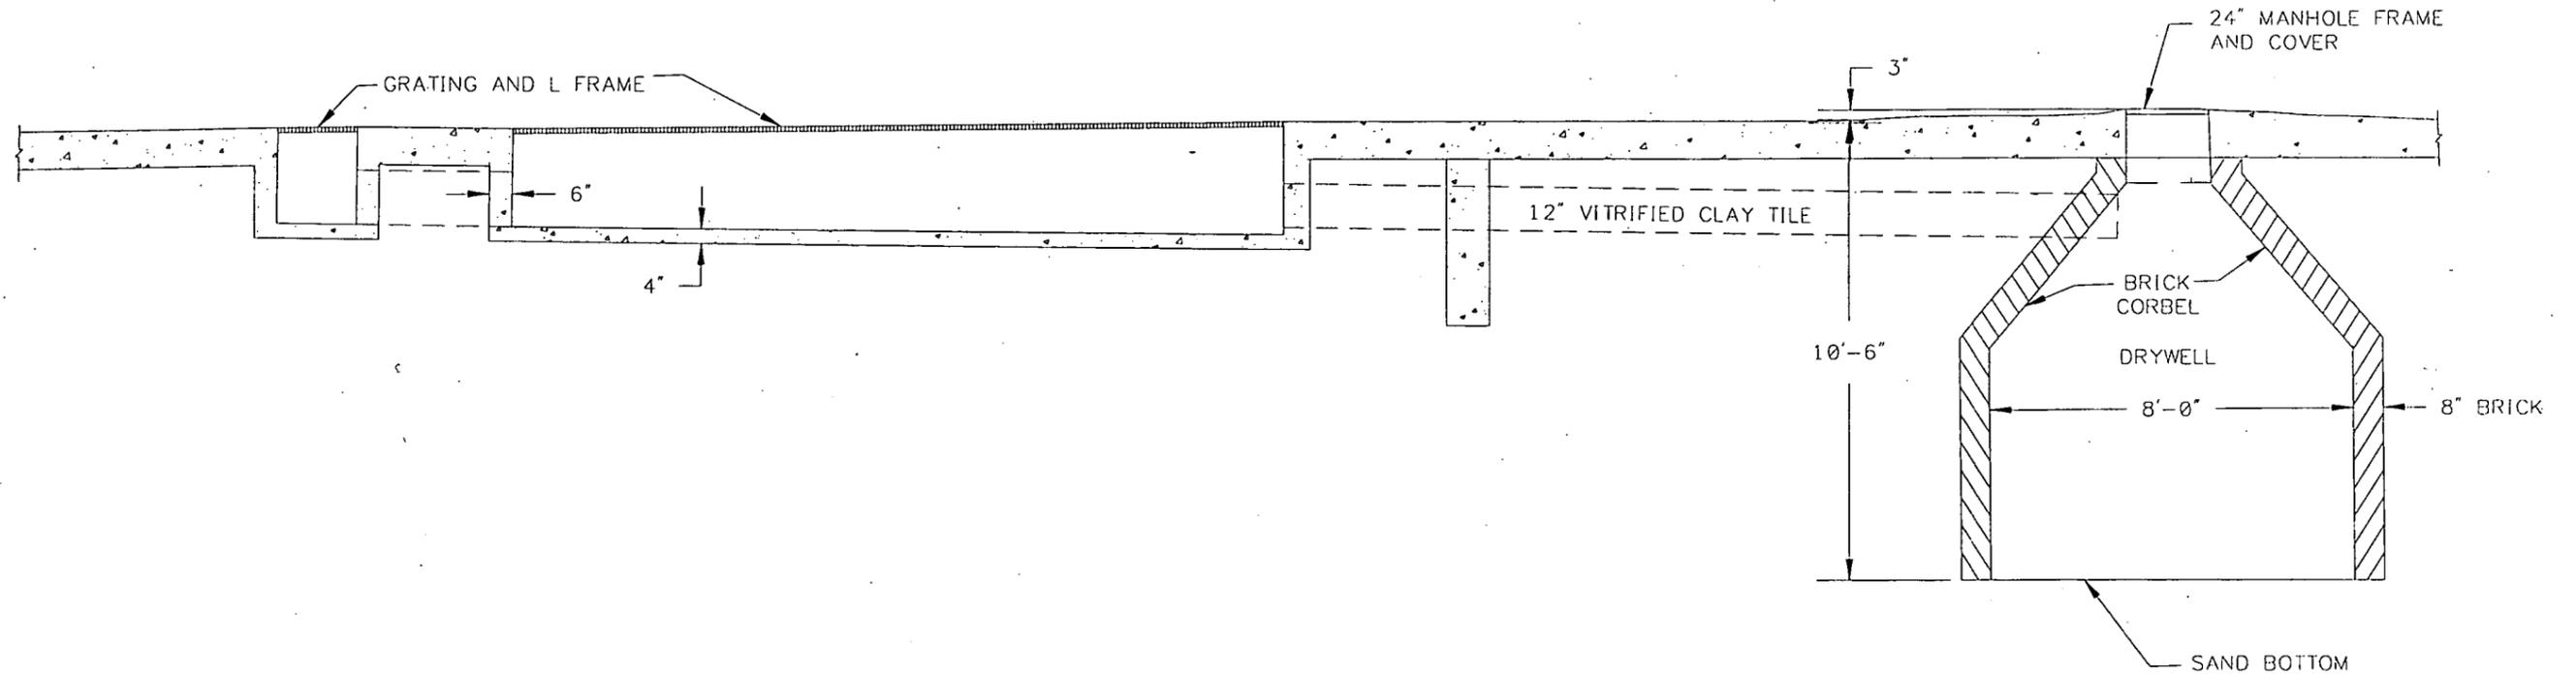
DRAWING 4-3

Drywells are the main feature of concern located at NIROP, Fridley. As shown on Figure 4-3, drywells were installed with a sand bottom so liquid would discharge through the drywell directly to the soil below. Drywells are identified throughout the main plant building, including the plating department, diesel room, foundry, heat treating, machine shop, and paint spray areas. Possible contamination from these areas includes solvents, diesel fuel, oil, paint sludge and cleaners. Potential locations of TCE usage and possible discharge through these drywells are in the plating, assembly, heat treating, foundry and paint shop.

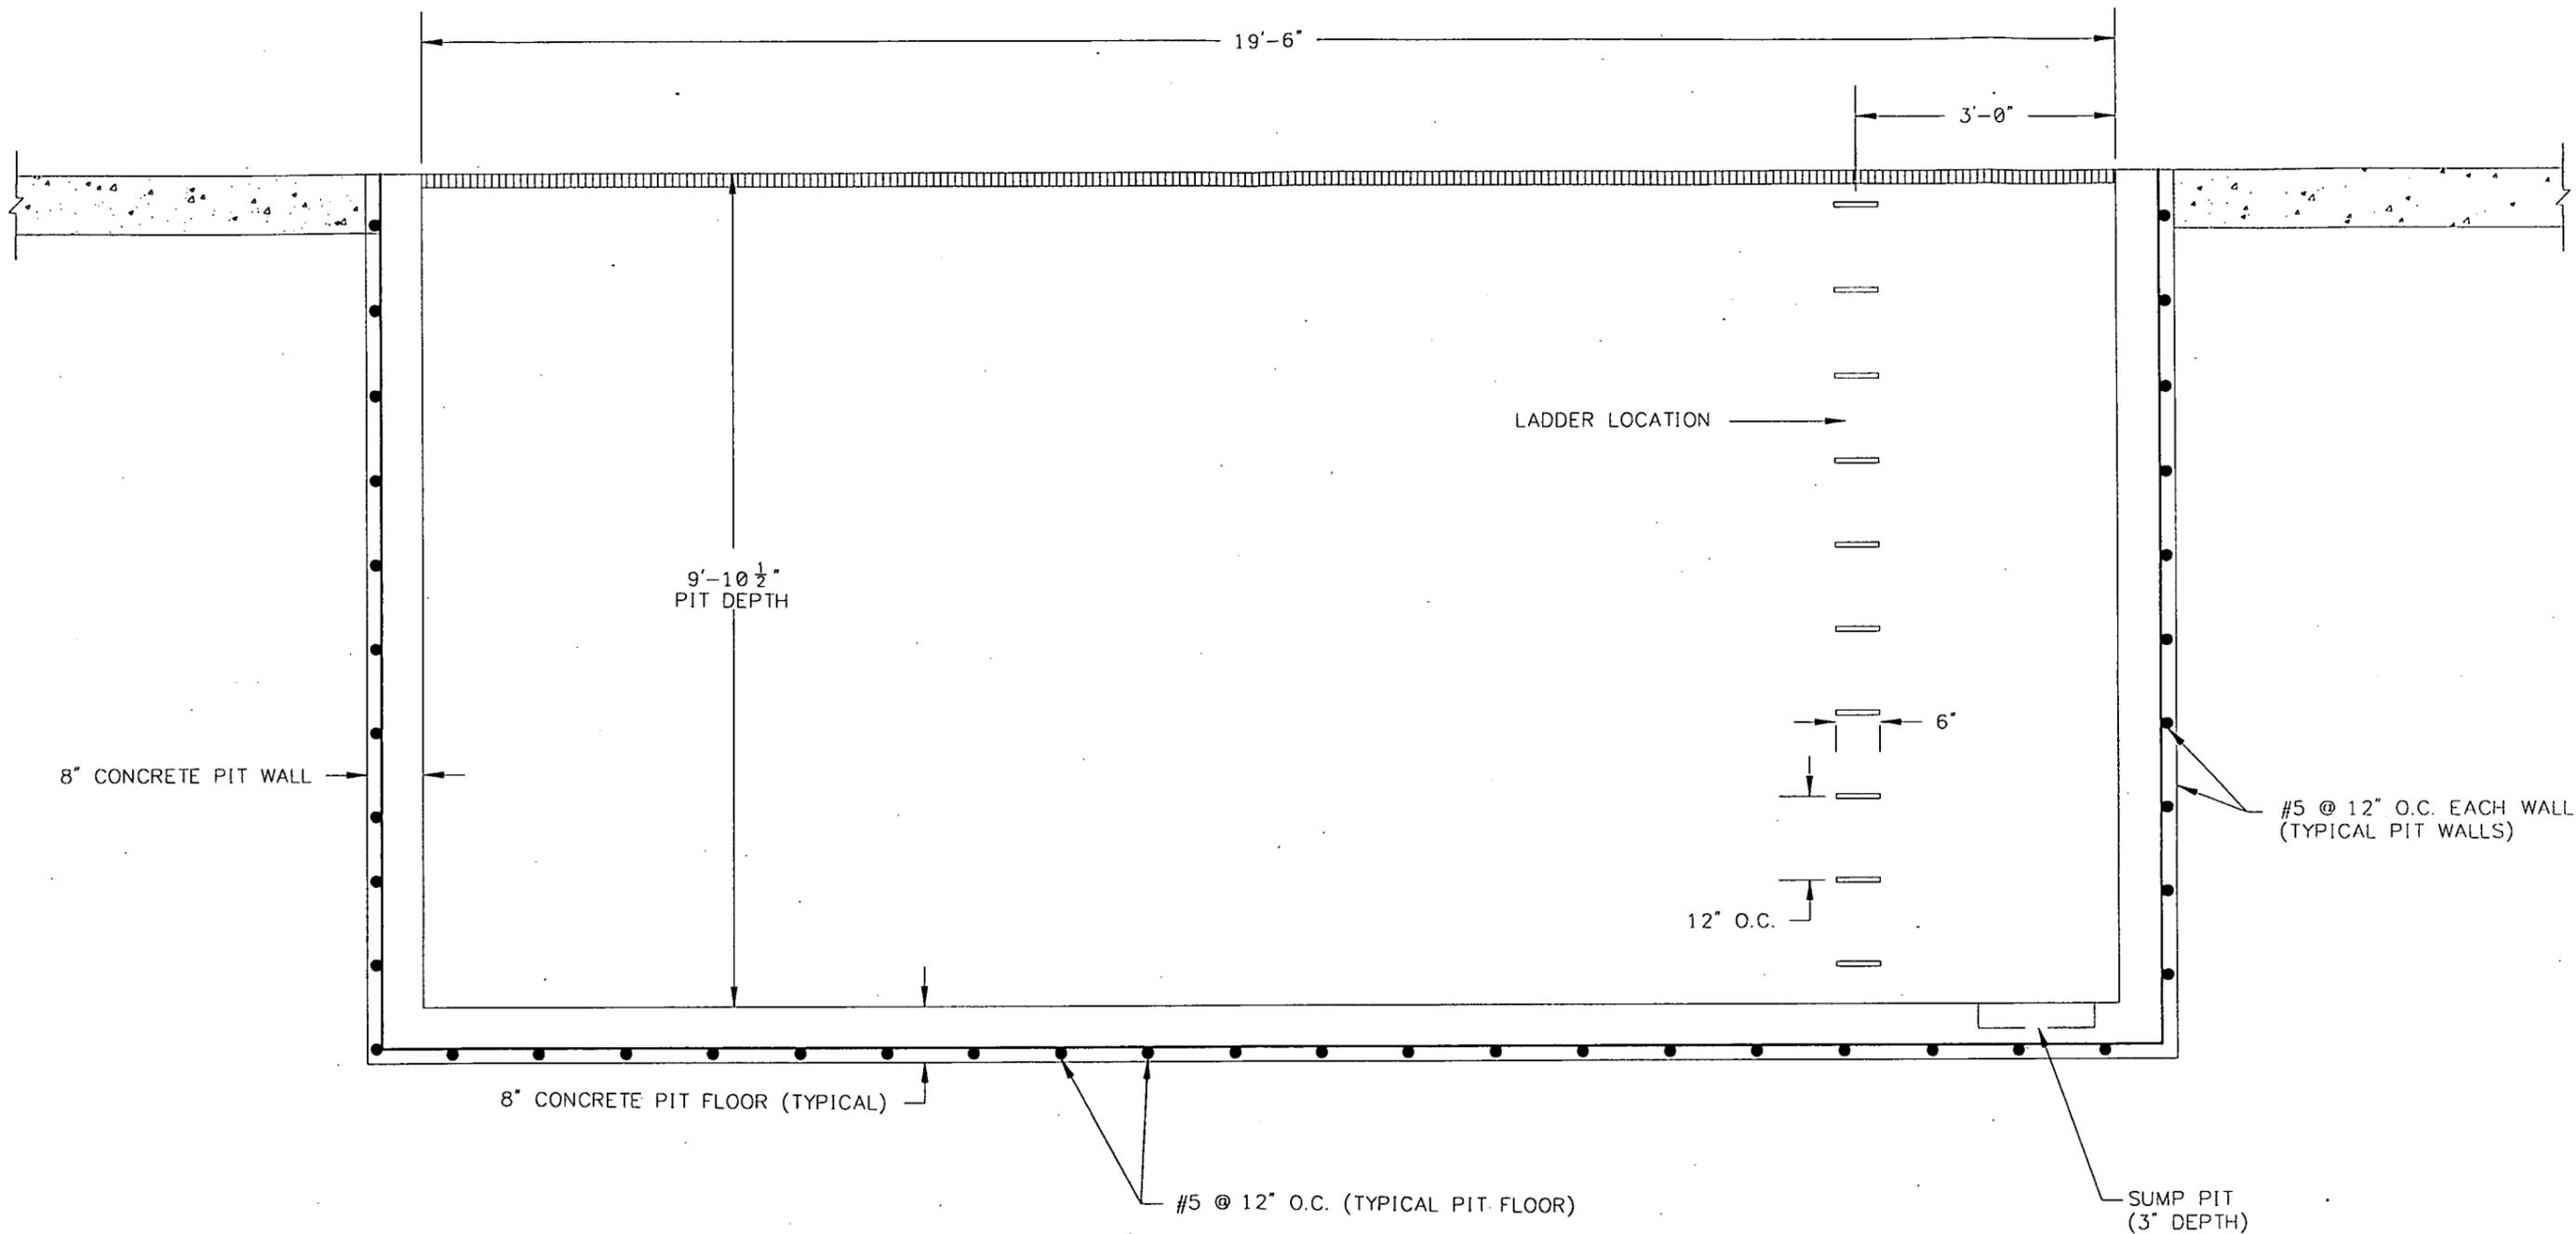
TYPICAL VAPOR DEGREASER PIT SECTION  
 NAVAL INDUSTRIAL RESERVE ORDNANCE PLANT  
 FRIDLEY, MINNESOTA  
 SCALE: 1/2" = 1'-0"

AOC 33 is the location of a degreaser pit in the foundry area. The pit was located on the northern side of 14th Avenue between Columns 7E and 8E. The pit was 7 feet long by 6 feet, 10 inches wide and 3 feet 6 inches deep below grade (PE 150, 1965). The pit was in use until at least 1968 (PE 351, 1968). A typical degreaser pit cross section detail is shown on Figure 4-4.

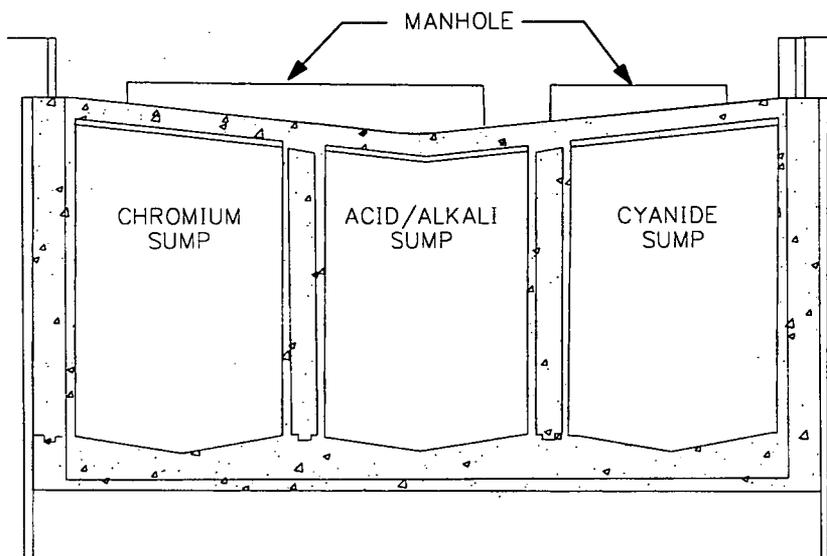
TYPICAL SECTION: EXISTING SUMPS (POST-1973)

A soil investigation conducted in the east plating shop detected TCE as the primary contaminant in the soil. TCA, acetone, styrene, and metals such as chromium, lead, and cyanide were detected at slightly elevated levels in the soil. Metals results in soil were highest in the vicinity of a previously existing sump (Halliburton NUS Corporation, May 1995). Based on the contamination found in the east plating shop, contamination is likely to have occurred through existing sumps located throughout NIROP.

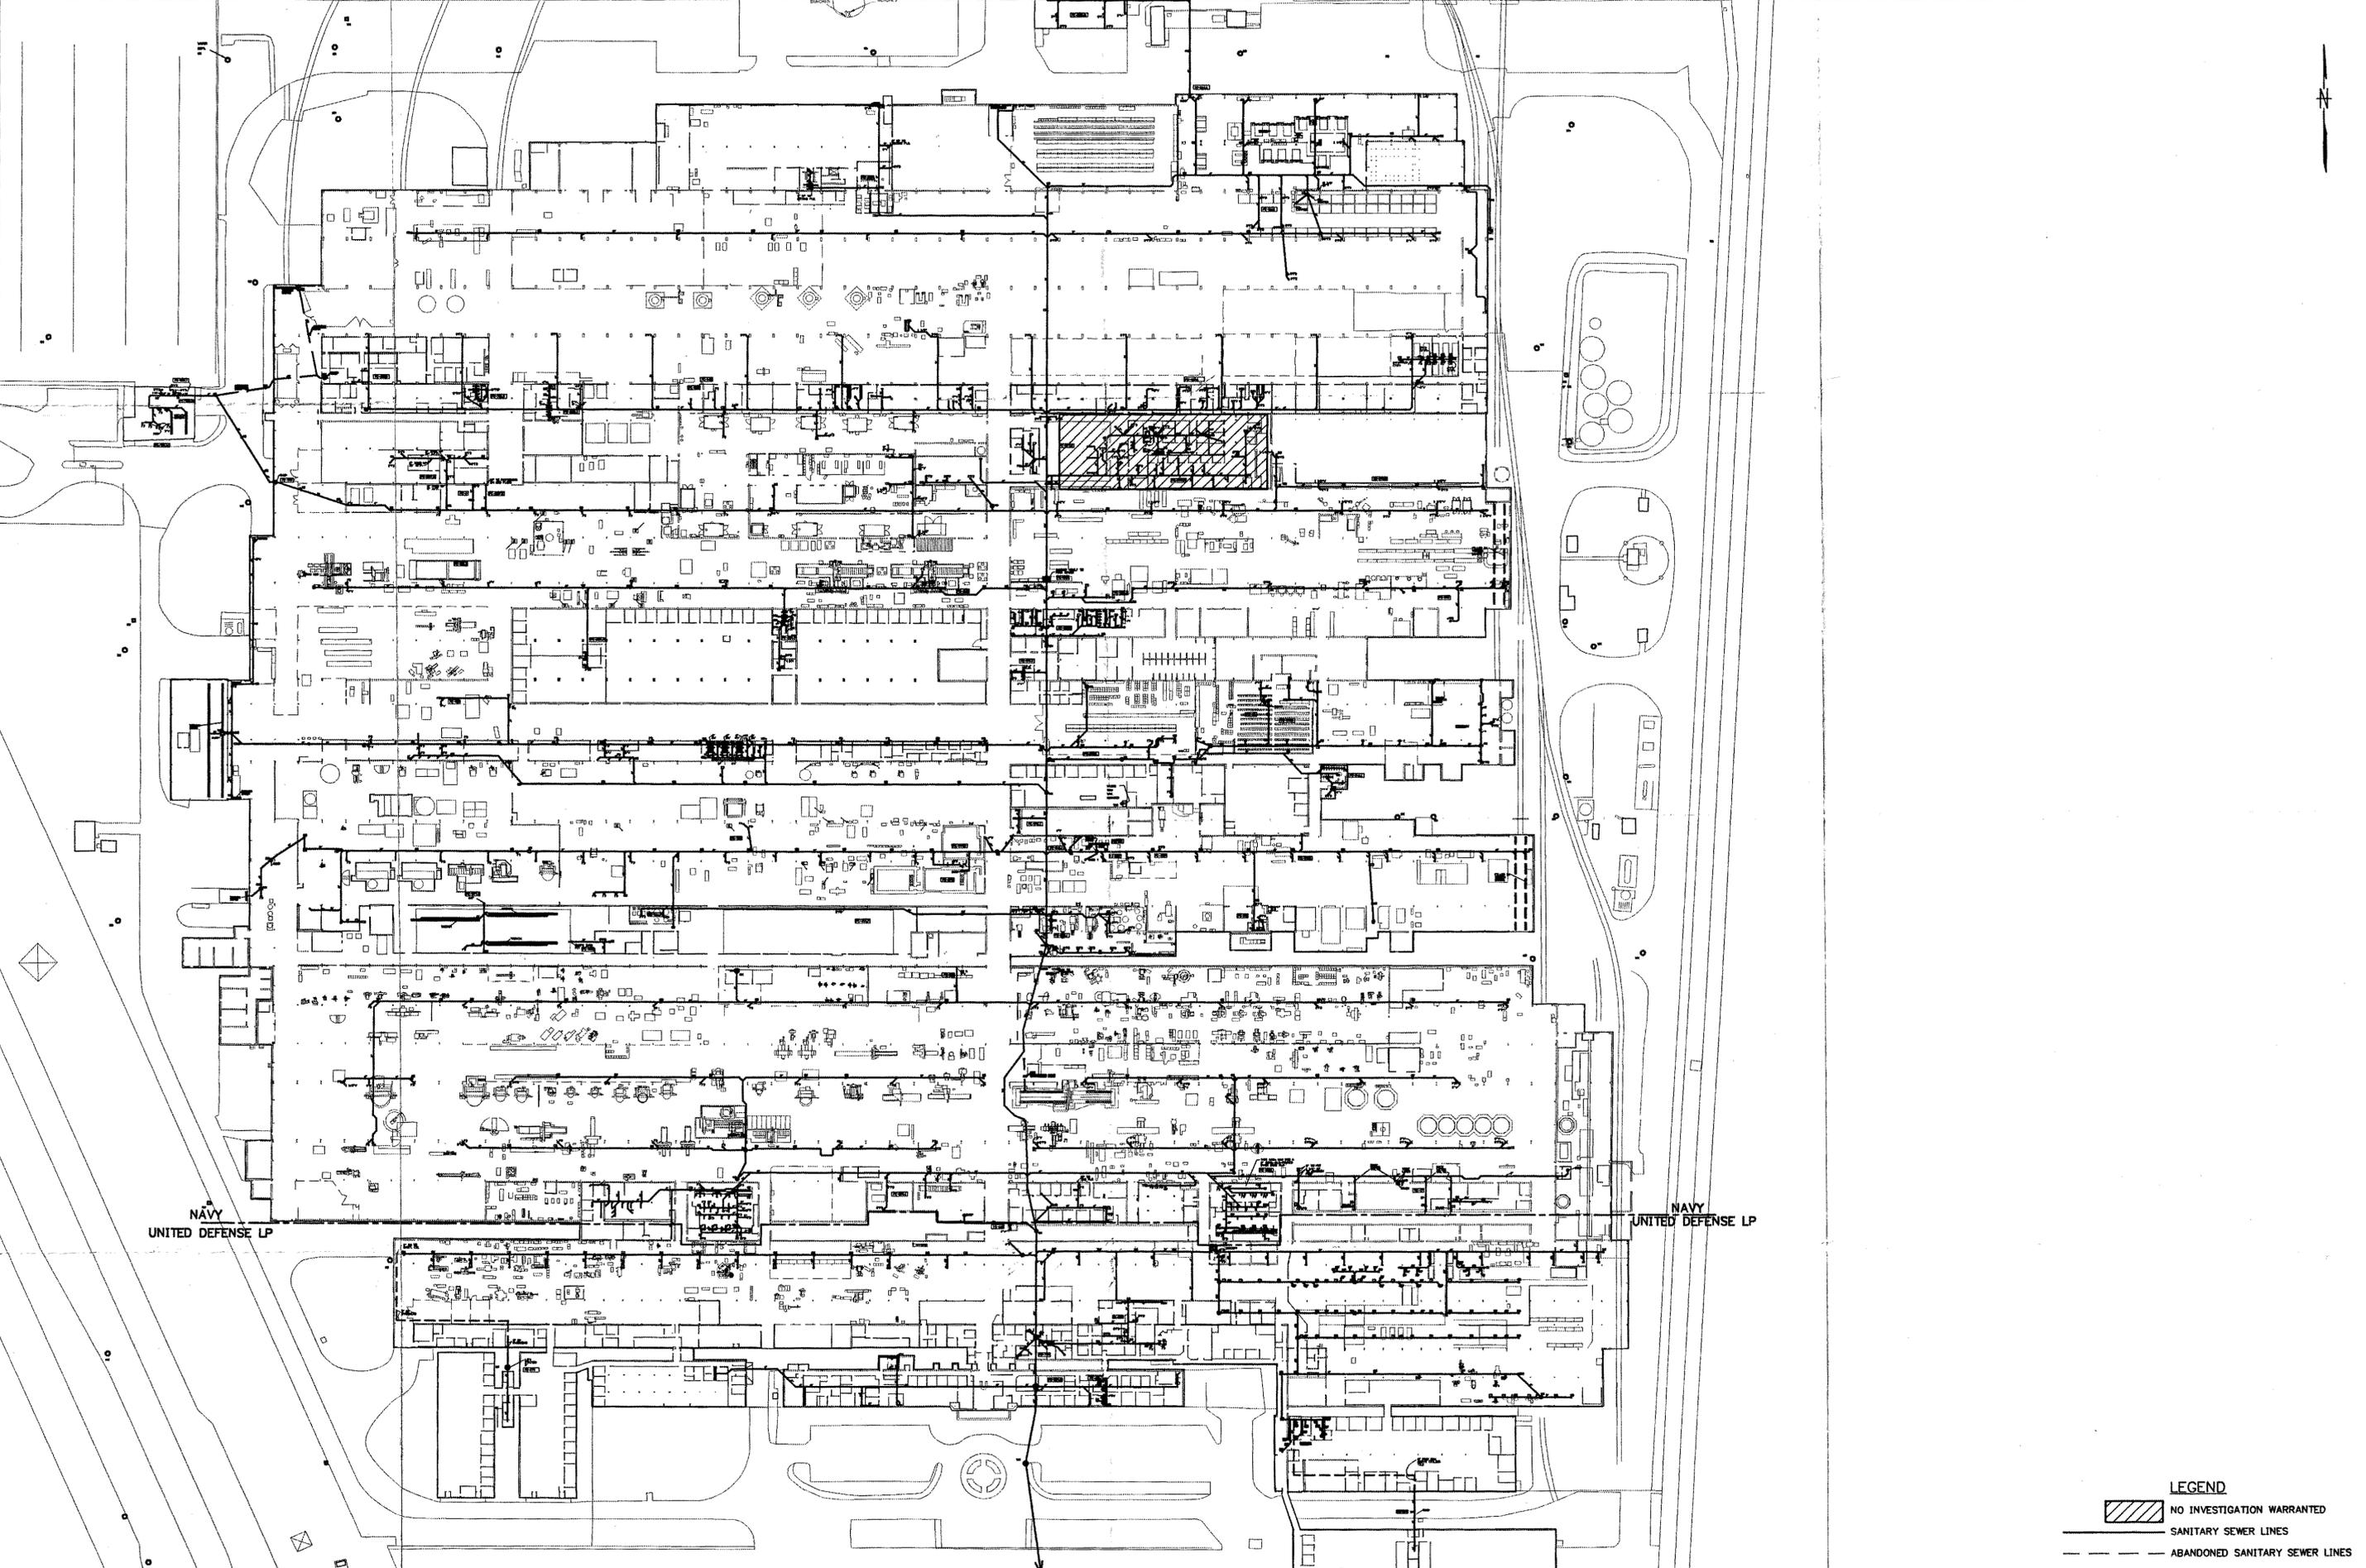
The condition of the clay pipes that make up the sanitary sewer system for the plant is unknown. TCE discharged to the sanitary sewer system could have leaked to the soil if there were cracks in the pipe. Production areas within the NIROP facility discharged waste liquid directly to the sanitary sewer. These consisted of: wastewater containing cyanide and metals generated by plating operations; spent cooling solutions from the machine shop; spent alkaline cleaner and phosphating solution used to clean parts in the paint shop; wash water containing detergents for cleaning small quantities of parts in the assembly area; water-based oils generated in the heat treating department; and wastewater from the boilers in the

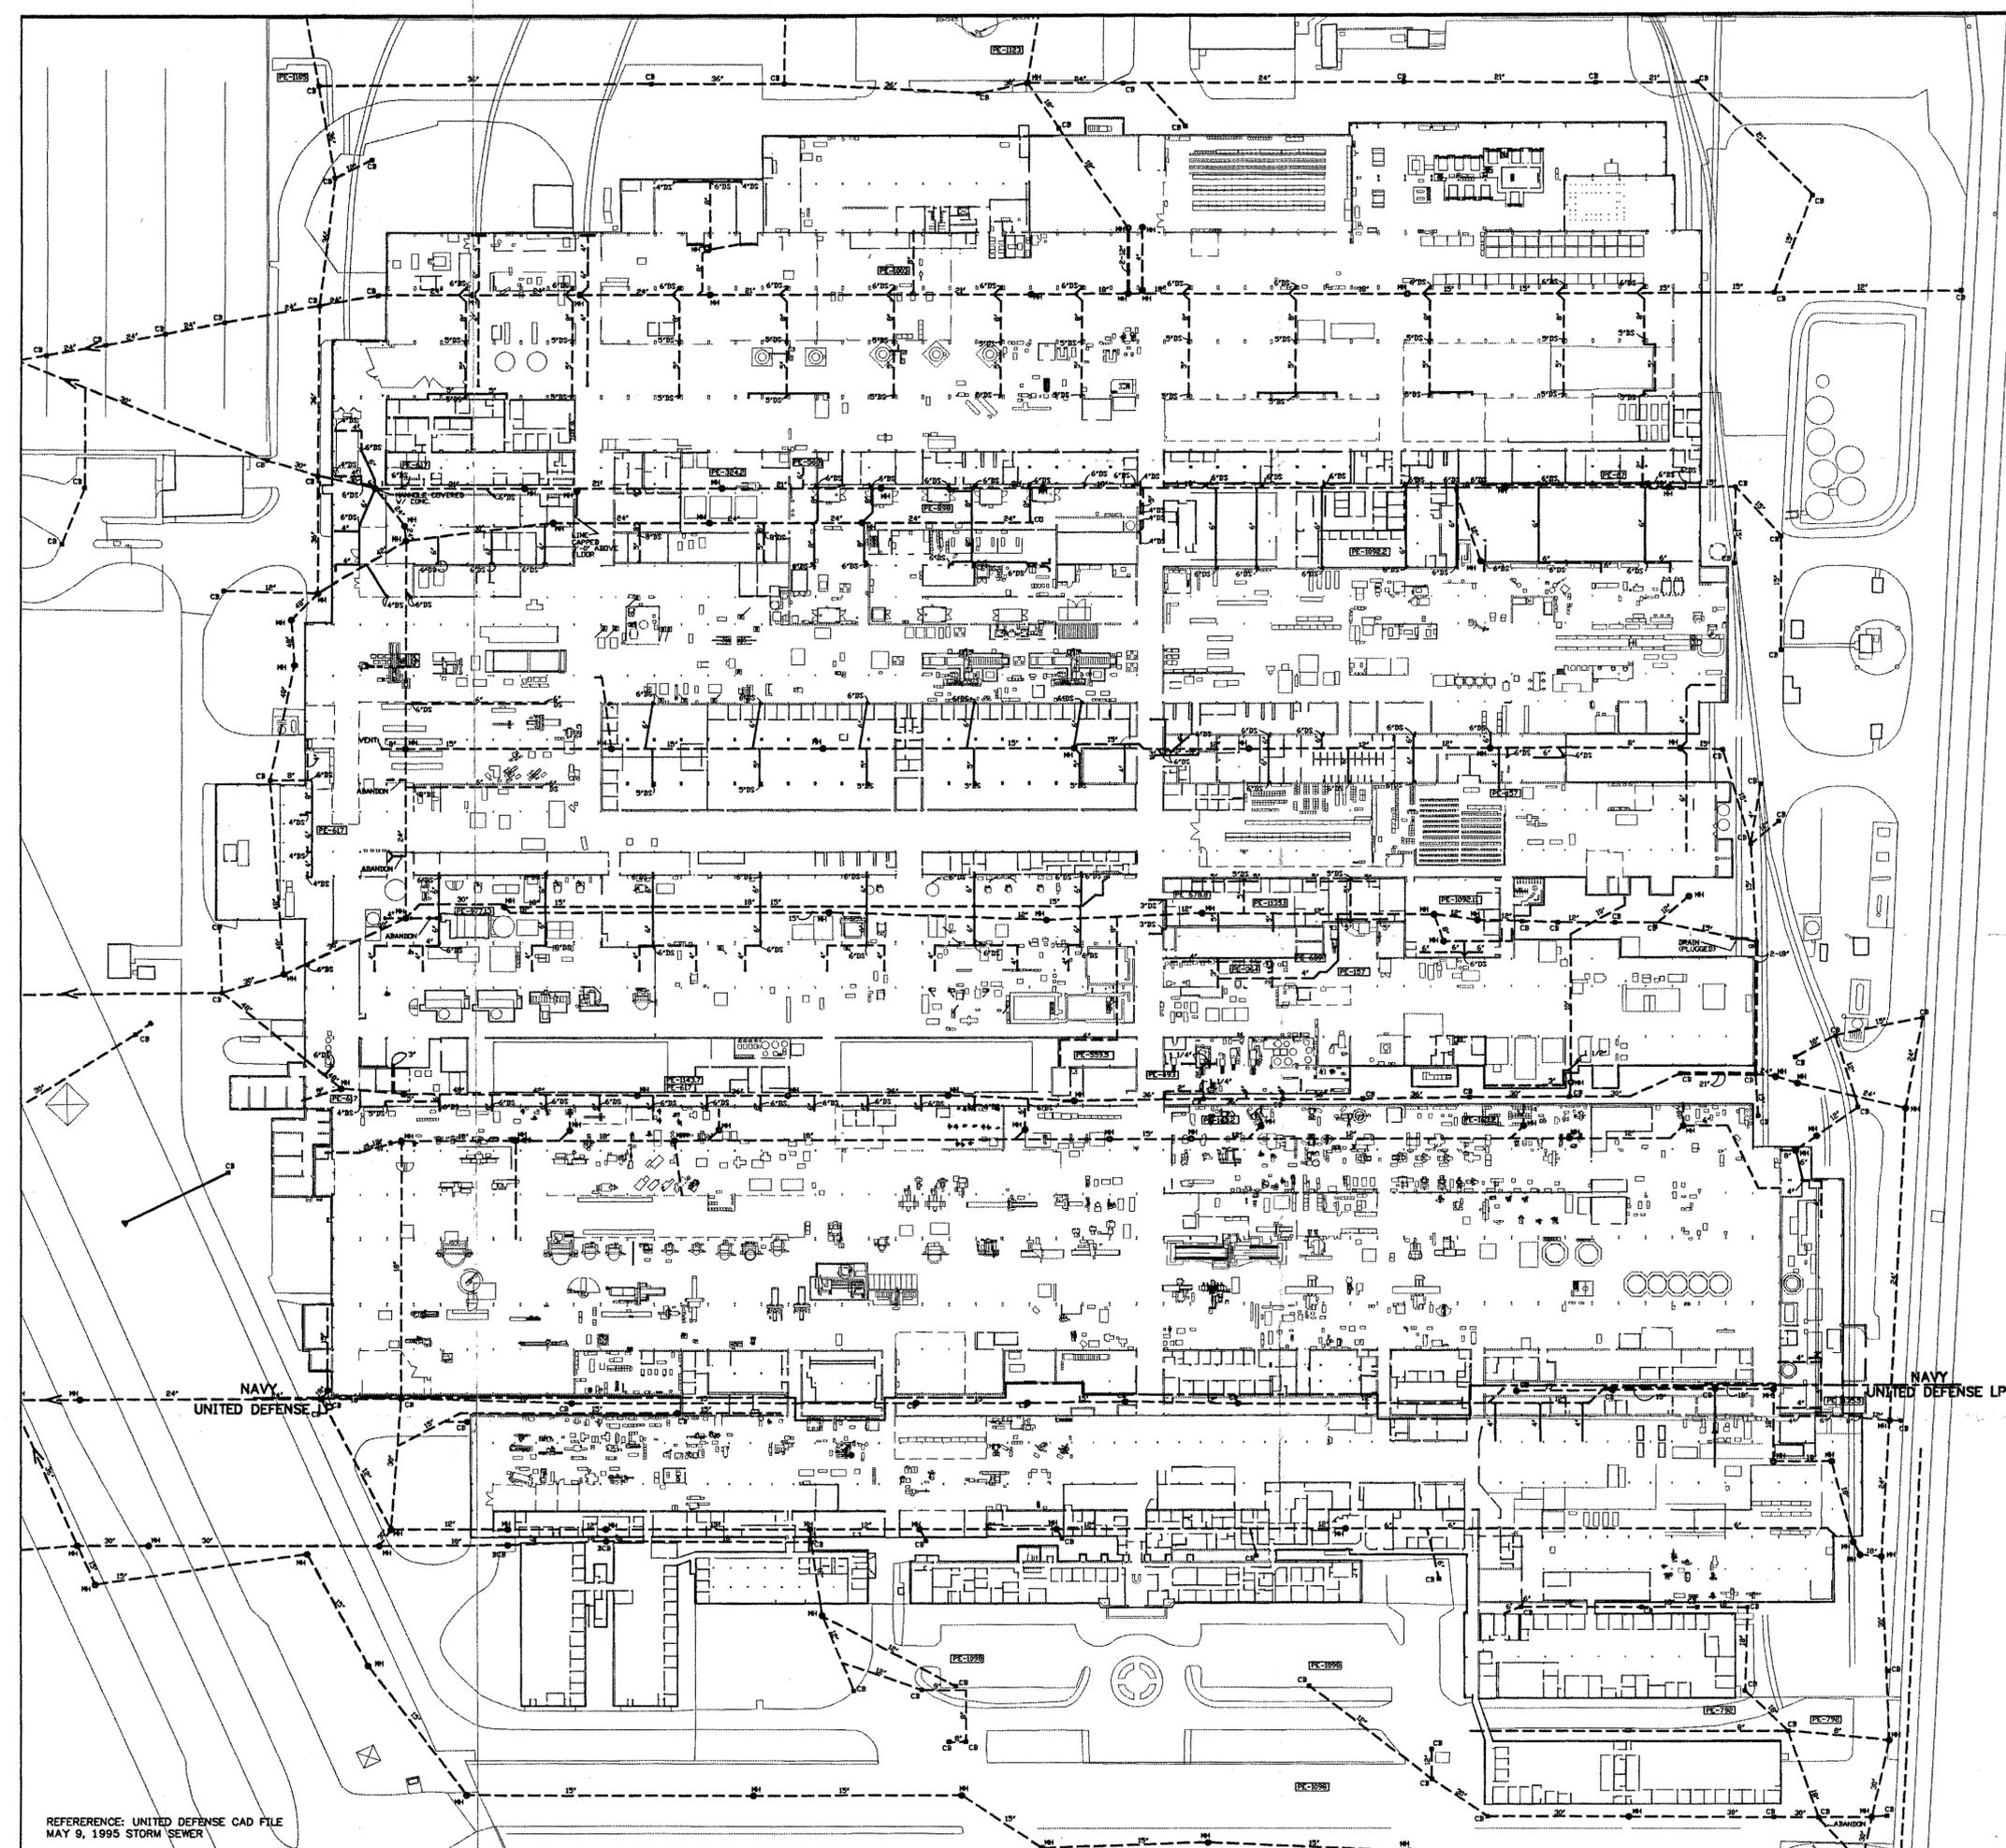
REFERENCE: UNITED DEFENSE CAD FILE  
MAY 9, 1995 STORM SEWER

The condition of the storm sewer system is unknown. Contaminants which entered the storm sewer could have leaked to the soil if there were cracks in the sewer pipe. The potential areas of concern discussed above encompass most of the NIROP facility. Spills have been documented in the assembly department, non-destructive testing area, and plating department for the 1980s. Spills are likely to have occurred at NIROP from the 1940s through 1970s in similar production areas where TCE was transported or used.
