N61414.AR.001872
NAB LITTLE CREEK
5090.3a

TIER 2 SITE VISIT NAB LITTLE CREEK VA
10/27/1998
NAB LITTLE CREEK

Little Creek Tier II Site Visit

27 October, 1998

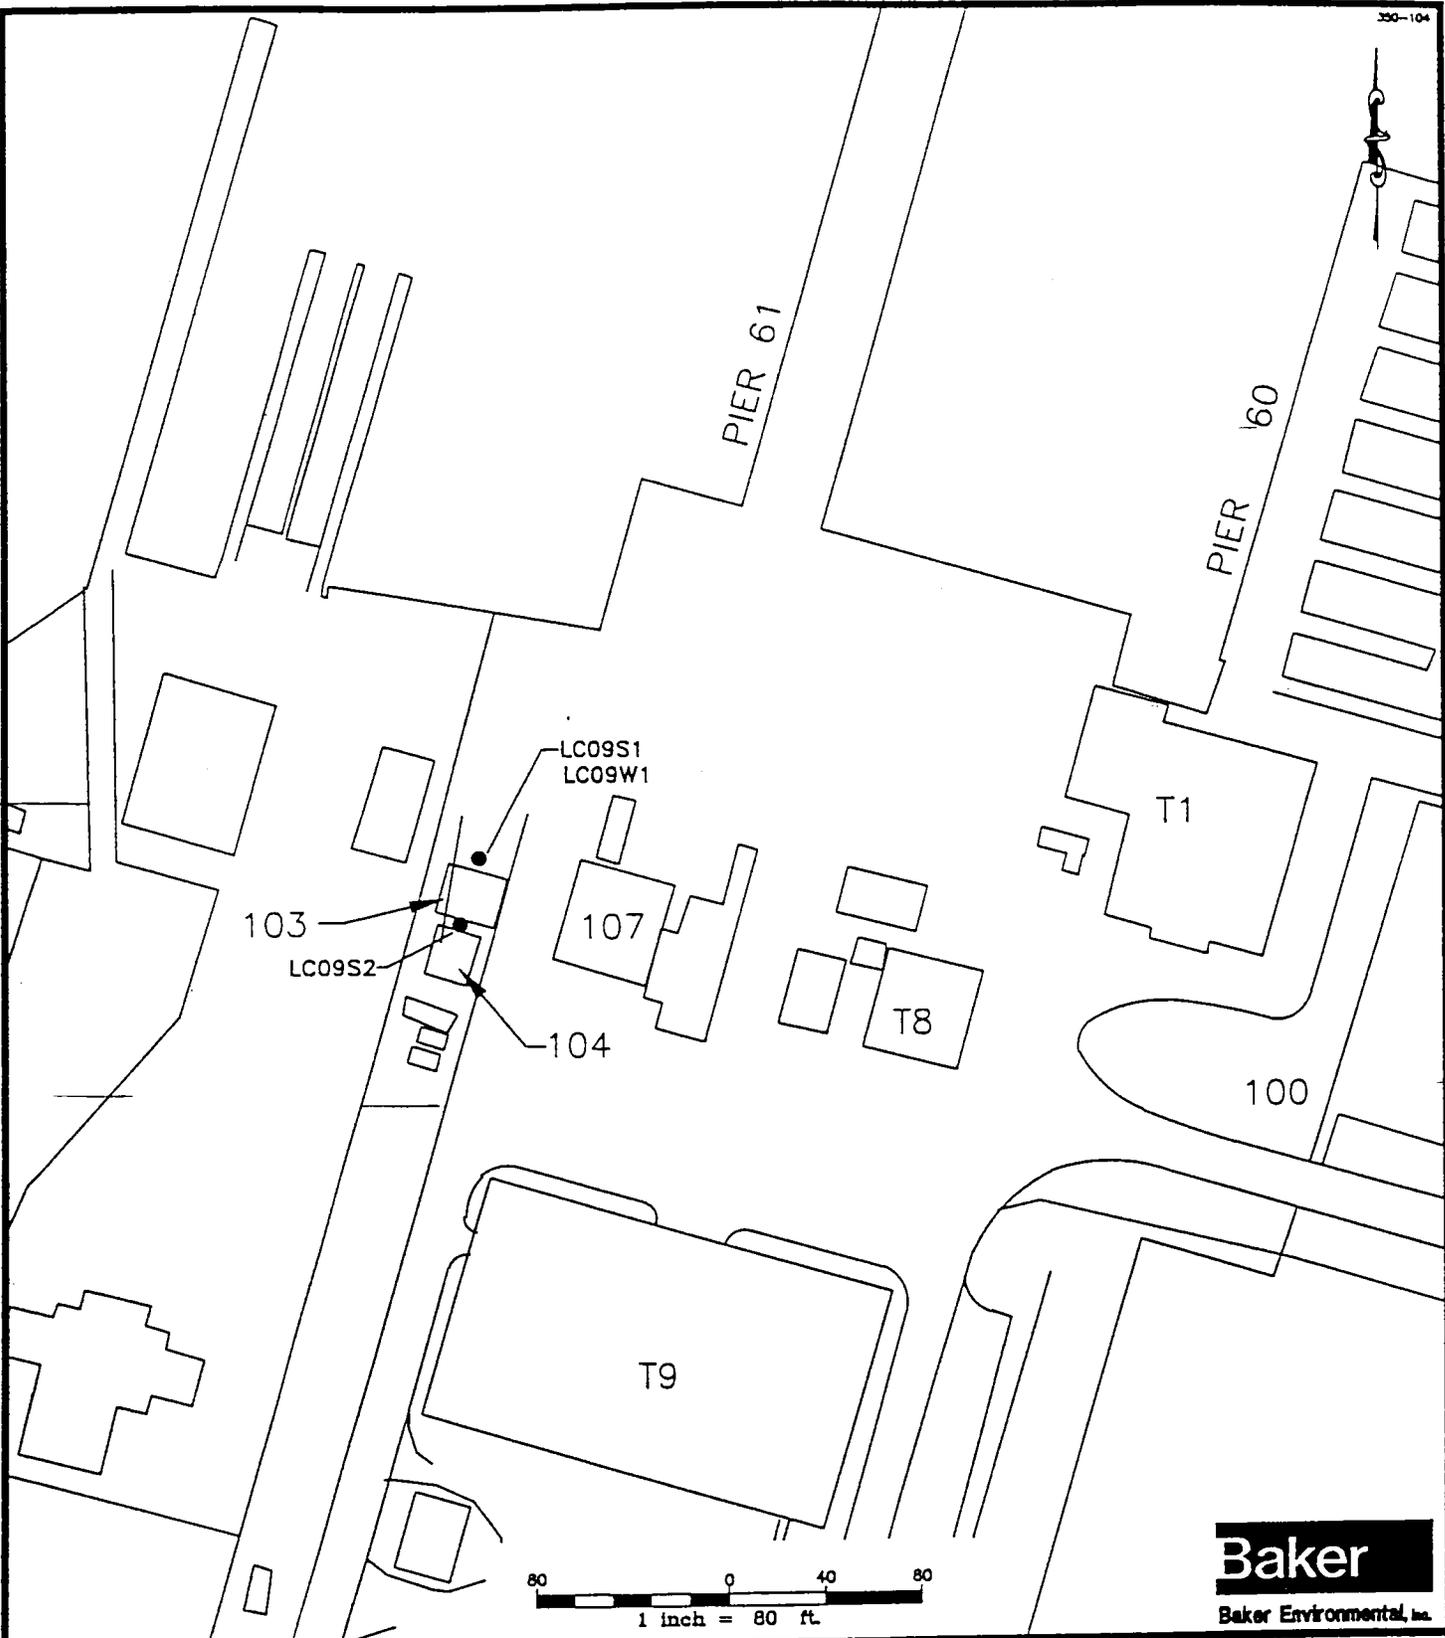
SAMPLE LOCATION MAP
SITE 117
SPECBOAT 2 BATTERY STORAGE AREA
SWMU 4
NAVAL AMPHIBIOUS BASE, LITTLE CREEK
NORFOLK, VIRGINIA

300 to 400 ft² area was used from 1943 until 1980 to store lead-acid batteries. Paint wastes, oily wastes, and scrap metals were also stored in this area. There were no release controls present. Oil stains were noted on the ground in the area. There are also reports of batteries rupturing during the winter, and their contents being released onto the ground. The site is paved with concrete and asphalt, with the exception of grass areas along the fence and around the buildings. Human contact with contaminated soil is possible in areas with exposed soil. Access to the site area is limited as the area is fenced with a controlled security gate.

Soil – Lead, manganese

Groundwater - Lead, antimony, manganese

- Conduct field investigations as part of the SI

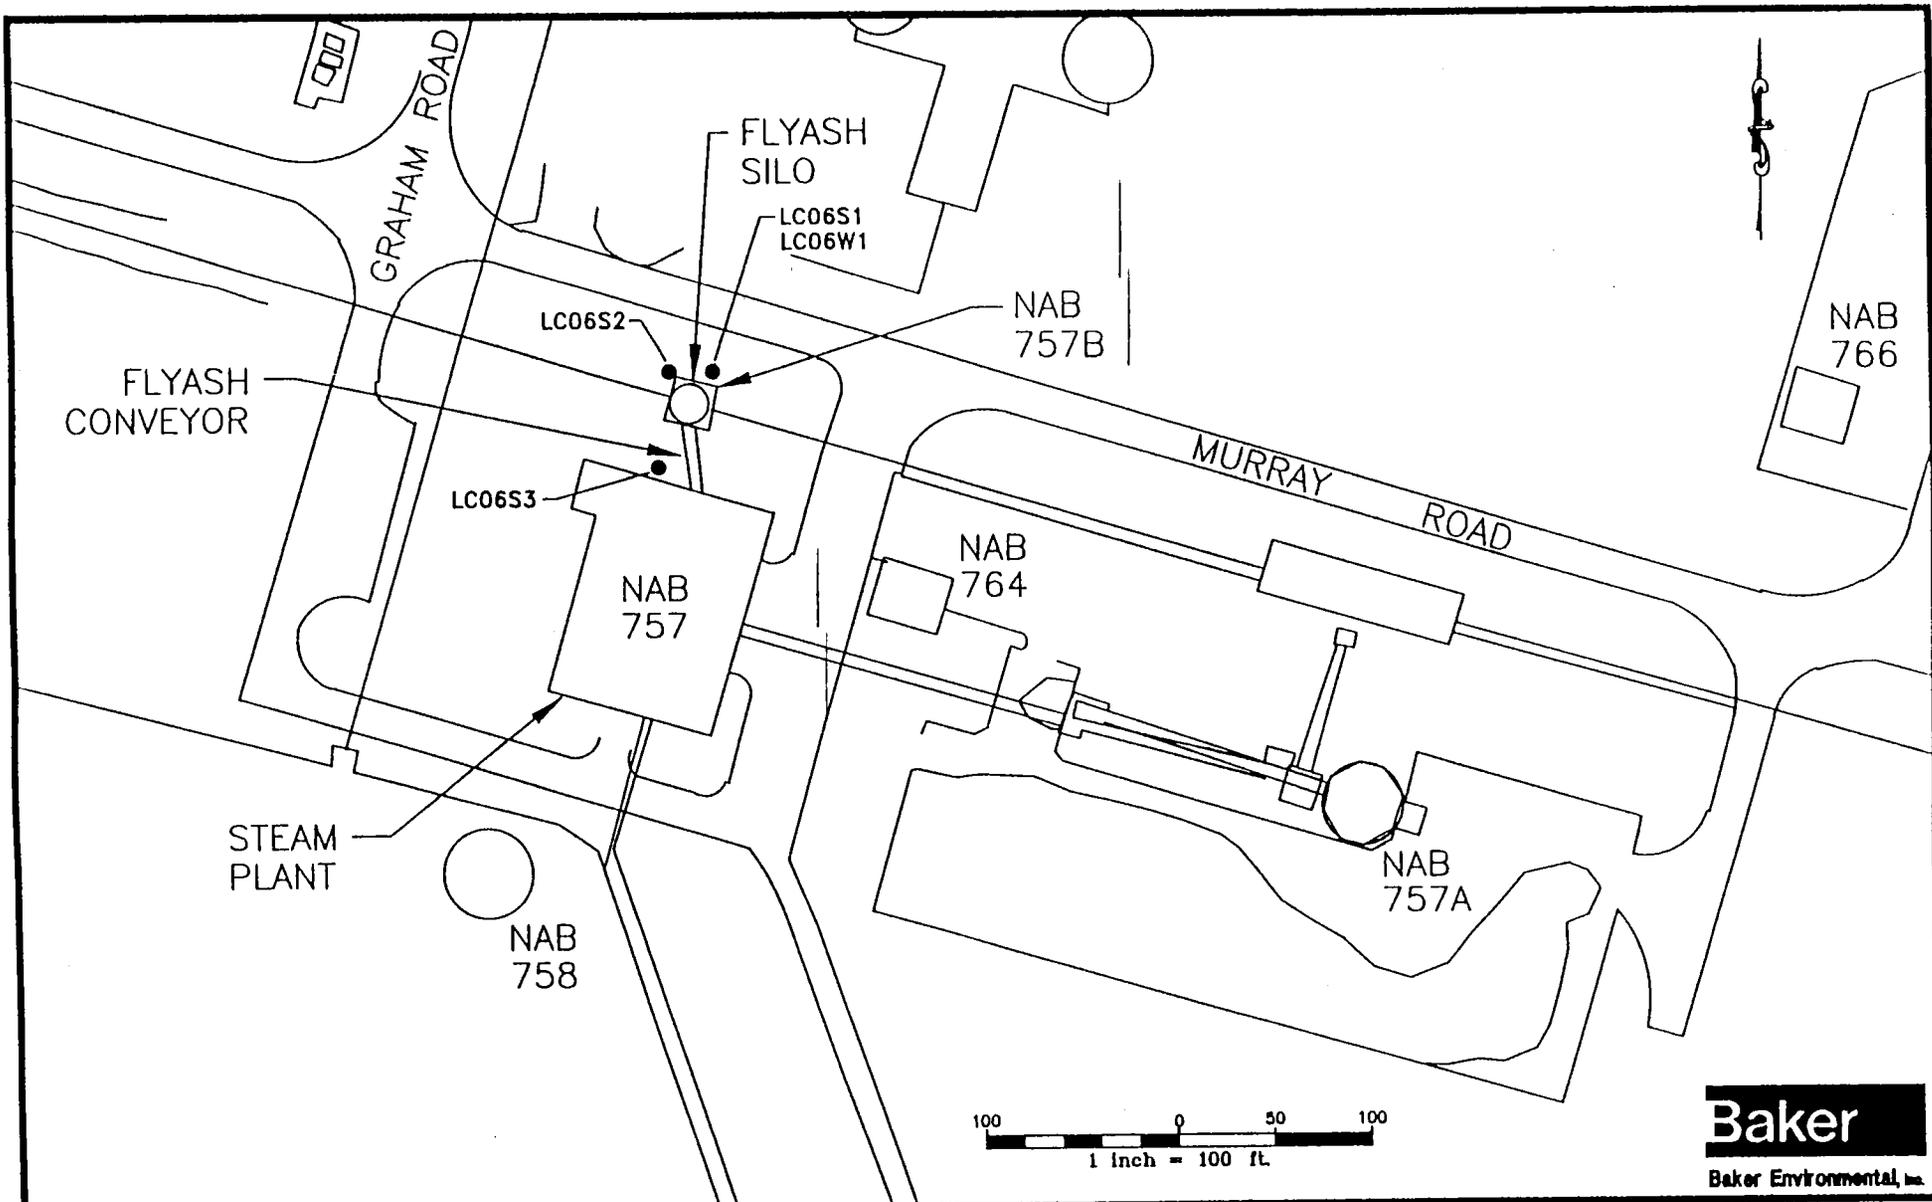
SAMPLE LOCATION MAP
SITE 105
STEAM PLANT FLYASH SILO
SWMU 2
NAVAL AMPHIBIOUS BASE, LITTLE CREEK
NORFOLK, VIRGINIA

This area contains a flyash silo for the steam plant that has been operating since 1953. Bag houses are used to remove flyash from the steam plant exhaust. The collected flyash is transferred from the bag house to the silo by a vacuum pump system. The flyash is then stored in the silo until it is removed for disposal. Prior to transfer to railroad cars or trucks for transport, the flyash is sprayed with water for dust control. However, flyash was still released during transfer from the silo to the railroad cars. The site is partially covered with concrete under and around the flyash silo, with a paved access road to the north. The rest of the site is covered with vegetation.

Soil – Arsenic, antimony, beryllium, manganese

Groundwater – Arsenic, beryllium, lead, manganese, vanadium

- Conduct field investigations as part of SI
- Possible EE/CA for soil removal

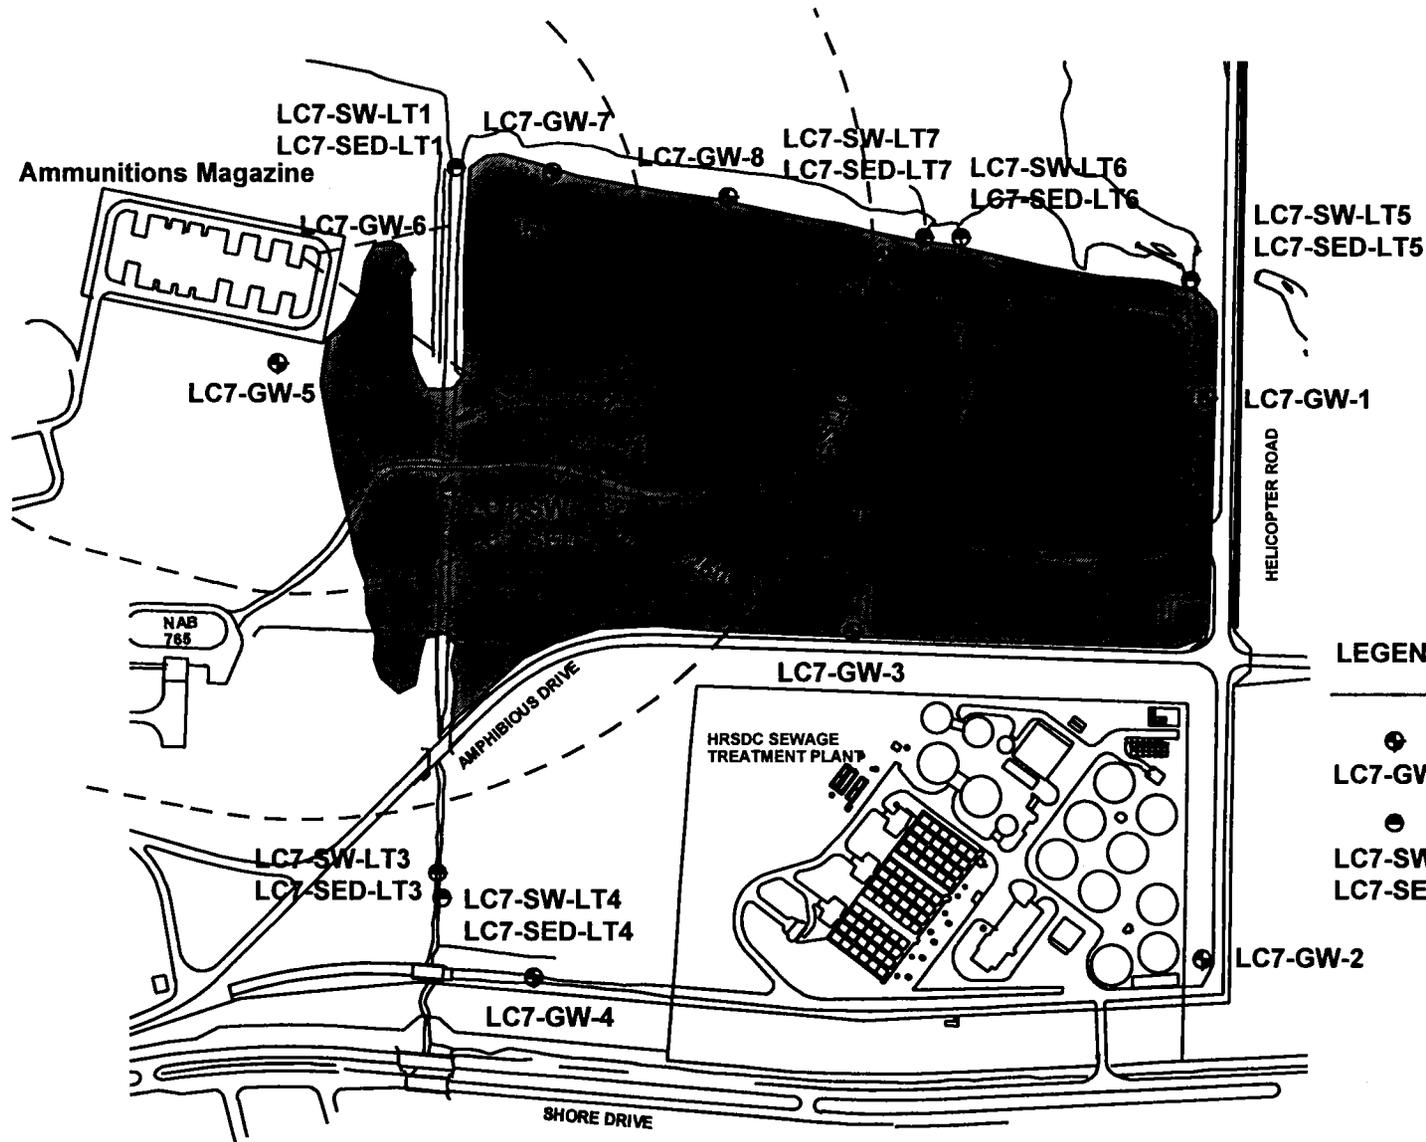
Site 7

The landfill (38 acres-500,000 cy) operated from 1962-1979 initially as a trench type landfill then as an area landfill. During its period of operation, it accepted all wastes from NAB Little Creek. Until closure, the landfill operated under a Virginia solid waste permit. At the time of closure, the landfill was covered with 24" of compacted soil for the final cover. Open burning continued on the site until 1984. In 1994 the landfill was covered with 6 inches of soil and revegetated. Due to the landfill's location within the explosive arc of the ordnance magazine, no buildings or traveled roads can be built on the site. As part of the approved Remedial Action, in 1998, OHM removed 610 cy of debris from the shoreline and replaced the fence around the landfill. Hudgins Corp placed 20,000 cy of soil and vegetated with wildlife grasses. The landfill waste is now located approximately 30" below the ground surface. Because the institutional control issue had not been resolved, the DD for the remedial action was not signed by VDEQ.

Soil - PCB, arsenic, cadmium, chromium, copper, manganese, nickel, zinc

Groundwater - Arsenic, chromium, silver, thallium, zinc

Sediment - SVOCs, PCBs, arsenic, beryllium, copper, iron, lead, manganese, zinc

Surface Water - Arsenic, copper, iron, lead, manganese, zinc

The Supplemental Ecological Assessment concluded that there are a variety of sources for the Contaminates of Concern (COC) found in Little Creek Harbor. Although localized impacts from the COCs may be related to Site 7, there does not appear to be a significant impact on the ecological resources of Little Creek Harbor.

- Continue semi-annual groundwater, surface water, and sediment monitoring (Rounds 2 and 3)
- Submit periodic groundwater monitoring letter reports

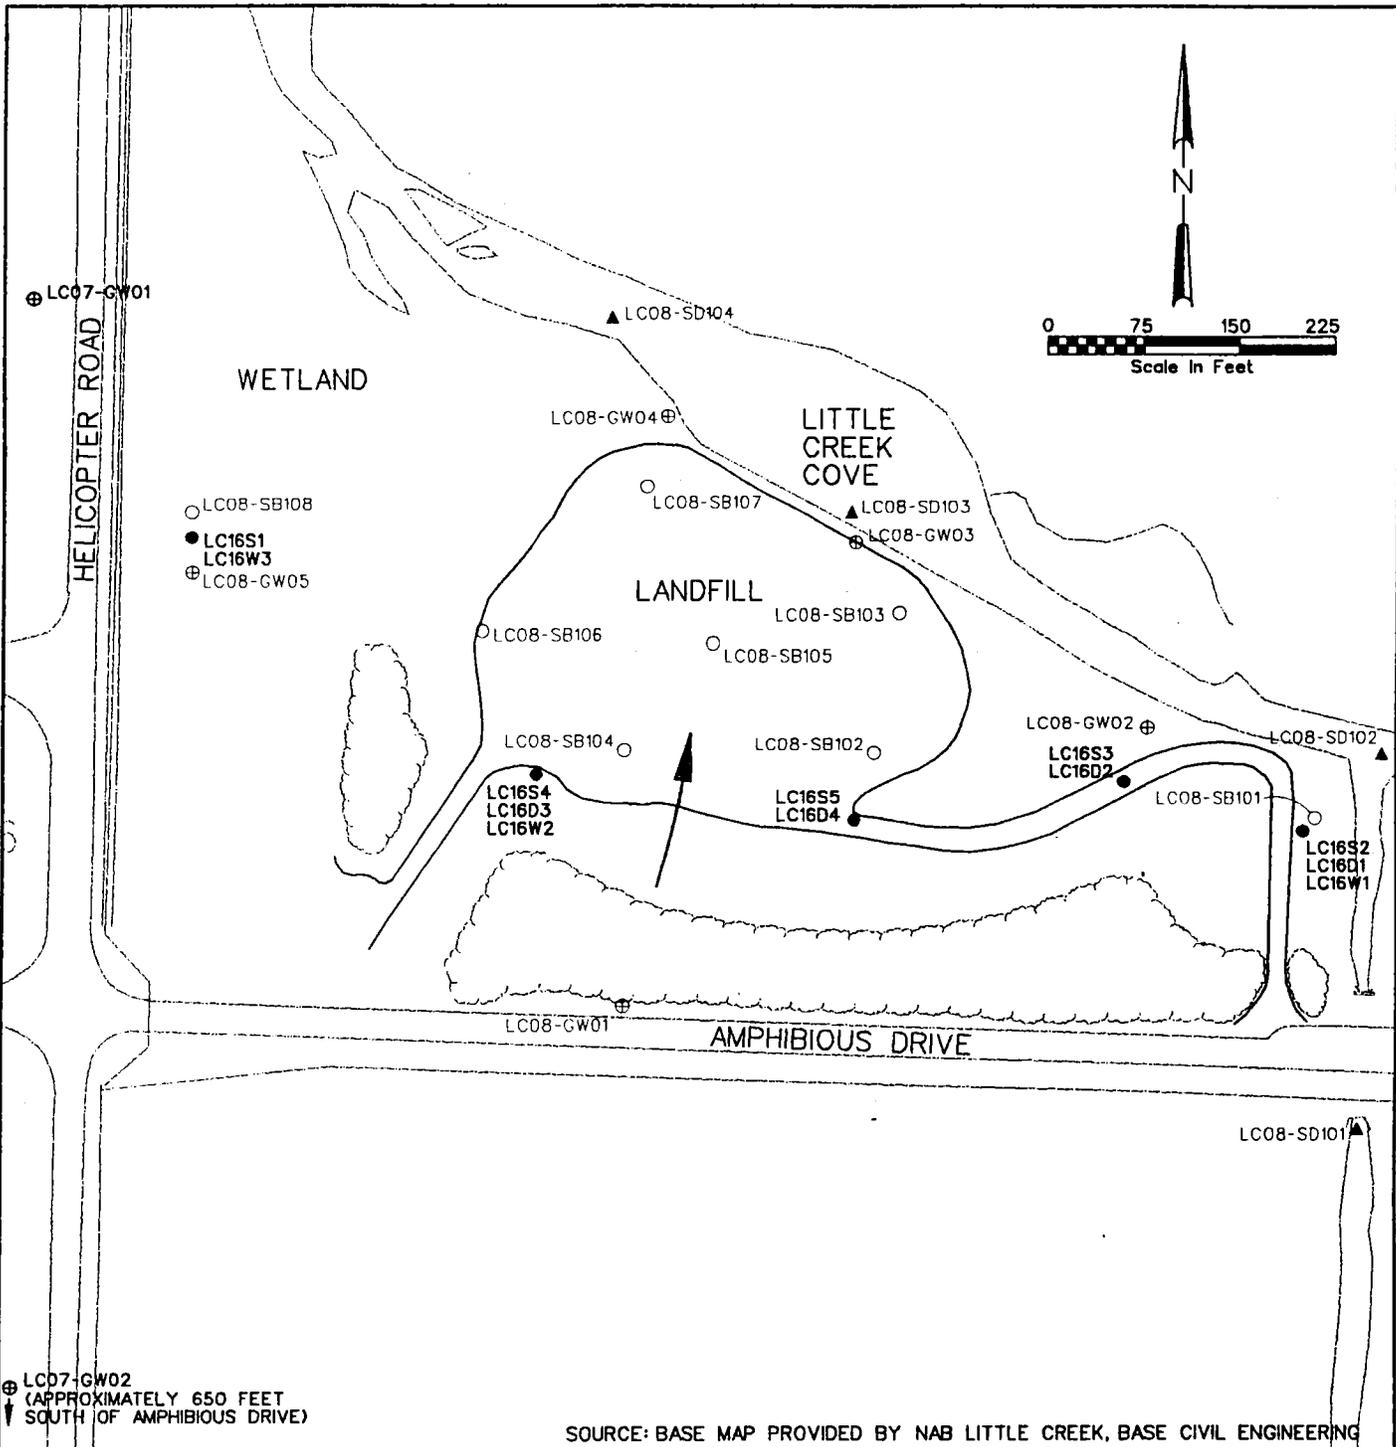
Figure 3-2
PROPOSED SAMPLING LOCATIONS
SITE 8 - DEMOLITION DEBRIS LANDFILL
NAB LITTLE CREEK
 VIRGINIA BEACH, VIRGINIA

Formerly classified as SWMU 84. The landfill (2 acres-4840 cy) operated from 1971 to 1979 as a disposal area for demolition debris. The landfill was constructed in a pit PWC had excavated materials from to cover parking lots. Wastes were placed to a depth of 3'. Wastes contained within the landfill included a potentially mercury-contaminated carpet from the demolition of a dental clinic, debris from buildings destroyed by fire, concrete piping, and debris removed from the bar screen in the base sewage treatment plant. Due to the lack of any records indicating hazardous waste disposal, and because the landfill operated while Site 7 was still open, it is assumed no hazardous waste was placed at Site 8. As part of the Site Investigation in September 1998, five monitoring wells were installed and sampled, as well as eight surface and subsurface soil samples, and four sediment samples.

Soil – Arsenic, antimony, lead, manganese, PCBs

Groundwater - Arsenic, barium, beryllium, cadmium, chromium, lead, manganese, nickel, vanadium

- Perform qualitative baseline human health and ecological risk assessment
- Prepare SI report

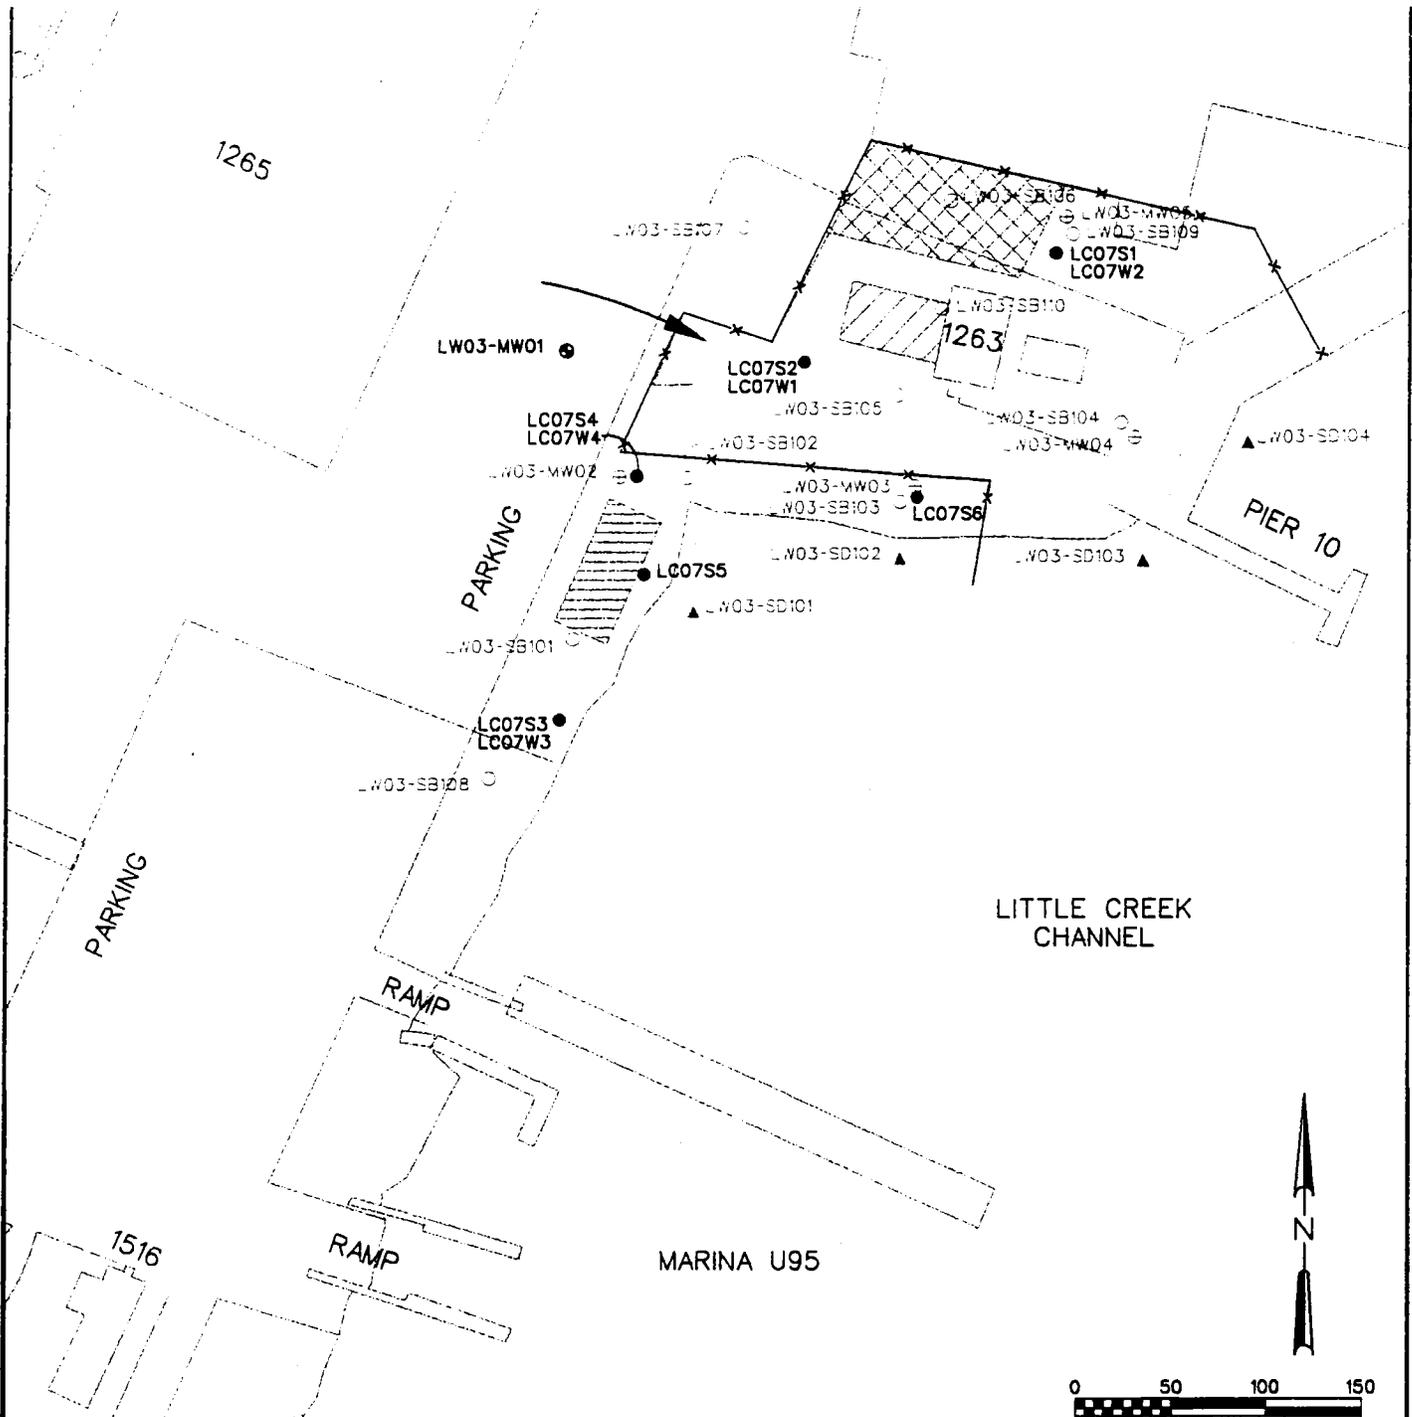
Figure 1-2
PROPOSED SAMPLING LOCATIONS
SWMU 3 - PIER 10 SANDBLAST AREA
NAB LITTLE CREEK
VIRGINIA BEACH, VIRGINIA

This area was used for sandblasting boats from 1962 to 1984. After 1984, anchors and anchor chains were sandblasted at the site. Up until 1995, sandblasting took place on a concrete pad located on the west side of Building 1263. The sandblast material was periodically removed from the site for disposal following EP toxicity testing indicating the residue was not hazardous. Paint chips and grit covered the unpaved ground south of the pad to the water's edge and the nearshore bottom of Little Creek Harbor. In 1982, a fence with privacy slats was installed around the sandblasting area to limit access to the site. The fence also prevents windblown sandblast materials from migrating outside the area. This fence is generally closed and locked outside working hours. In 1993 the area had been covered with asphalt, except for a small area to the northeast of the sandblasting pit. Little or no vegetation covers this unpaved area. Prior to 1993, runoff from sandblasting operations occurred as sheet flow. In 1993, a catch basin and a regulated outfall were constructed at the site. Some runoff from other areas of the site may still flow into Little Creek Harbor, located on the east side of SWMU 3. In 1995, a new sandblasting area was constructed in the northwest corner of the compound. This new area consisted of a concrete pad surrounded by a 4 to 5 foot concrete wall. The new sand blasting area was only used for about a year. Now all blasting on the base occurs *inside* building CB-125, a new facility built specifically for blasting. A picnic area located in the southwest portion of SWMU 3 is currently off-limits to personnel. A project has been funded to cover the area with 3" of soil and sod. Historic releases likely occurred in the past when sandblasting residue was lying directly on the ground surface.

Soil - Arsenic, antimony, beryllium, chromium, copper, lead, manganese, nickel, zinc

Groundwater - Total (unfiltered) metals: Arsenic, beryllium, cadmium, chromium, copper, lead, manganese, nickel, vanadium

- Perform qualitative baseline human health and ecological risk assessment
- Prepare SI report

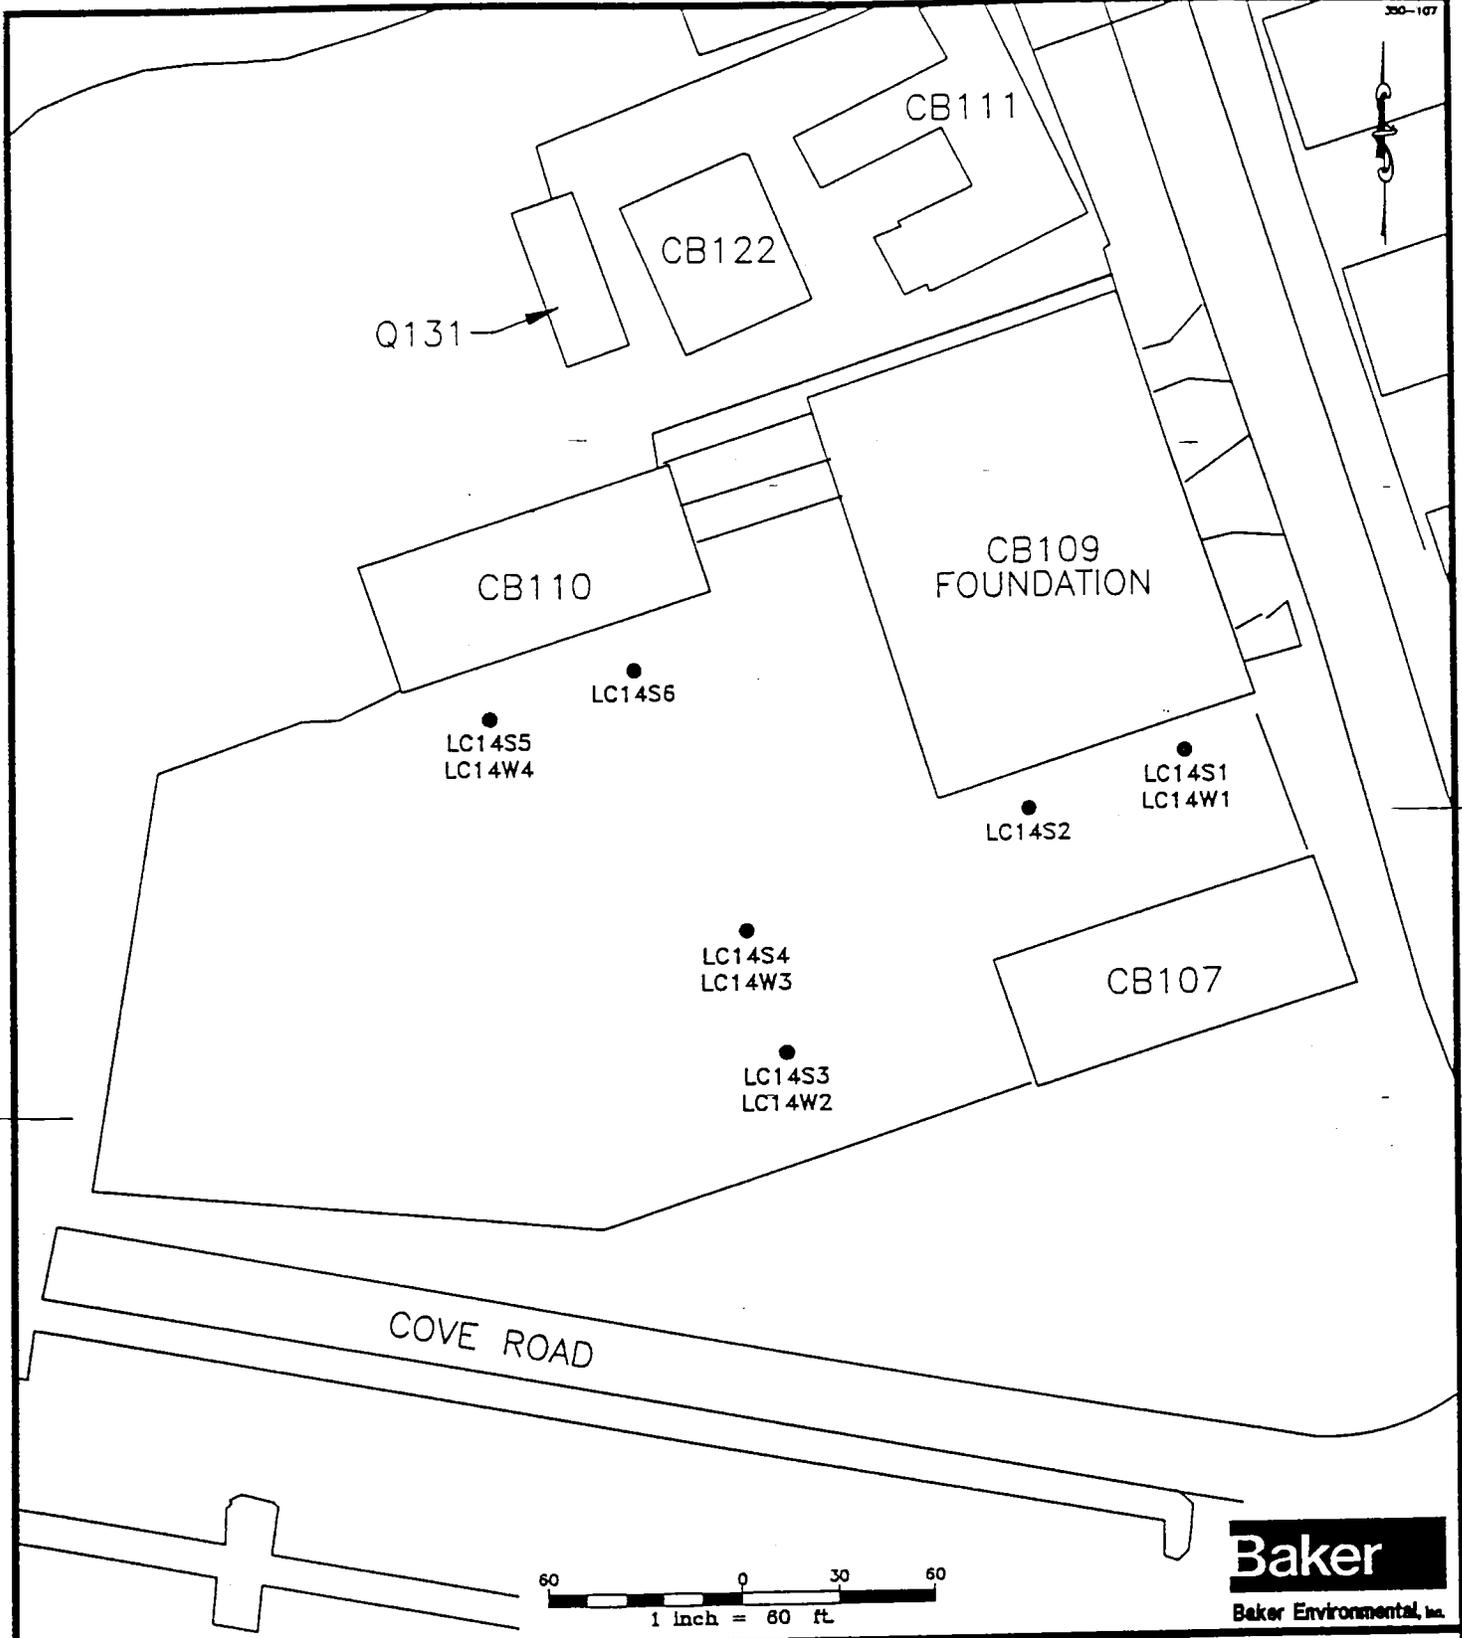
SAMPLE LOCATION MAP
SITES 131, 132 & 133
SEABEE AREA

This area consists of three separate waste management areas. 1) Former SWMU 131, Satellite Accumulation Point for Paint Wastes, included a 55-gallon drum and several smaller cans stored on a wooden pallet over bare soil. Wastes included paints and thinners. No release controls were present and soil staining was evident. 2) Former SWMU 132, Inoperative Wire Degreaser, was an elevated trough 20 feet long and 12 inches deep filled with JP-5 aircraft fuel to degrease wires. The degreaser has been taken out of service. No release controls were present and there was evidence that JP-5 apparently leaked from a valve and stained the soil below. 3) Former SWMU 133, Excess Material Storage Area, was a gravel yard used to store excess paints, cables and other material. The paints were stored on wooden pallets and were covered with canvas tarps. Stains were observed in this area.

An asphalt road exists along the perimeter of the site. Concrete slabs indicate the locations of former structures. The remainder of the site is soil with little to no vegetative cover. The site is completely open, with unrestricted access. Human contact with potentially contaminated soils is possible.

Soil – Arsenic, antimony, chromium, lead, manganese

Groundwater - Arsenic, antimony, beryllium, chromium, lead, manganese

- Conduct field investigations as part of the SI

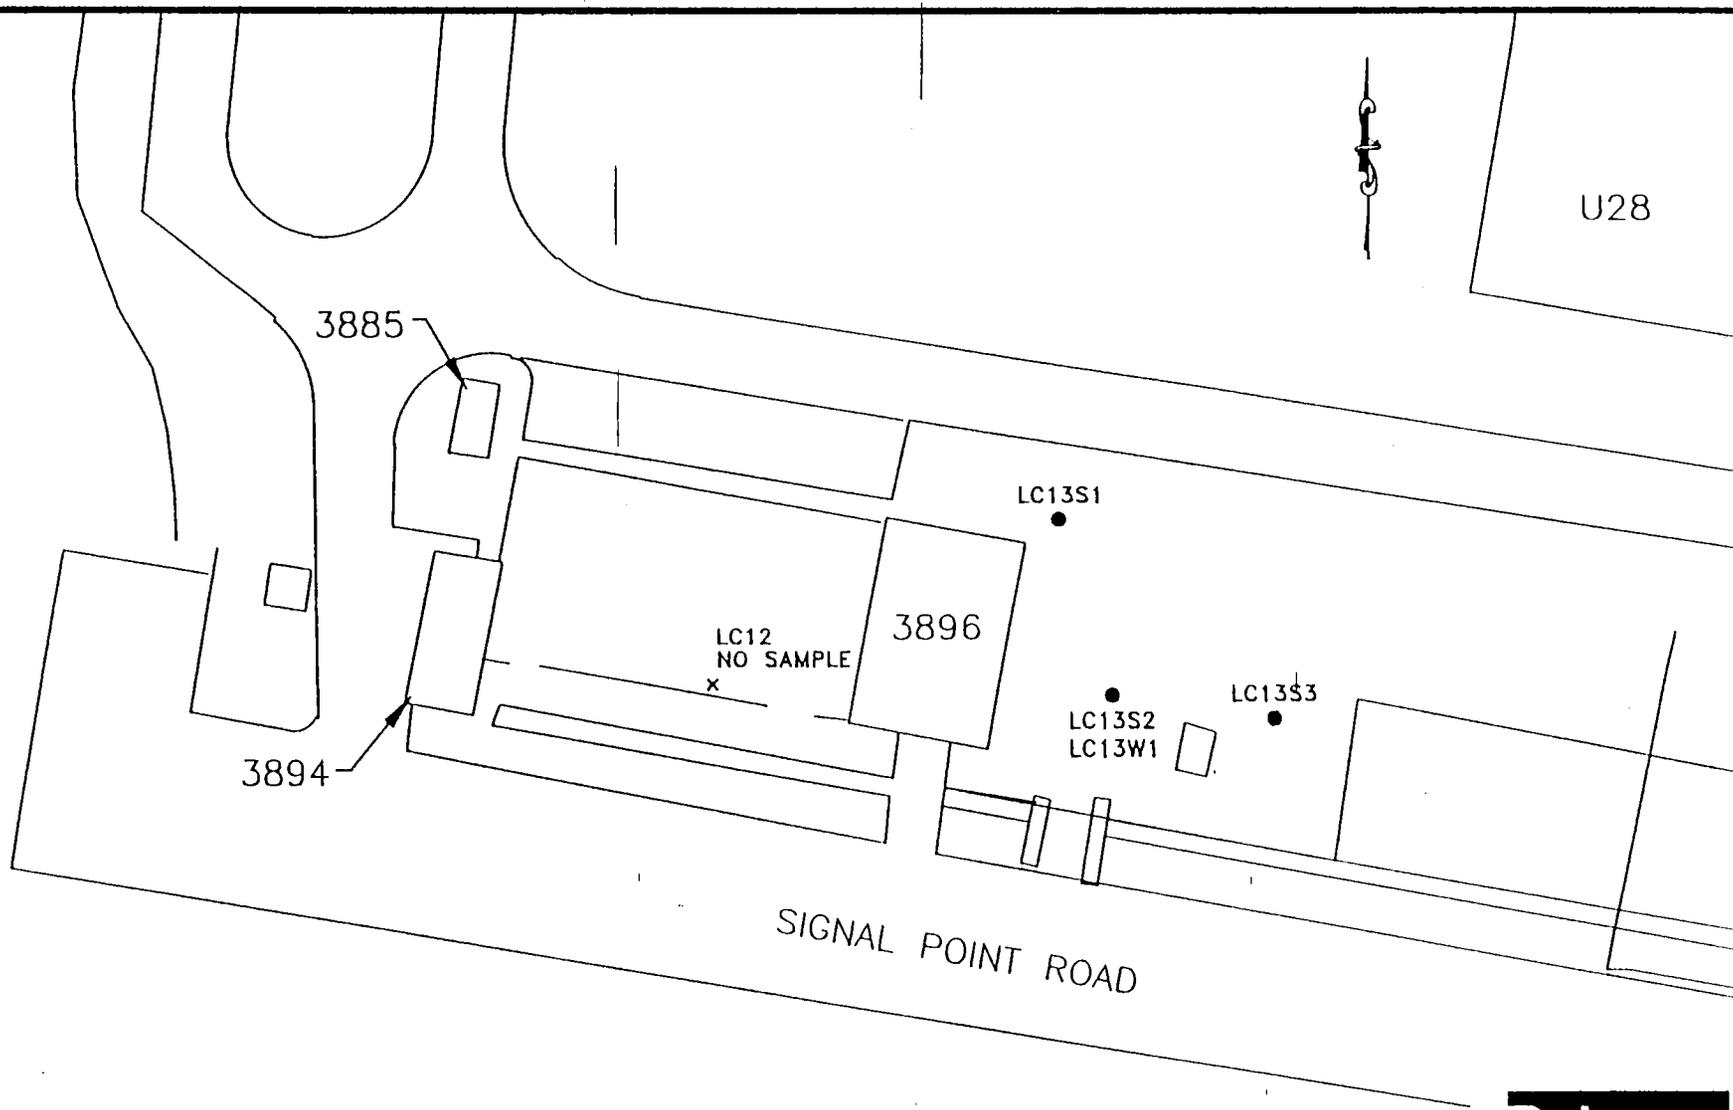
SAMPLE LOCATION MAP
 SITE 129 - BLDG. 3896 AREA,
 SATELLITE ACCUMULATION POINT
 SITE 130 - BLDG. 3896 AREA,
 BOAT PAINTING
 NAVAL AMPHIBIOUS BASE, LITTLE CREEK
 NORFOLK, VIRGINIA

Activities at this site included grinding of boat hulls in preparation for painting, and painting of boats. Metal grindings and paint over-spray were allowed to fall onto the ground. No release controls were present. In addition, bilge water, metal grindings, paints, and thinners were released to the soil. The site was paved with concrete and/or asphalt after boat maintenance activities were initiated at the site. There is, however, an area north of the current boat maintenance area and along the compound fence that is unpaved and has little vegetative cover. Access to the site is restricted. Little Creek Cove is located south of the site and may receive some surface water discharge.

Soil – SVOCs, antimony, beryllium, lead, manganese

Groundwater – Arsenic, antimony, beryllium, chromium, lead, manganese, vanadium

- Conduct field investigations as part of SI

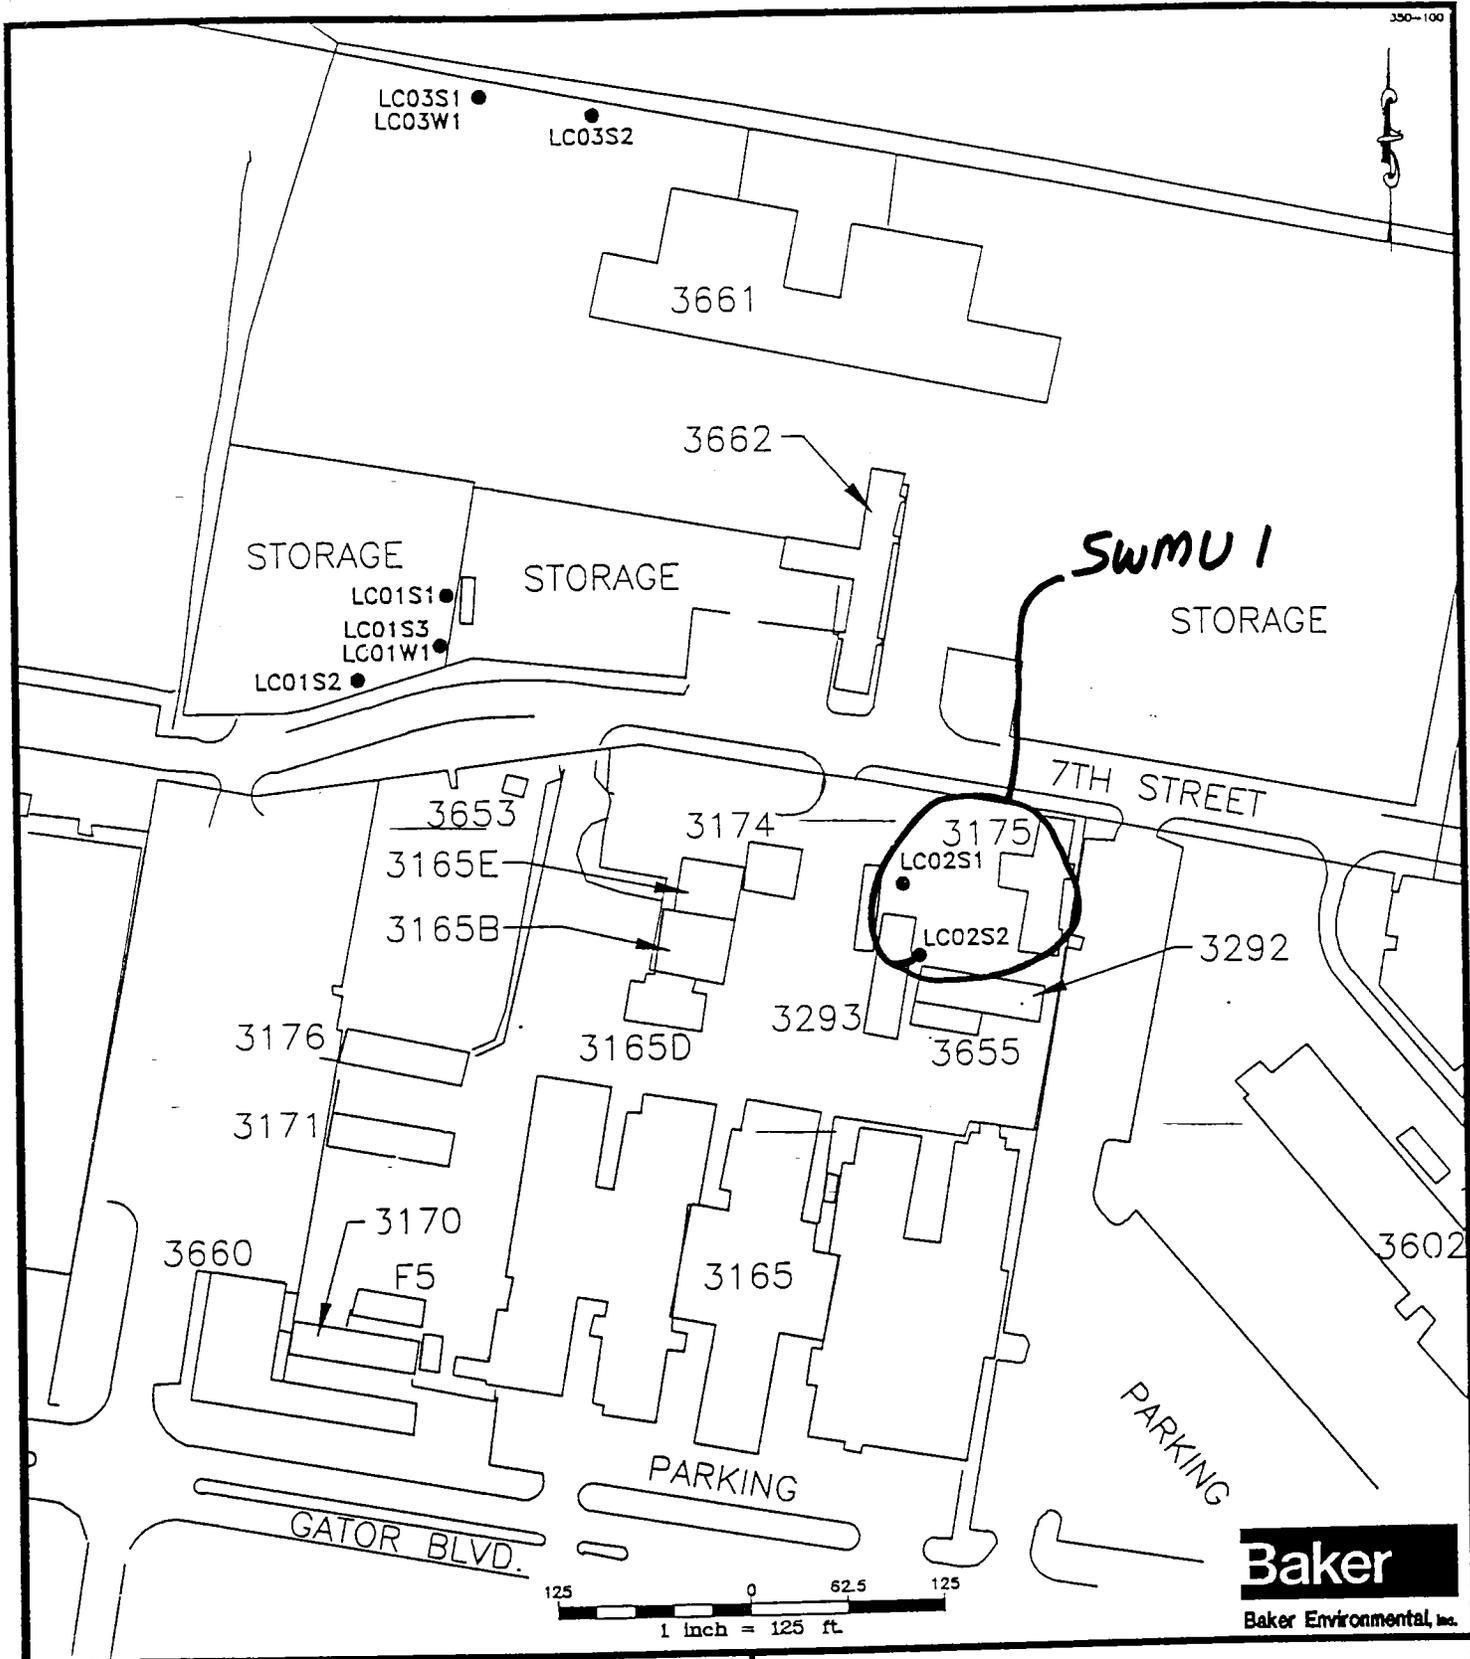
SAMPLE LOCATION MAP
 SITE 16 - TRANSFORMER STORAGE AREA, POLE YARD
 SITE 17 - SMALL TRANSFORMER STORAGE AREA, 3175
 SITE 20 - PWD TRANSPORTATION GARAGE NAVAL AMPHIBIOUS BASE, LITTLE CREEK NORFOLK, VIRGINIA

The paved yard was used beginning in 1975 for storage of small, non-PCB containing transformers. However, the site may have been used for repair of PCB containing transformers. Contaminant release history is unknown. The site was later paved with asphalt.

Soil - PCBs, SVOCs, pesticides

Groundwater - None tested

- Conduct field investigations as part of SI
