EXECUTIVE SUMMARY  
FOR  
CONFIRMATION STUDY ON  
HAZARDOUS WASTE SITES  
AT  
NAVAL EDUCATION AND TRAINING CENTER  
NEWPORT, R.I.

November 26, 1985

Loureiro Engineering Associates  
10 Tower Lane  
Avon, CT 06001

A/E Contract No. N62472-83-C-1154

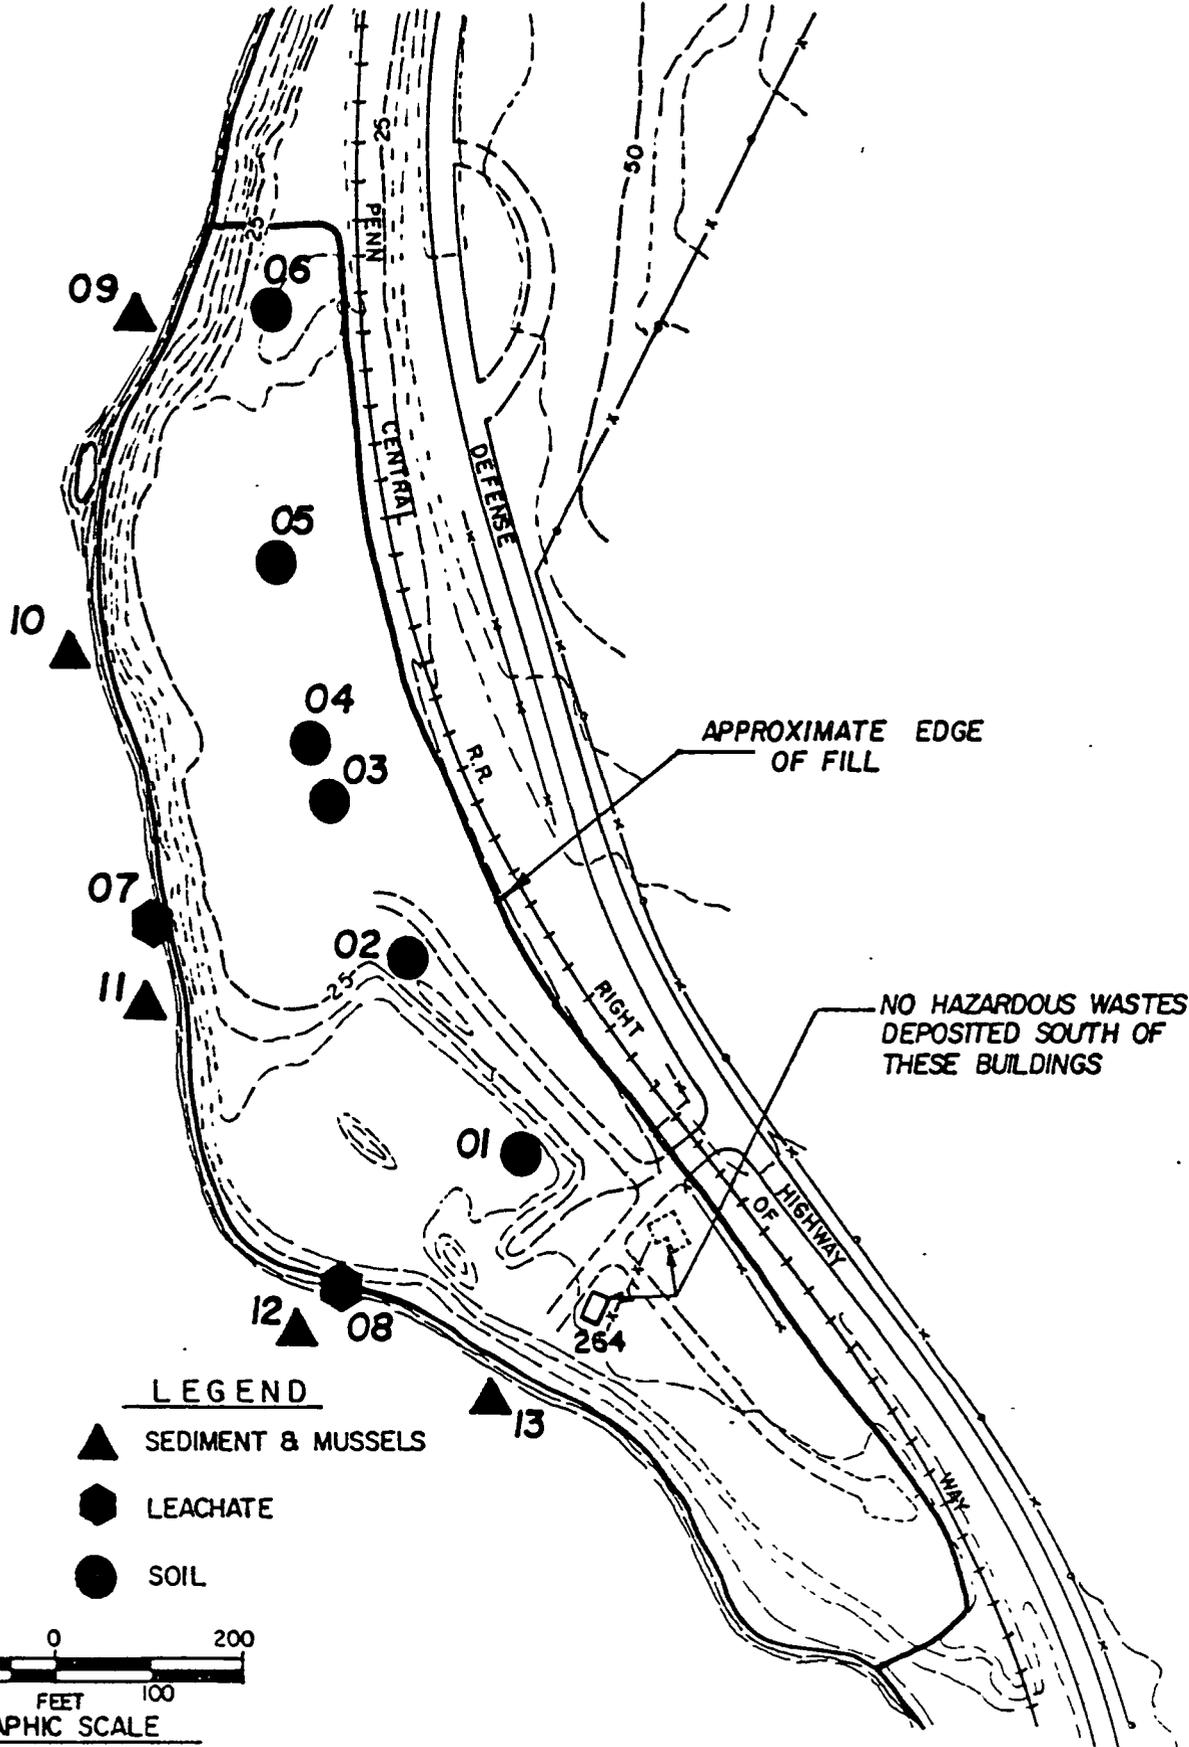
FIG. NO. 3

The results of the verification step sampling and analysis indicate that metals are accumulating in sediments and mussels near the McAllister Point Landfill based on comparison to data from the control stations. Elevated levels of lead, copper, nickel, and chromium were detected in the sediments while elevated copper concentrations were found in the mussels.

The sediment samples seemed to indicate that certain metals are accumulating in the vicinity of Station Nos. 12 and 13 near the south end of

the landfill. The pollutants are not being concentrated by the mussels to the same extent, although the copper concentrations in the mussels were substantially higher near the south end of the landfill than at other stations further north or at the control stations. There is no significant accumulation of metals in the soil cover.

The data seems to indicate that the landfill has caused or is continuing to cause metal deposition near Station Nos. 12 and 13.

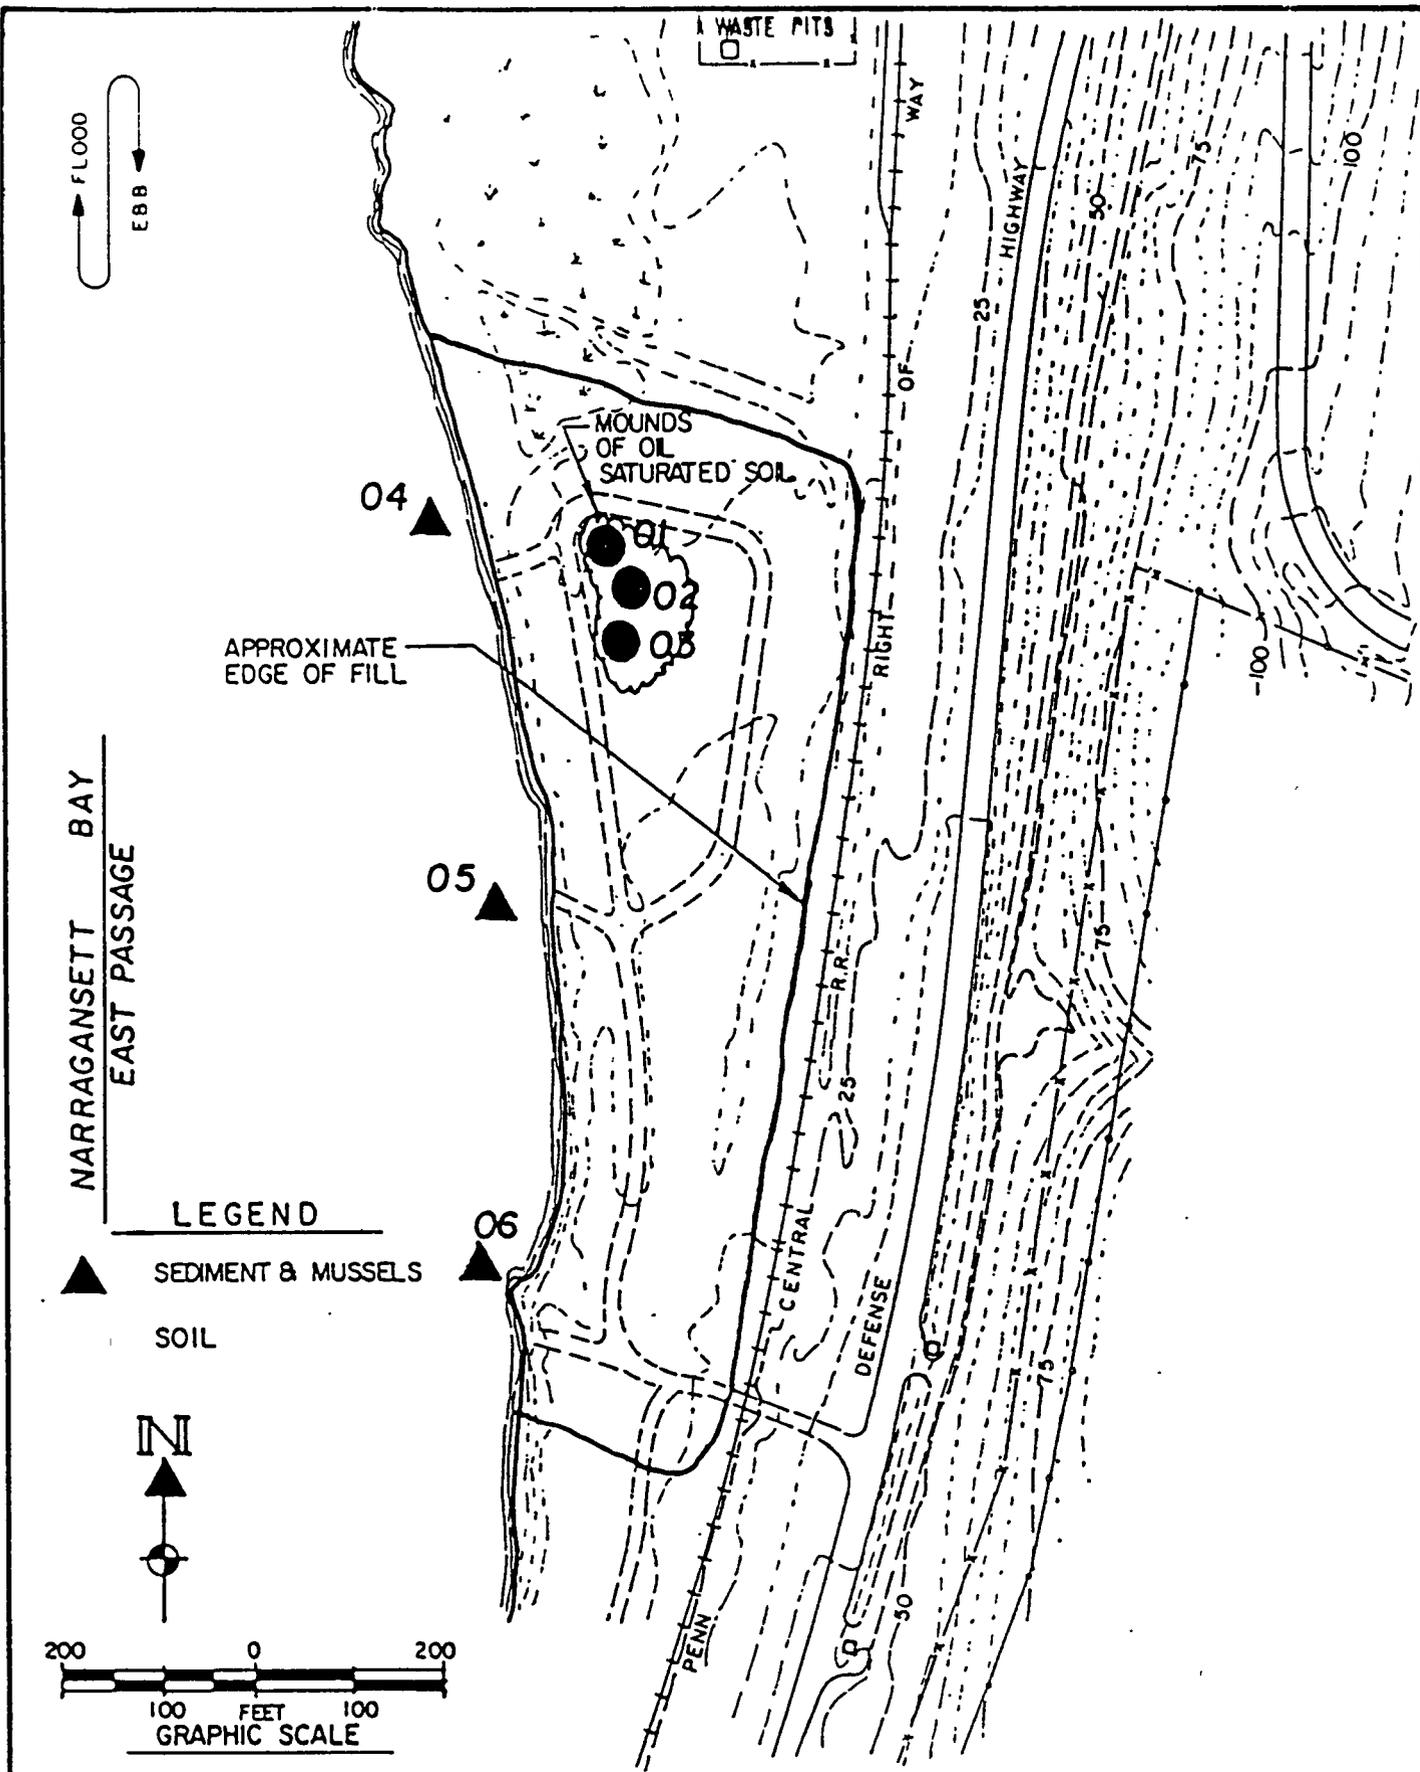
FIG. NO. 5

The analytical data on samples collected indicate that there is no significant accumulation of metals or PCBs in sediment or mussels collected at the three marine sampling points in comparison to data from control stations. The composite soil sample indicated the presence of some lead and very high concentrations of petroleum based hydrocarbons (PBHC). No PCBs were detected.

- Remove the oily soil piles to the limits shown on Figure No. 5 and dispose of the material as oil spill clean-up materials.
- Fill the disturbed area with clean soil, grade to drain and provide loam to promote growth of grass.

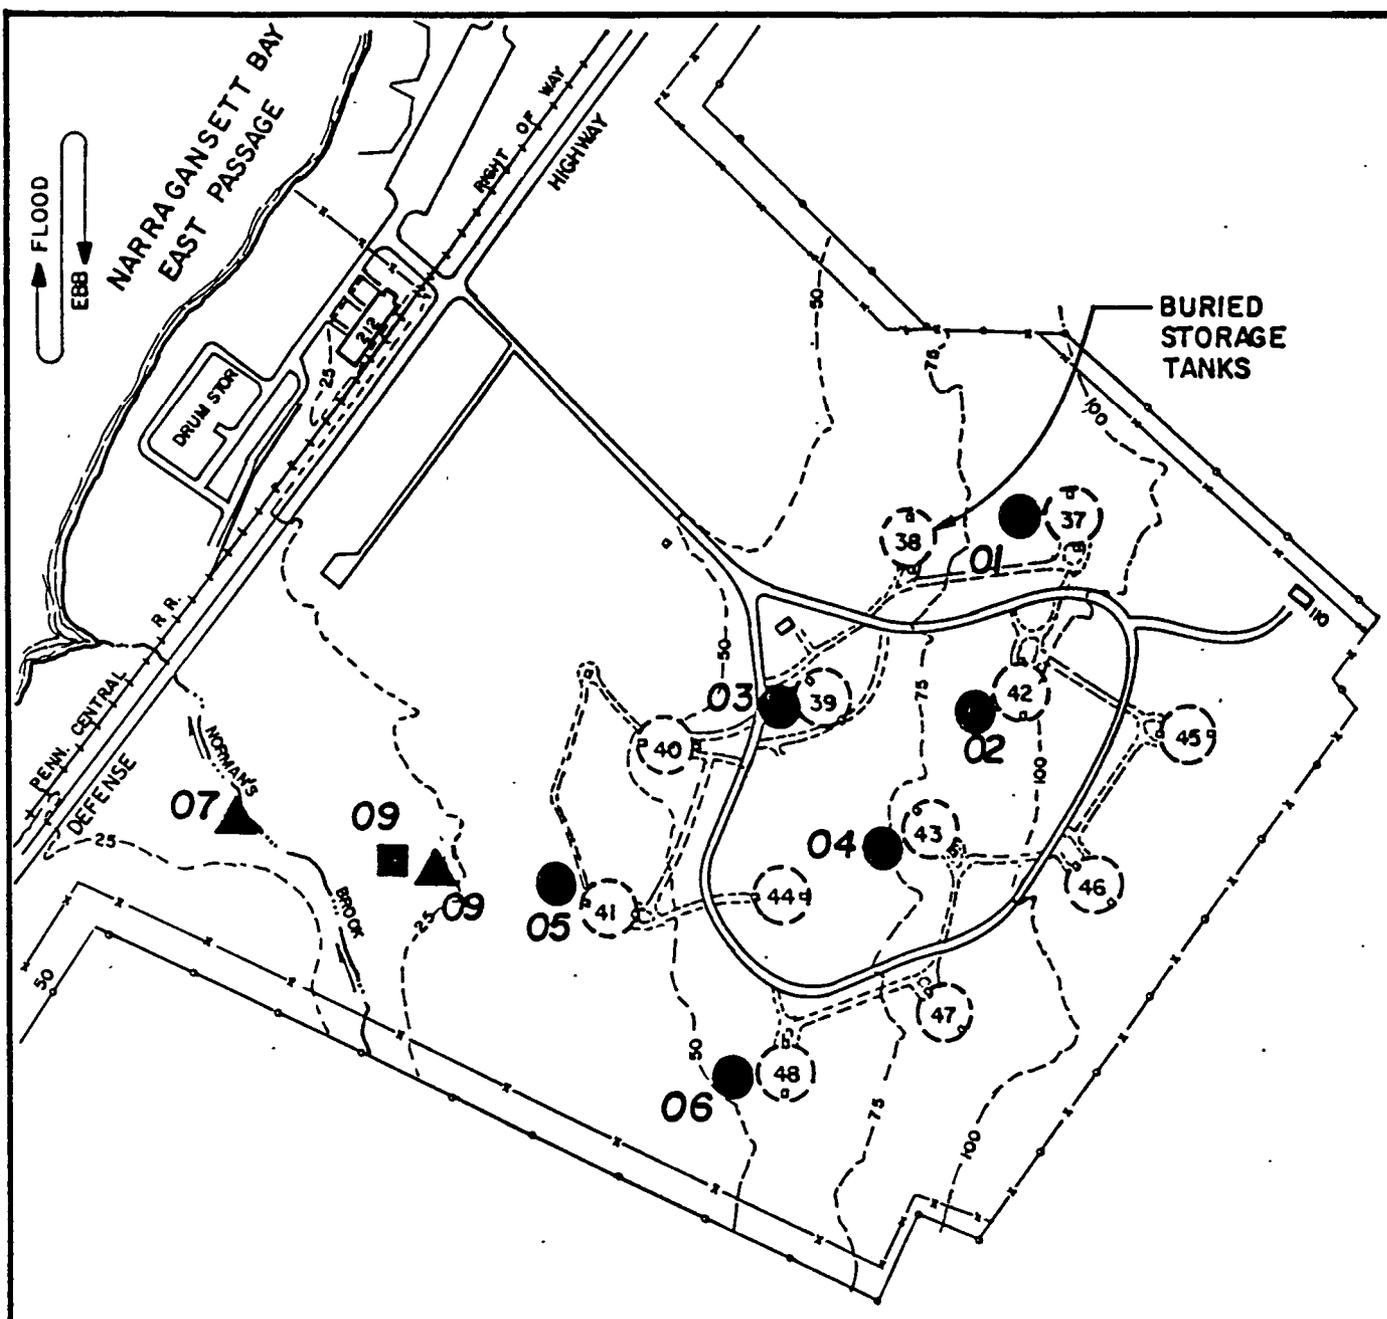
FIG. NO. 12

THE SURFACE WATER AT STATION 09 WAS ACTUALLY GROUNDWATER SEEPAGE IN WET WEATHER.

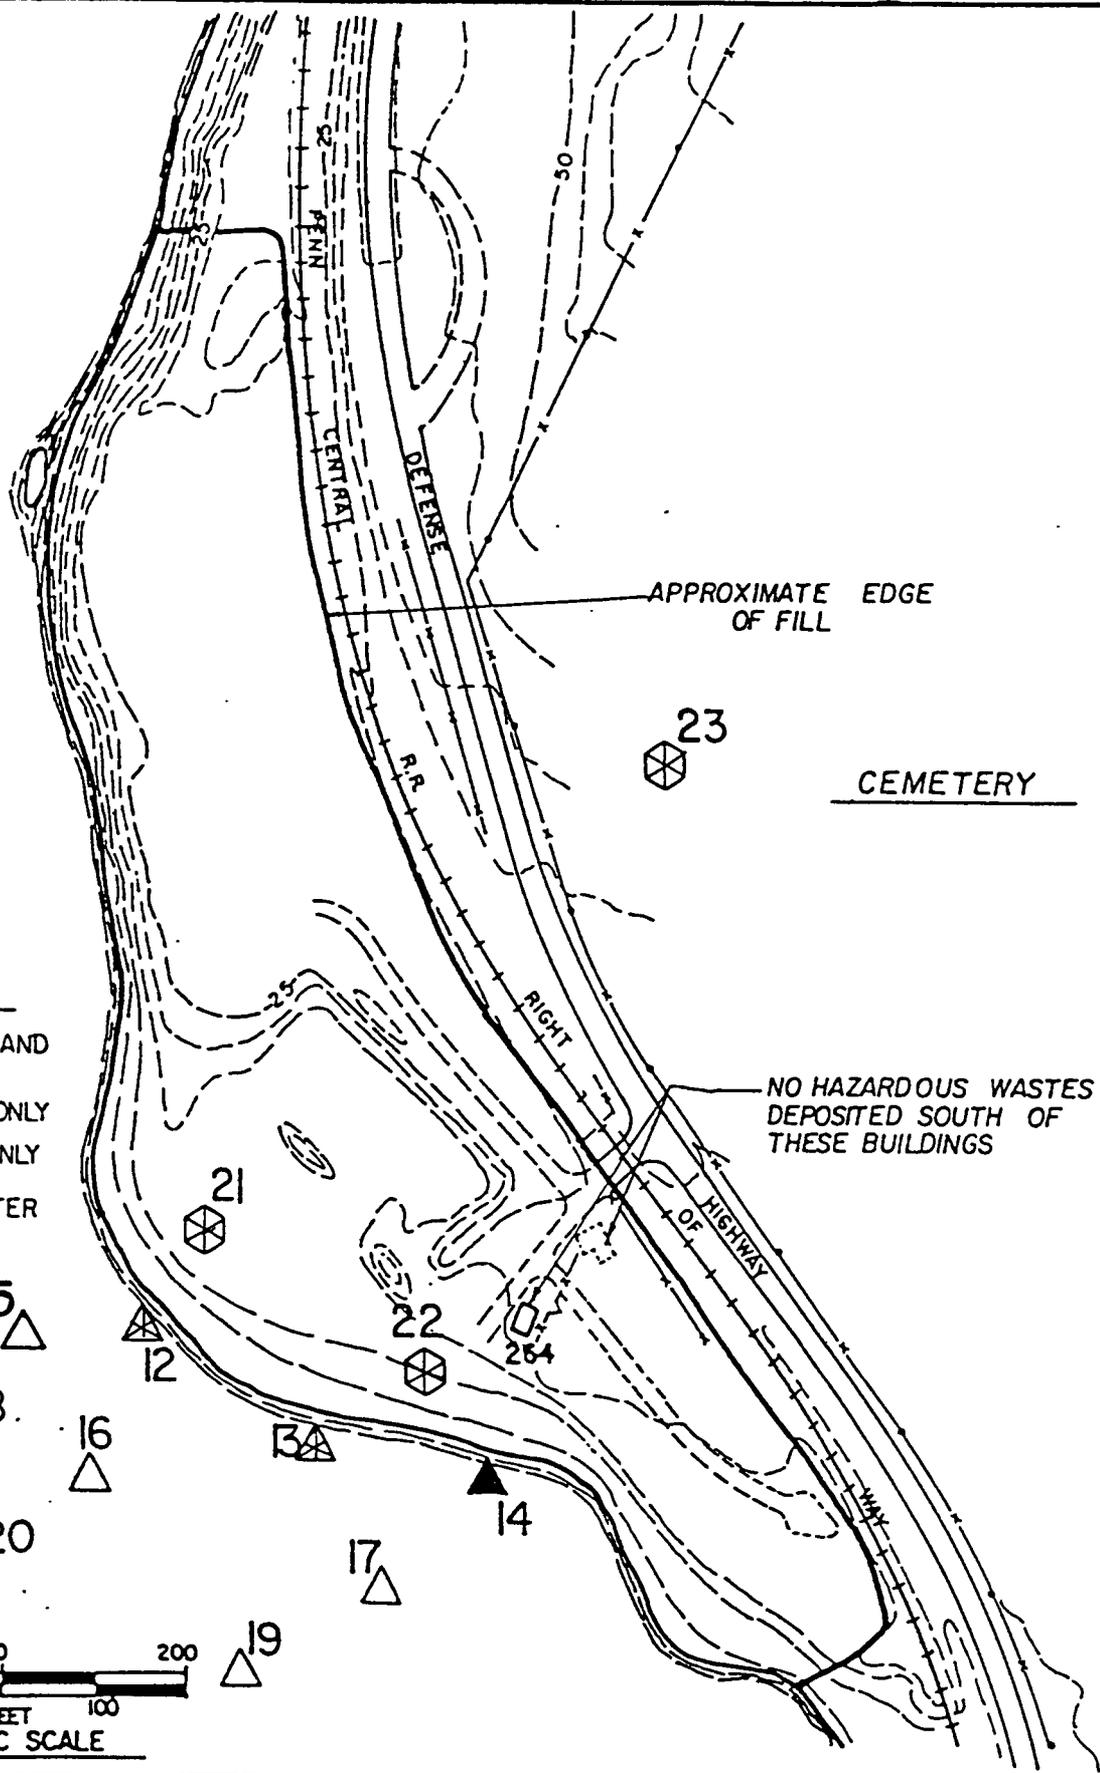
FIG. NO. 4

In general, the off-shore sediments sampled in the characterization step were found to be less contaminated than the near-shore sediments. Elevated levels of lead, copper, and nickel were found in sediments close to shore but the chromium concentrations at these stations were only slightly above the control sample concentrations. Lead and copper are being assimilated by mussels at rates higher than the controls.

Four sets of samples were collected from the three monitoring wells, one upgradient and two downgradient of or in the fill. Samples from the two wells located in the landfill showed concentrations of lead and copper significantly higher than in the upgradient well. The results do not indicate that the landfill is a continuing major source of environmental contamination.

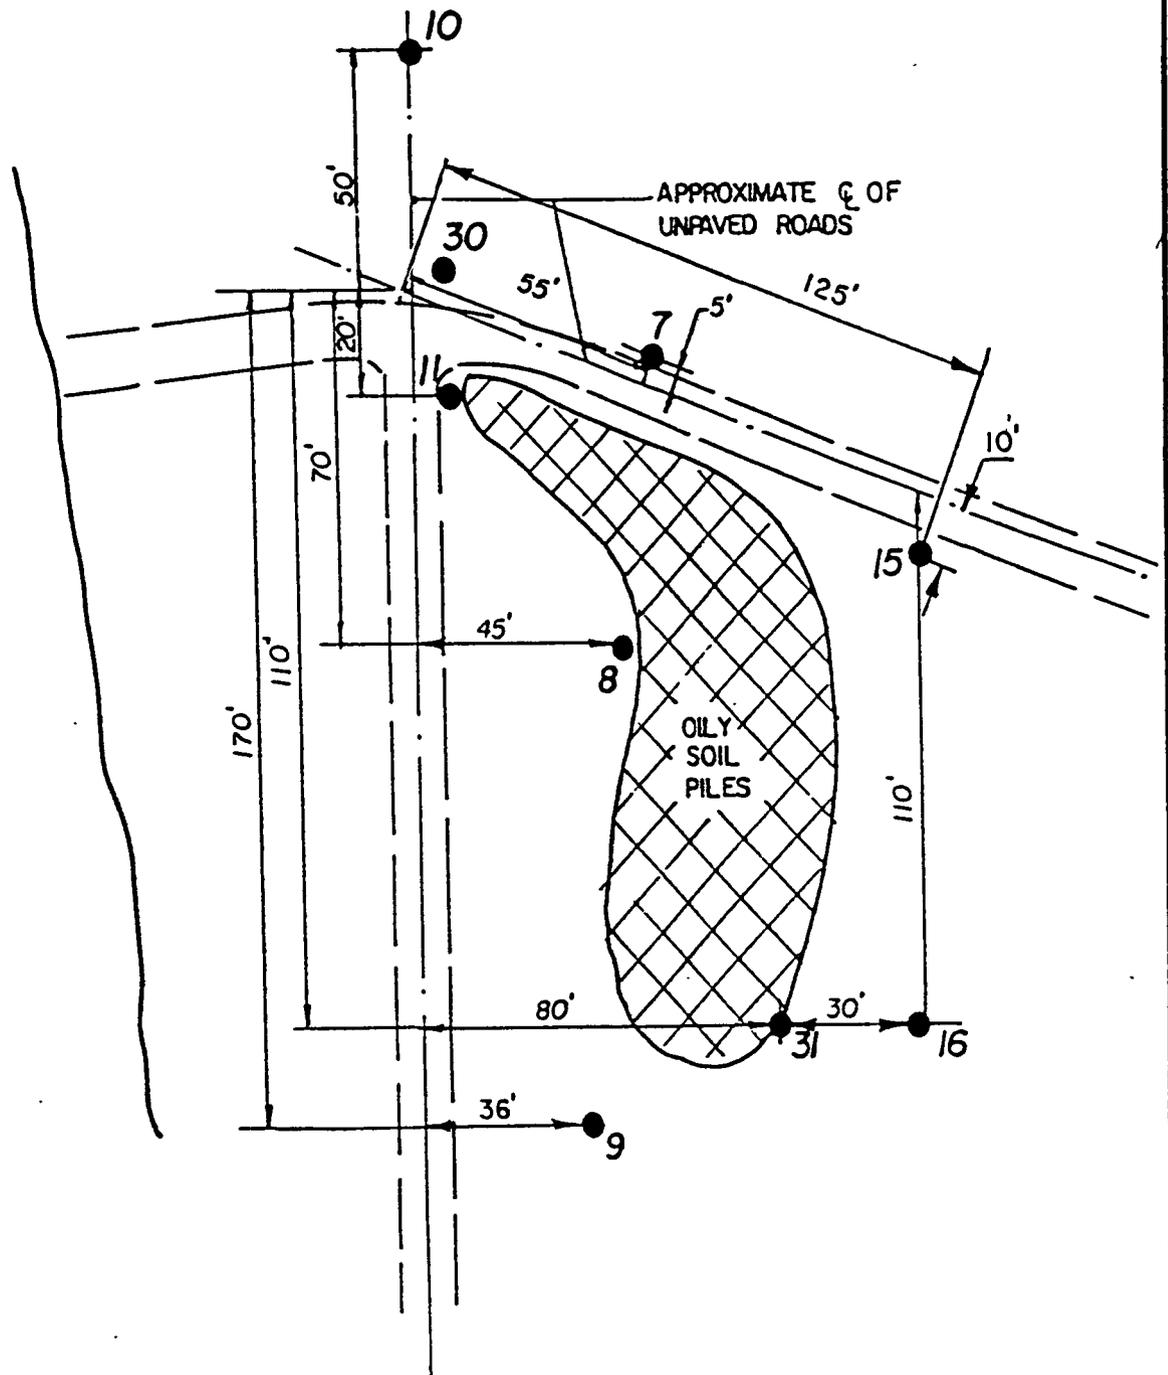
FIG. NO. 7

order to determine the extent of the PBHC contaminated soil. None of the test holes showed any significant travel of oil laterally away from the piles. Some of the holes showed accumulations of waste bituminous paving material. These investigations indicate that the oily material has not migrated laterally away from the surface piles of the soil. Some downward migration may have occurred under the piles, but there was no indication of this at holes adjacent to the piles.

OILY SOIL PILES = 6000 S.F. @ 3 FEET  
 AVE. DEPTH = 670 C.Y.
