DEPARTMENT OF THE NAVY
NAVAL EDUCATION AND TRAINING CENTER
NEWPORT, RHODE ISLAND 02841-5000

5090
Ser 026/424E
07 FEB 1990

Re: Oil Spill at Tank No. 53, Tank Farm 5

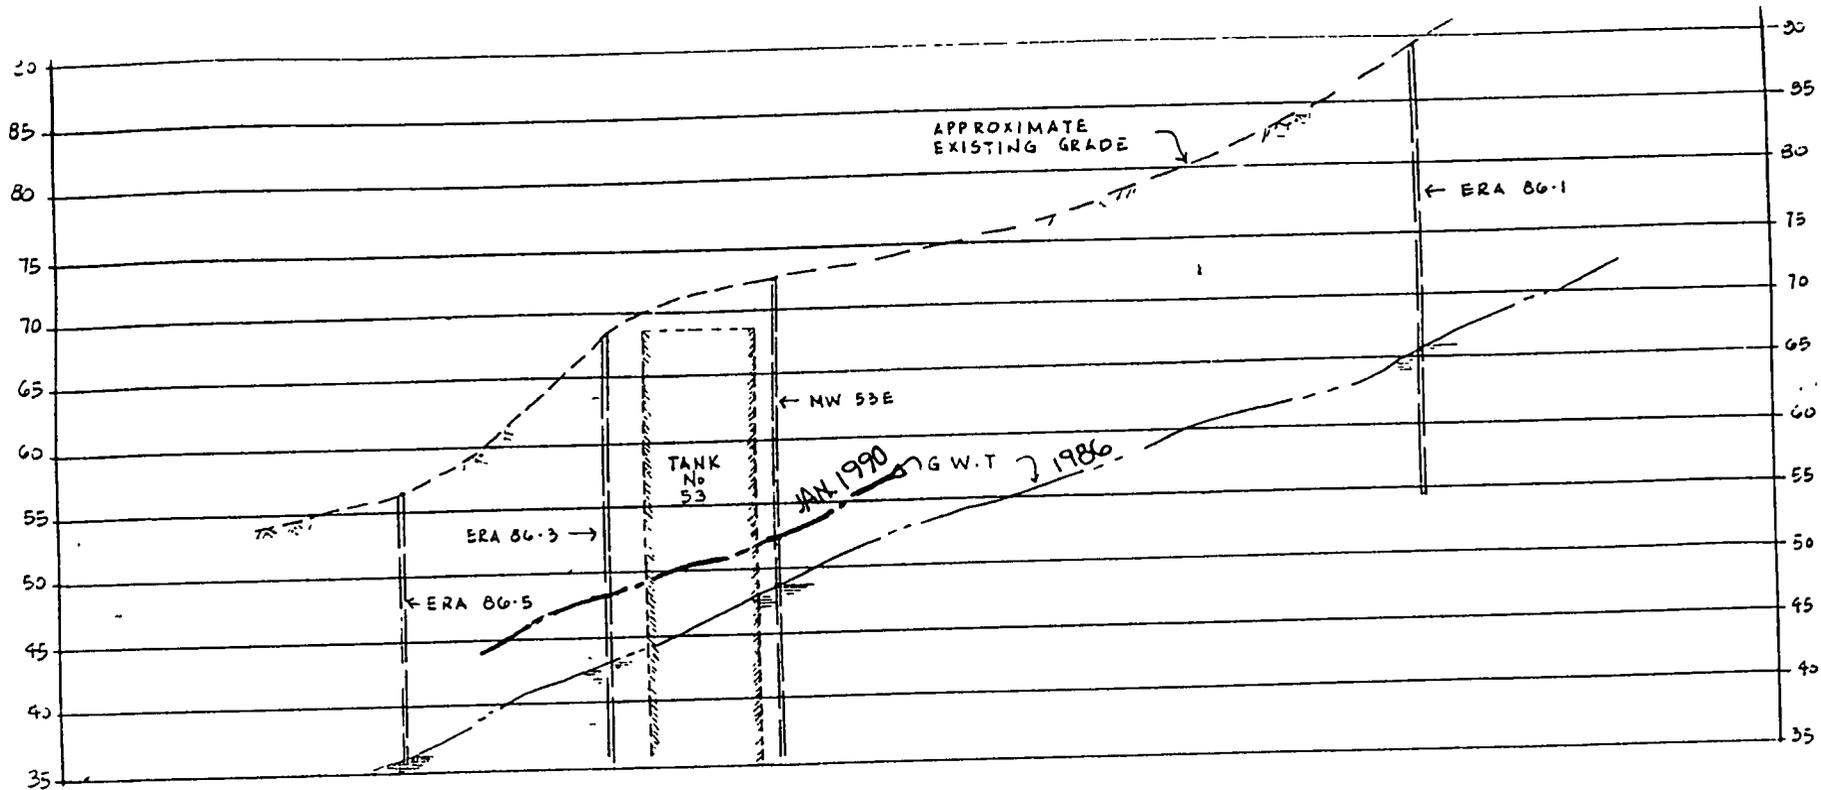
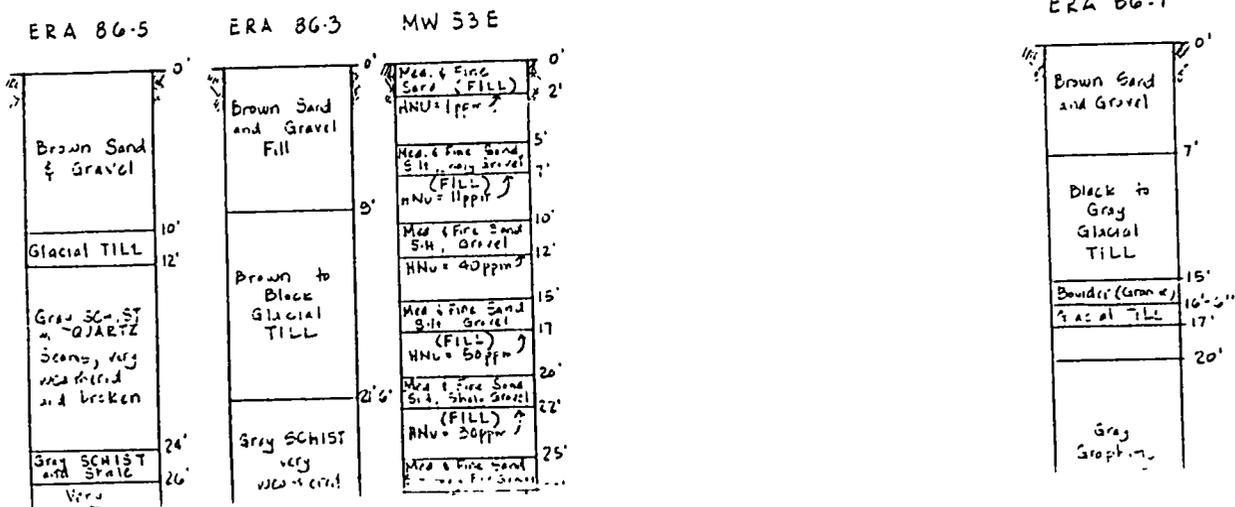
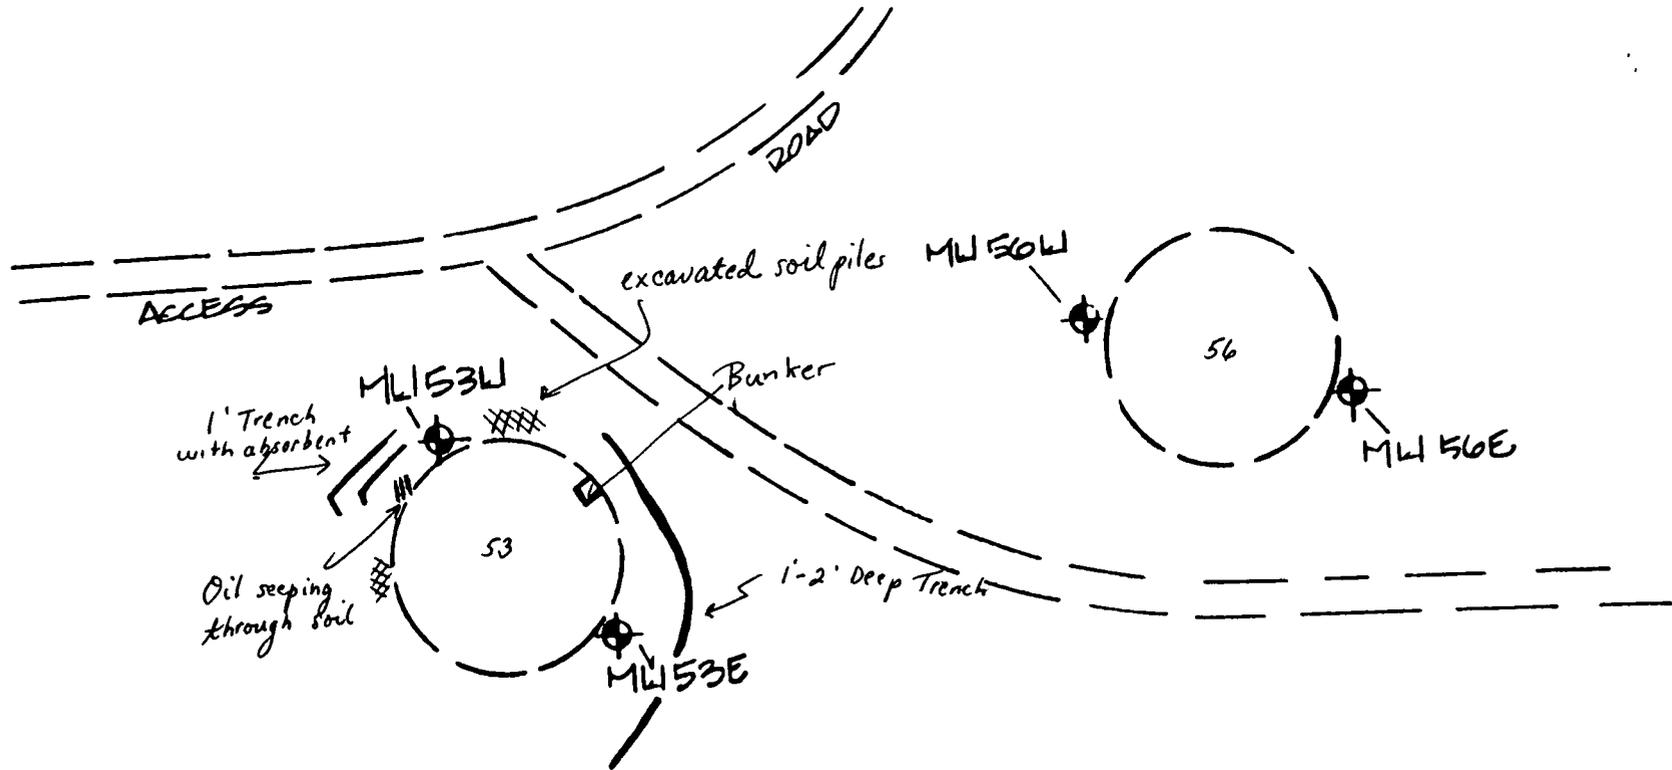
Oil Spill at Tank 53, TF 5

We suspect that the oil leak has resulted from water entering the tank from surface water passing through the shallow ground cover over the tank and entering the tank through joints at the 9 inch thick concrete roof. The oil displaced by the infiltration of water is escaping through the top. Groundwater table elevations are shown in the attached "Profile A-A". The difference in hydrostatic pressure between the groundwater and the oil pool at the tank wall indicates that infiltration is not due to the groundwater.

Nearby construction activity in Tank Farm 5 has probably affected the natural hydrogeology in the vicinity of Tank 53. The soil covering the northwest quadrant of the tank had been disturbed and the vegetation and top soil had been removed. Two mounds of excavated soil piled adjacent to the tank impounded surface water runoff and allowed it to accumulate on the tank, thus preventing

In order to control the escape of oil from the tank, the following emergency remedial measures have been taken and are shown in the attached Figure 1:

1. On January 30, an interceptor trench, 1 foot in depth, was excavated along the northwest perimeter of the tank and filled with absorbent materials to soak up residual oil on the surface.
2. On February 1, oil was pumped from inside the bunker into a waste oil truck. In addition, oil was pumped from inside the tank gauge opening to reduce the level within the tank. Another interceptor trench was excavated along the east side of the tank to divert surface water runoff.
3. One of the mounds of excavated soil is being removed from the vicinity of the tank to preclude surface water runoff from being impounded on the roof of the tank.
