**FINAL ACTION MEMORANDUM  
FOR  
QUAY WALL SITE - RESPONSE TO DISCHARGE OF PETROLEUM  
PRODUCT**

**U.S. NAVAL SUBMARINE BASE  
NEW LONDON  
GROTON, CONNECTICUT**

**COMPREHENSIVE LONG-TERM  
ENVIRONMENTAL ACTION - NAVY (CLEAN) CONTRACT**

**JANUARY, 1995**

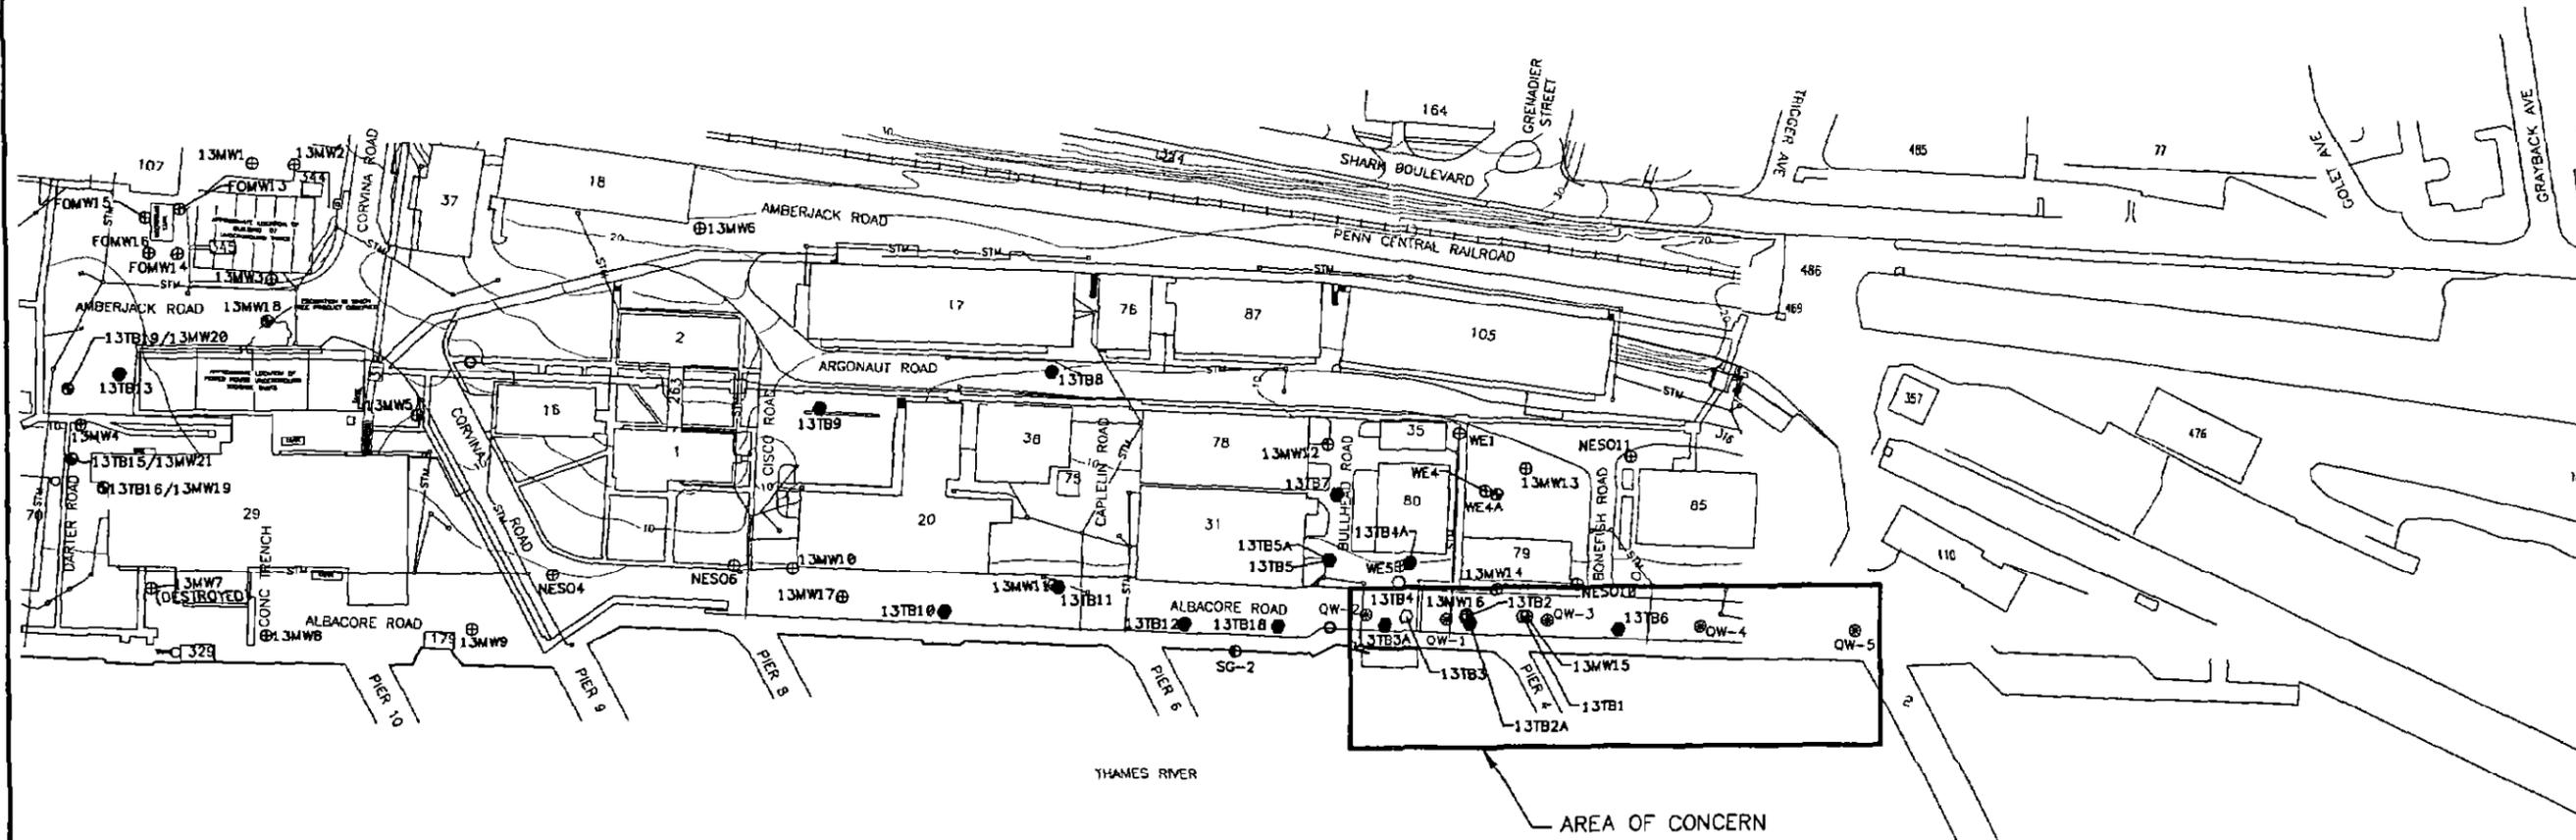
FIGURE A  
PLAN VIEW OF AREA OF CONCERN

The site is located at NSB, New London, Groton, Connecticut. It is situated on the Thames River between Pier 4 and Pier 6, southwest of Building 79. The surrounding land is primarily industrial buildings and piers used for maintenance of Navy vessels. The area surrounding Pier 4 is underlain by numerous underground utilities and utility access passages. A power plant with underground storage tanks is located northwest of Pier 4. Fuel transfer mains used up until the early 1980's are located approximately 150 feet east of Pier 4. Branch lines from the main are located throughout the area northeast of Pier 4 and southeast of the power station. A former waste oil pit was also located in Building 79. Figure A (included in the Attachment Section) provides a plan view of the area of concern at the base.

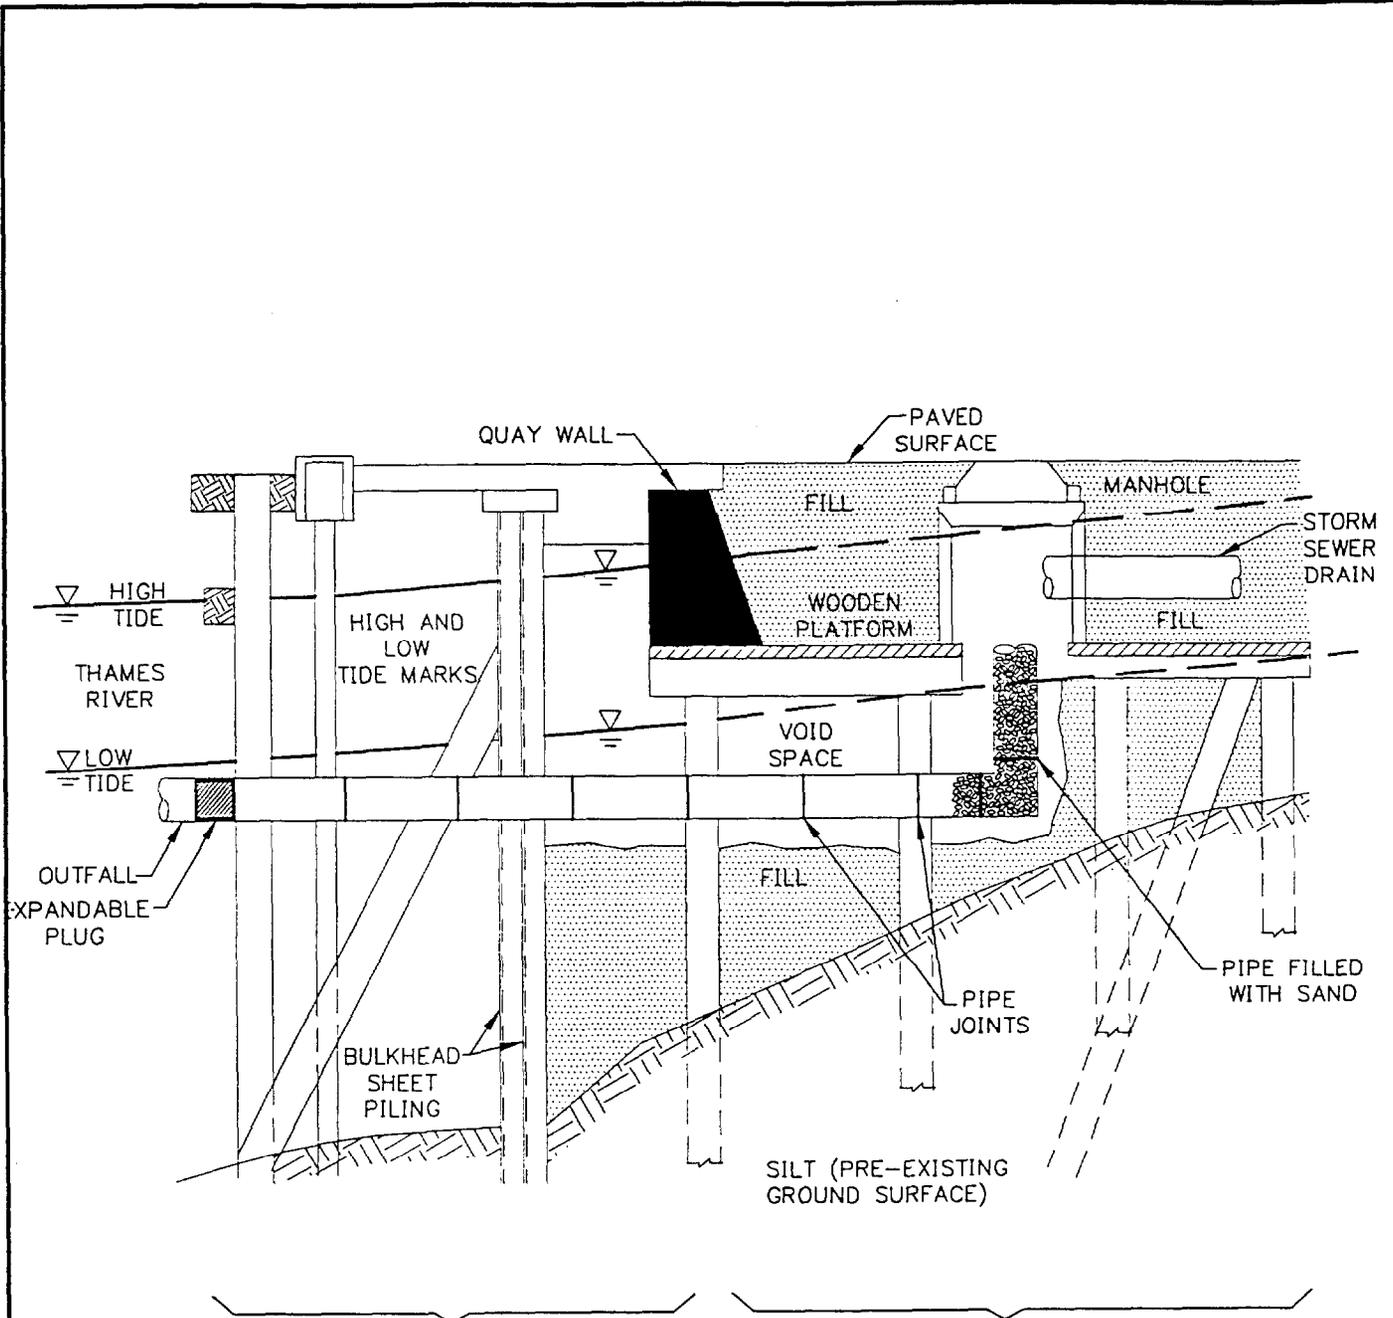
From the inspection of the area it was determined that the bulk of the product was present below the planking of the historical platform. A cross-section of the area is included in Figure B (attached). The wooden planking system was encountered at 6 to 8 feet below grade. Product was observed to be present in the void space below the wooden planking and in electrical manholes throughout the Lower Subbase. Additional activities were conducted at the site in December 1994 to prevent an additional release of petroleum to the river. These activities included installing 5 recovery wells along the water front near Building 79. These investigations confirmed that a void space is present under wooden pilings behind the bulk head sheet pilings and that oil is present in this area (see Figure B). Samples were collected of the sediment in this void space and were analyzed for numerous parameters to determine the compounds present in the petroleum material. Results of these samples are discussed in detail in the 'Proposed Quay Wall Investigation and Emergency Response' letter that was submitted to The State of Connecticut Department of Environmental Protection Agency on December 8, 1994.

Based on these investigations, the void space underlying the wooden planking is suspected to be source of oil which was released to the Thames River. Discussions with base personnel indicated that the oil present in the void space may enter the sewer pipe through joints or cracks. The portion of the storm sewer pipe in the manhole has been filled with sand to prevent the infiltration of oil into the top of the pipe. Low tides are suspected to cause a drop in the water level behind the quay wall, thereby allowing the oil to flow into the river through the storm sewer pipe via joints or cracks in the sewer pipe.

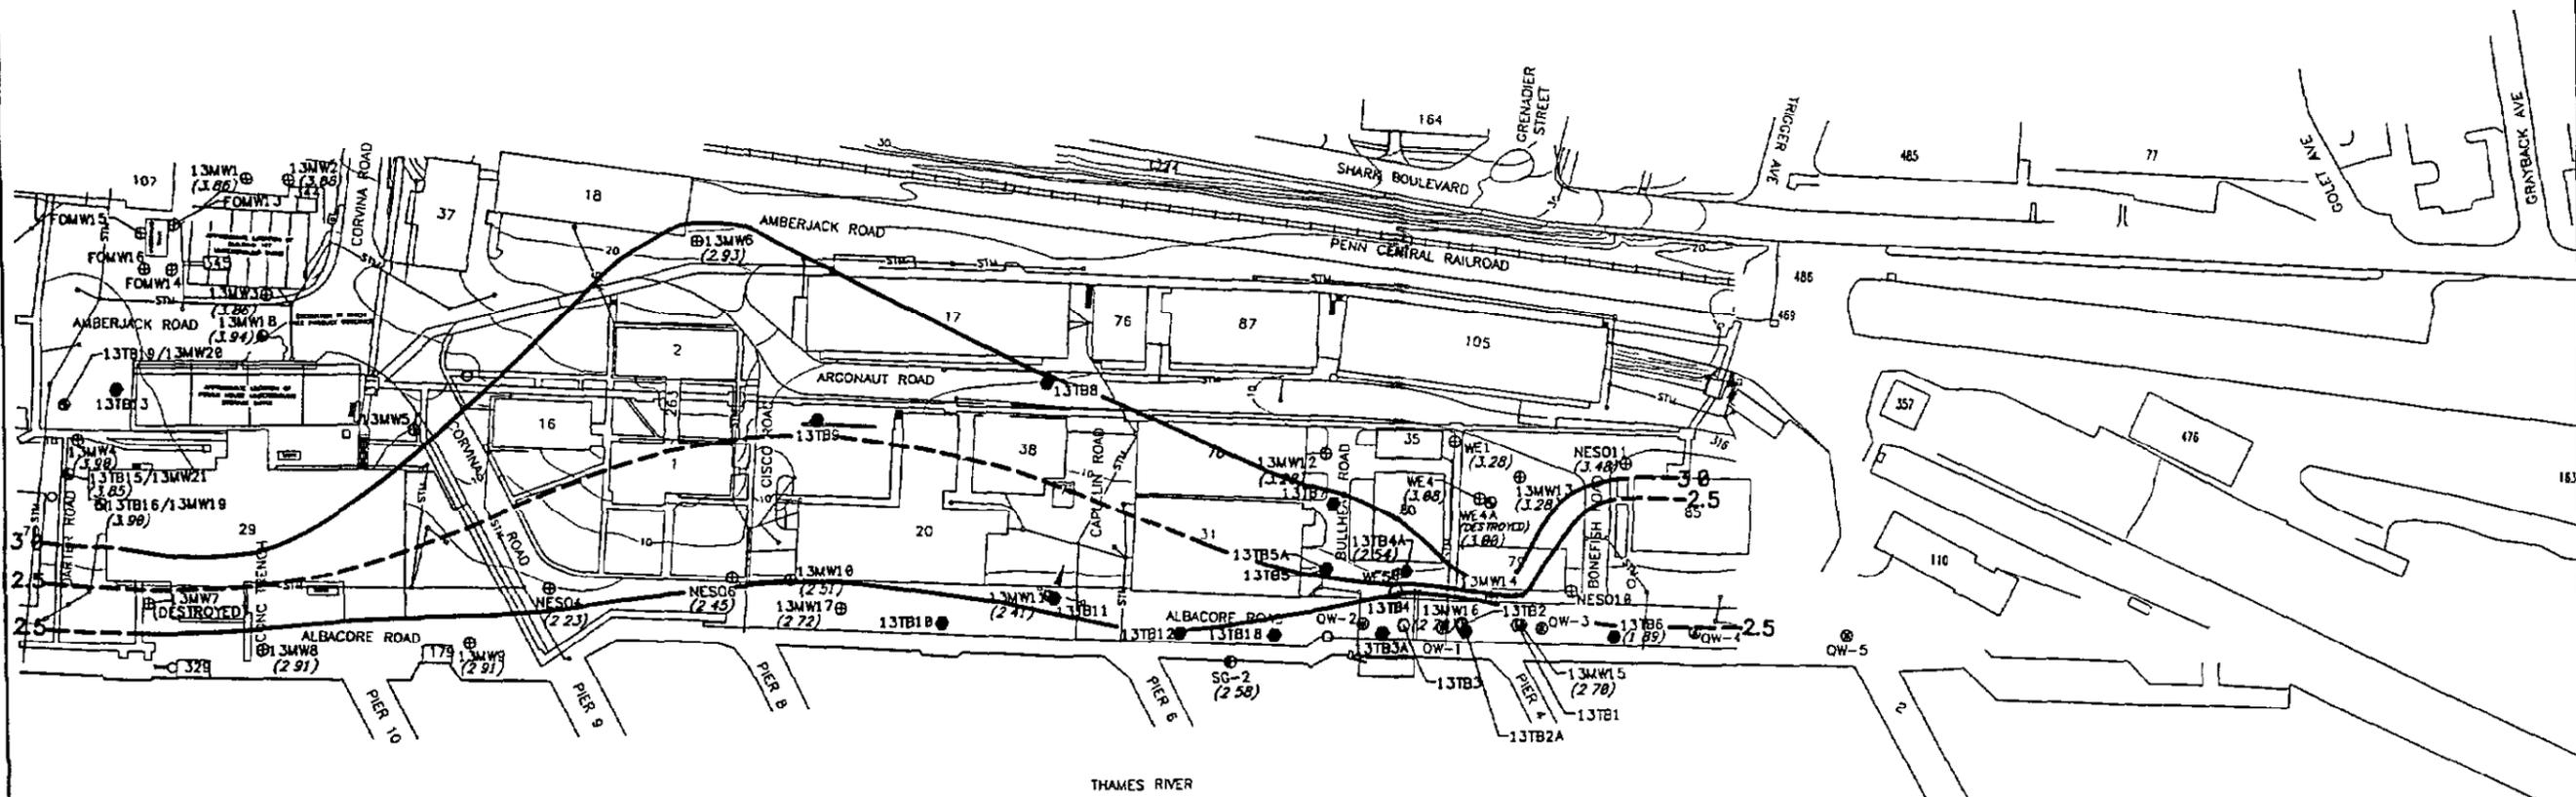
FIGURE C

The direction of groundwater flow in the area of the quay wall is toward the river. Groundwater elevation is influenced by tidal fluctuations. This influence increases as groundwater approaches the pier area. Typical groundwater flow directions are provided in Figure C (included in the Attachment Section).
