**Annual Landfill Inspection Report
for
Area A Landfill**

**Naval Submarine Base
New London
Groton, Connecticut**

October 2005

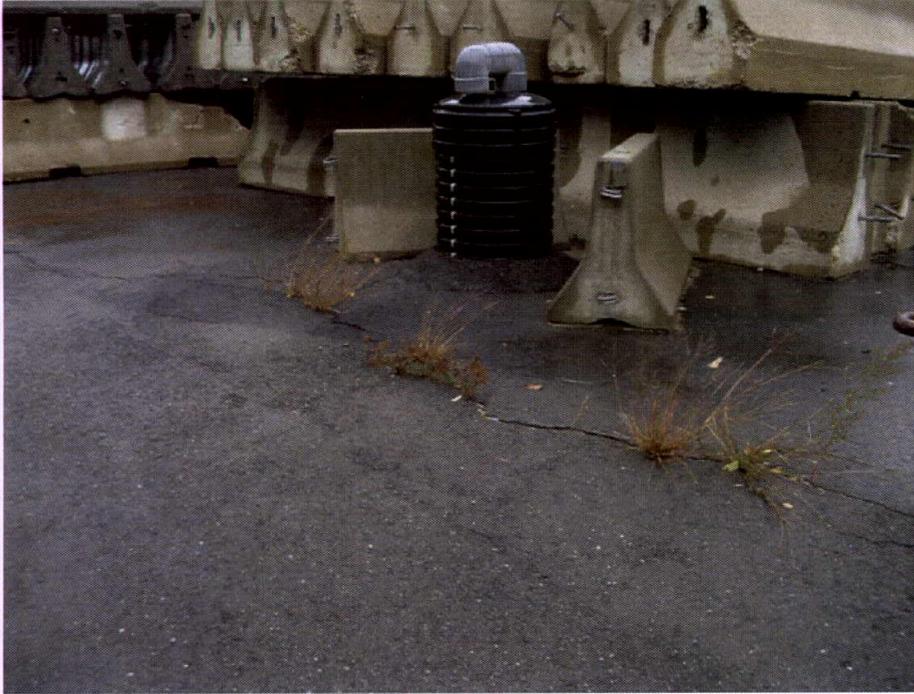
The asphalt pavement was found to be in fair condition with evidence of significant cracks. The cracks or separations are likely a result of thermal expansion and contraction and/or minor landfill settlement. Crack/separation thicknesses ranged from approximately 1/8-inch to 1/2-inch in width. Vegetation was observed to be growing in several of the cracks. No significant spauling of the pavement was evident; however, spauling will likely occur if the cracks are not sealed and repaired. The cracks also act as a conduit for water to infiltrate which will lead to additional damage of the pavement by freeze-thaw action. Damaged pavement was also observed in the areas where heavy equipment was stored without adequate protection for the asphalt cap. Bulges in the asphalt were observed in the Deployed Parking Area located in the eastern portion of the site.

Note that there was not evidence of significant landfill settlement (i.e., vertical separation at monitoring well road boxes); therefore, the cracks are likely a result of horizontal thermal expansion and contraction. Since asphalt pavement mixes are designed to be flexible and resist thermal expansion/contraction forces, an inferior asphalt mix and/or placement method may be the root cause of the joint separation/failure.

Cracks in pavement with vegetative growth.

Recommended corrective measures for the cap system include sealing the cracks in the asphalt pavement and increased housekeeping and maintenance measures (see Housekeeping and Maintenance). Crack sealing should be performed by an experienced asphalt repair contractor and, be completed in accordance with the State of Connecticut Highway Department specification

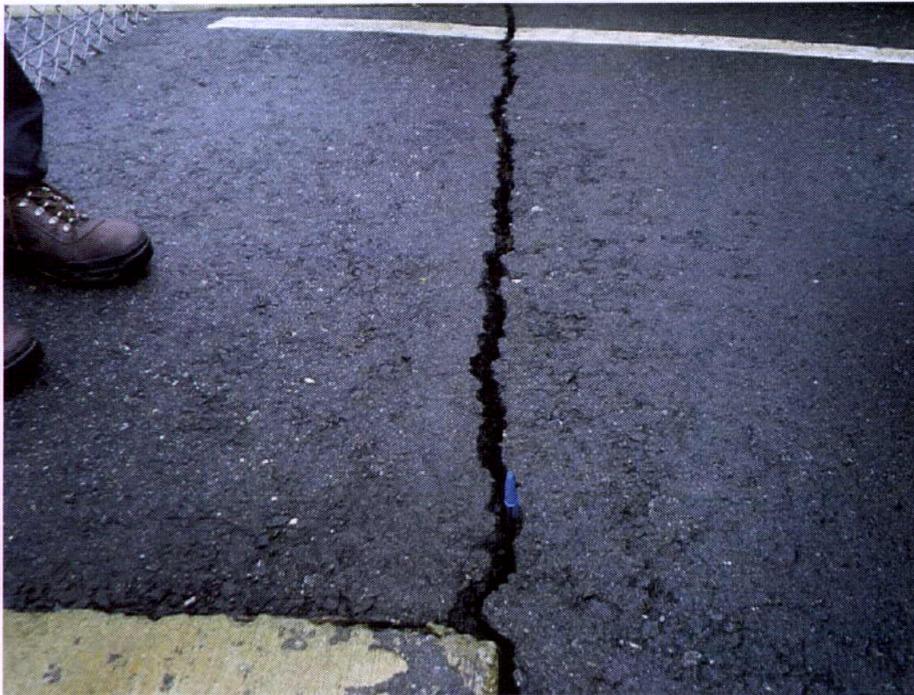
Cracked pavement in deployed parking area.

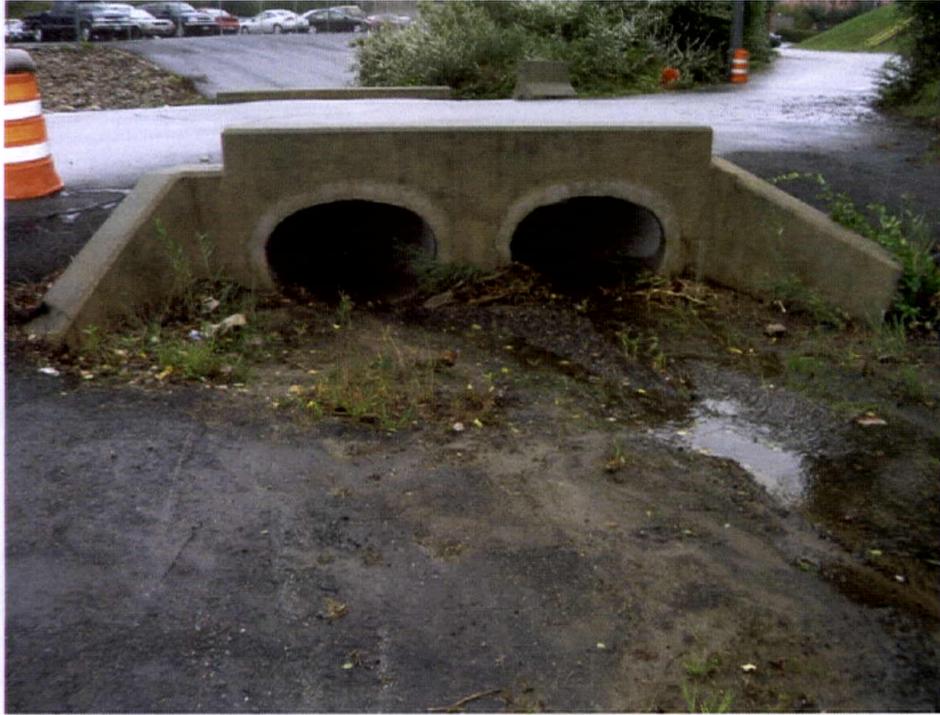
No deficiencies associated with the integrity of the channel were noted during the visual inspection. Significant amounts of sediment were observed in the northwest portion of Channel A and Channel C. The likely source of the sediment for Channel A is the adjacent slope that is not entirely stabilized with vegetation (see Landscaping Features). Debris, including sticks and leaf litter were identified in the channels as well. It was evident that the sediment and debris are restricting the water flow through the channels, that is, pooling of water was observed in some locations along these channels. Pooling of water was significant at the outlet of Culvert 2 where Channel C is full of sediment and roots.

i) Condition of Culvert 2 Headwall	<input checked="" type="checkbox"/>	<input type="checkbox"/>	<input checked="" type="checkbox"/>	<input type="checkbox"/>	Sediment build up needs regular maintenance

Sediment and vegetation build up at culvert No. 2 inlet.

Recommended corrective measures for the drainage channels include removal of all sediment, debris, and vegetation. Routine, periodic maintenance (i.e., quarterly) should also be implemented by base facility personnel to identify obstructions and remove them.

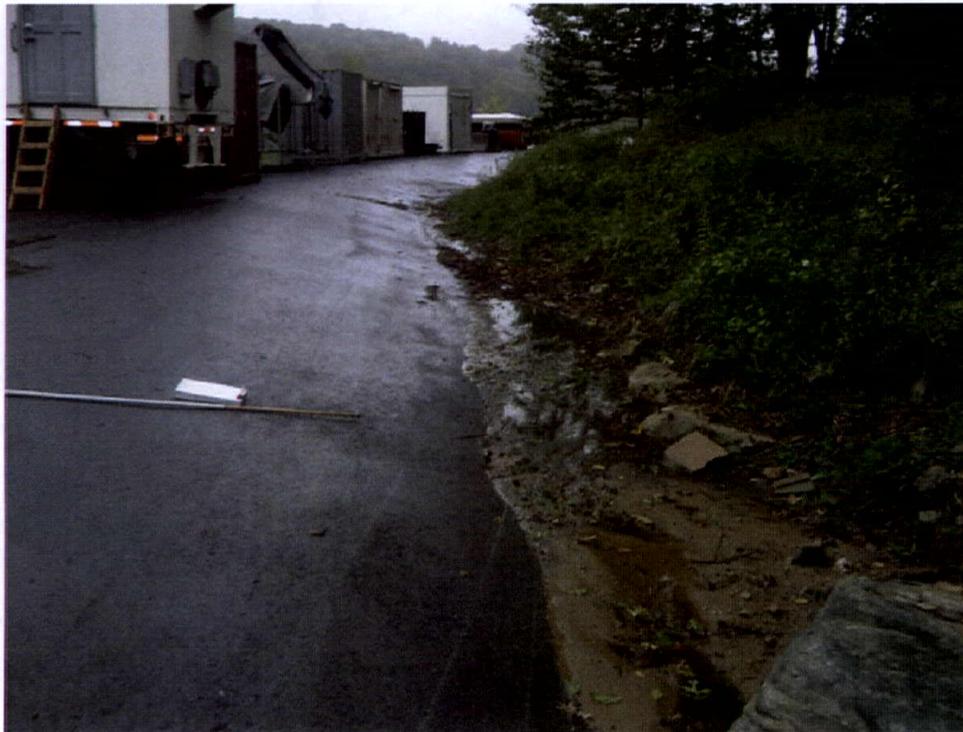
c) Siltation within Swale	<input checked="" type="checkbox"/>	<input type="checkbox"/>	<input type="checkbox"/>	<input checked="" type="checkbox"/>	Siltation noted needs to be addressed

Sediment build up in Channel A.

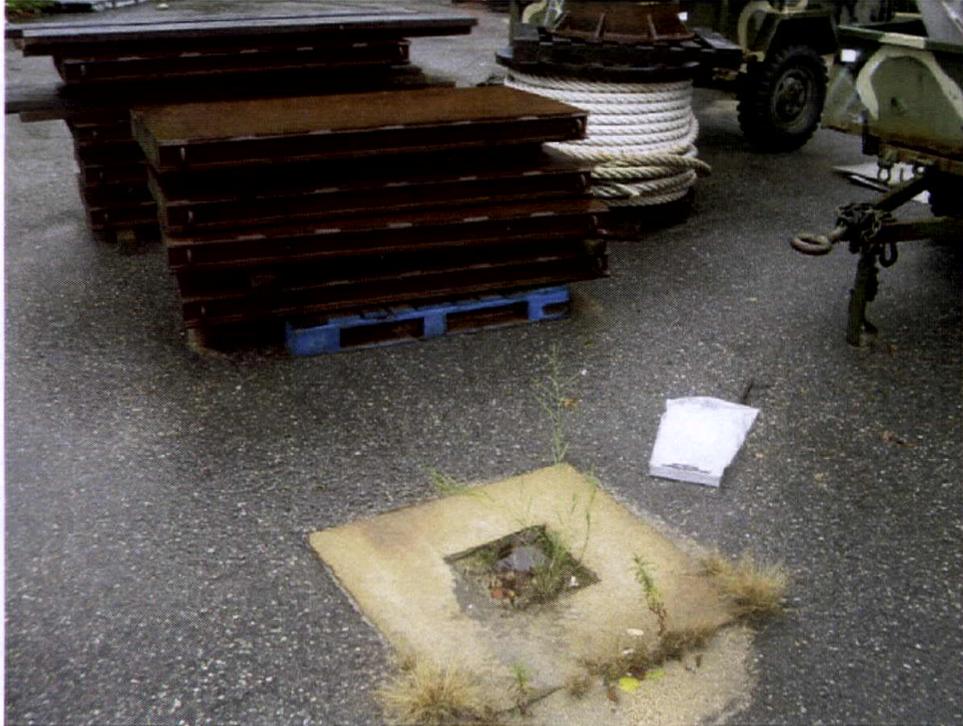
Fifty-three (53) groundwater monitoring wells are located within the vicinity of the Area A landfill. The surface area around many of the wells is in need of repair/maintenance. These items include broken concrete around well covers, sediment buildup on well covers, vegetation growing between the concrete-asphalt interface, missing well covers, and missing well cover bolts. It should also be noted that there were no bollards observed around any of the monitoring wells' protective standpipes. The bollards should be installed if deemed necessary or the item should be removed from the inspection checklist. During the inspection it was identified that many of the wells were not sampled during recent sampling events. If the monitoring wells are no longer required to be sampled they should be closed. Any monitoring wells that still require sampling should be repaired as necessary to maintain the integrity of the well.

Missing cover and damage to 2LMW8D.

Sediment and vegetation on and around the well covers should be removed. Cracks/separations at the concrete asphalt interface should be sealed to help prevent vegetative growth. Missing well covers and bolts should be replaced. Inspections will continue in upcoming sampling events and landfill inspections.

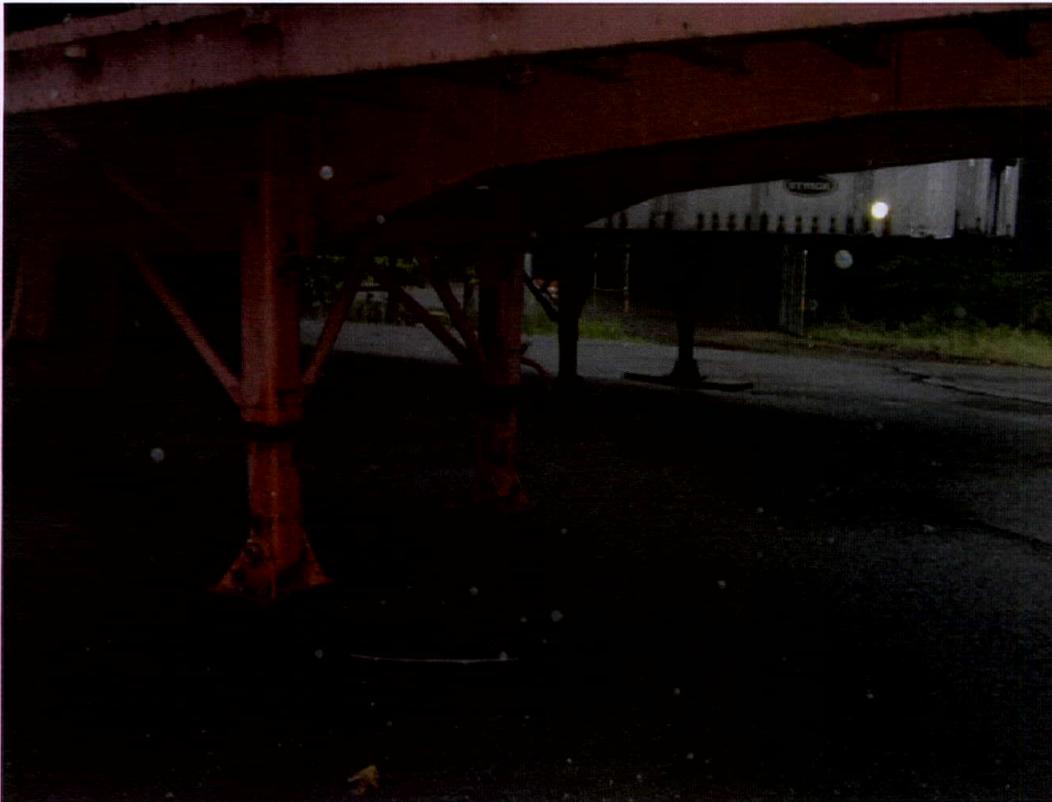
General housekeeping issues include the amounts of staged equipment and materials at the landfill. Some of the equipment and materials have not been staged in a systematic, orderly manner and protection of the asphalt cap is a concern. Trailer hitches and heavier equipment and materials should be placed onto protective surfaces (e.g., concrete blocks, steel plates, pallets, etc.) to prevent damage to the asphalt cap and subsurface cap system components (i.e., the gas collection and venting system and monitoring wells). Since there is relative unrestricted access by all users of the base, it is difficult to maintain a protocol for proper storage at the landfill.

Equipment stored without proper protection for the asphalt surface.

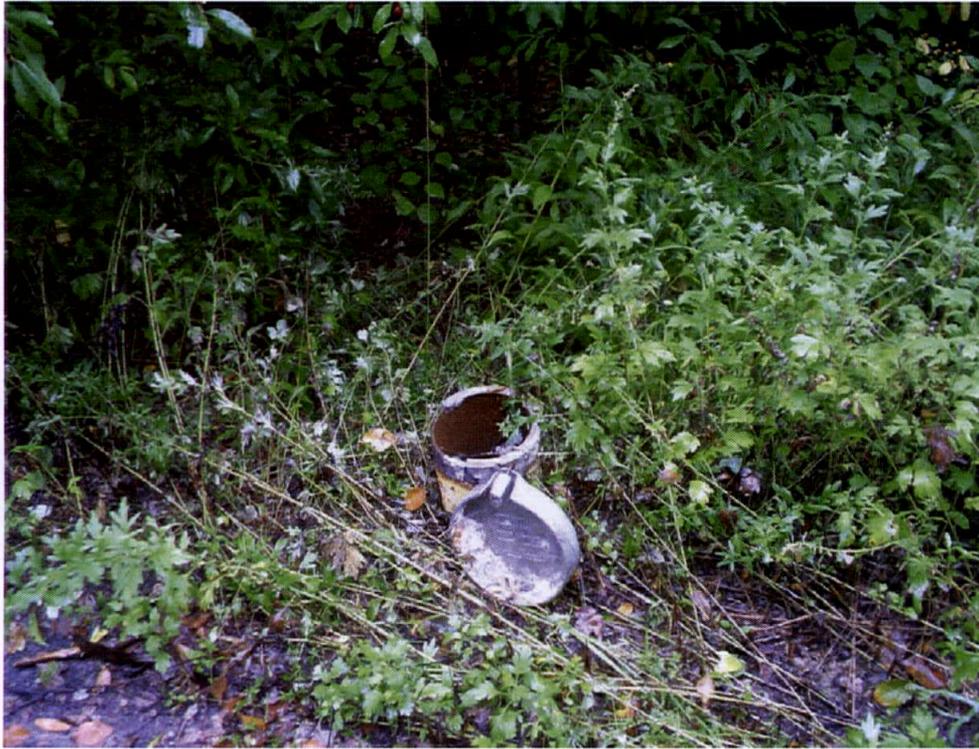
2MW21S broken cap, well exposed to elements.

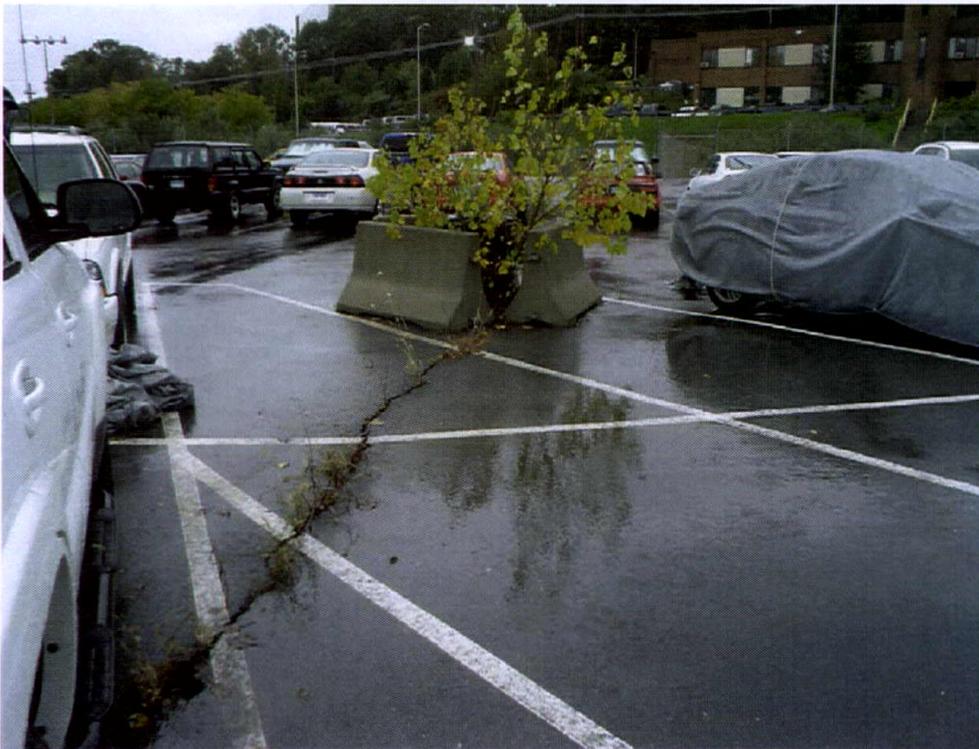
noted on any of the gas vents. Screens are recommended to be installed for every gas vent. Additionally near some gas vents cracks were noted in the asphalt with vegetation growing in the crack. Gas vent GVR-1 and GVR-11 need an additional jersey barrier for protection.

Vegetation growing through asphalt near GVR-27.

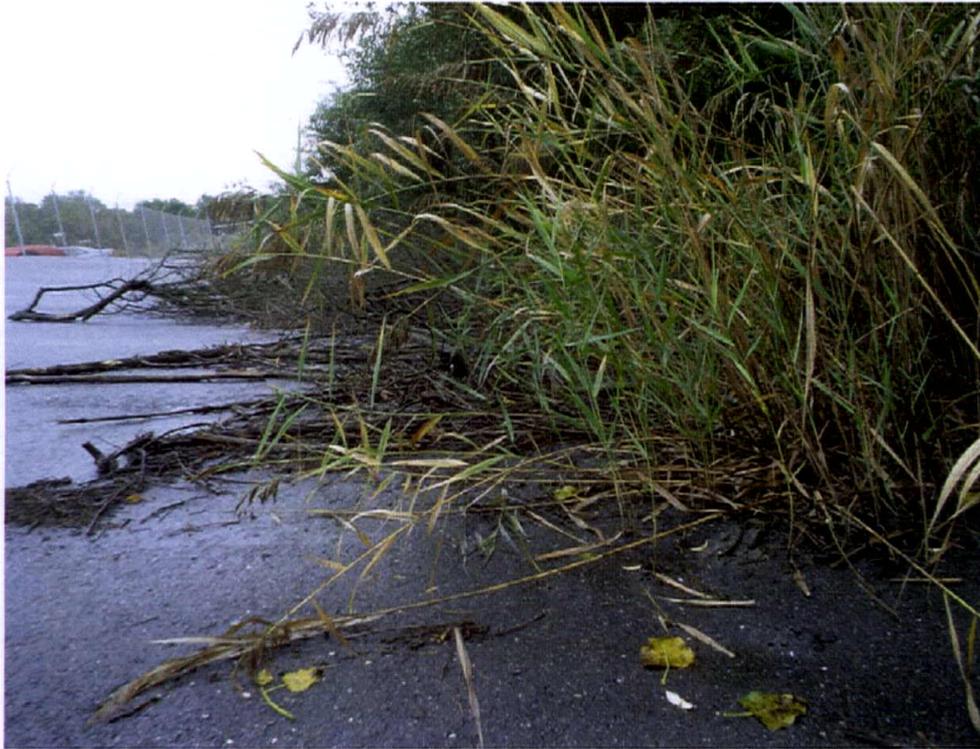
Vegetation was also observed growing in the sediment deposits in the channels. Fragmites were observed growing through the asphalt in Channel B. Additionally, vegetative intrusion in Channel B and D obscured the asphalt channels. If the obstructions and vegetation are not periodically removed and continue to accumulate/grow thereby restricting flow and creating pooling conditions, degradation of the asphalt lining (e.g., cracking, spalling, depression, etc.) and erosion at adjacent vegetated areas may occur.

d) Invasive Vegetation within Swale	<input checked="" type="checkbox"/>	<input type="checkbox"/>	<input type="checkbox"/>	<input checked="" type="checkbox"/>	Vegetation noted growing through pavement

Vegetation growing through Channel B.

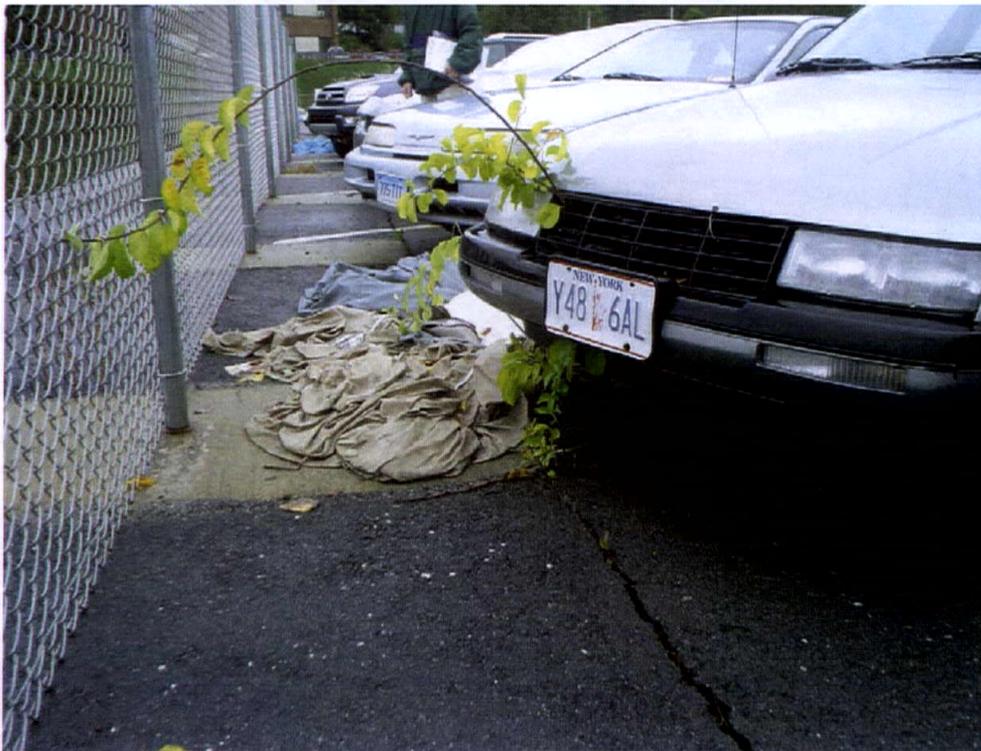
c) Cracks in Pavement	<input checked="" type="checkbox"/>	<input type="checkbox"/>	<input type="checkbox"/>	<input checked="" type="checkbox"/>	Cracks on slope behind barriers and in deployed parking area Vegetation growing in the cracks

Vegetation growing through crack in asphalt in deployed parking area.
