**Annual Landfill Inspection Report  
Defense Reutilization and Marketing Office  
(DRMO) – Year 2004**

**Naval Submarine Base  
New London  
Groton, Connecticut**

**Engineering Field Activity, Northeast  
Naval Facilities Engineering Command**

September 2005

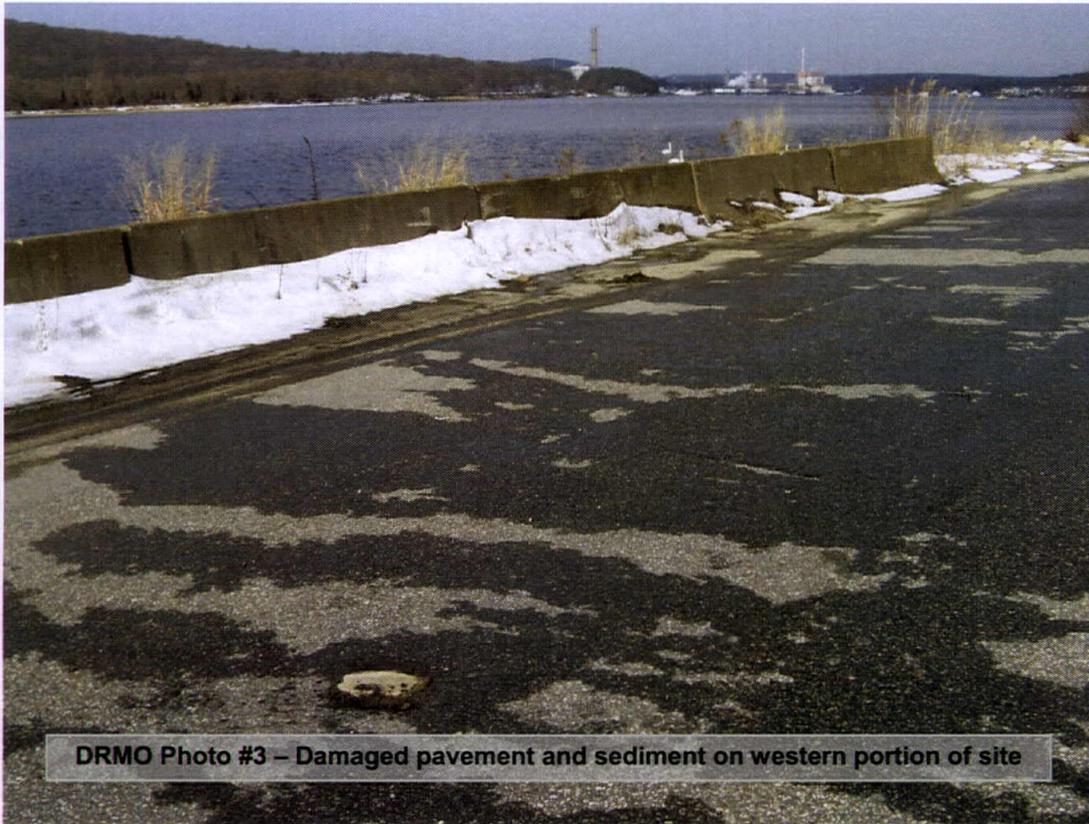
The asphalt grade appeared to be relatively level and consistent. A buildup of sediment was observed along the northwestern portion of the site during both inspections. This sediment build up is most likely associated with ponding (i.e., standing water).

The asphalt pavement within the cap limit was found to be in good condition. Some surficial scaring of asphalt has occurred and some minor cracks were observed but no holes penetrating the asphalt were observed during either inspection. A small area of damaged pavement was observed along the western boundary of the site. Depressions in the pavement were observed around 6MW11S and 6MW11D. Both these areas should be repaired. No exposed cap components were observed during either inspection.

**DRMO Photo #3 – Damaged pavement and sediment on western portion of site**

Recommended corrective measures for the cap system include improvement of drainage through west perimeter jersey barriers to prevent sediment and water buildup, sealing the cracks and repair along with continued monitoring of the depressions around 6MW11S and 6MW11D. It was assessed during supplemental inspection activities that these corrective actions could be addressed along with operation and maintenance activities during 2005. Please see the attached Corrective Action Plan (Appendix A) for more information on the corrective measures and their scheduled dates.

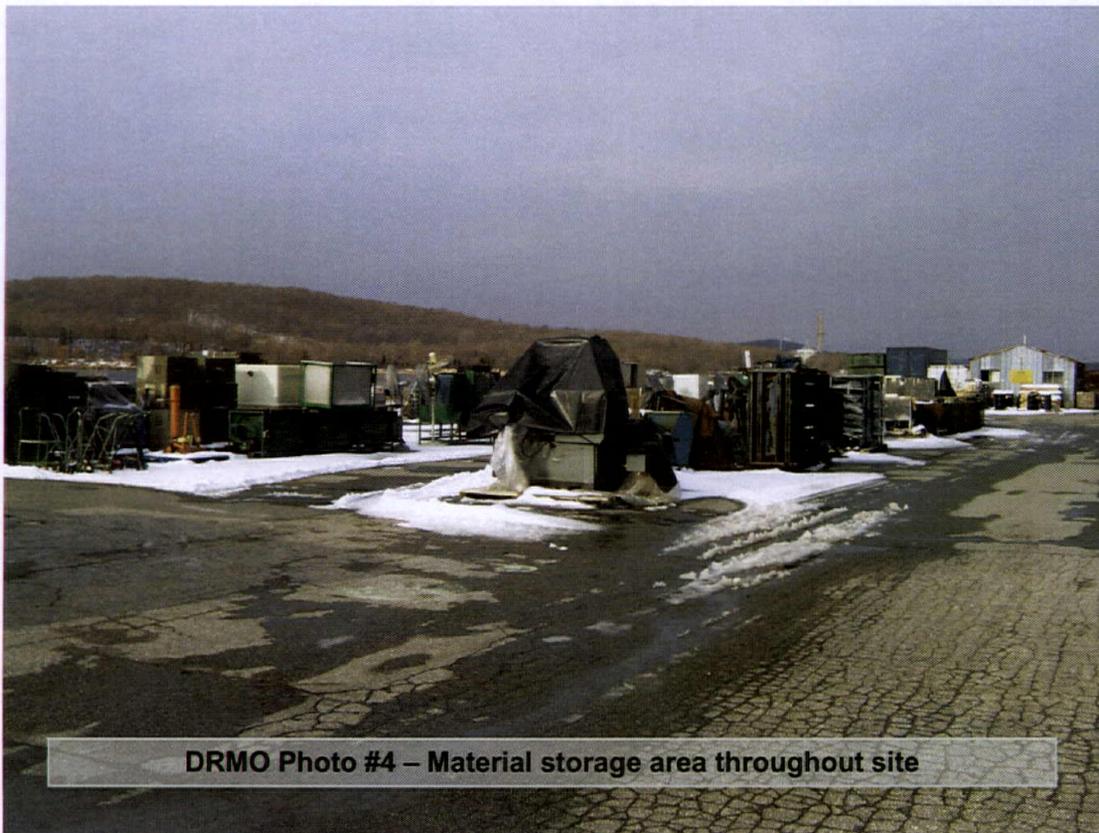
**DRMO Photo #4 – Material storage area throughout site**

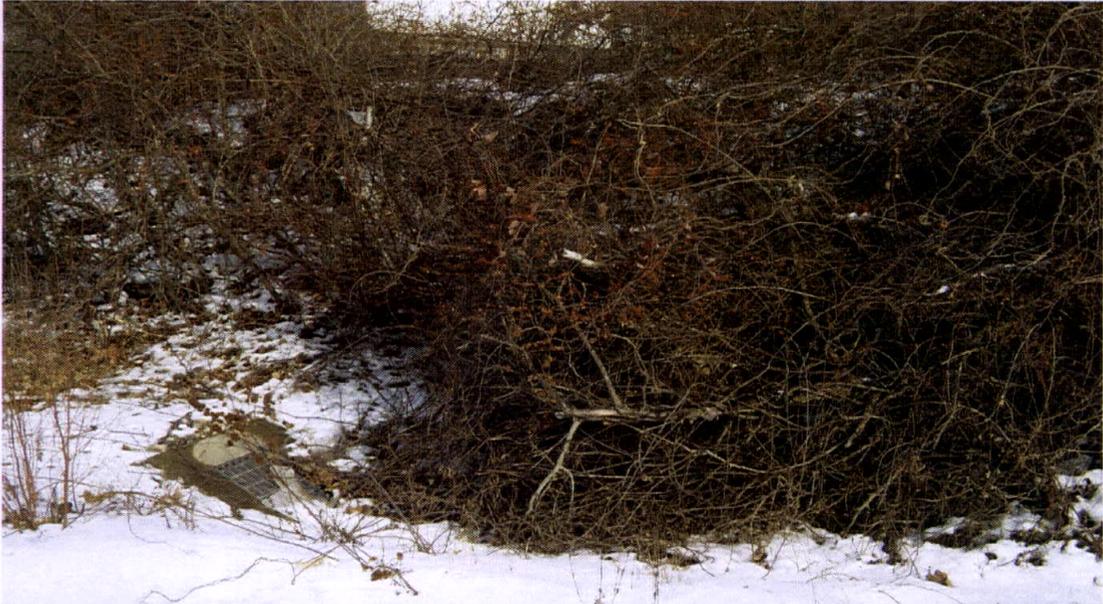
**DRMO Photo #5 – Brush pile in drainage swale in vicinity of drop inlet on northern portion of site**

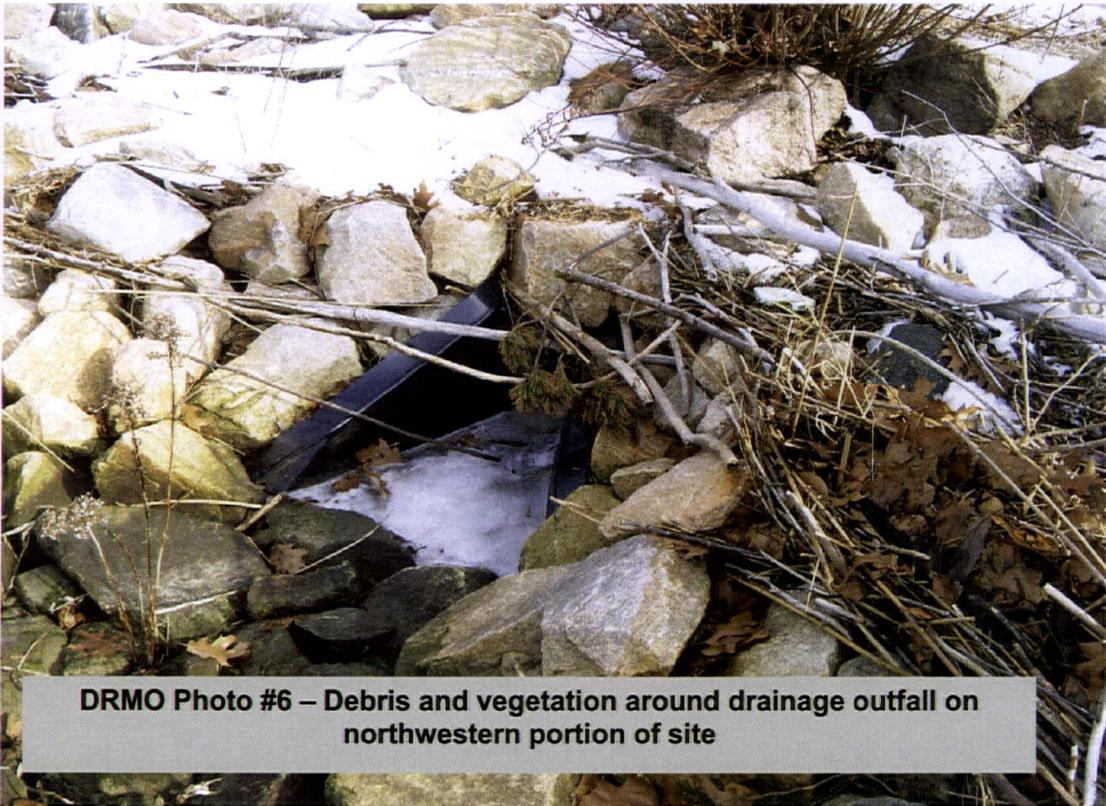
**DRMO Photo #6 – Debris and vegetation around drainage outfall on northwestern portion of site**

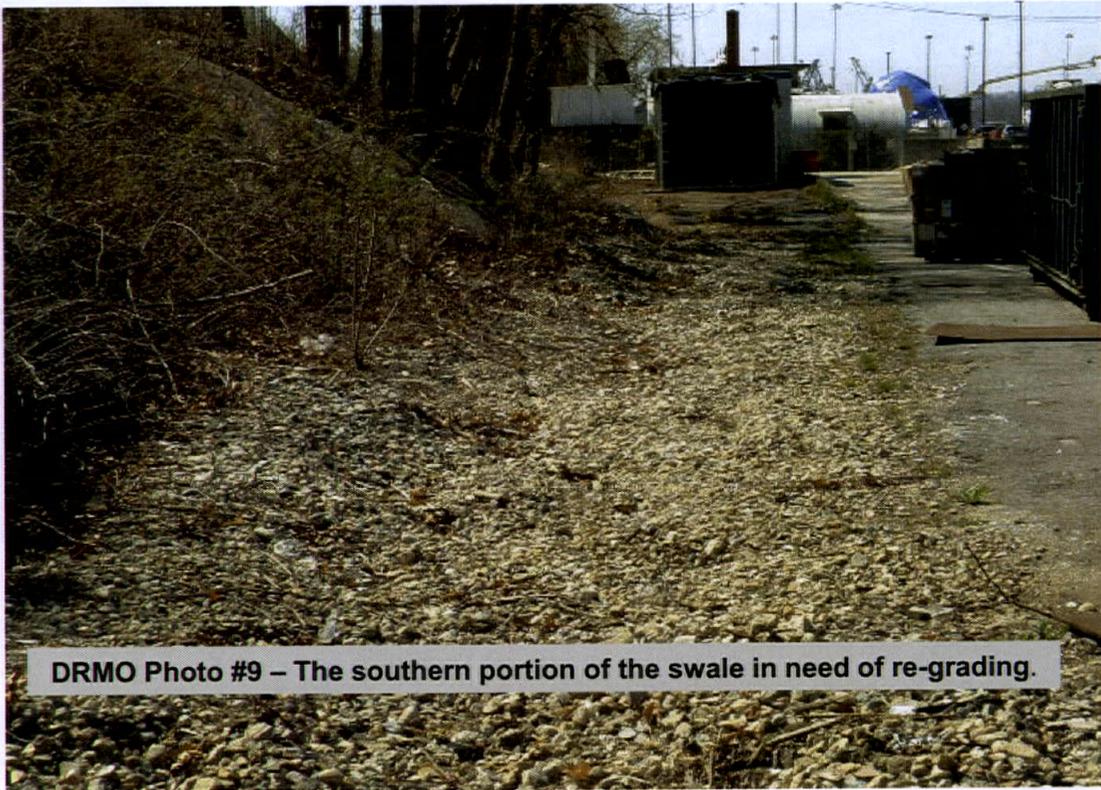
The stone lined drainage swale located at the eastern perimeter of the site was inspected and found to be in generally good condition. However, a small portion at the southern end of the swale is need of regarding to maintain proper drainage. No accumulated sediment was observed in the swale. Some leaf litter and loose brush was observed in the swale and should be removed. During the 26 April 2005 supplemental inspection, the catch basin was observed to have buildup up of leaf litter in the bottom. During the inspections, northern portions of the swale were covered with dense

**DRMO Photo #9 – The southern portion of the swale in need of re-grading.**

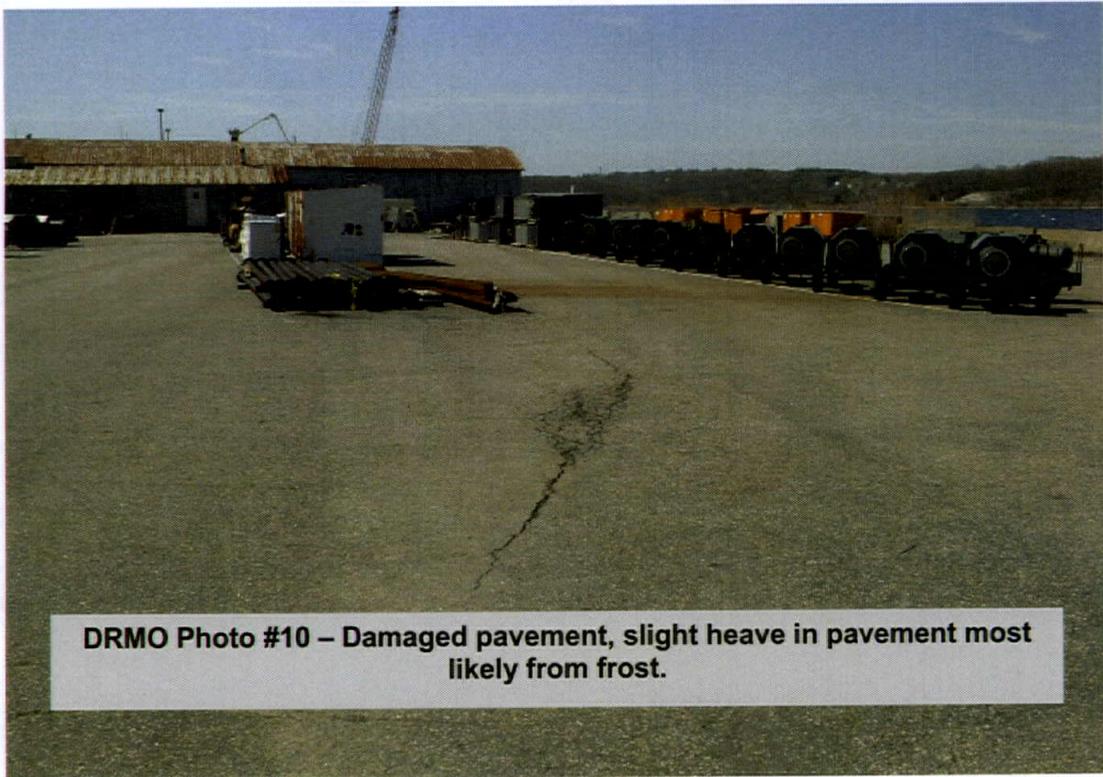
**DRMO Photo #10 – Damaged pavement, slight heave in pavement most likely from frost.**

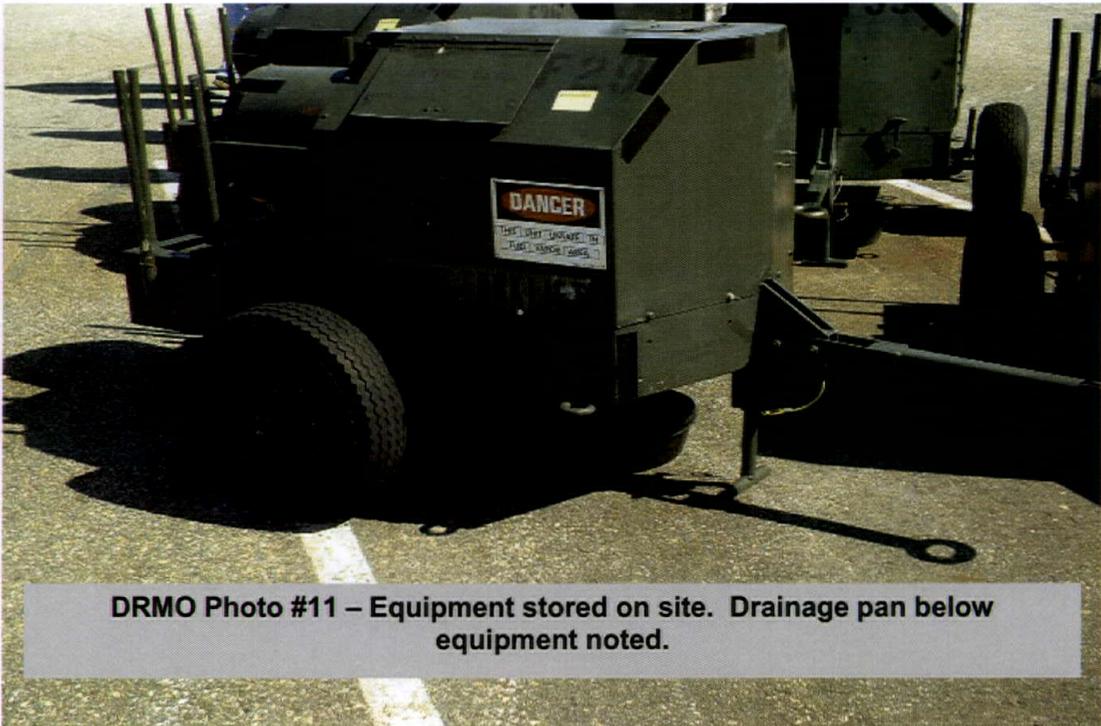
**DRMO Photo #11 – Equipment stored on site. Drainage pan below equipment noted.**
