**Annual Landfill Inspection Report
Defense Reutilization and Marketing Office
(DRMO)**

**Naval Submarine Base
New London
Groton, Connecticut**

OCTOBER 2005

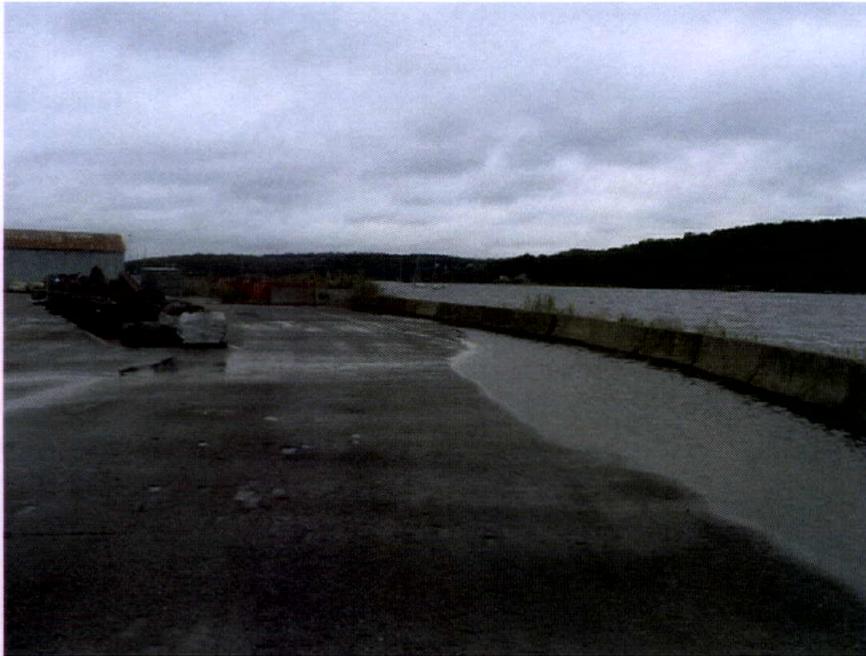
The asphalt grade appeared to be relatively level and consistent. Surface runoff was observed to flow westerly toward the River. Standing water was observed along the western portion of the site, parallel to the jersey barriers during the inspection.

g) Standing Water - other than above (b)	<input checked="" type="checkbox"/>	<input type="checkbox"/>	<input type="checkbox"/>	<input checked="" type="checkbox"/>	Puddle over repaired crack in pavement and along length of concrete barrier Puddle along jersey barriers

A view of the standing water along the jersey barriers.

Recommended corrective measures for the cap system include improvement of drainage through west perimeter jersey barriers to prevent sediment and water buildup and continued monitoring of the depressions around the jersey barriers. Cracks should

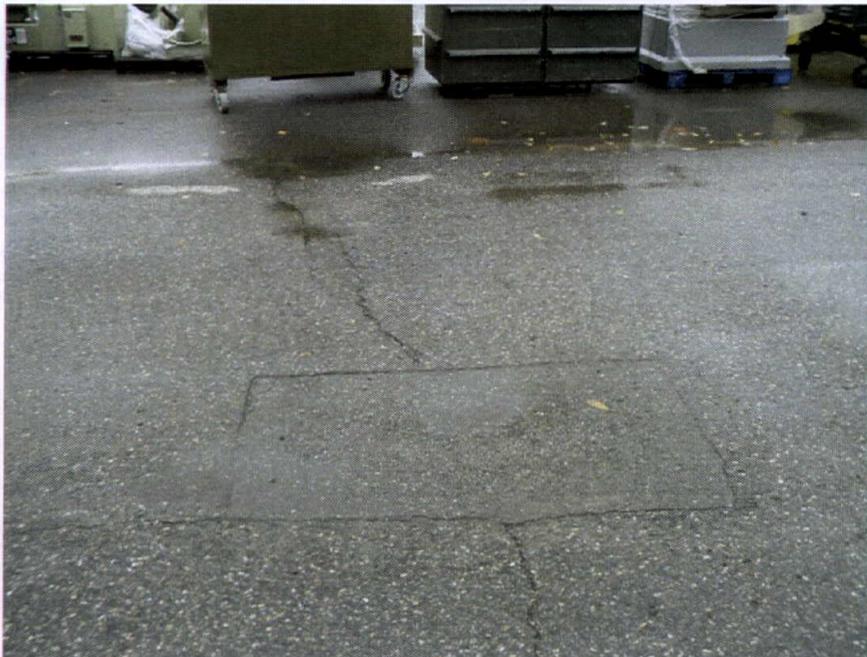
c) Cracks in Pavement	<input checked="" type="checkbox"/>	<input type="checkbox"/>	<input type="checkbox"/>	<input checked="" type="checkbox"/>	Minor cracks observed in cap area

A view of cracks in the asphalt cap's surface.

also be sealed as part of a routine maintenance plan. It was assessed during inspection activities that these corrective actions were not time critical and could be addressed along with operation and maintenance activities during 2006.

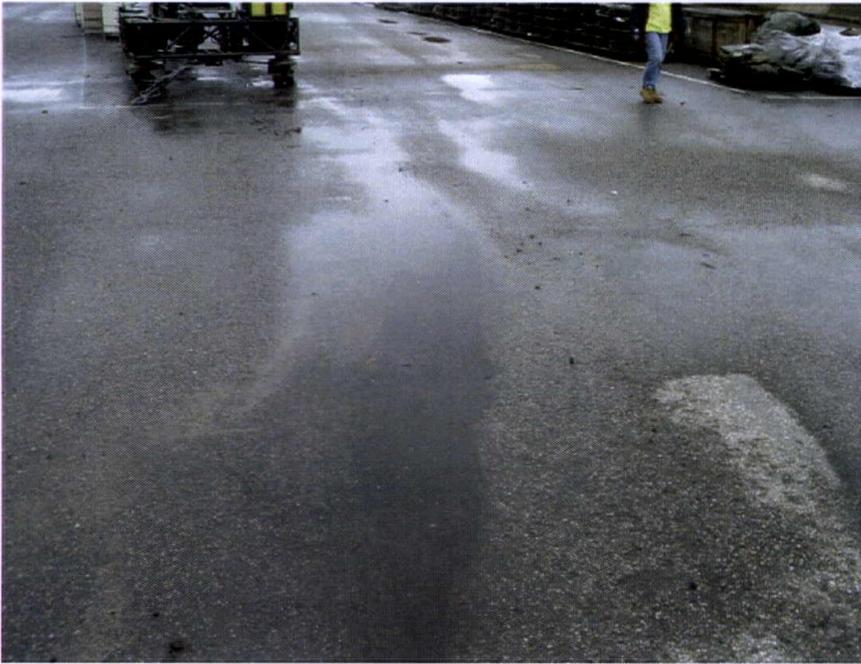
A view of a recently sealed crack in the asphalt surface under standing water.

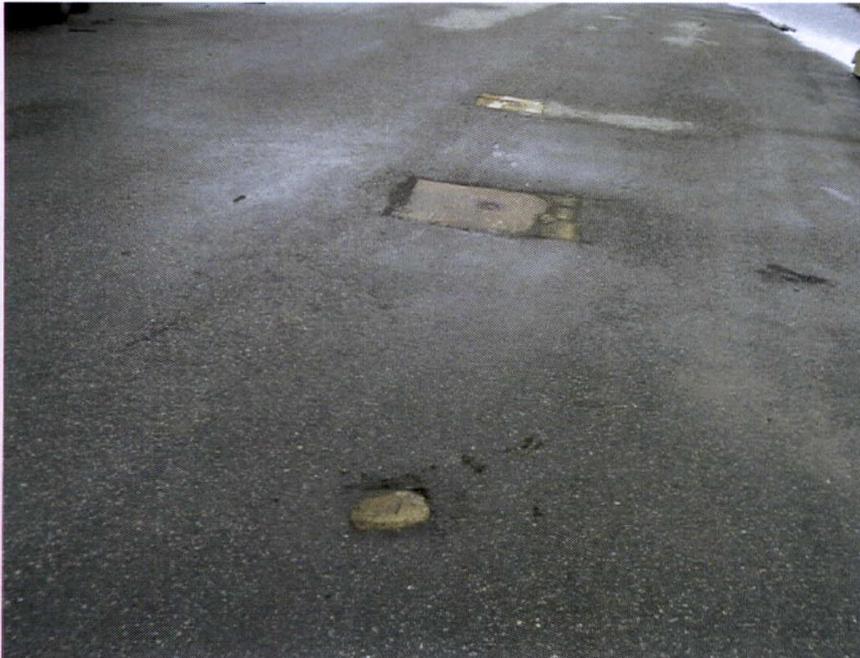
b) Condition of Flush Mount Well Cover	■	□	■	□	None
c) Condition of Well Lock	■	□	■	□	Reportedly no lock
21) 6MW10D					
a) Condition of Surface Surrounding Well Cover	■	□	□	■	Damaged concrete

A view of the piece of concrete embedded in the asphalt cap proximal to 6MW10D with damaged concrete (back ground).

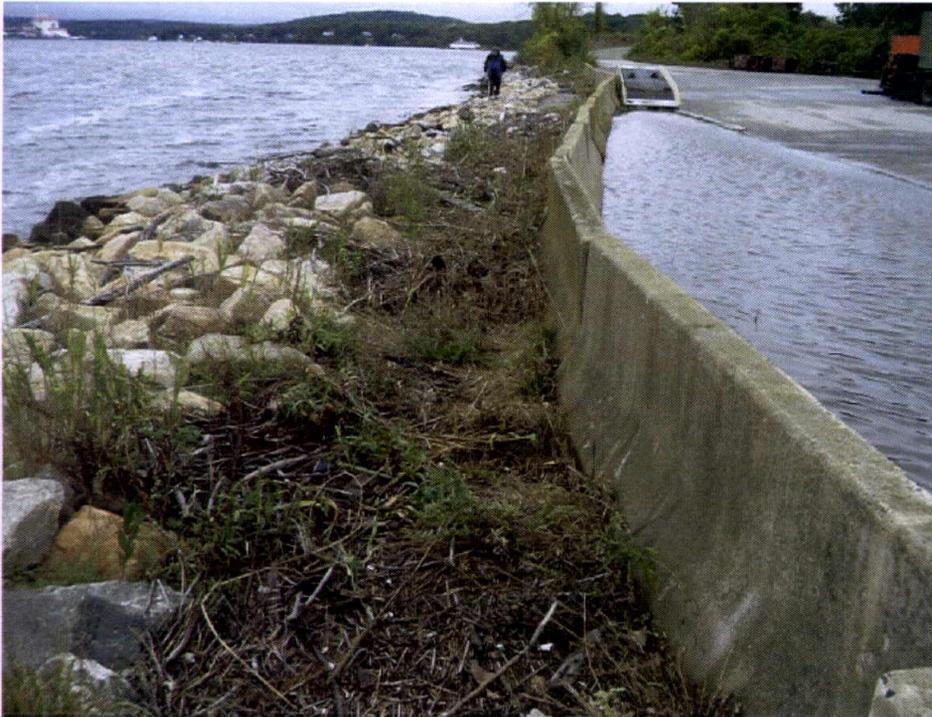
The shore-line rip-rap protection along the Thames River was in good condition and no indications of erosion were evident at culvert outfall area. Vegetation including fragmites was observed growing in the rip-rap.

6) Thames River Riprap					
a) General Condition of Riprap Protection	<input checked="" type="checkbox"/>	<input type="checkbox"/>	<input checked="" type="checkbox"/>	<input type="checkbox"/>	Fragmites growing along gravel river side of jersey barriers
MONITORING WELLS

A view of the vegetation growing in the rip-rap.

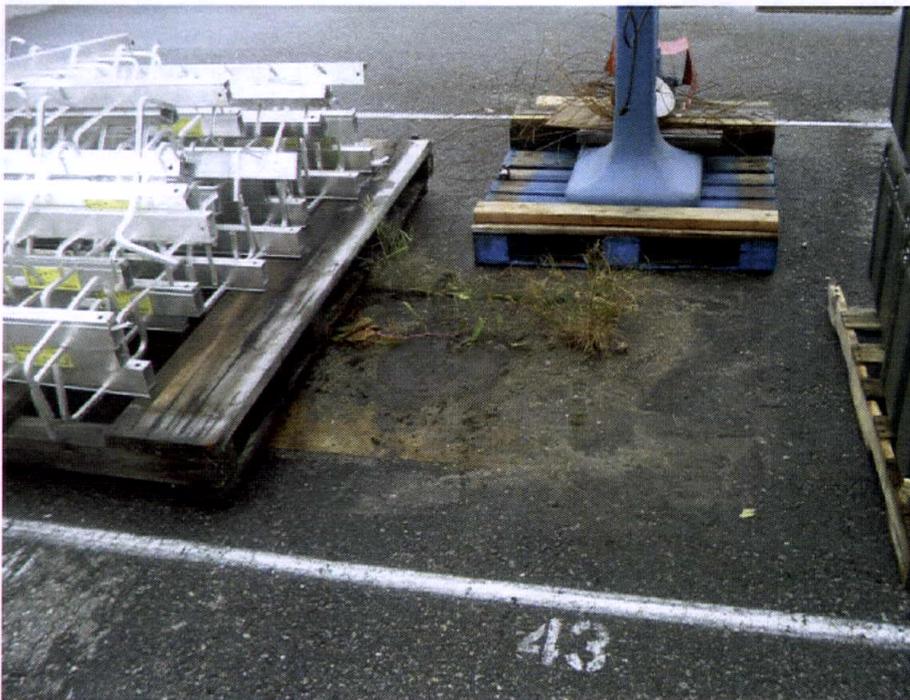
AREA OF INSPECTION	INSPECTED	DOES NOT APPLY	REPAIRS/MAINTENANCE NOT RECOMMENDED	REPAIRS/MAINTENANCE RECOMMENDED	NOTES AND COMMENTS
18) 6MW8S					
a) Condition of Surface Surrounding Well Cover	■	□	□	■	Well was located under stored equipment. Sediment build up noted on surface that should be cleaned off.

6MW8S sediment build up on and around monitoring well cover.
