TECHNICAL MEMORANDUM FOR EXPANDED SITE INSPECTION RESULTS FOR MORTAR
IMPACT AREA DAM NECK ANNEX NAS OCEANA VA
11/5/2012
CH2MHILL

Mortar Impact Area
Naval Air Station (NAS) Oceana Dam Neck Annex
Virginia Beach, Virginia

Expanded Site Inspection Results for the Mortar Impact Area Dam Neck Annex - Naval Air Station Oceana, Virginia

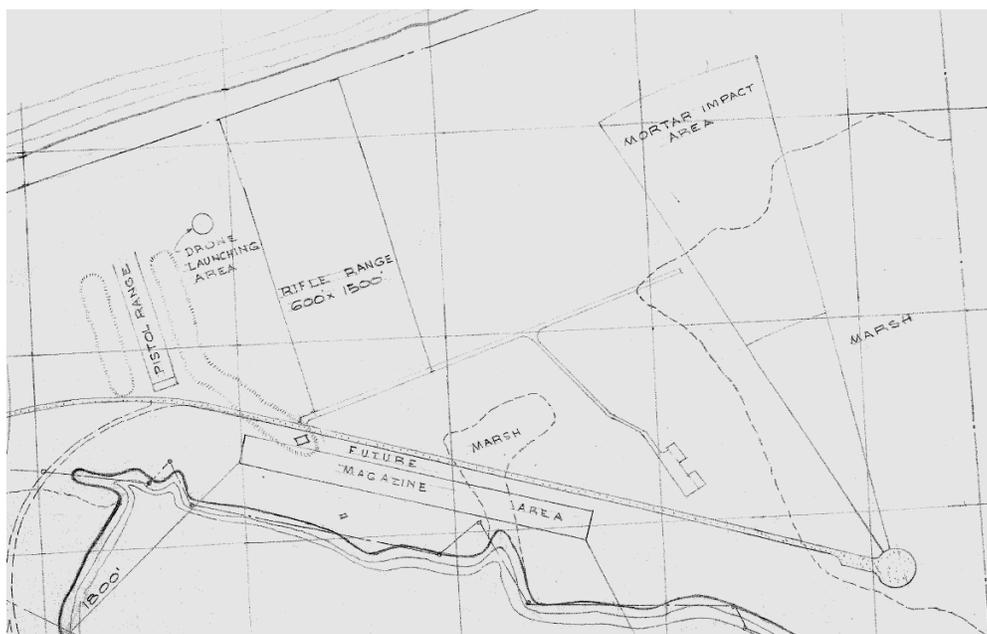
FIGURE 4
 1950 FADTC Dam Neck Proposed Station Layout Schematic, Dam Neck, Virginia
 showing Mortar Impact Area, Rifle Range, and Pistol Range

The MIA was identified on an archival schematic dated 1950. The source of the schematic (shown below) is the Foreign Affairs Defense and Trade Select Committee (FADTC) and as the title indicates it is a proposed station layout schematic for the Mortar Impact Area, Rifle Range, and Pistol Range at Dam Neck, Virginia. (Malcolm Pirnie, 2008)

Aerial photographic analysis conducted on aerial maps from 1942, 1945, 1951, 1955, 1958, 1962, and 1964 did not show any evidence of this range (ERI, 2011). Two representative aerial maps (1950 and 1964) are presented in **Attachment B**.

Based on the results of the findings of the historical aerial photography analysis indicating the site never existed, and that no munition related items were found during the intrusive investigation, no further action is recommended for this site.

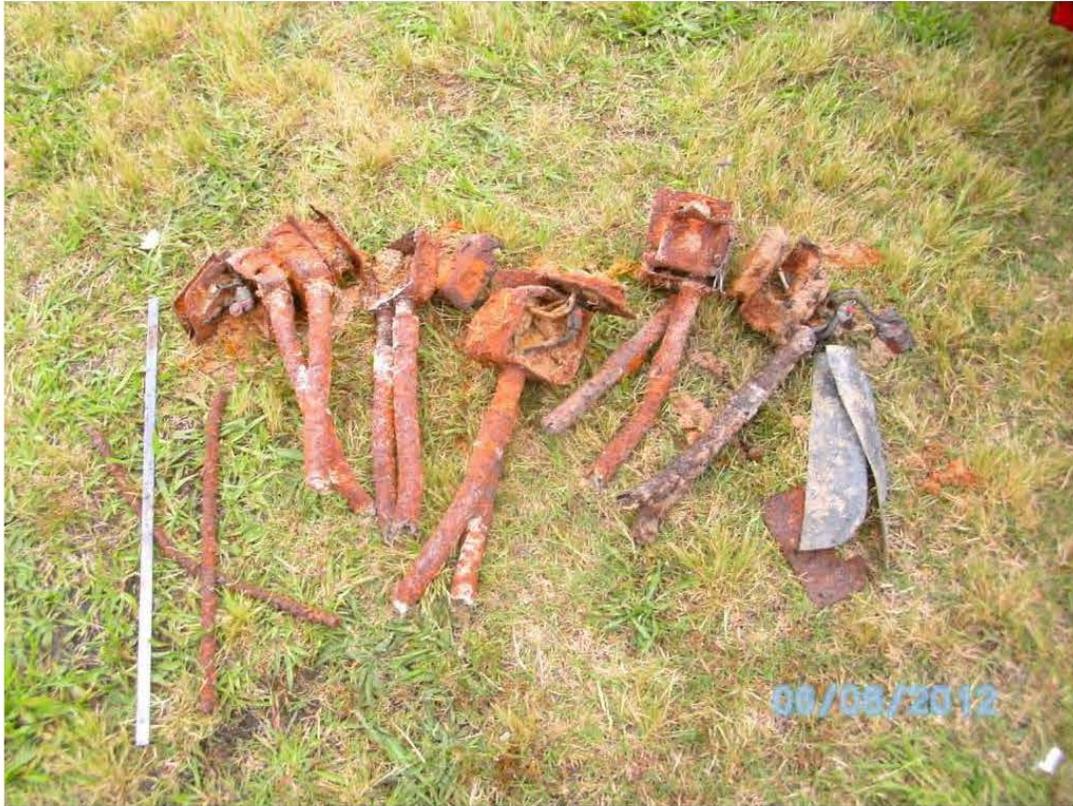
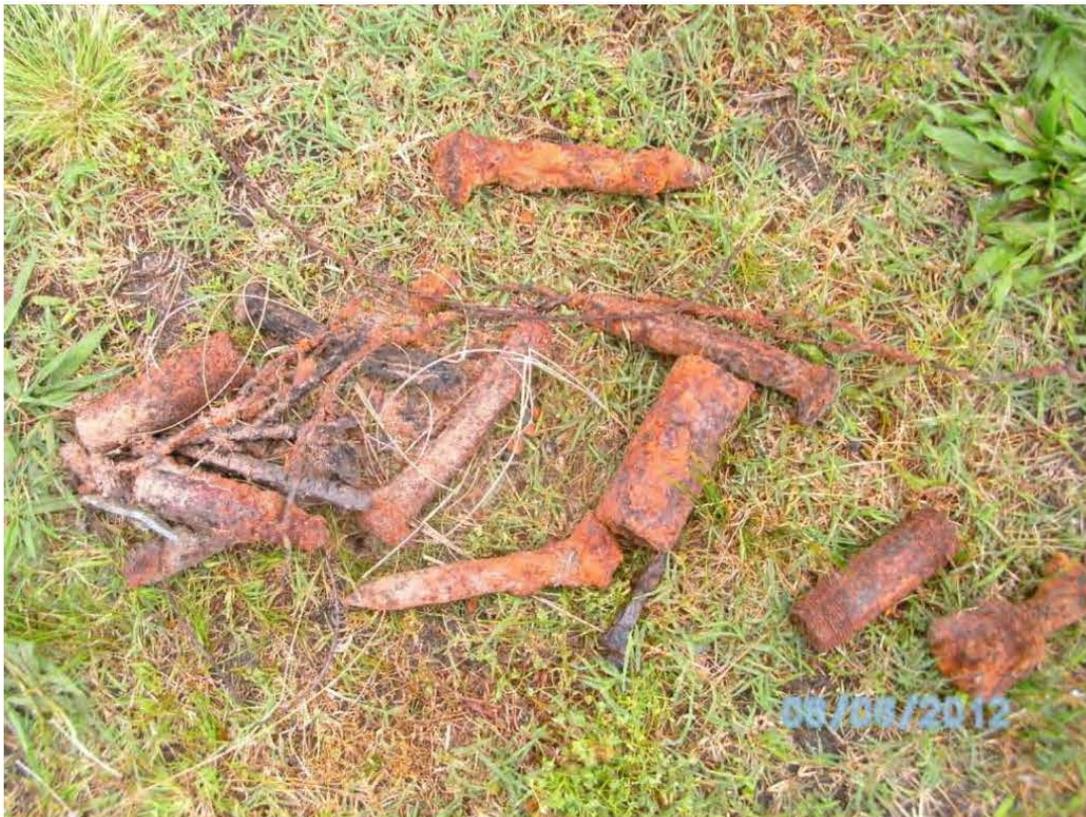
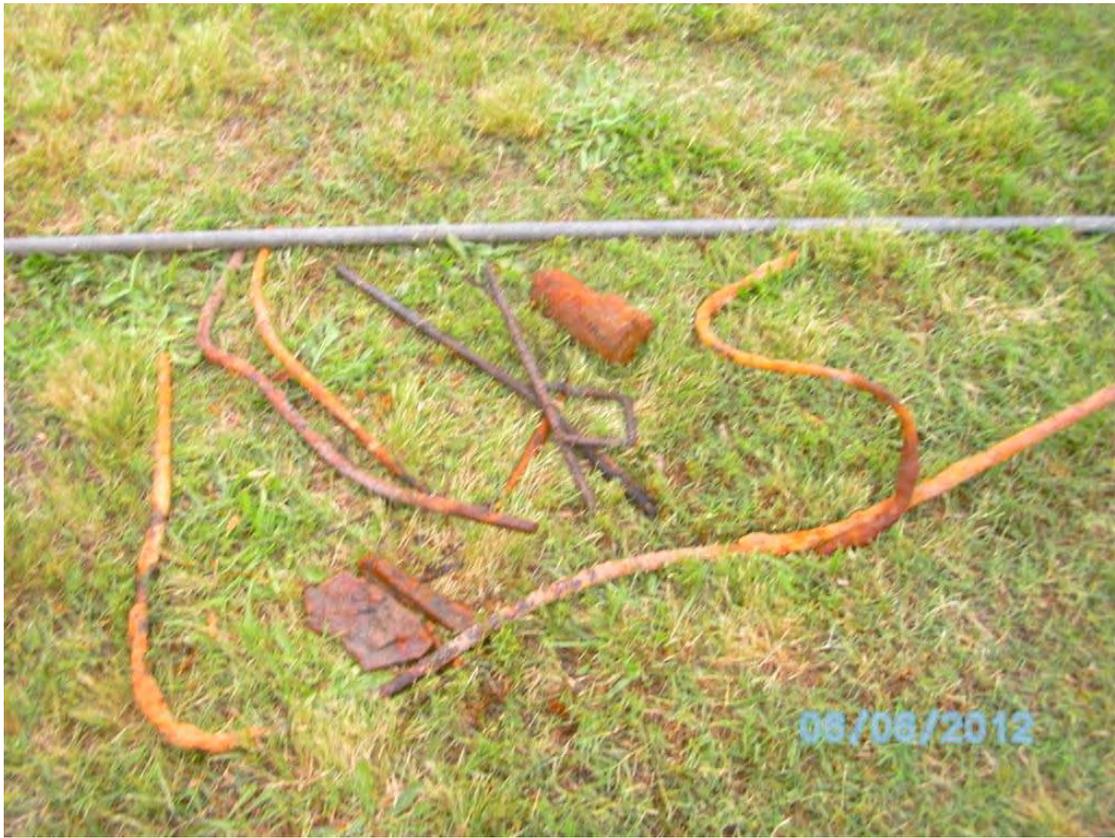
Cultural Debris Items

Intrusive investigation activities were conducted on June 4 through June 6, 2012. NAEVA Geophysics of Charlottesville, Virginia, was subcontracted to re-acquire the position of the geophysical anomalies previously identified, using RTK GPS; and USA Environmental of Oldsmar, Florida, was subcontracted to provide unexploded ordnance (UXO) technicians to excavate the selected anomalies. The description and disposition of Priority 1 anomalies excavated during intrusive activities is presented in **Table 2**. No MEC items, only cultural debris items, were discovered in the MIA during the intrusive investigation; therefore further investigation is not warranted at the site. Photographs of the cultural debris items removed during intrusive activities are presented in **Attachment A**.

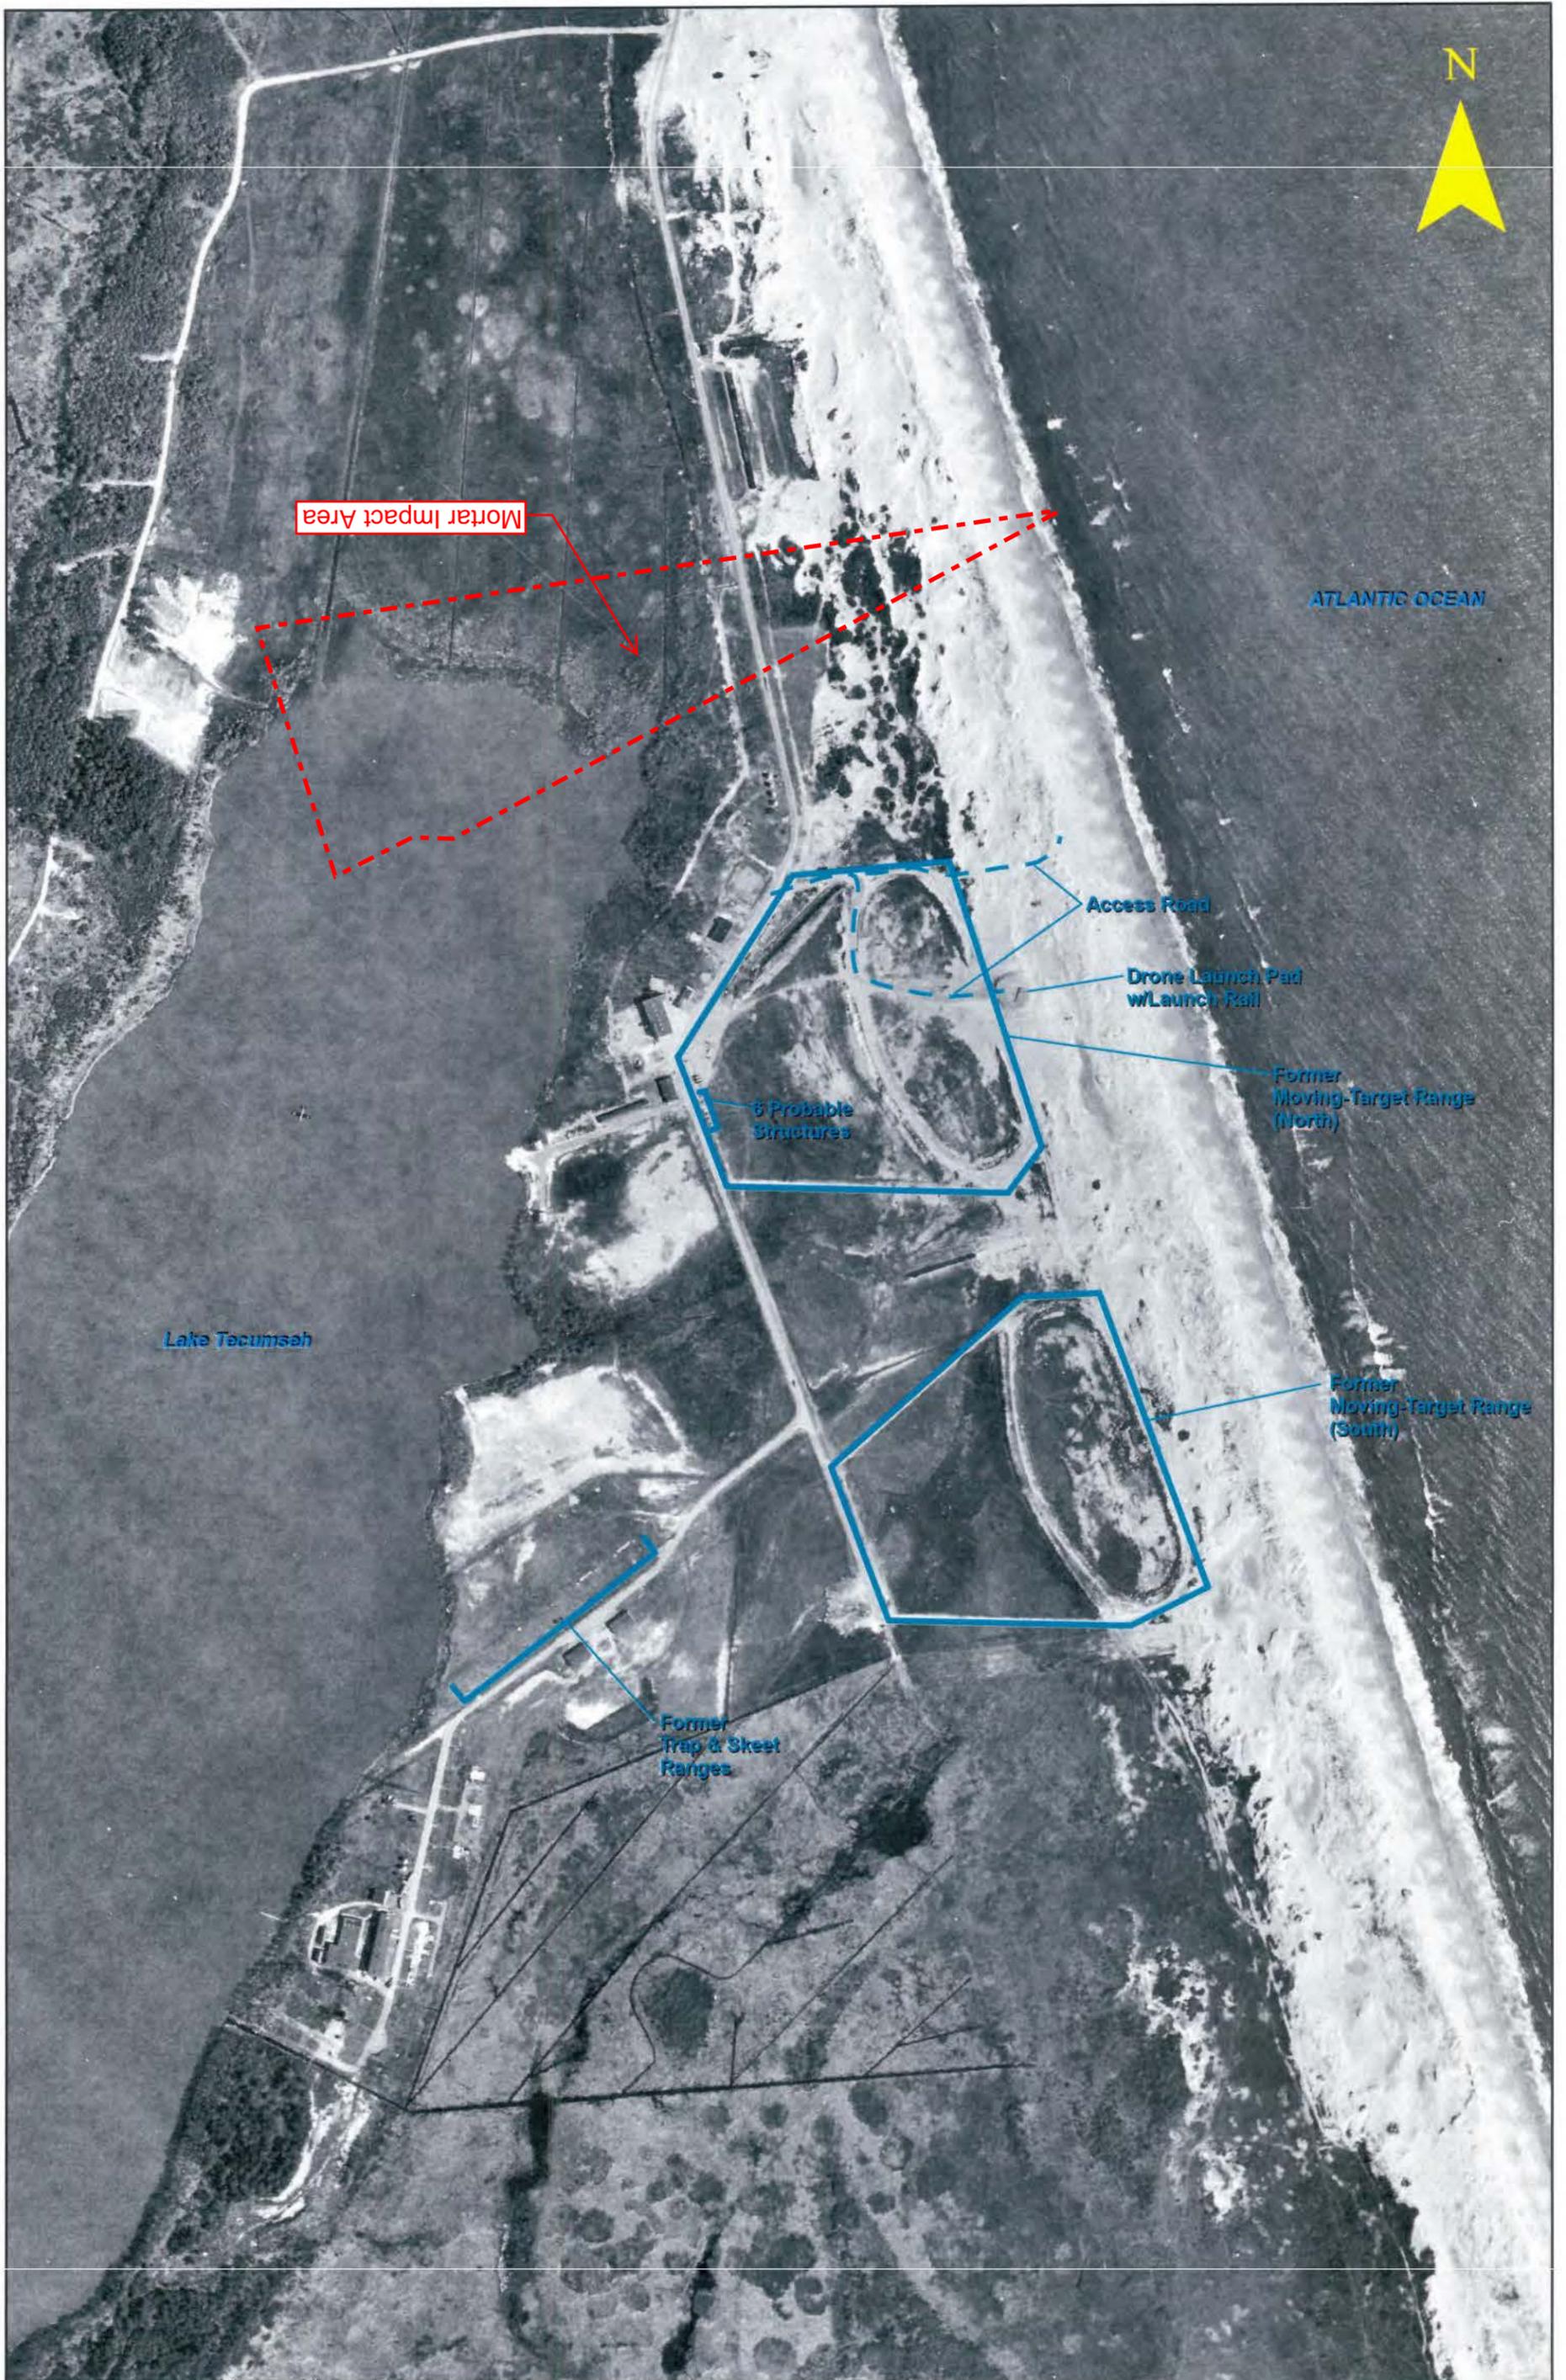
Figure 4
Dam Neck Annex, Virginia

April 18, 1951
Analysis Print

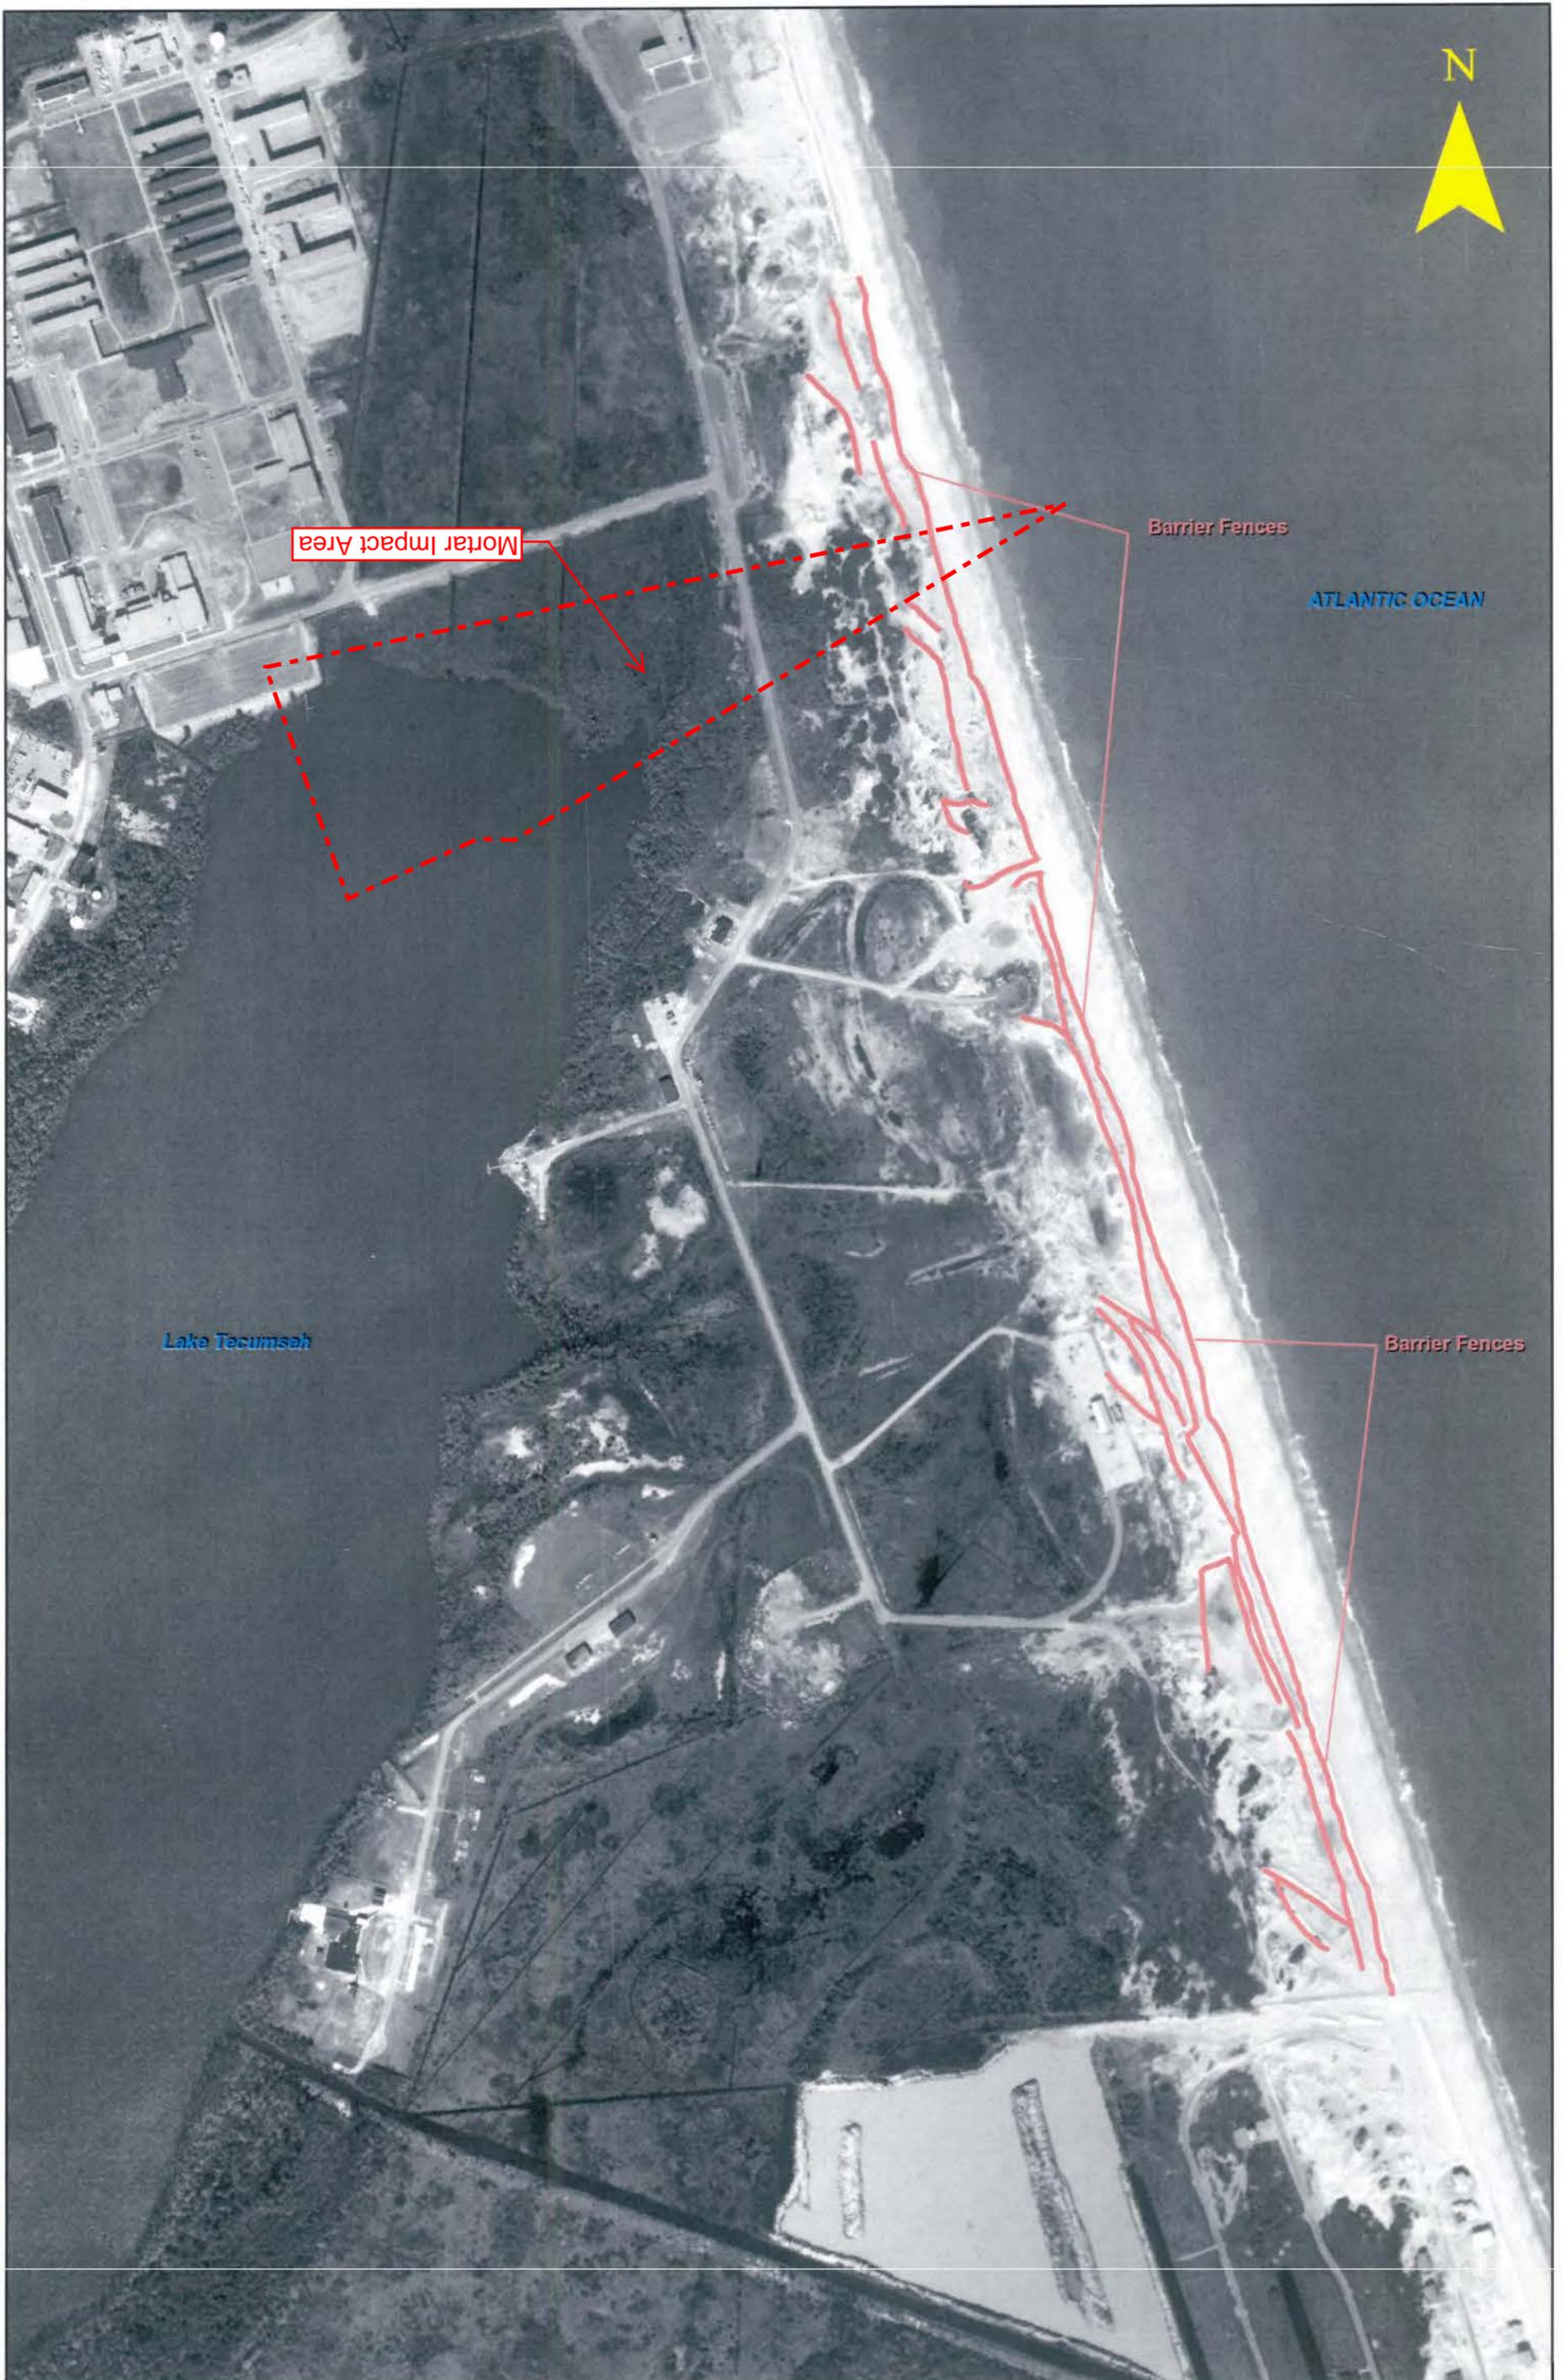
Figure 8
Dam Neck Annex, Virginia

October 25, 1964
Analysis Print
