IR Site Inspections – 1st Quarter 2006

St. Juliens Creek Annex, Chesapeake, Virginia

PREPARED FOR: Agnes Sullivan/NAVFAC Mid-Atlantic
INSPECTIONS CONDUCTED BY: Rebekah Ives/CH2M HILL - VBO
Agnes Sullivan/NAVFAC Mid-Atlantic
DATE: March 31, 2006

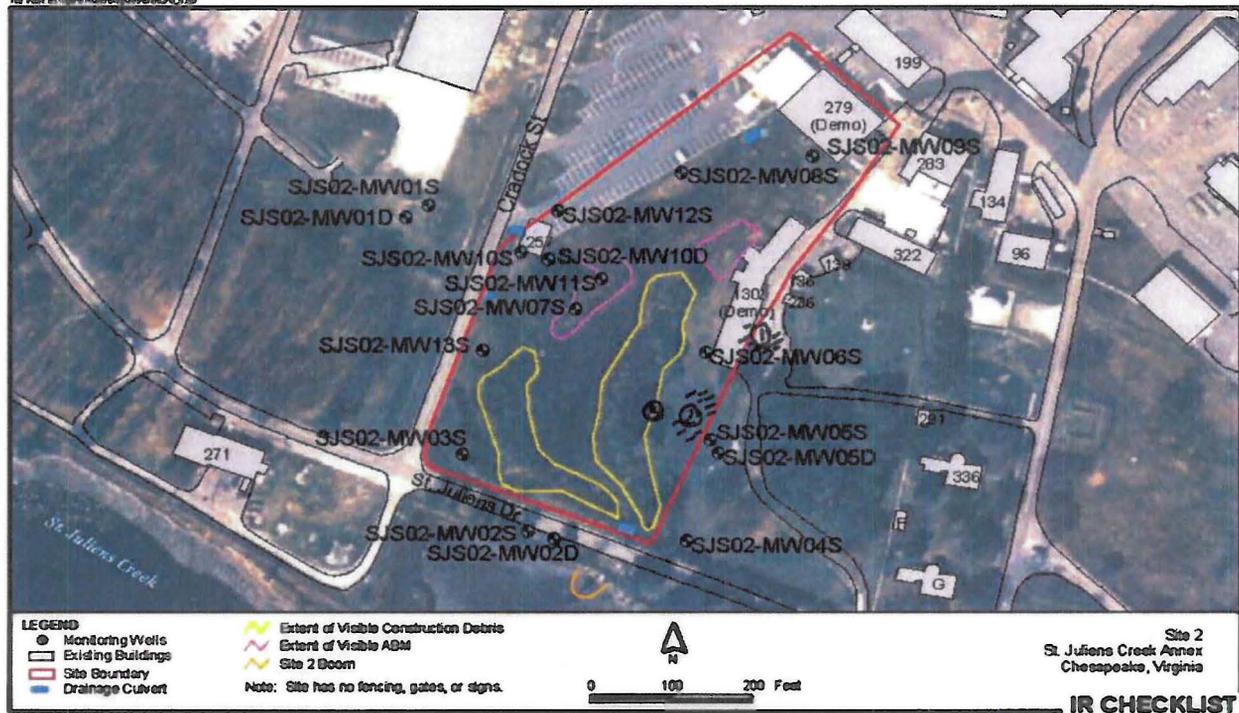
Site 2 - Waste Disposal Area B
St. Juliens Creek Annex, Chesapeake, Virginia

At the time of the inspection, there were no signs of unauthorized intrusive activities within the site or in the vicinity. Soil disturbances in the form of tire ruts were still noted in the field adjacent to monitoring wells SJS02-MW05S and SJS02-MW05D, as they were in the last inspection. However, vegetative regrowth in this area continues to be evident. This area should be assessed during the next quarterly site inspection to ensure the continuation of vegetative re-growth. A wood pallet was also observed in the same vicinity.

Four wood pallets and two wood beams were located near the southeastern corner of previously demolished Building 130. These pallets were utilized during the Site 21 temporary and monitoring well installation activities conducted in November 2005. They will be utilized during upcoming IR site activities and taken off-site at the demobilization of the project.

- ① - 4 wood pallets + 2 wood beams - Question #3
- ② - Tire ruts - Question #3
- ③ - Wood pallet - Question #3

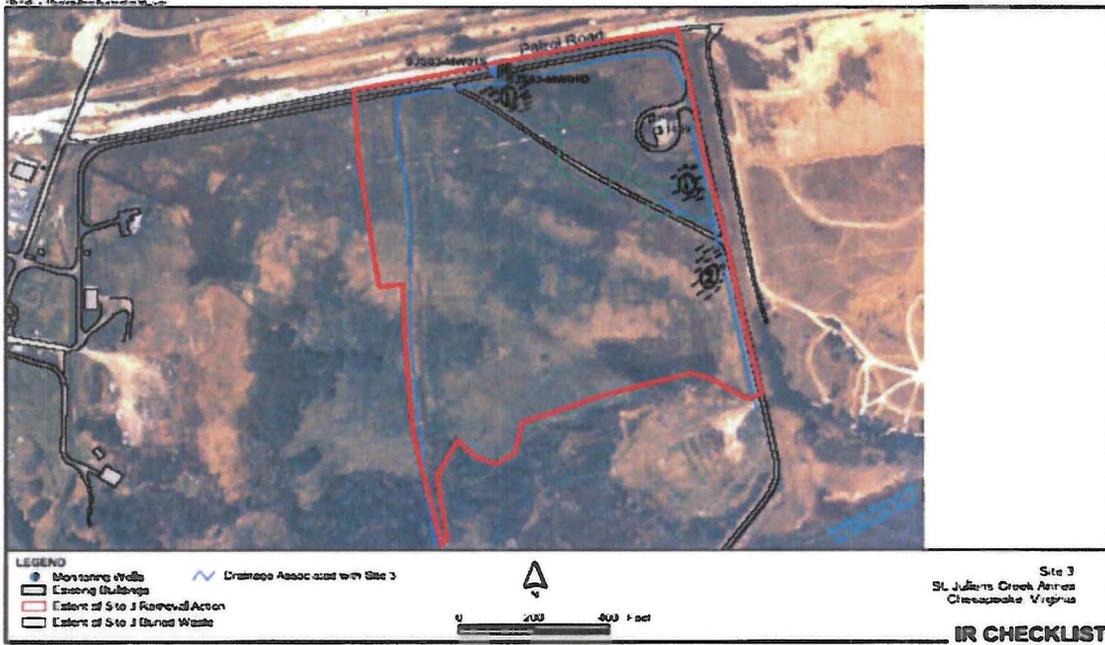
Site 3 - Waste Disposal Area C
St. Juliens Creek Annex, Chesapeake, Virginia

Ponded surface water was observed in two locations paralleling the cut-through road at Site 3. Additionally an area of depressed ground with wetland type vegetative growth was evident along the eastern drainage ditch. At the southern end of the Site 3 eastern drainage ditch, the culvert appeared to be clogged and not draining. It is recommended that the culvert be unclogged or replaced to promote Site 3 drainage and prevent potential impacts to the soil cover at Site 4, located just south of Site 3.

- ① Ponded areas on-site due to poor drainage - Question #4
- ② Depressed area w/ evidence of previous ponding - Question #4

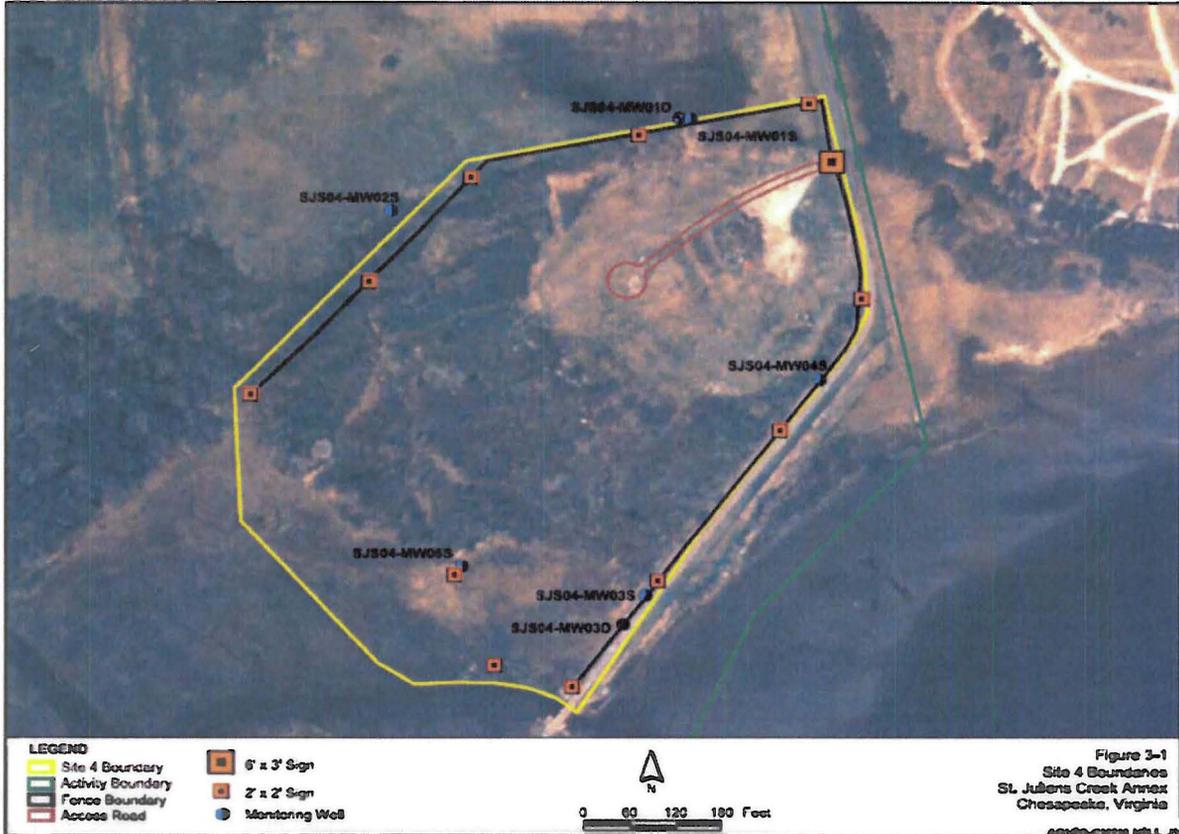
Figure 3-1
 Site 4 Boundaries
 St. Juliens Creek Annex
 Chesapeake, Virginia

At the time of the inspection, there were no signs of unauthorized intrusive activities and no IDW storage was observed within the site or in the vicinity. The soil cover at Site 4 was completed in October 2005. The drainage ditches were in good condition and all monitoring wells, including casings and bollards were in good condition. Furthermore, the signs indicating the site boundary and the fence enclosing the site were in good condition.

Note: signs were in good condition - question #5

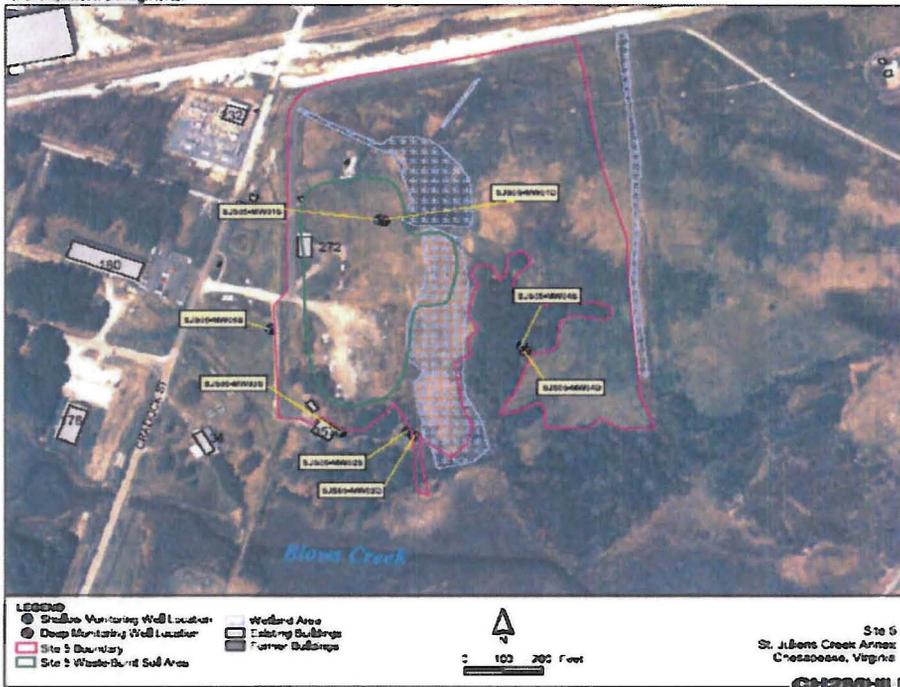
Site 5 - Burning Grounds
St. Juliens Creek Annex, Chesapeake, Virginia

At the time of the inspection, there were no signs of unauthorized intrusive activities and no IDW storage was observed within the site or in the vicinity. The area was free of identifiable concerns. All of the Site 5 monitoring wells, including casings and bollards were in good condition. Furthermore, the signs indicating the site boundary were in good condition.

Note: signs in good condition

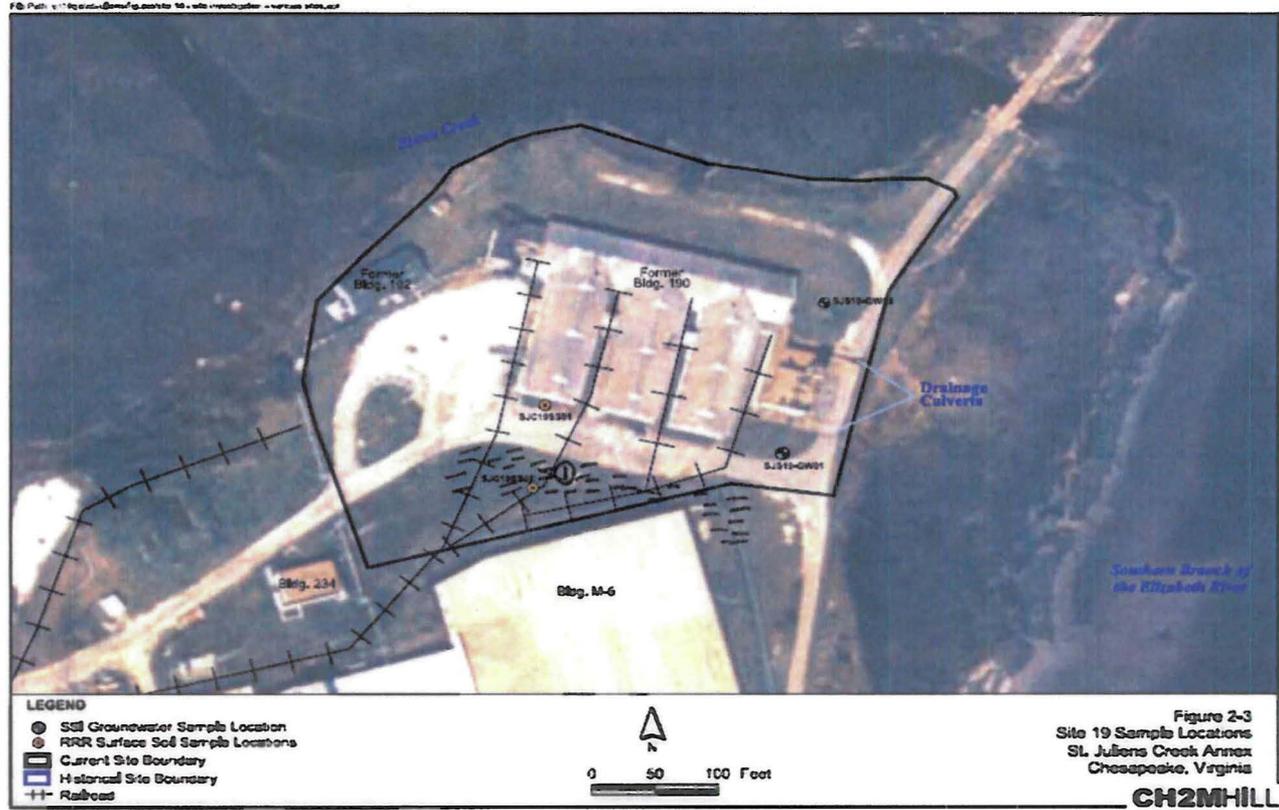
Figure 2-3
Site 19 Sample Locations
St. Jullens Creek Annex
Chesapeake, Virginia

At the time of the inspection, there were no signs of unauthorized intrusive activities and no IDW storage was observed within the site or in the vicinity. However, nine piles of soil, (approximately 4' x 6' x 6') were observed in the southern portion of the site and in the vicinity of the metallic slag. The Navy representative had previously been identified of the situation and contacted the individual responsible.

① - Nine piles of soil, approximately 4' x 6' x 6' around metallic slag area. - Question #3

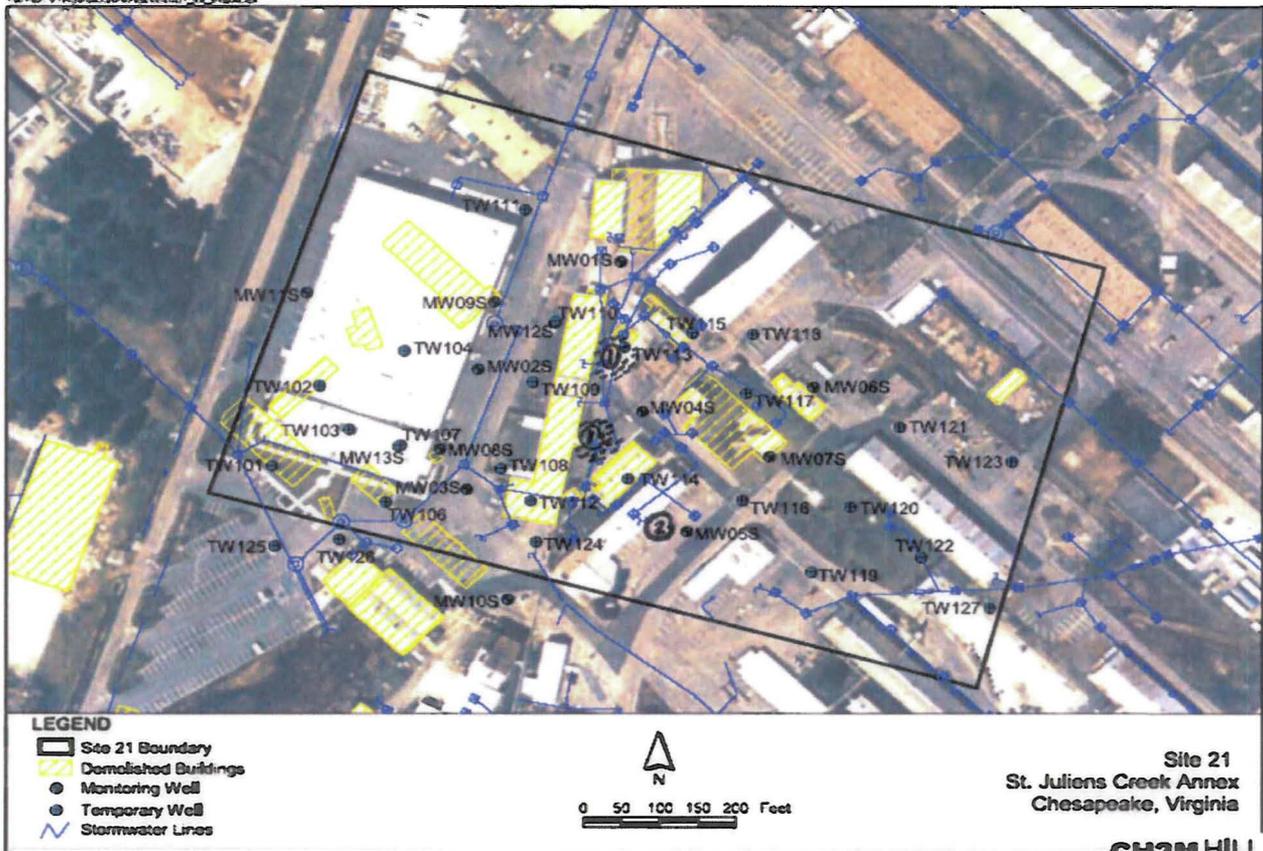
Site 21
 St. Juliens Creek Annex
 Chesapeake, Virginia

At the time of the inspection, there was evidence of intrusive activities within the site boundary. Construction equipment and two open excavations were observed. One excavation (approximately 12' by 8' by 5') was present during the last inspection east of monitoring well SJS21-MW09S. This excavation appeared to be in the same condition as

before, with the exception of some new trash. The new excavation was approximately 4' by 4' by 8' and had standing water in it. The excavation is located in an area of potential groundwater contamination. The existing groundwater and storm water analytical data, and a comparison of the groundwater data to non-hazardous disposal criteria were provided to the Navy on September 6, 2005. The most recent data, collected in October and November 2005 has also been provided to the Navy. The Navy will make further contact with the public works department.

Additionally, a 55-gallon Super D-3 Diesel engine oil drum is staged in the vicinity of SJS21-MS05S. The drum is properly labeled and staged on a pallet. No secondary containment was observed. The drum is approximately 30 feet from a flammable tanker truck. Between the two items is an Ingersoll-Rand generator labeled as an ignition source.

① - Excavation area to repair stormwater lines. Old excavation (12'x8'x5') still present w/ trash in hole. New excavation (24'x4'x8'). Standing H₂O in hole - construction equipment nearby - Question # 1.

② - 55 gallon Super D-5 Diesel engine oil drum staged by MW058. Drum approximately 20' S/E of flammable tankers. Between the two is an Ingersoll-Rand generator (ignition source). - Question # 2.
