IR Site Inspections - 1st Quarter 2007

St. Juliens Creek Annex, Chesapeake, Virginia

DATE: March 26, 2007

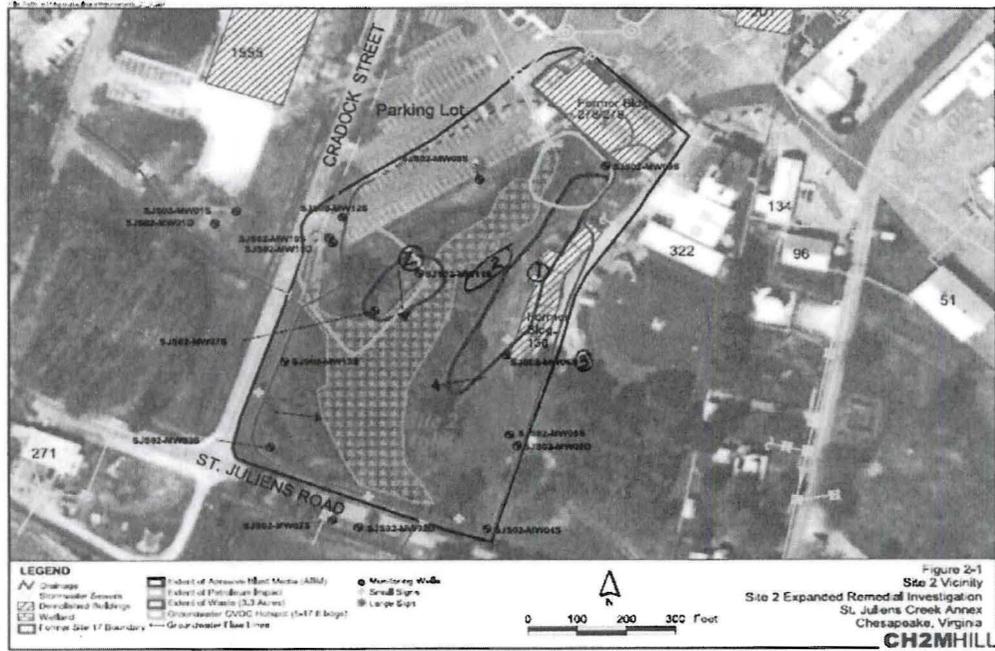
Site 2 - Waste Disposal Area B
St. Juliens Creek Annex, Chesapeake, Virginia

At the time of the inspection, there were no signs of intrusive activities within the site or in the immediate vicinity. The soil disturbances caused by tire ruts in the field adjacent to monitoring wells SJS02-MW05S and SJS02-MW05D, noted during previous inspections, were visible. However, vegetative re-growth in the area has been successful.

IDW resulting from sampling activities at Sites 4 and 21, conducted in February 2007, was located on the site in the vicinity of former Building 130. The IDW was stored on secondary containment, properly labeled, and is pending analysis and disposal. No signs of dumping of chemicals were observed. However, concrete and wood debris, also observed during previous inspections, remain in the wooded areas of the site. A couch, two railroad ties, and a wooden pallet were observed adjacent to the site, near the southeastern corner of previously demolished Building 130. The wooden pallet was used during a previous investigation and will be removed during the IDW disposal activities.

- ① IDW staging area: Drums staged on secondary containment and properly labeled - Question 2.
- ② Concrete and wood debris - Question 3.
- ③ Couch, wooden pallet, and two railroad ties discarded adjacent to site boundary - Question 3.

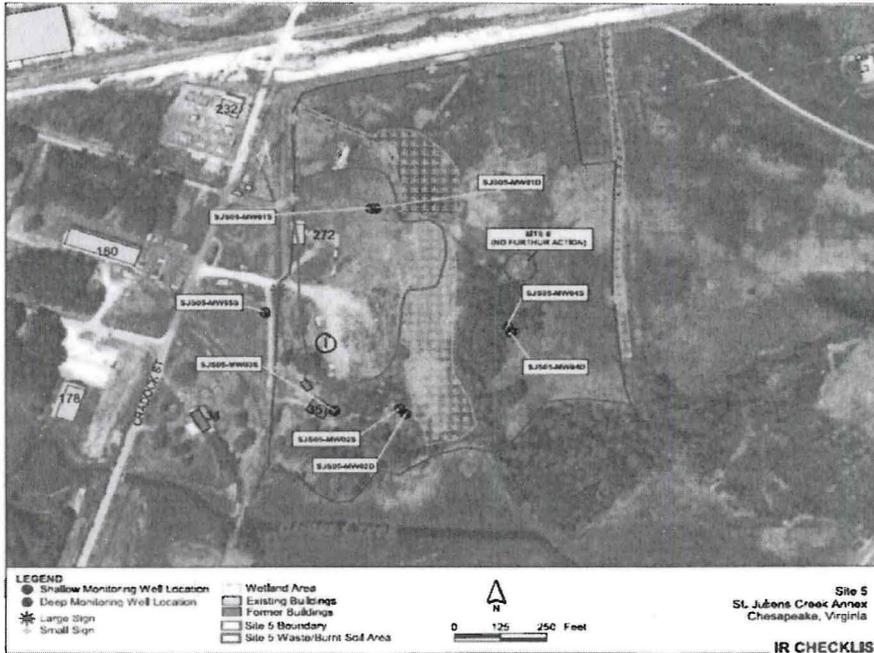
Site 5
St. Juliens Creek Annex
Chesapeake, Virginia

At the time of the inspection, there were no signs of intrusive activities and no IDW storage was observed within the site or in the vicinity. A pallet and pile of soil were observed in the southwestern area of the site. These items have been observed at the site during previous site visits. All of the Site 5 monitoring wells, including casings and bollards, were in good condition. Furthermore, the signs indicating the site boundary were in good condition.

① Pallet and soil pile - Question 3.

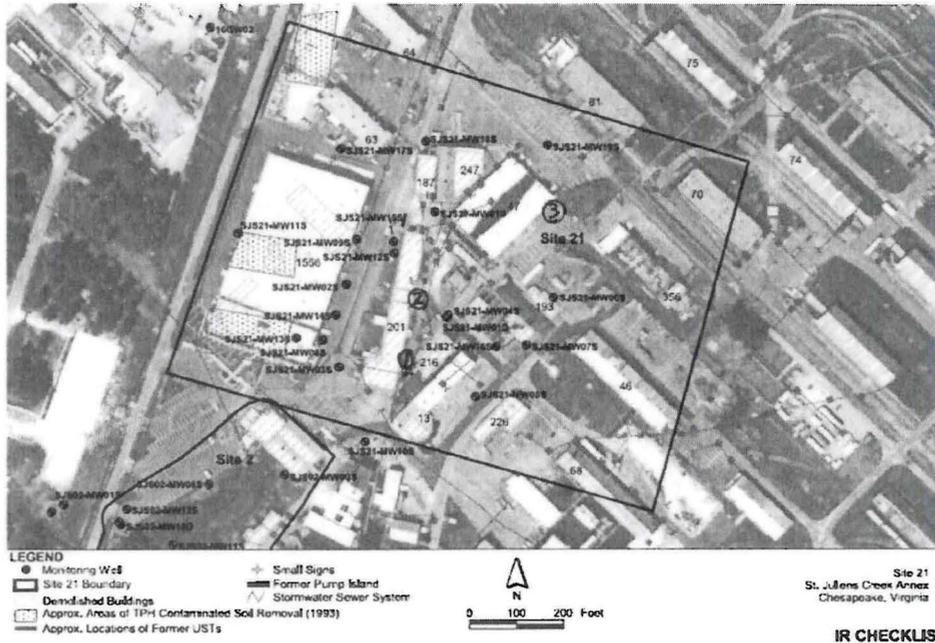
Site 21 - Industrial Area

At the time of the inspection, evidence of intrusive activities was observed within the site boundary. Two open excavations, also noted during previous site inspections, were present in the vicinity of former Building 201. The northern excavation (approximately 12' x 8' x 5') and southern excavation (approximately 4' x 4' x 8') appeared to be in similar condition as during the previous inspection, both excavations contained standing water. Facility Operations personnel have indicated that the excavations are a result of ongoing storm sewer line repairs and will be backfilled when repairs are complete. The extent of the northern excavation will not change, but the southern excavation will be extended approximately 20 feet west into the parking lot towards Building 1556 to repair the drop inlet and connected piping. The excavations are located in an area of potential groundwater contamination. The existing groundwater and storm water analytical data, and a comparison of the groundwater data to non-hazardous disposal criteria were provided to the NAVFAC Mid-Atlantic Remedial Project Manager (RPM). The RPM will coordinate with Facilities Operations as necessary through the remaining repair activities.

The drum observed during the previous site inspection, has been removed from the site. Four 55-gallon steel drums were observed in the parking lot east of Building 47 during the inspections. The drums were staged on a pallet without secondary containment. Labels on the drums identified the contents as diesel engine antifreeze/coolant. Miscellaneous construction and wood debris was observed throughout the site, which is expected due to the industrial nature of the site.

- ① Storm sewer excavation: 5' x 5' x 8', with standing water, appears abandoned - Question 1.
- ② Storm sewer excavation: 12' x 7' x 5', with standing water, appears abandoned - Question 1.
- ③ Four 55-gallon drums labeled "Diesel Engine/Antifreeze/Coolant" staged on a pallet in parking lot east of Building 47. - Question 3.

All site monitoring wells were in good condition. Furthermore, the signs indicating the site boundary were in good condition. The phrase "No Access Allowed" will be removed from the signs, based on the RPM's request.
