ER Site Inspections – 2nd Quarter 2009

St. Juliens Creek Annex, Chesapeake, Virginia

DATE: June 23, 2009

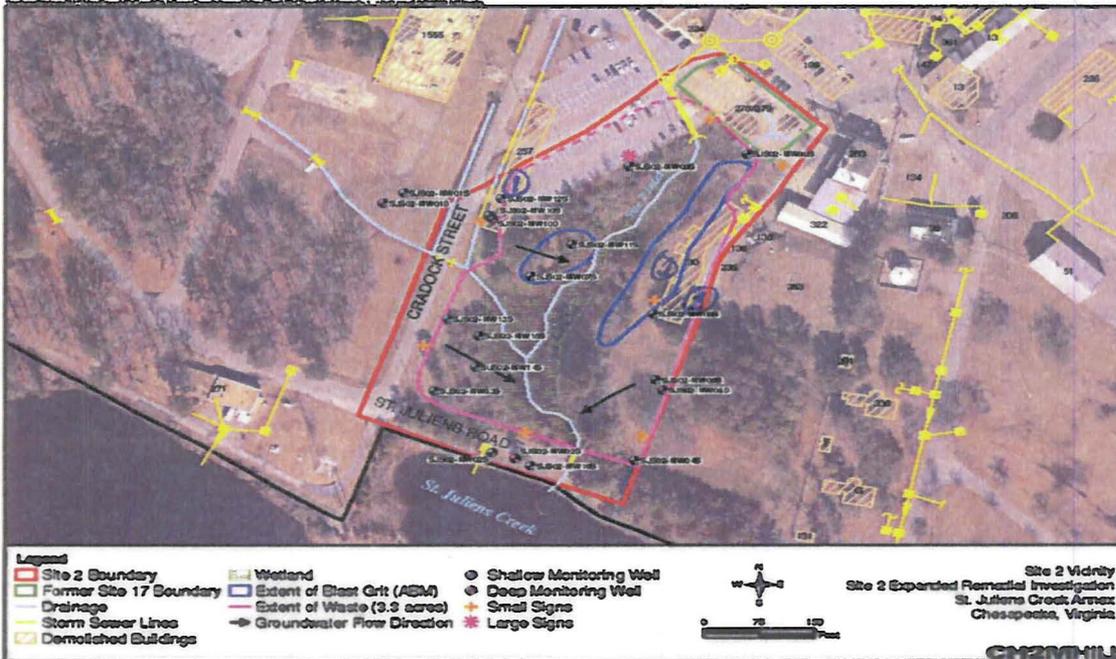
Site 2 - Waste Disposal Area B

No investigation-derived waste (IDW) was observed at the site. However, several pallets (approximately 17) used for secondary containment remain on the eastern side of the site in the vicinity of the former IDW staging area. These pallets should be removed by the contractor that used them for secondary containment. Concrete and wood debris, observed during previous inspections, remain in the wooded areas of the site. Miscellaneous debris, including a couch, a box, wood, and bottles, also observed during previous inspections, remain on the eastern edge of the site near the former IDW staging area.

All of the Site 2 monitoring wells, including casings, bollards, and locks, were in good condition, with the exception of monitoring well SJS02-MW12S. The flanges for the flush-

mount well casing of SJS02-MW12S are damaged, prohibiting bolts from functioning properly, and replacement is recommended during future site activities. The signs indicating the site boundary were in good condition and have been updated with the correct contact phone number.

- ① COATS MISSING FROM MWIR'S - QUESTION 4
- ② STACK OF PALLETS (APPROX 17) FROM OLD SECONDARY CONTAINMENTS - QUESTION 3
- ③ DEBRIS (COUCH, WOOD, BOTTLES, ETC) - QUESTION 3

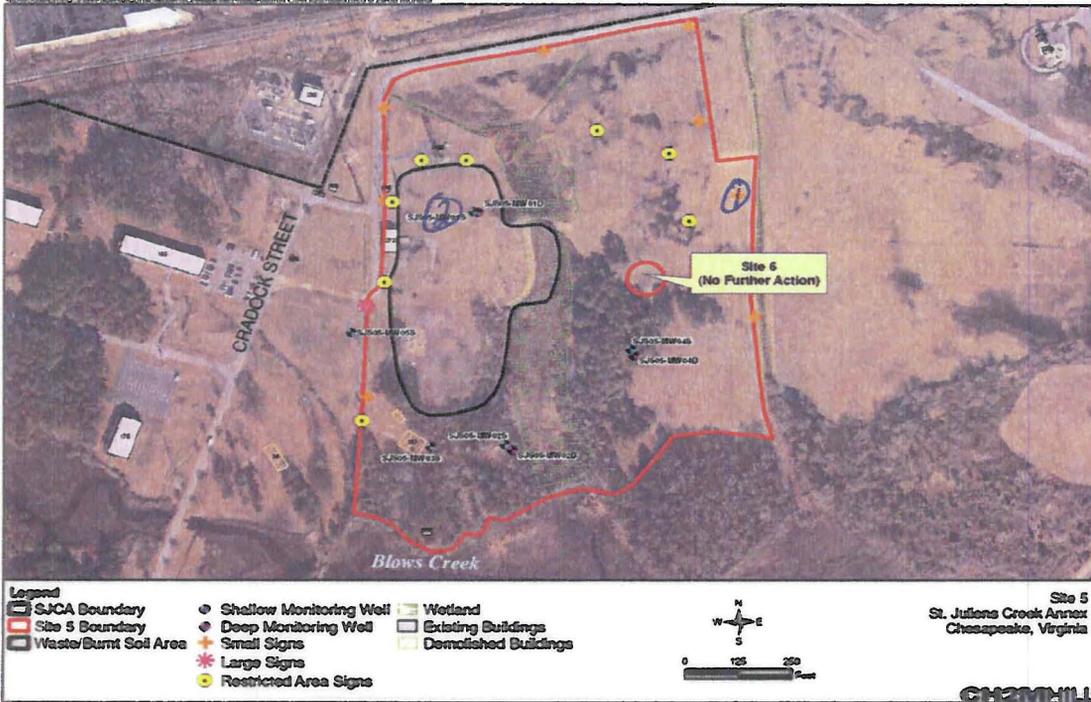
Site 5 - Burning Grounds
St. Juliens Creek Annex, Chesapeake, Virginia

At the time of the inspection, there was evidence of intrusive activities within the site (see previous site inspection reports). These activities are associated with the ongoing removal action. Erosion and sediment controls are in place and functioning for the disturbed areas. The silt fence around portions of the waste/burnt soil area is falling down and should be repaired prior to initiation of land-disturbing activities. No dumping of chemicals was observed within the site or in the vicinity. No IDW was observed on the site.

Only monitoring well SJS05-MW05S was inspected, as all other monitoring wells fall within a restricted access area due to the munitions and explosives of concern encountered at the site. Monitoring well SJS05-MW05S, including the casing, bollards, and lock, was in good condition. The signs indicating the site boundary were in good condition and have been updated with the correct contact phone number, with the exception of a sign on the eastern boundary of the site that was removed during the removal action. This sign will not be replaced because all signs are to be removed upon completion of the removal action; and therefore, it will be removed from the site inspection checklist used during future site inspections. As a result of recent mowing operations observed within the site, eight additional signs have been posted around the perimeter of the waste/burnt soil area and adjacent removal areas to identify them as a restricted area.

① SIGN MISSING - QUESTION 5
 ② ON GOING SITE ACTIVITIES/EXCAVATION - QUESTION 1
 NOTE: ONLY MWOS INSPECTED BECAUSE OF HAZARDS ASSOCIATED W/ POTENTIAL MEC.

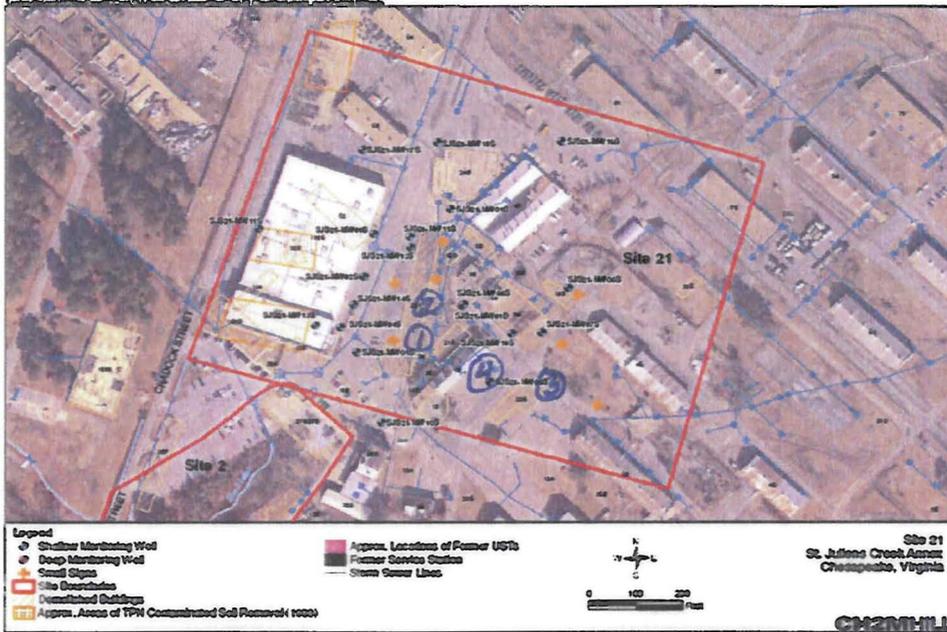
Site 21 - Industrial Area
St. Juliens Creek Annex, Chesapeake, Virginia

At the time of the inspection, evidence of intrusive activities was observed within the site boundary. Two open excavations, also noted during previous site inspections, were present in the vicinity of the former location of Building 201. The northern excavation (approximately 12' x 8' x 5'), noted during the first IR site inspections conducted during the second quarter 2005, and southern excavation (approximately 4' x 4' x 8'), first noted during the first quarter 2006 inspection, appeared to be in similar condition as during the previous inspection. Both excavations contained vegetation. Facility Operations personnel have indicated that the excavations are a result of ongoing storm sewer line repairs and will be backfilled when repairs are complete. The extent of the northern excavation will not change, but the southern excavation will be extended approximately 20 feet west into the parking lot towards Building 1556 to repair the drop inlet and connected piping. The excavations are located in an area of groundwater contamination. The existing groundwater and storm water analytical data, and results of the Remedial Investigation Human Health Risk Assessment were provided to the NAVFAC Mid-Atlantic Remedial Project Manager (RPM). The RPM will coordinate with Facilities Operations as necessary through the remaining repair activities.

The 55-gallon steel drum observed in the southeast corner of the site, near Building 68, during the previous inspection, has been removed. However, a 55-gallon drum labeled "bad gas" was present in the parking lot area behind Building 13 and three drums labeled as "oil" (likely motor oil for vehicle maintenance) were present near the corner of Building 68

(on the concrete adjacent to the fence). All of the drums appeared to be in good condition, but were not in a secondary containment.

- ① & ② OPEN EXCAVATION - QUESTION 1
- ③ 3 DRUMS (55-GALLON) - LIKELY MOTOR OIL) ADJACENT TO FENCE DUMPS IN GOOD CONDITION (FULL) NOT IN SECONDARY CONTAINMENT. - QUESTION 3
- ④ 1 RED DRUM LABELED AS "OLD GAS" NOT IN SECONDARY CONTAINMENT. APPROX 1/2 TO 3/4 FULL. - QUESTION 3

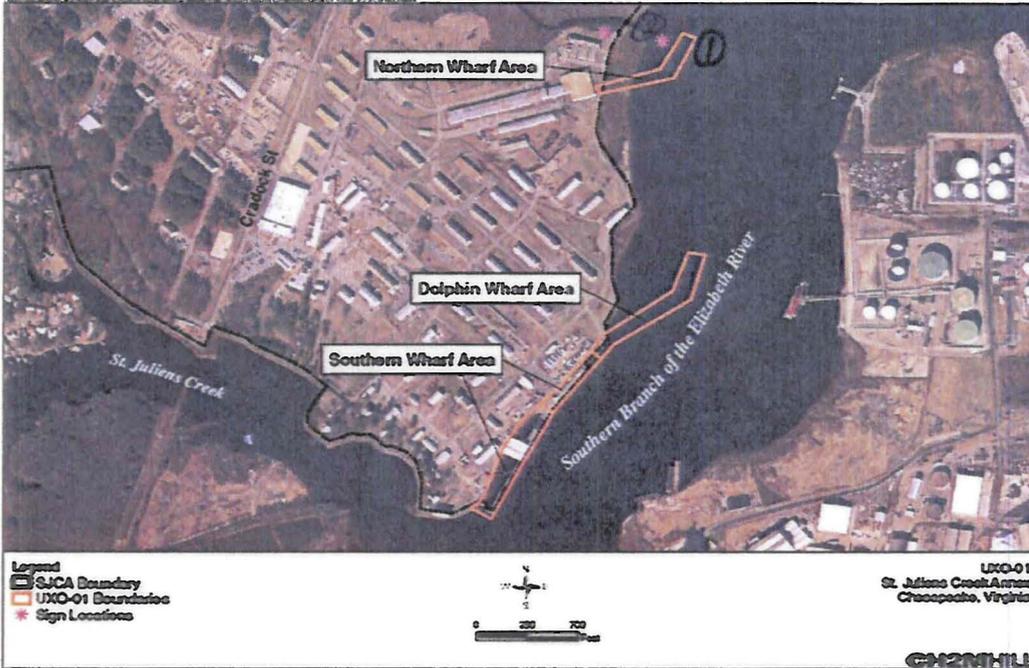
UXO 1 - Wharf Area Sediments

No intrusive activities, IDW, or abnormal debris were observed at the site during the inspection. A barge with a crane on it appeared to be anchored in the vicinity of the northern wharf. No activities were observed on the barge. It is estimated that the barge was located approximately 15 to 30 yards from the former pilings. It is recommended that this vessel be monitored to ensure intrusive activities and anchoring within the site boundaries of UXO 0001 does not occur. The signs indicating the site boundary were in good condition. The land side sign has been updated with the correct information; however, the sign located in the water will need to be updated during future site activities when a boat is available. Placement of signs in the vicinity of the southern wharf area should be considered during future site activities.

① BARGE ANCHORED IN WATER ADJACENT TO NORTHERN WHARF PILINGS. CRANE ATTACHED TO BARGE. CRANE LABELED AS "WEEKS 510" ON BOAT AND SHIP AS "WEEKS 150". NO ONBOARD ACTIVITIES OBSERVED.

② SIGN NEEDS UPDATED WITH CORRECT CONTACT INFO
